Project Name :  
Merthyr Branch  
Wales & Borders

Drawing Title :  
Trees with Bat Roost Potential

## Appendix B: Dusk Emergence / Dawn Re-entry Survey Results

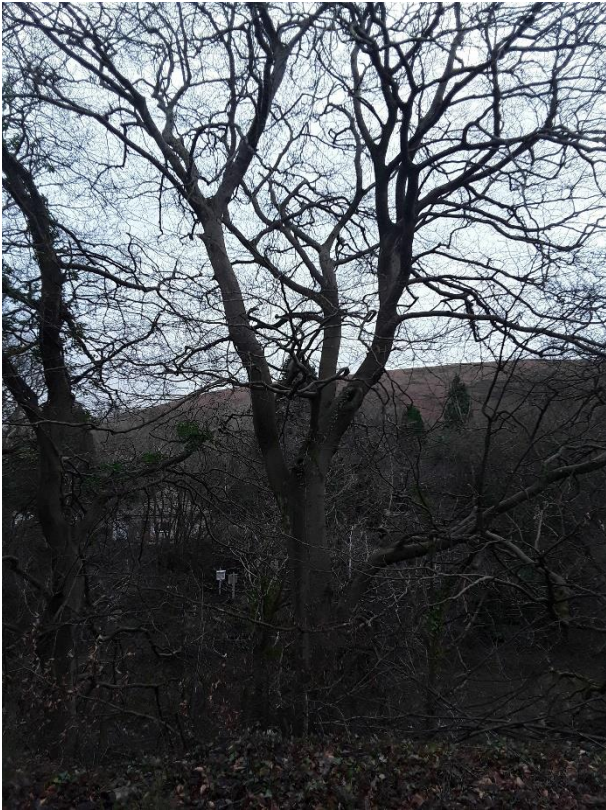
**Photo 1:** MER 1 Beech with moderate bat roost potential.

| Tree Number | Location (Grid Reference) | Location (ELR Mileage and Chain) | Survey 1 | | Survey 2 | | Notes |
|---|---|---|---|---|---|---|---|
| MER 1 | ST 08378 94927 | CAM 16m 46ch | 13/06/2021 | Dusk Emergence Survey | 18/07/2021 | Dusk Emergence Survey | No emergences recorded. Mainly P.pyg and P.pip foraging and commuting activity along rail corridor and adjacent woodland. |

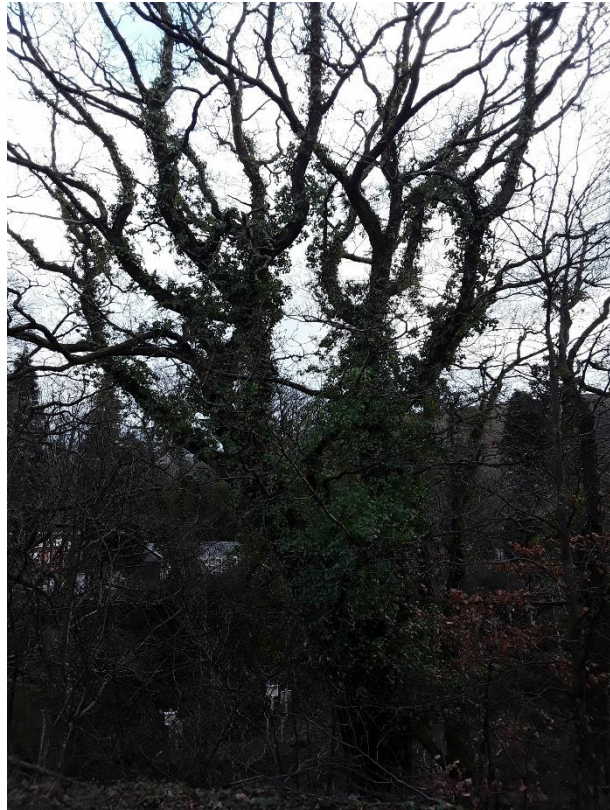
**Photo 2:** MER 2 Oak sp. with moderate bat roost potential.

| Tree Number | Location (Grid Reference) | Location (ELR Mileage and Chain) | Survey 1 | | Survey 2 | | Notes |
|---|---|---|---|---|---|---|---|
| MER 2 | ST 08386 94940 | CAM 16m 47ch | 13/06/2021 | Dusk Emergence Survey | 18/07/2021 | Dusk Emergence Survey | No emergences recorded. Mainly P.pyg activity with occasional P.pip, noctule and BLE. |

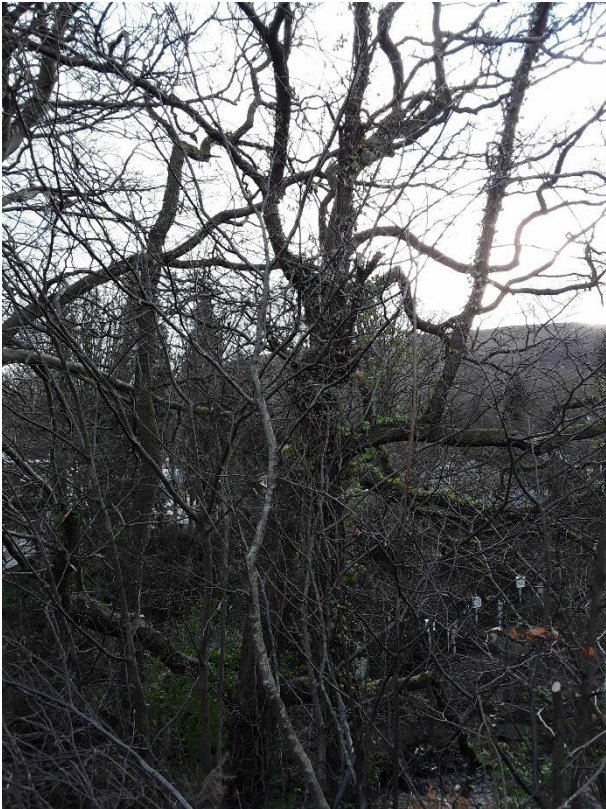
**Photo 3:** MER 3 Oak sp. with moderate bat roost potential.

| Tree Number | Location (Grid Reference) | Location (ELR Mileage and Chain) | Survey 1 | | Survey 2 | | Notes |
|---|---|---|---|---|---|---|---|
| MER 3 | ST 08391 94948 | CAM 16m 48ch | 13/06/2021 | Dusk Emergence Survey | 18/07/2021 | Dusk Emergence Survey | No emergences recorded. High P.pyg foraging activity within the understory surrounding the tree, with occasional P.pip and myotis activity. |

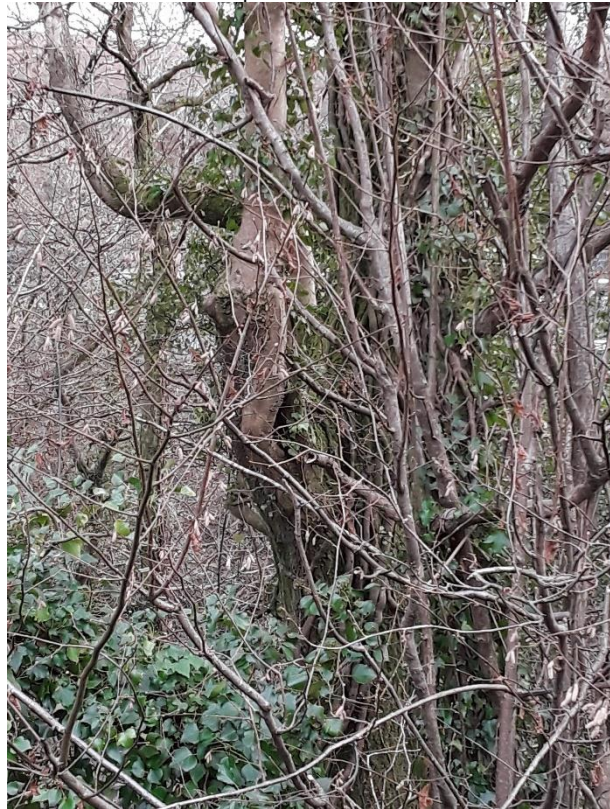
**Picture 4:** MER 4 ash with moderate bat roost potential.

| Tree Number | Location (Grid Reference) | Location (ELR Mileage and Chain) | Survey 1 | | Survey 2 | | Notes |
|---|---|---|---|---|---|---|---|
| MER 4 | ST 08465 95023 | CAM 16m 52ch | 19/07/2021 | Dusk Emergence Survey | N/A | N/A | No emergences recorded. High P.pyg and noctule foraging and commuting activity, with occasional P.pip and myotis activity. |
