| Subject | P/25/0151 - Erection of residential annexe - Y Goedwig, Cardiff Road, Treharris | Date | 30/07/25 |

BE Ecological Ltd visited Y Goedwig, Cardiff Road, Treharris to undertake a brief walk over of the site for planning permission to erect a residential annexe. As part of the works, the drive will be extended and the retaining wall pushed back to accommodate it.

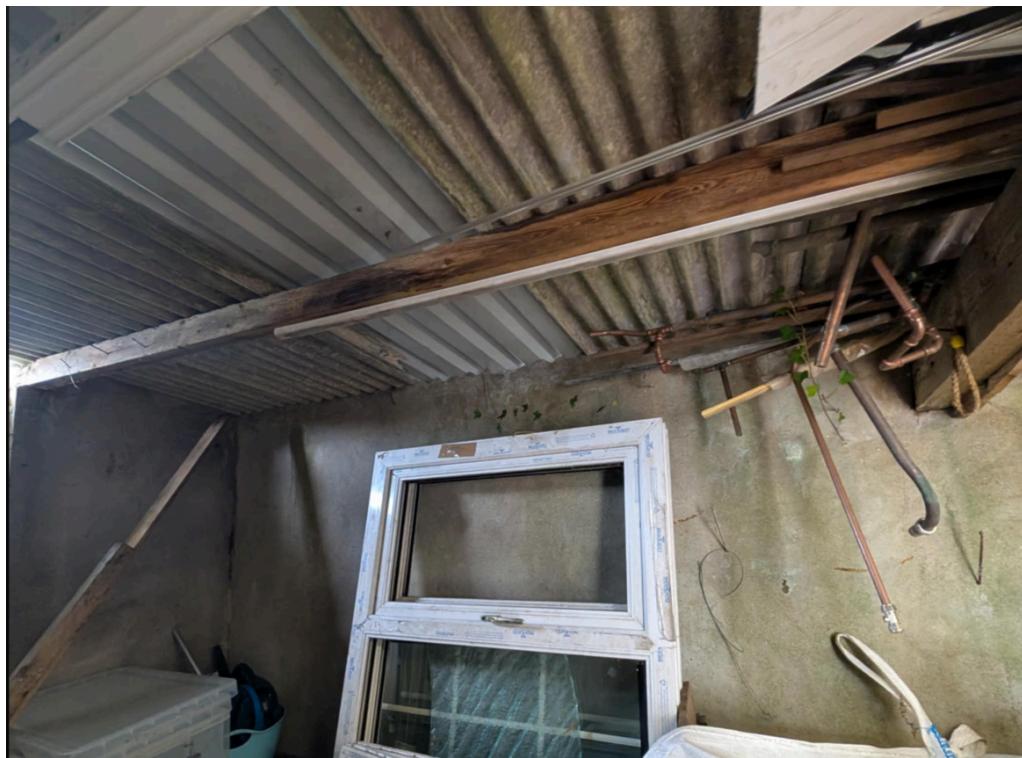
The building is a typical flat roof single skin garage. The roof comprises of asbestos and tin sheets. The wall plates are able to be seen from the interior of the building in places, the rest have the sheet material sitting on them so there is no gap present. The roof is unlined. Whilst there are some gaps beneath fascias, they are generally heavily cobwebbed with the underside able to be viewed. The garage is currently used for storage and is falling into a state of disrepair. No bats or evidence of bats or birds was noted throughout the survey. It is considered that providing the garage is dismantled in line with a method statement that no further surveys are required.

Plate 1- interior of garage

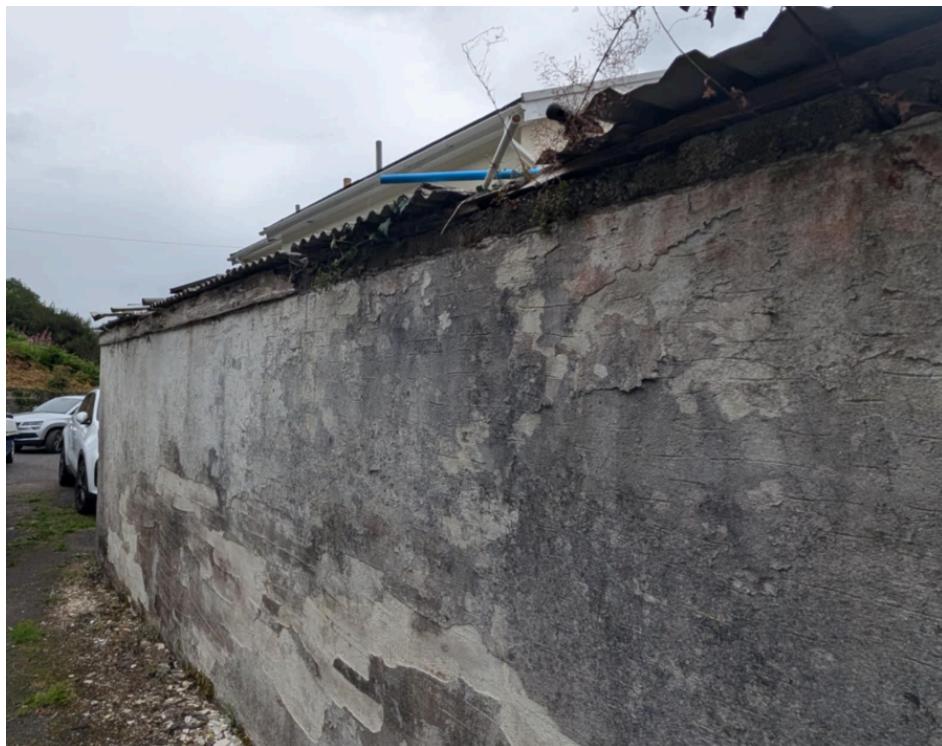
Plate 2- example of fascia and damage

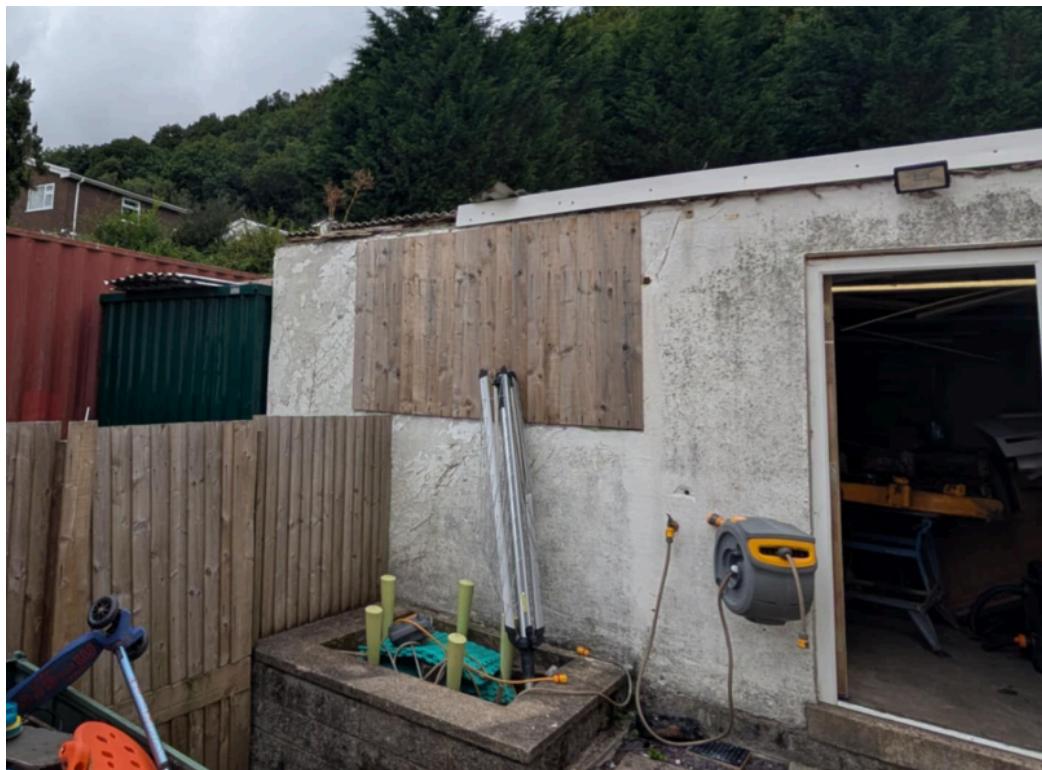
Plate 3- metal strip/fascia where the gap beneath can be viewed

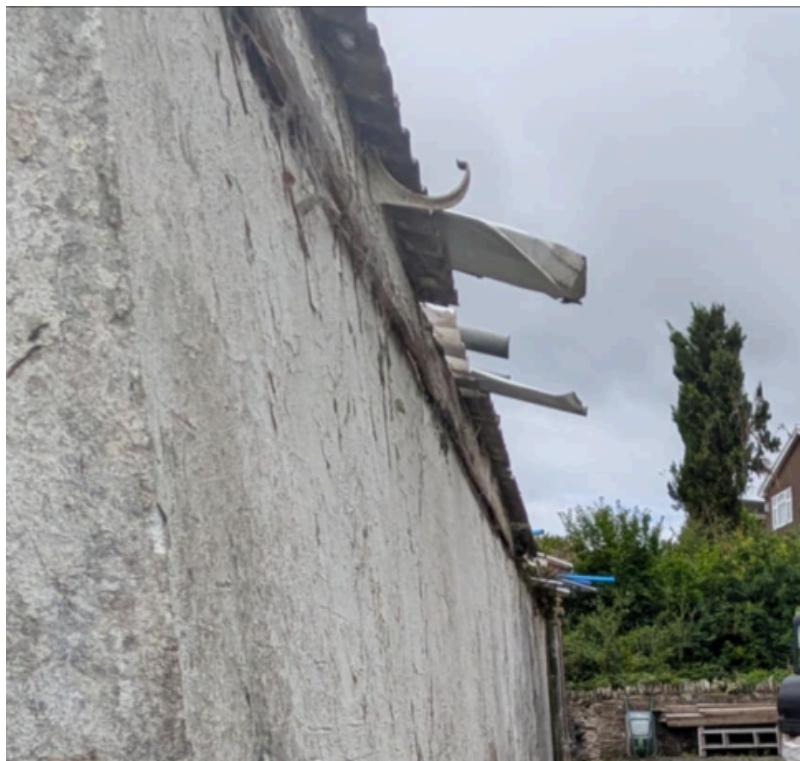
Plate 4- heavily cobwebbed fascia in places

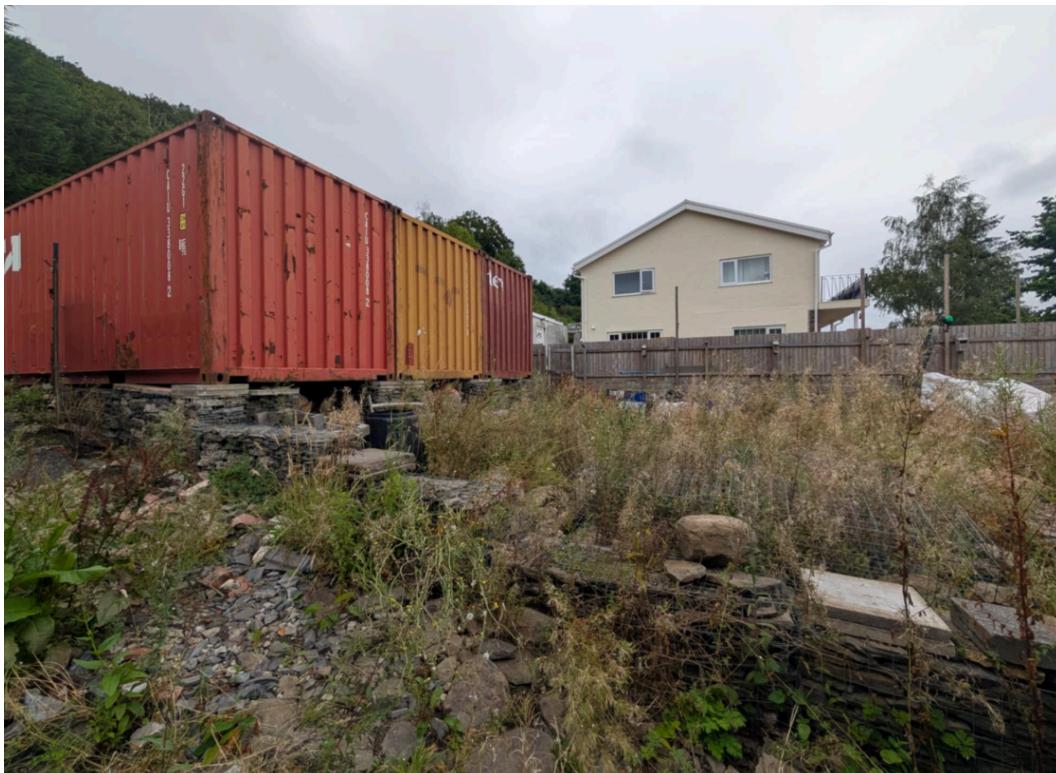
The area where the annexe will be situated comprises of hard standing and early successional vegetation such as dock, thistle, grasses and rosebay willowherb on top of what appears to be crushed stone. It is possible that small numbers of reptiles may be present within this area, however, these are likely to be limited to small numbers of slow worm or common lizard should any be present

Plate 2- Area where annexe will be sited

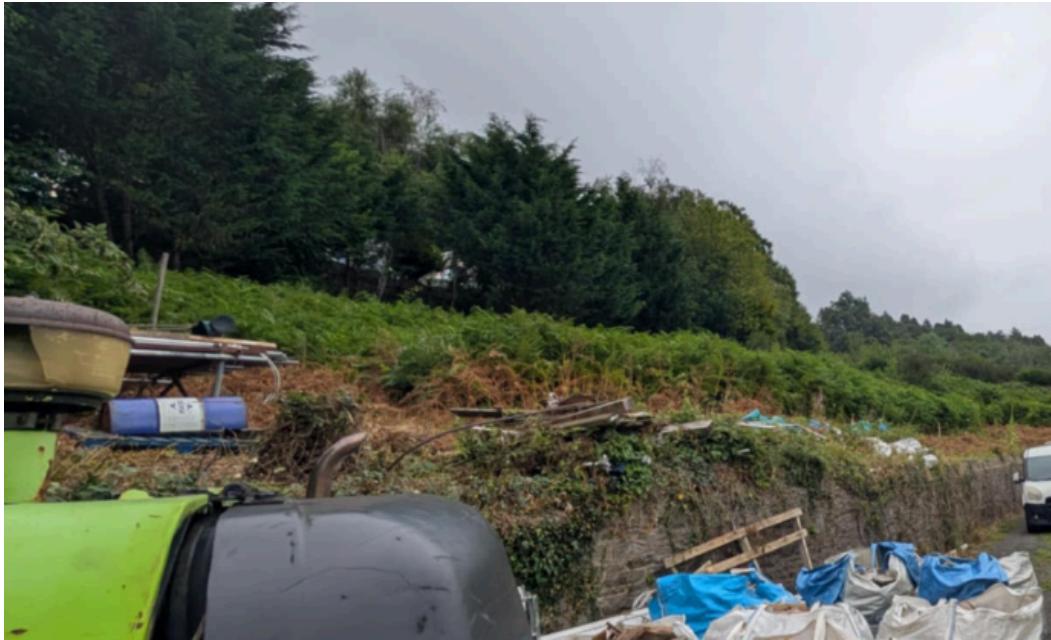
The area of ground where the retaining wall will be repositioned currently comprises of bracken which has been strimmed to ground level. There is some ivy coverage on the wall and some dumped materials.

Plate 3- retaining wall
