# Townscape Heritage Initiative Scheme

## Design & Access Statement

## Manettes Building, Pontmorlais, Merthyr Tydfil

February 2022

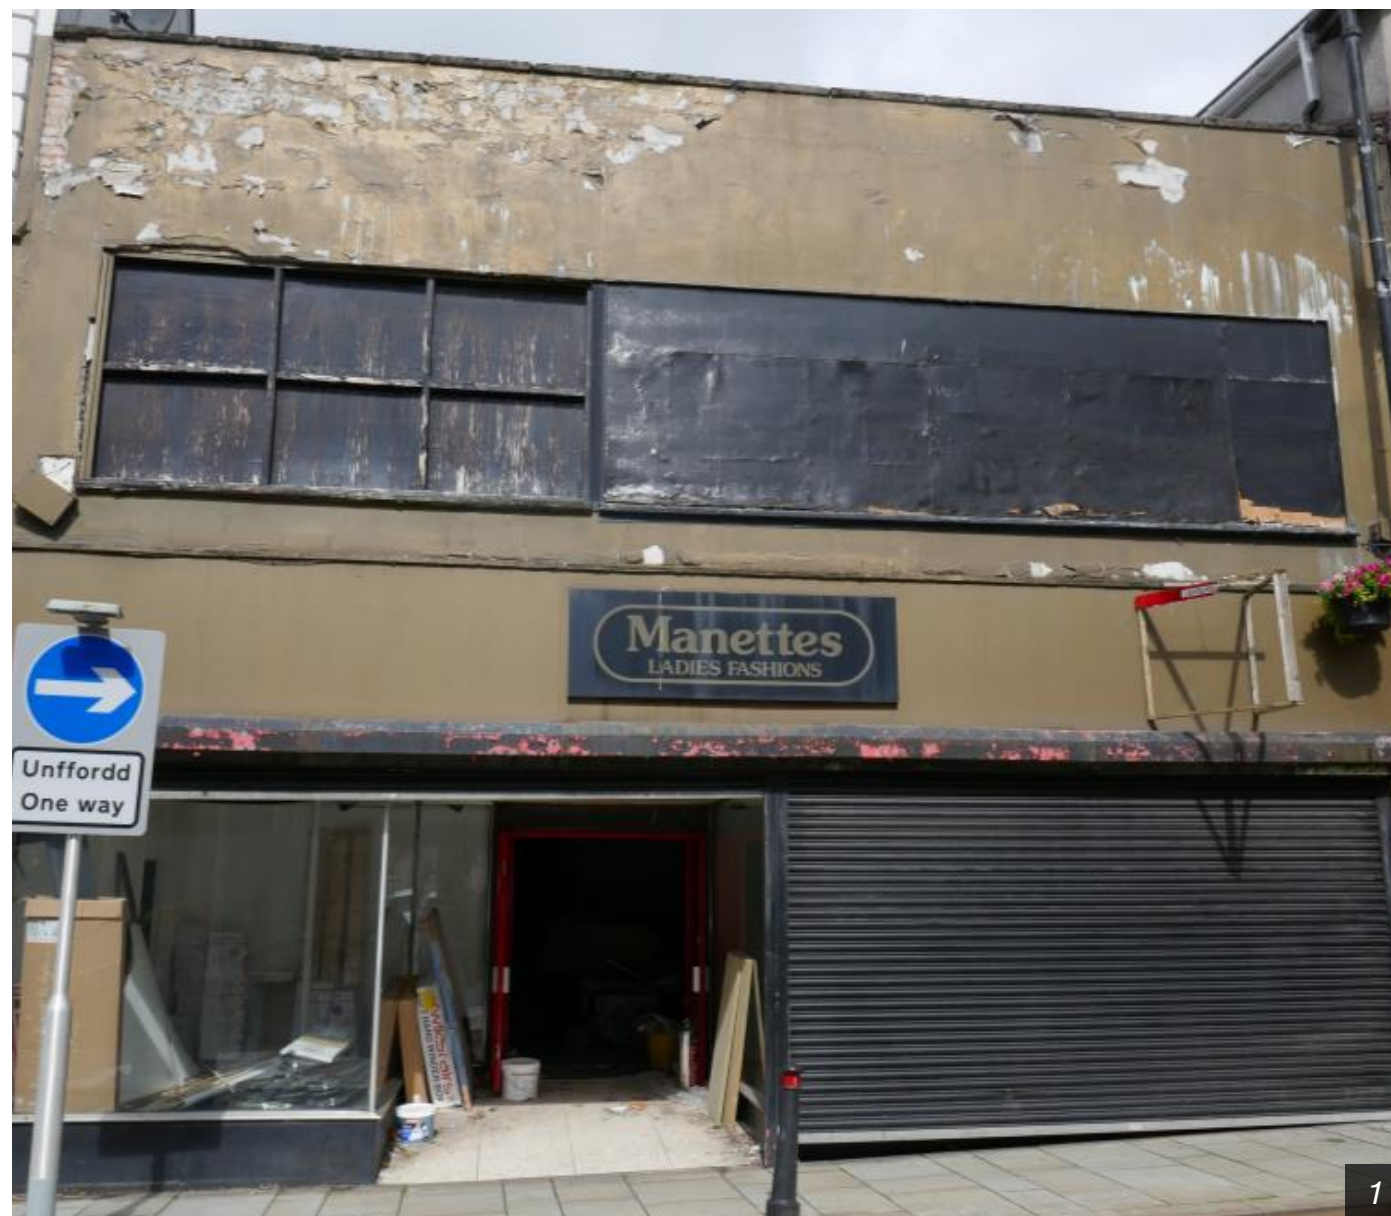
1. View of the shop front from the High Street

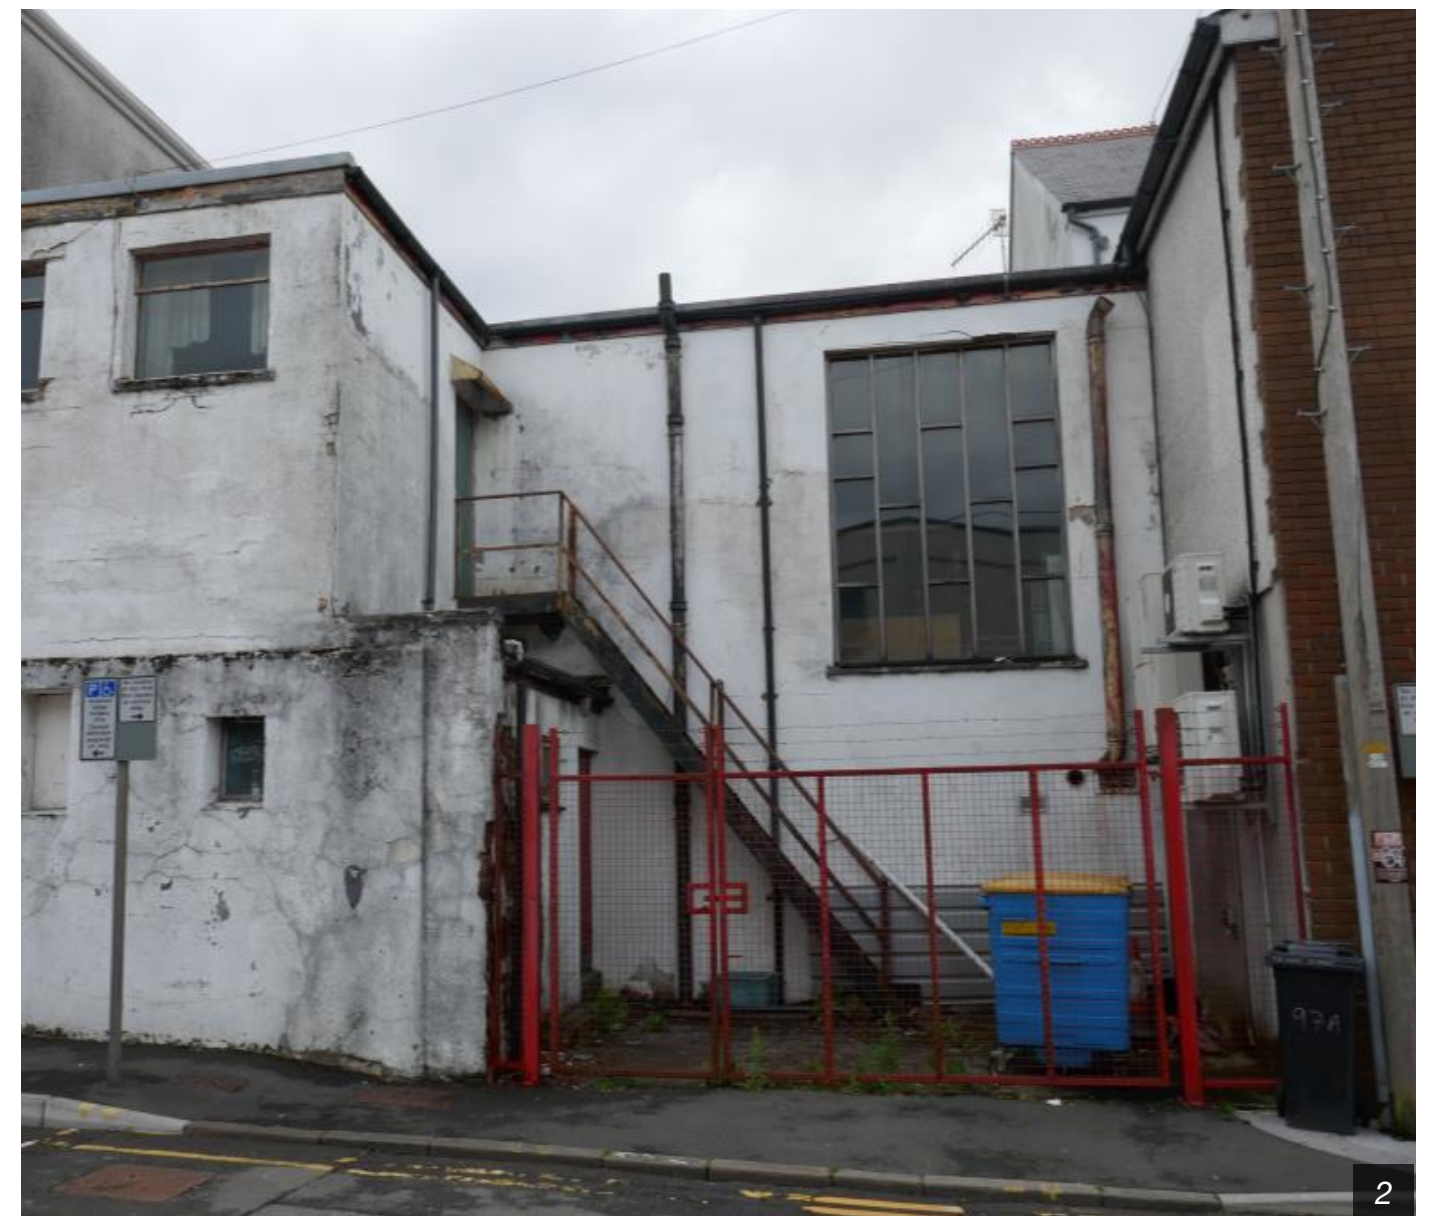
2. The rear view of the building from Castle Yard

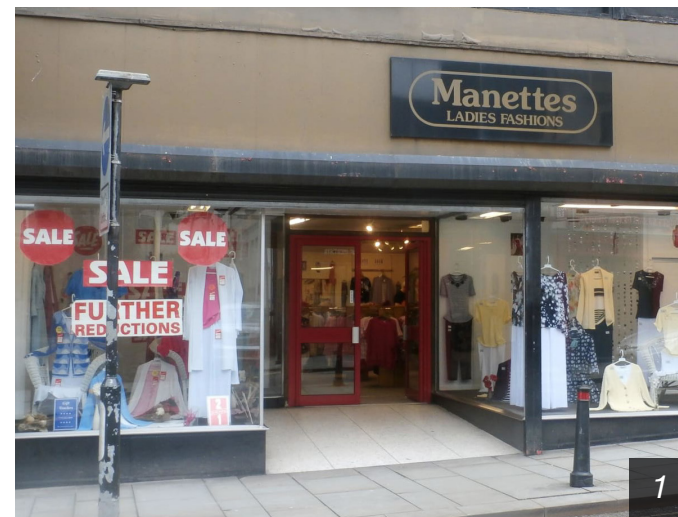
The original shopfront, shutter and signage has been removed from the front elevation and replaced. The glazed shopfront has black metal frames, stallrisers and a double door. The double entrance door ramps up slightly from the street. There is a black external roller shutter to the shopfront.

1. Existing shopfront with tiled entrance ramp
2. Deteriorating render/paint on front elevation with corroded beam behind
3. Boarded up first floor windows
4. Rear access stair and security gates/fence
5. Metal windows and damaged render
6. External roller shutters

- New doors to rear elevation
- Removal of tiled finish to front entrance ramp and adapt existing stallriser to suit new shopfront
- New ramped threshold with tiled finish - pattern TBA

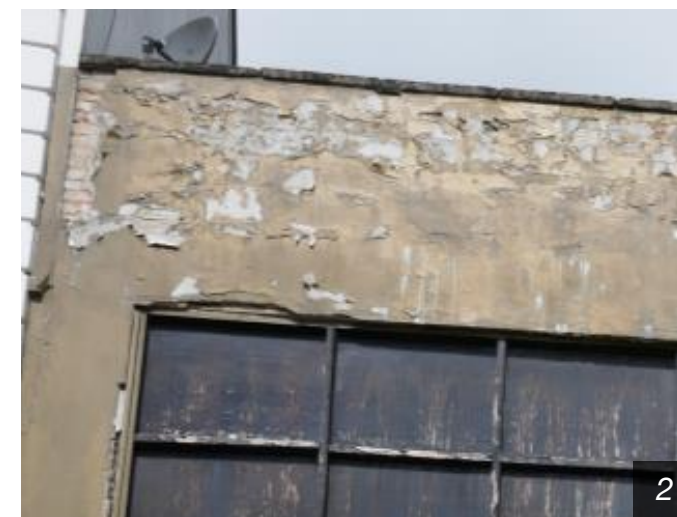
The front and rear elevations are both rendered. Historic photos of the front elevation shows different tones of render to the upper and lower parts of the front elevation. This has been painted over and is damaged in many places. The render to the rear elevation is also deteriorating. There is concern about the beam over the first floor windows that has corroded.

- Removal of deteriorated paint/render finishes and signage
- New render finishes to front elevation - colour/texture TBA (different treatment to ground and first floor in line with historic photos)

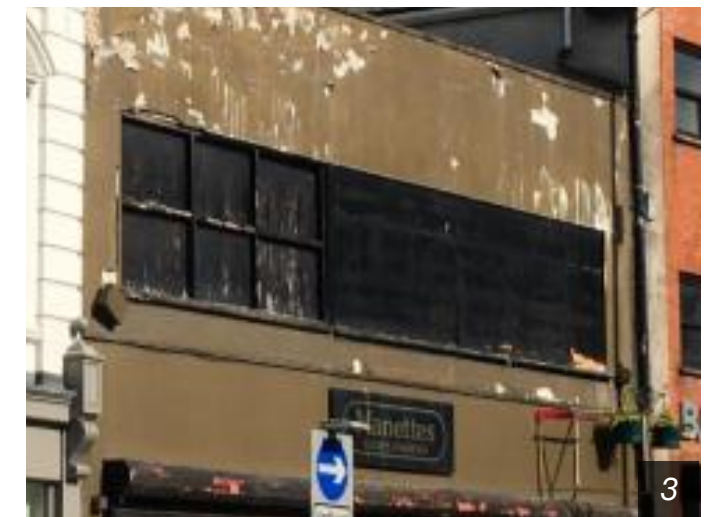
The windows to the front elevation have been boarded up and painted various colours over the years.

- Removal of existing shopfront, external shutter and first floor window boarding
- Installation of new metal framed shopfront with central external doors as historic images

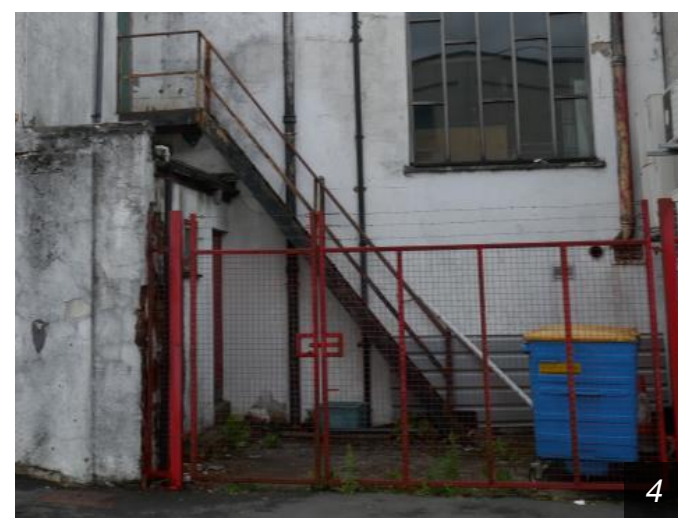
The East elevation fronts the High Street. A back road, Castle Yard, leads to the rear of the building where there is an external metal staircase leading to the first floor. There is a double gate and fence securing the entrance to the rear of the building where existing waste & recycling bins are stored.

- Removal of existing rear metal access stair and security gate/fence
- New security gates and fence to rear entrance
- Rebuilding of existing rear extension which is in poor condition

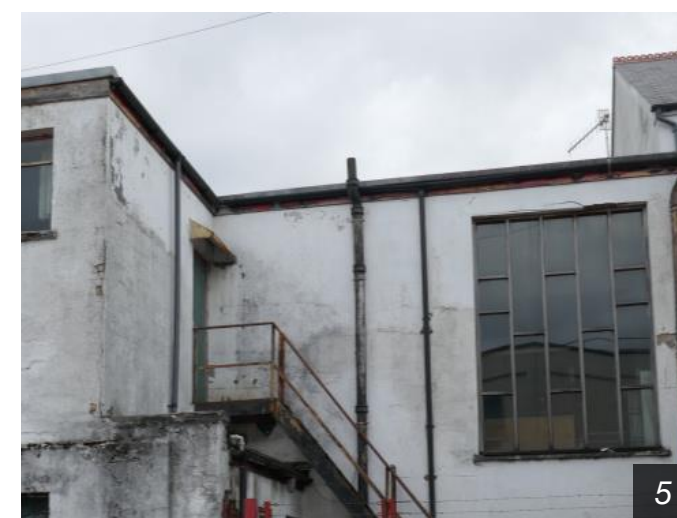
On the rear elevation there are a mix of timber and metal framed windows, some of which have

been painted, though in many places this finish is deteriorating. Some of the original openings have been blocked up since the building was constructed.

- New internal chainlink roller shutter
- Removal of existing windows and alterations to rear elevation to form new windows and door openings
- New metal framed windows to front and rear elevation of a more consistent appearance

- Render repairs/renewals to rear elevation
- Pointing repairs to existing concrete copings
- New shopfront signage - details TBA
- Alterations to masonry for new gutter outlets to hoppers - front & rear elevation

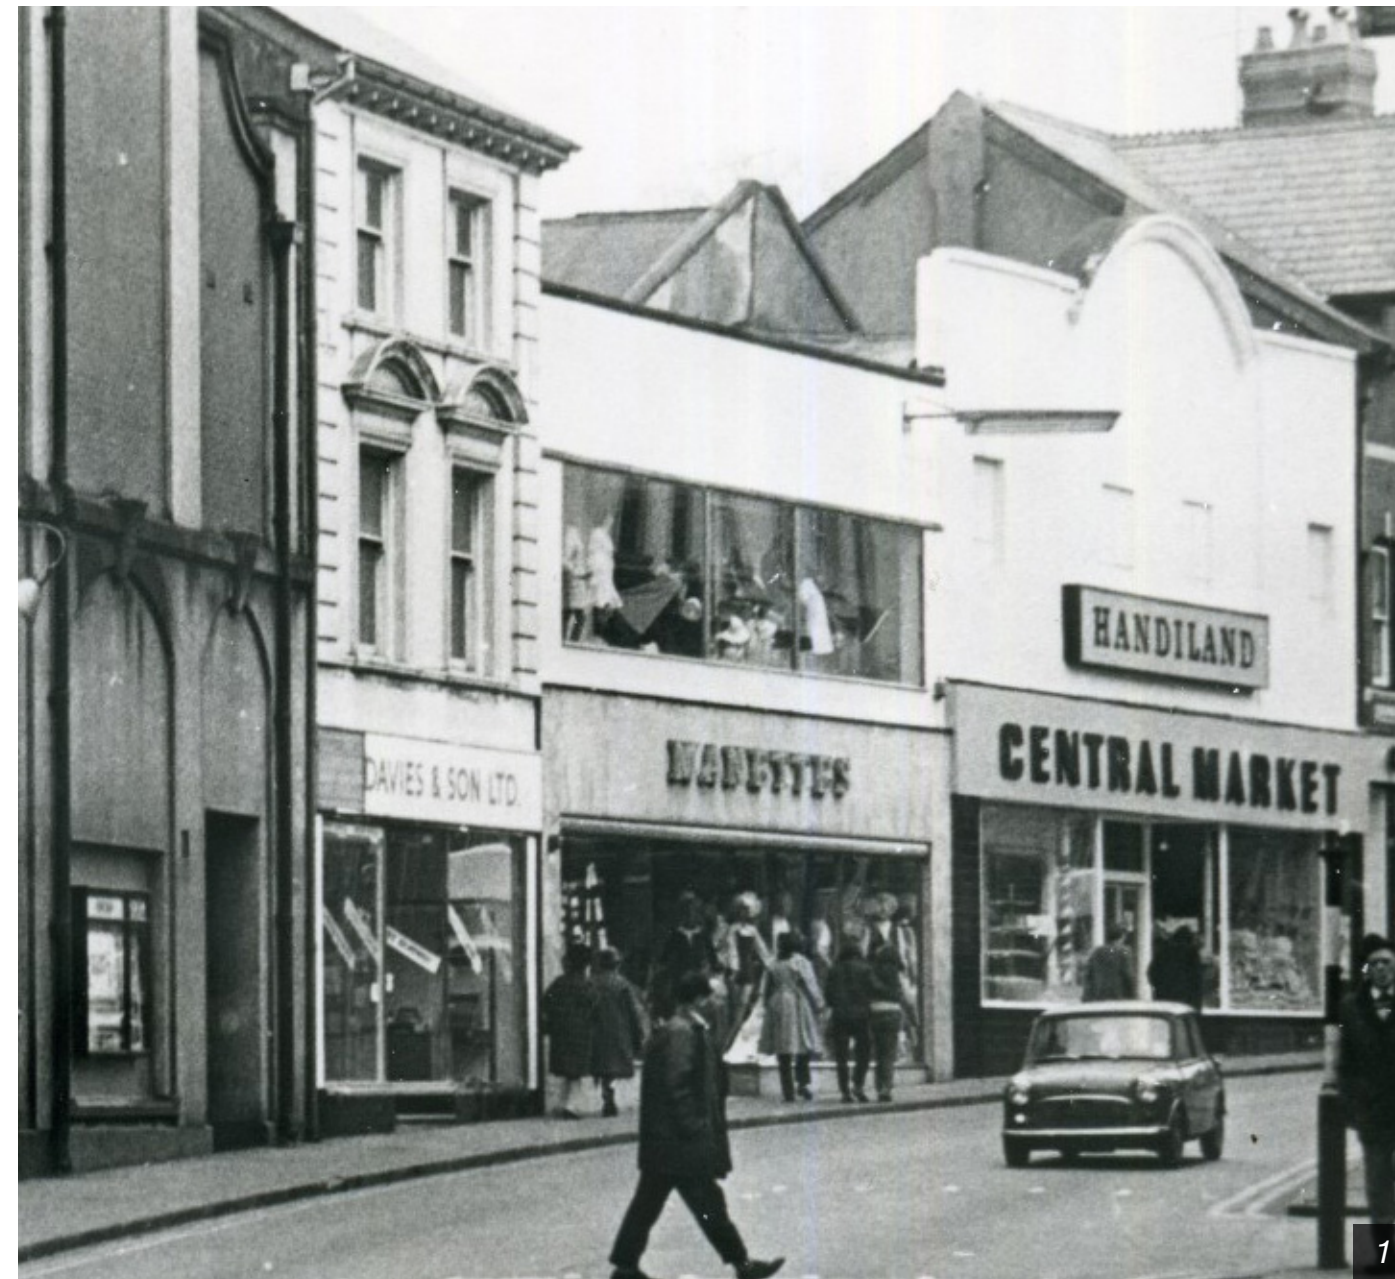
## 05 proposed alterations & repairs

The current proposal is to repair the deteriorating external envelope of the building and to remove the inappropriate alterations that are deemed to be harmful. The proposed alterations are based on existing details as well as historic photographs.

- Removal of existing rainwater goods/redundant SVP and sundry pipework etc. to rear elevation
- New metal rainwater goods including hoppers
- Removal of existing timber fascia boards and metal capping to wall head and replacement with new coping - rear elevation

The proposed works will remove the inappropriate and unsightly features such as the external security shutters, shopfront and boarded up windows. The existing render will be repaired and redecorated.

A new shopfront and new windows to the front elevation will replace the existing, with a metal frame and thin double glazed units, to match those in the historic photos.

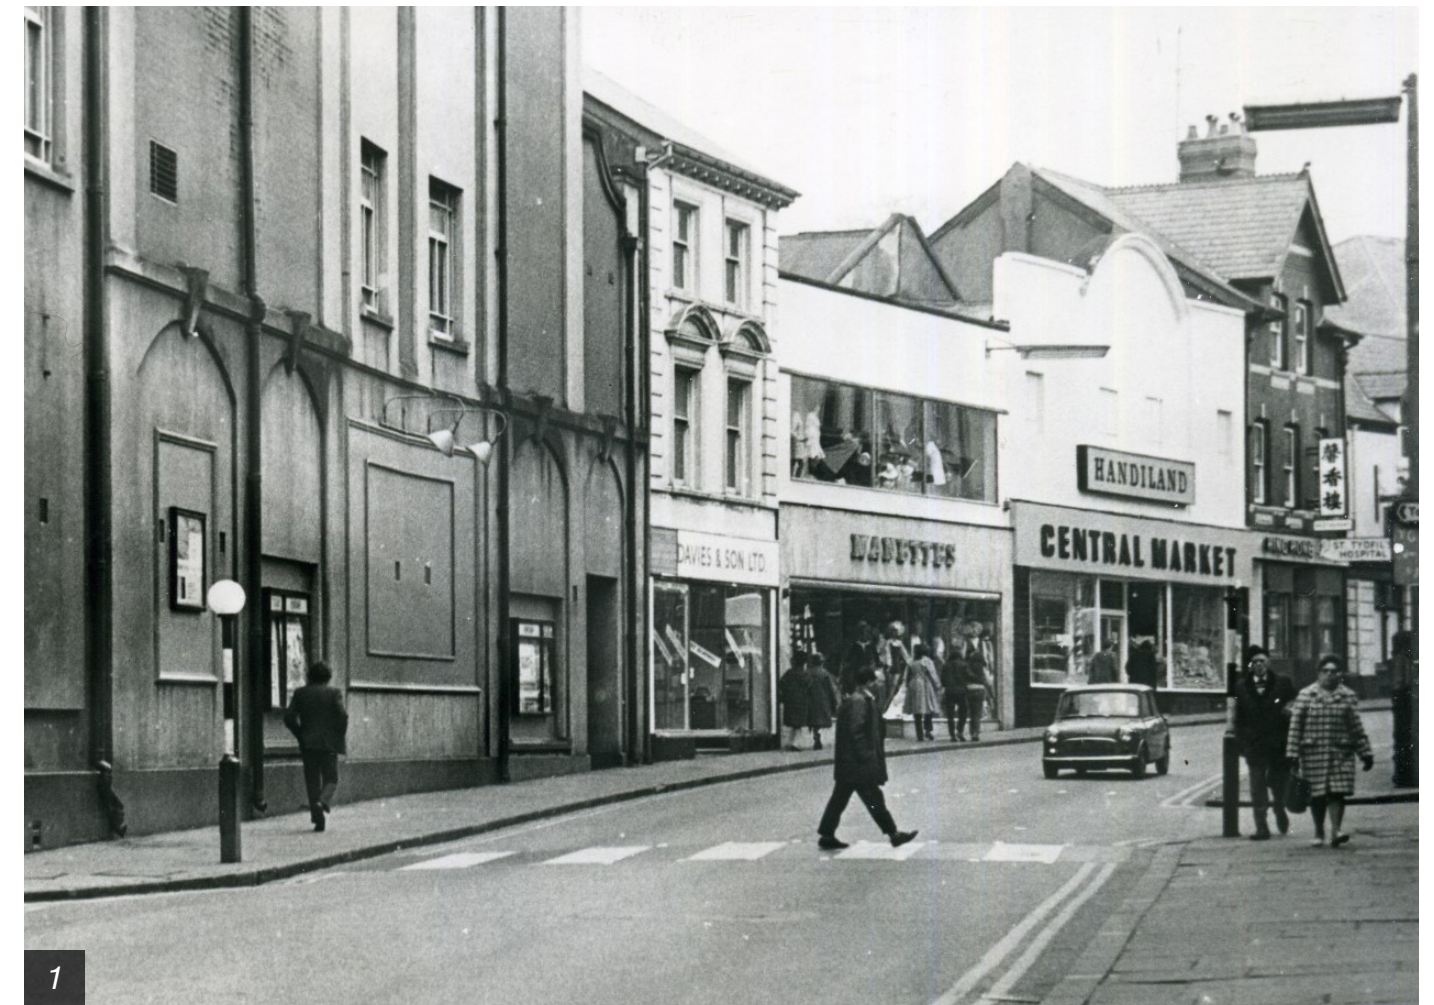
1. Historic photograph showing the street-scape (date unknown)
