**Bat Survey:** Wesley Methodist Church, South Street, Dowlais, Merthyr Tydfil, CF48  
3DS

**Instructed by:** Karl Lewis of LeTrucco Design Limited

**Reported by:** Ecological Services Ltd  
10 Mount Pleasant, Llanelly Hill, Abergavenny, Monmouthshire, NP7 0NT

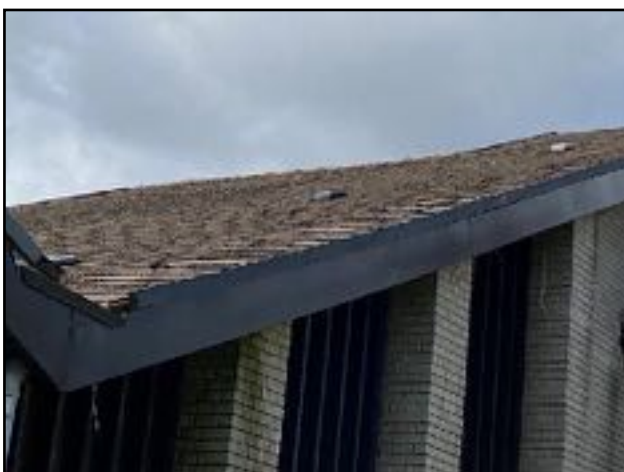
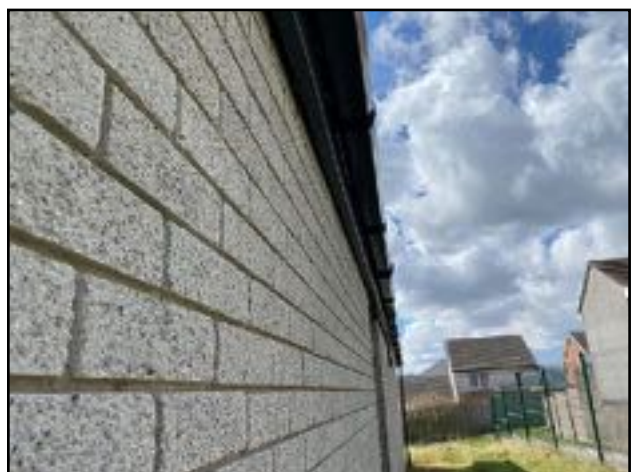
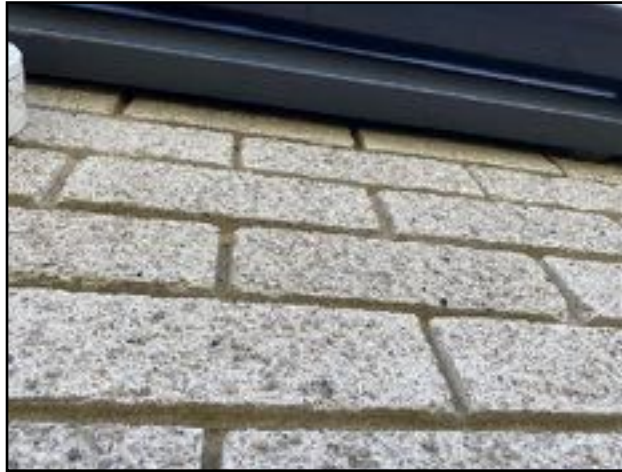
**6.6** Examples of apertures potentially allowing access to cavities in the building:

**6.3** Due to the condition of the building, there were a small number of opportunities for bats to access and use the building and those that were available were deemed as having at least low to moderate potential for bat use. There were areas of slipped tiles and raised ridge tiles; apertures around the roof line and the roof dormer and an aperture along the entire length of fascia on the northern elevation of the building.

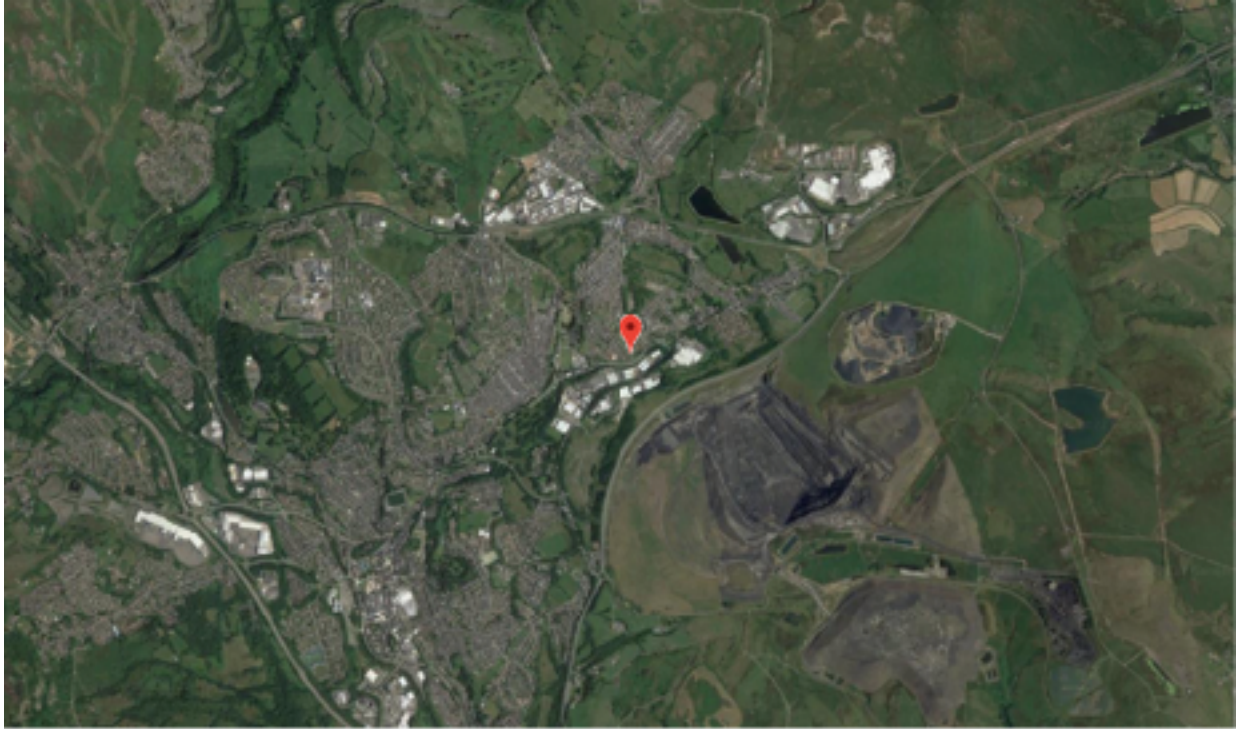
### **11.1 Aerial Site Photo**

**The site in its wider environment offering excellent ecological connectivity to the surrounding habitat.**
