**JOL'S, 30-31 HIGH STREET, MERTHYR TYDFIL**

**INITIAL BAT INSPECTION SURVEY**

**Bat Survey Report**

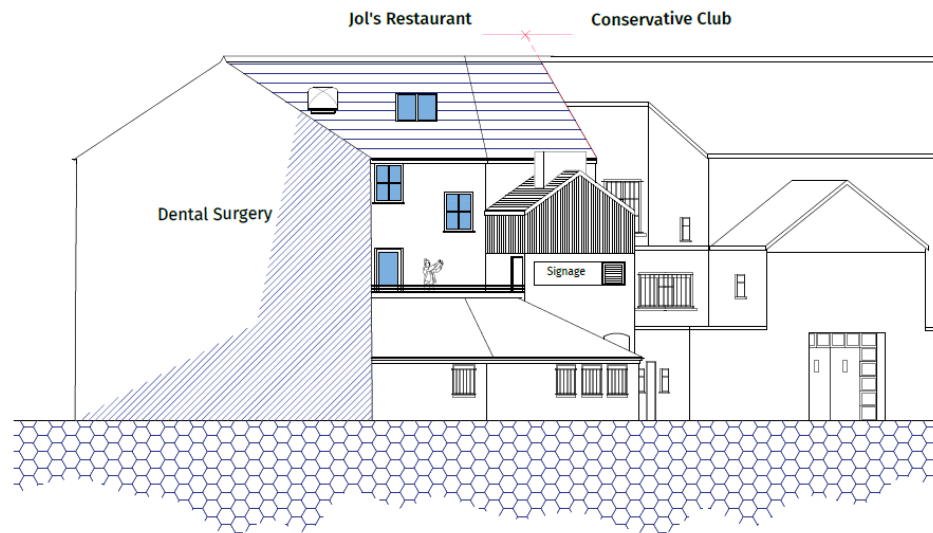
1 Proposed South Elevation  
1:100

It is proposed to demolish a single storey extension and replace it with a two storey extension. A roof light will be placed in the roof to give light to the upper floor.

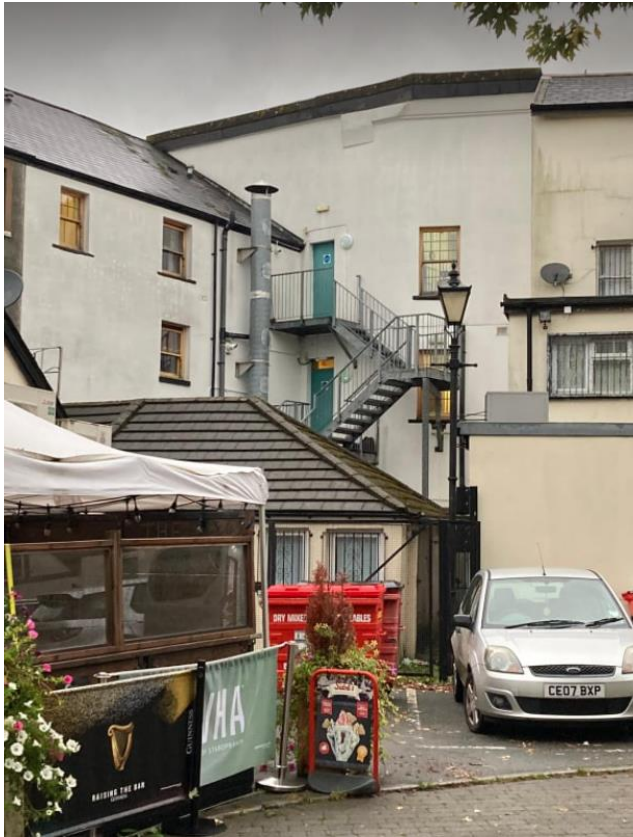
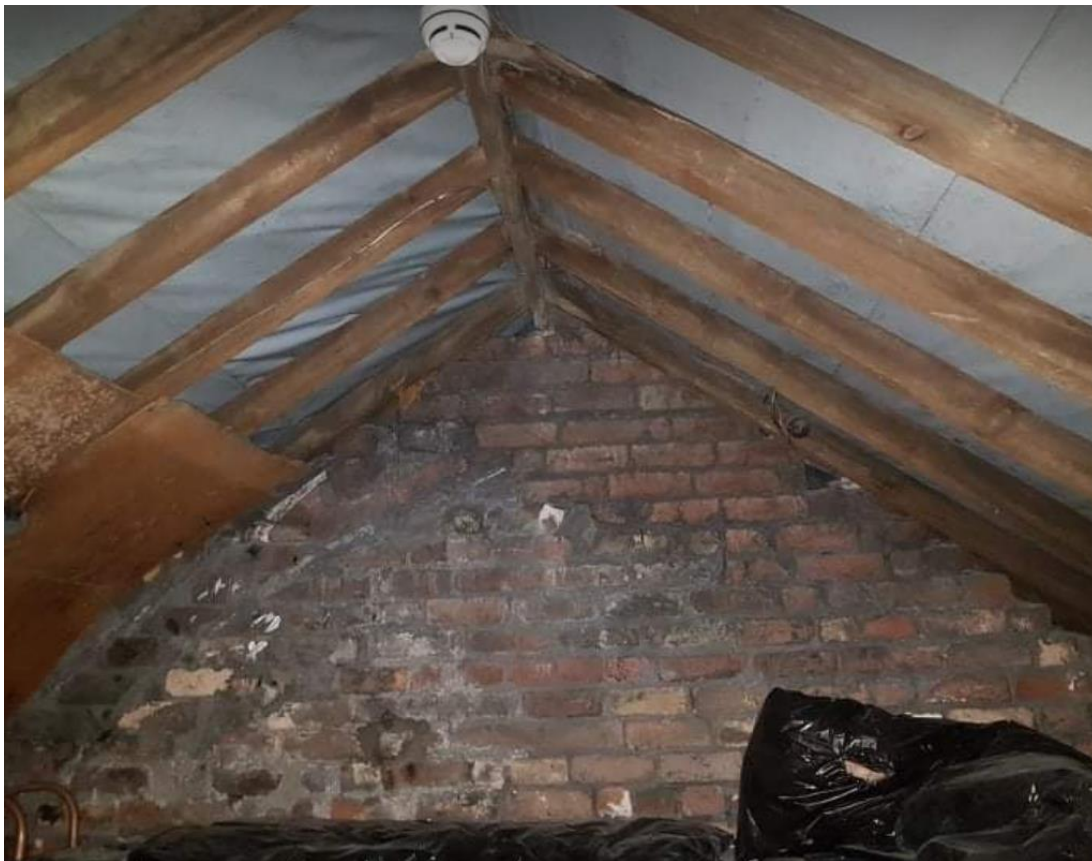
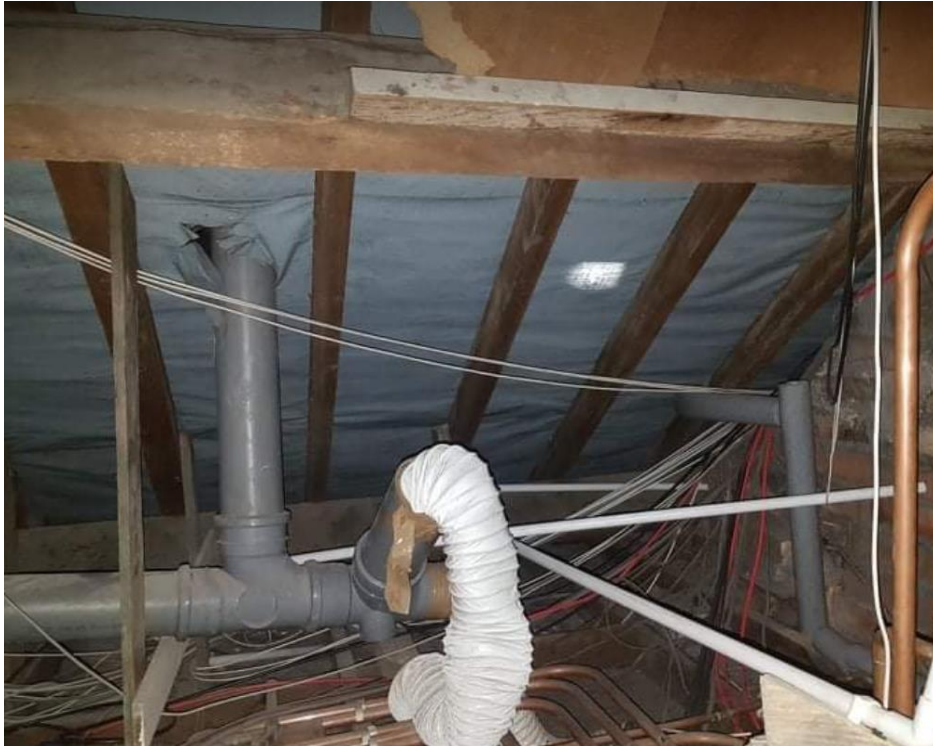
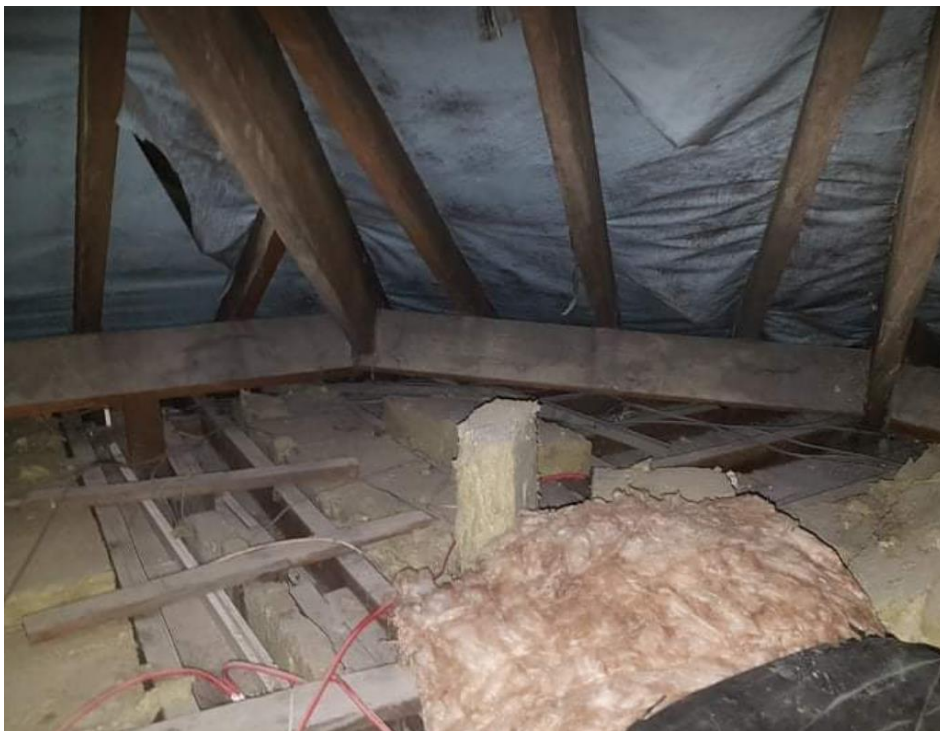
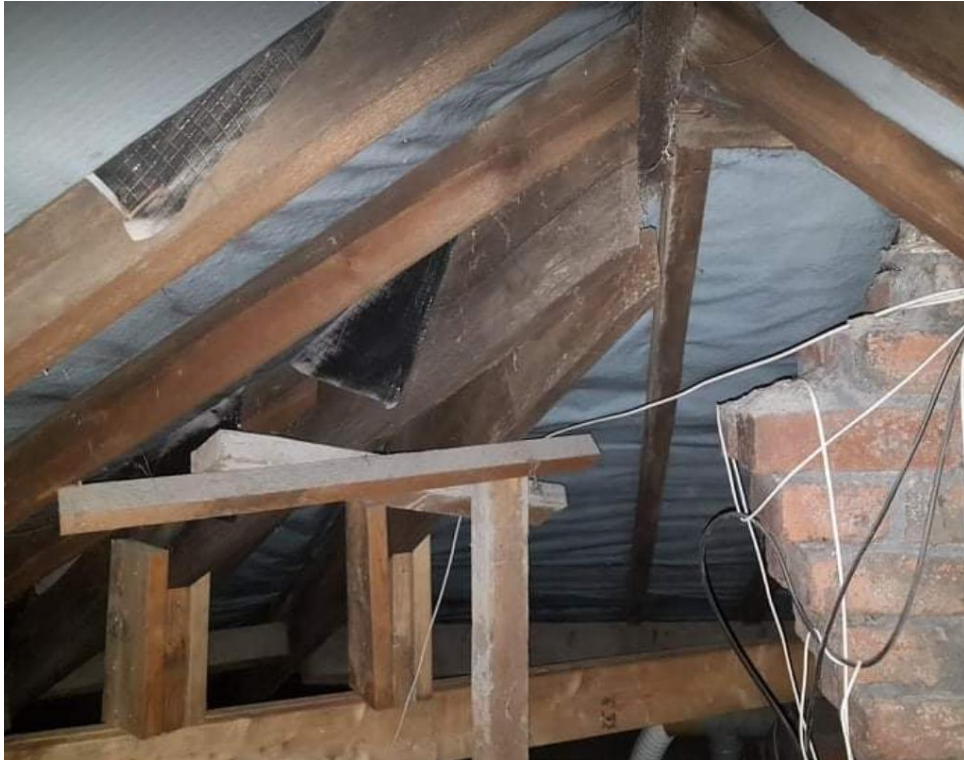
## APPENDIX A- PHOTOGRAPHS

The survey carried out by BE Ecological Ltd revealed no droppings or evidence of bats on the exterior of the buildings and failed to find any suitable, obvious access points for roosting bats.

The majority of slates on the main roof and the tiles on the single storey extension, appear to be in good order with no obvious potential for roosting bats. There are no obvious missing or slipped slates/tiles. Fascias and barge boards where present appear to be relatively tight fitting.

The single storey extension has metal security grates over the windows which extend to the fascia.

Internally there is only access to one area of roof (southern end of building). There is a roof void present that is approximately 2m from joist to ridge. The void is boarded and appears to be lined with a plastic membrane. The void is full of pipework and what appear to be some form of plumbing (possibly header tanks). There are brick partitions between buildings.

The void is extremely dark and there do not appear to be any gaps/obvious light ingress' into the void. No bats or evidence of bats was found on the exterior of the building.

As the tying in of the extension will temporarily disturb the roof, it is considered necessary that the work for this is undertaken in line with an ecological method statement and supervision.

The removal of the single storey roof will also need to be undertaken in line with a method statement and ecological supervision.
