*Report No. BC/MB/08.19.04.*

# **Geo-Environmental Report: Land at Colliers Row, Brondeg, Merthyr Tydfil.**

**Maxiom Developments Ltd.**

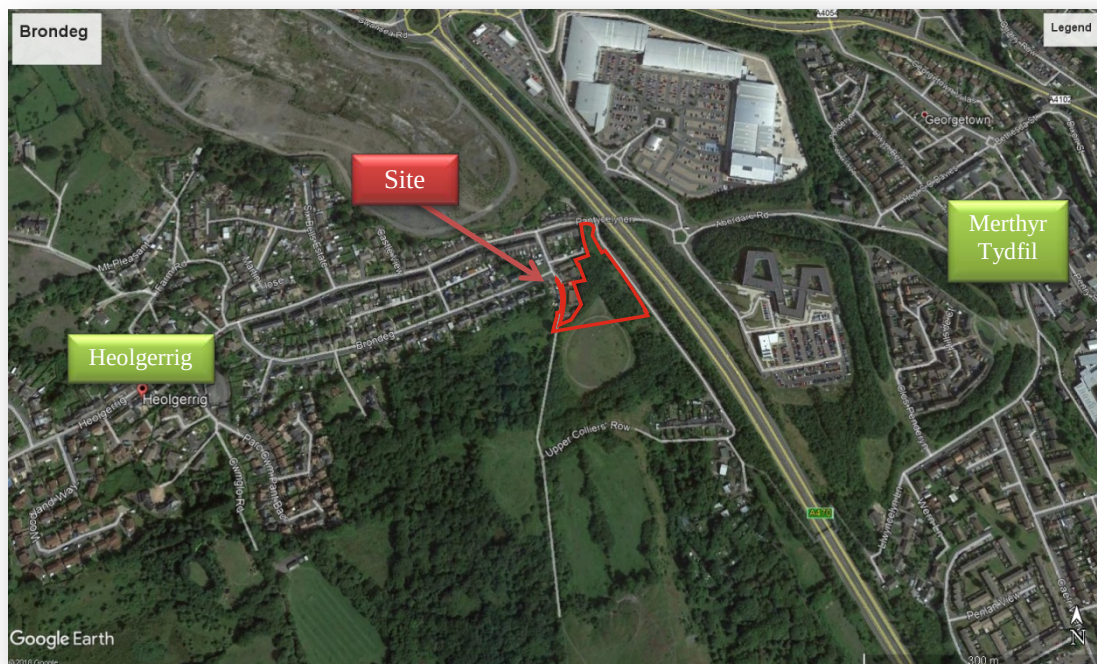
**Figure 1**  
**Aerial View of the Site**

The plot of land that is the subject of this report, 'the Site' is located on the western fringes of Merthyr Tydfil, approximately 700m west of the town centre; it is irregular in outline and occupies an area of approximately 0.82 hectares (see Figure 1 and *General Location Plan, drawing no. BC/MB/08.19.04.01*). The Site is located in a residential area on the fringes of the town and is bounded on its western side by residential dwellings and a lane; to the north is Aberdare Road and beyond it the Trago Mills retail site; to the east is the public highway serving Colliers Row, beyond which is the A 470 (T), and to the south there are a mixture of agricultural enclosures and open countryside.

The northern two thirds or so of the site is overgrown with immature trees and saplings and the southern part is an enclosure with what appears to be a trotting track on it. The Site is situated close to the floor of the Taff Valley.

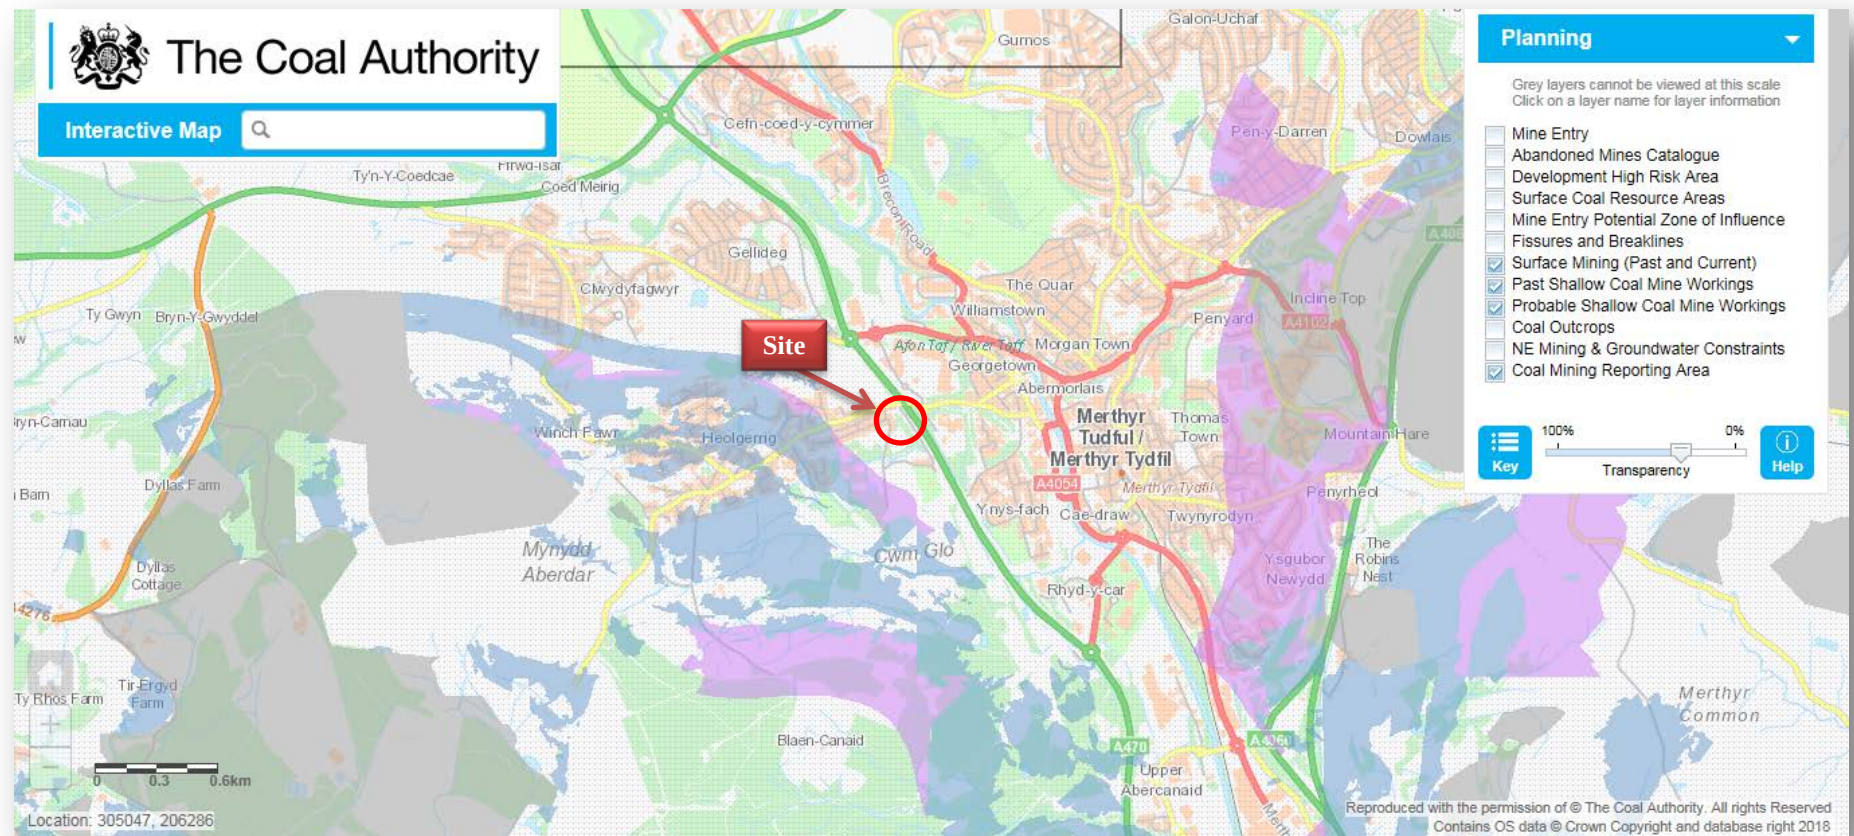
**Figure 3**  
**Print from The Coal Authority's Interactive Map**  
 (accessed 21<sup>st</sup> August 2019)

The extensive coal mining operations that have taken place in the vicinity of the Site all lie to the west and south-west of the Site. The Five Feet Gellideg Seam is the lowest coal seam in the geological sequence that has been widely mined and the old workings in the Seam do not underlie the Site. The Coal Authority's mining report covers a larger area than the Site but does not include the finger of land along the lane at the western side of the Site. However, the report is broadly applicable to the Site and identifies that there are no shallow coal workings that may affect the Site and there is no disused mine entry within the confines of the Site or within 20m of its boundary. Further, the Site has not been part of an opencast coal site. An inspection of The Coal Authority's interactive map identifies that the inclusion of the finger of land along the lane does not alter any of the findings of The Coal Authority's report.

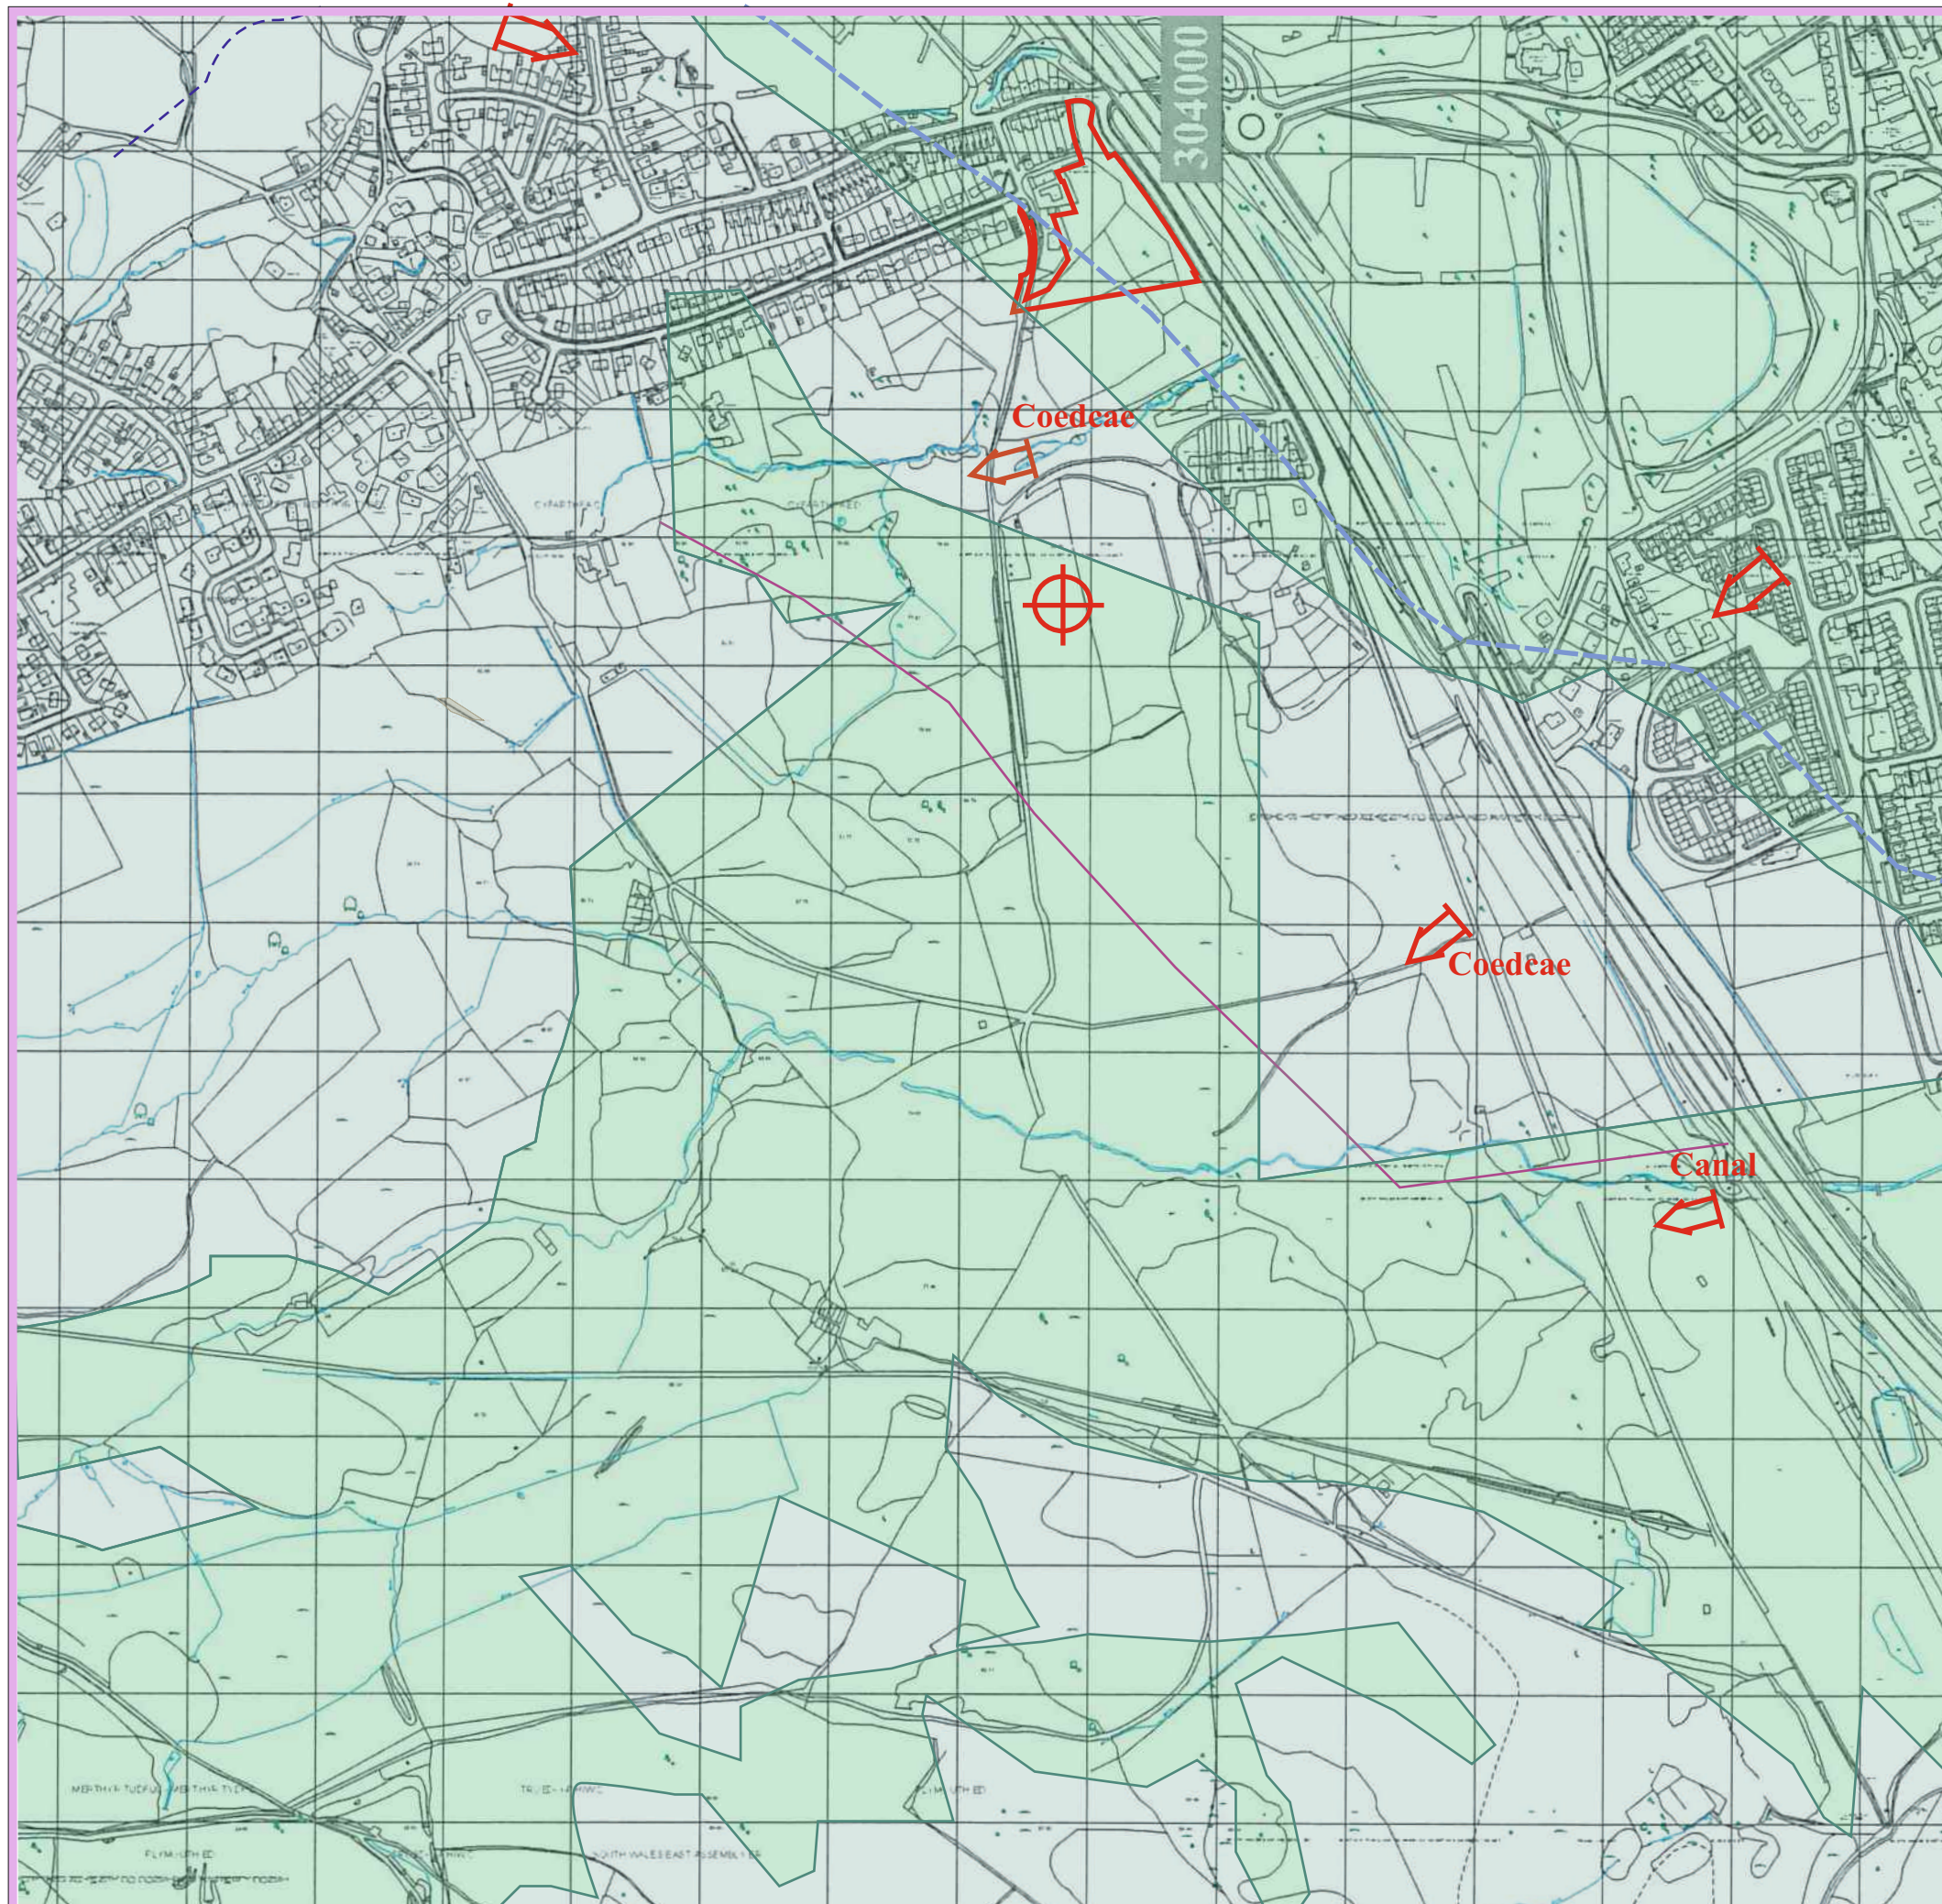
**Drawing No: BC/MB/08.19.04.04.**

The area has been subject to extensive underground mining operations since at least the earliest part of the nineteenth century. The inferred position of the outcrop for the Five Feet/Gellideg Seam passes through the south-west corner of the Site; if the inferred position is reasonably accurate then the outcrops passes through the Site with a north-westerly trend and the seam does not underlie the overwhelming majority of the Site. Our searches found no record of old coal workings underlying the Site.

## *Plan of Old Workings in the Five Feet/Gellideg Seam.*

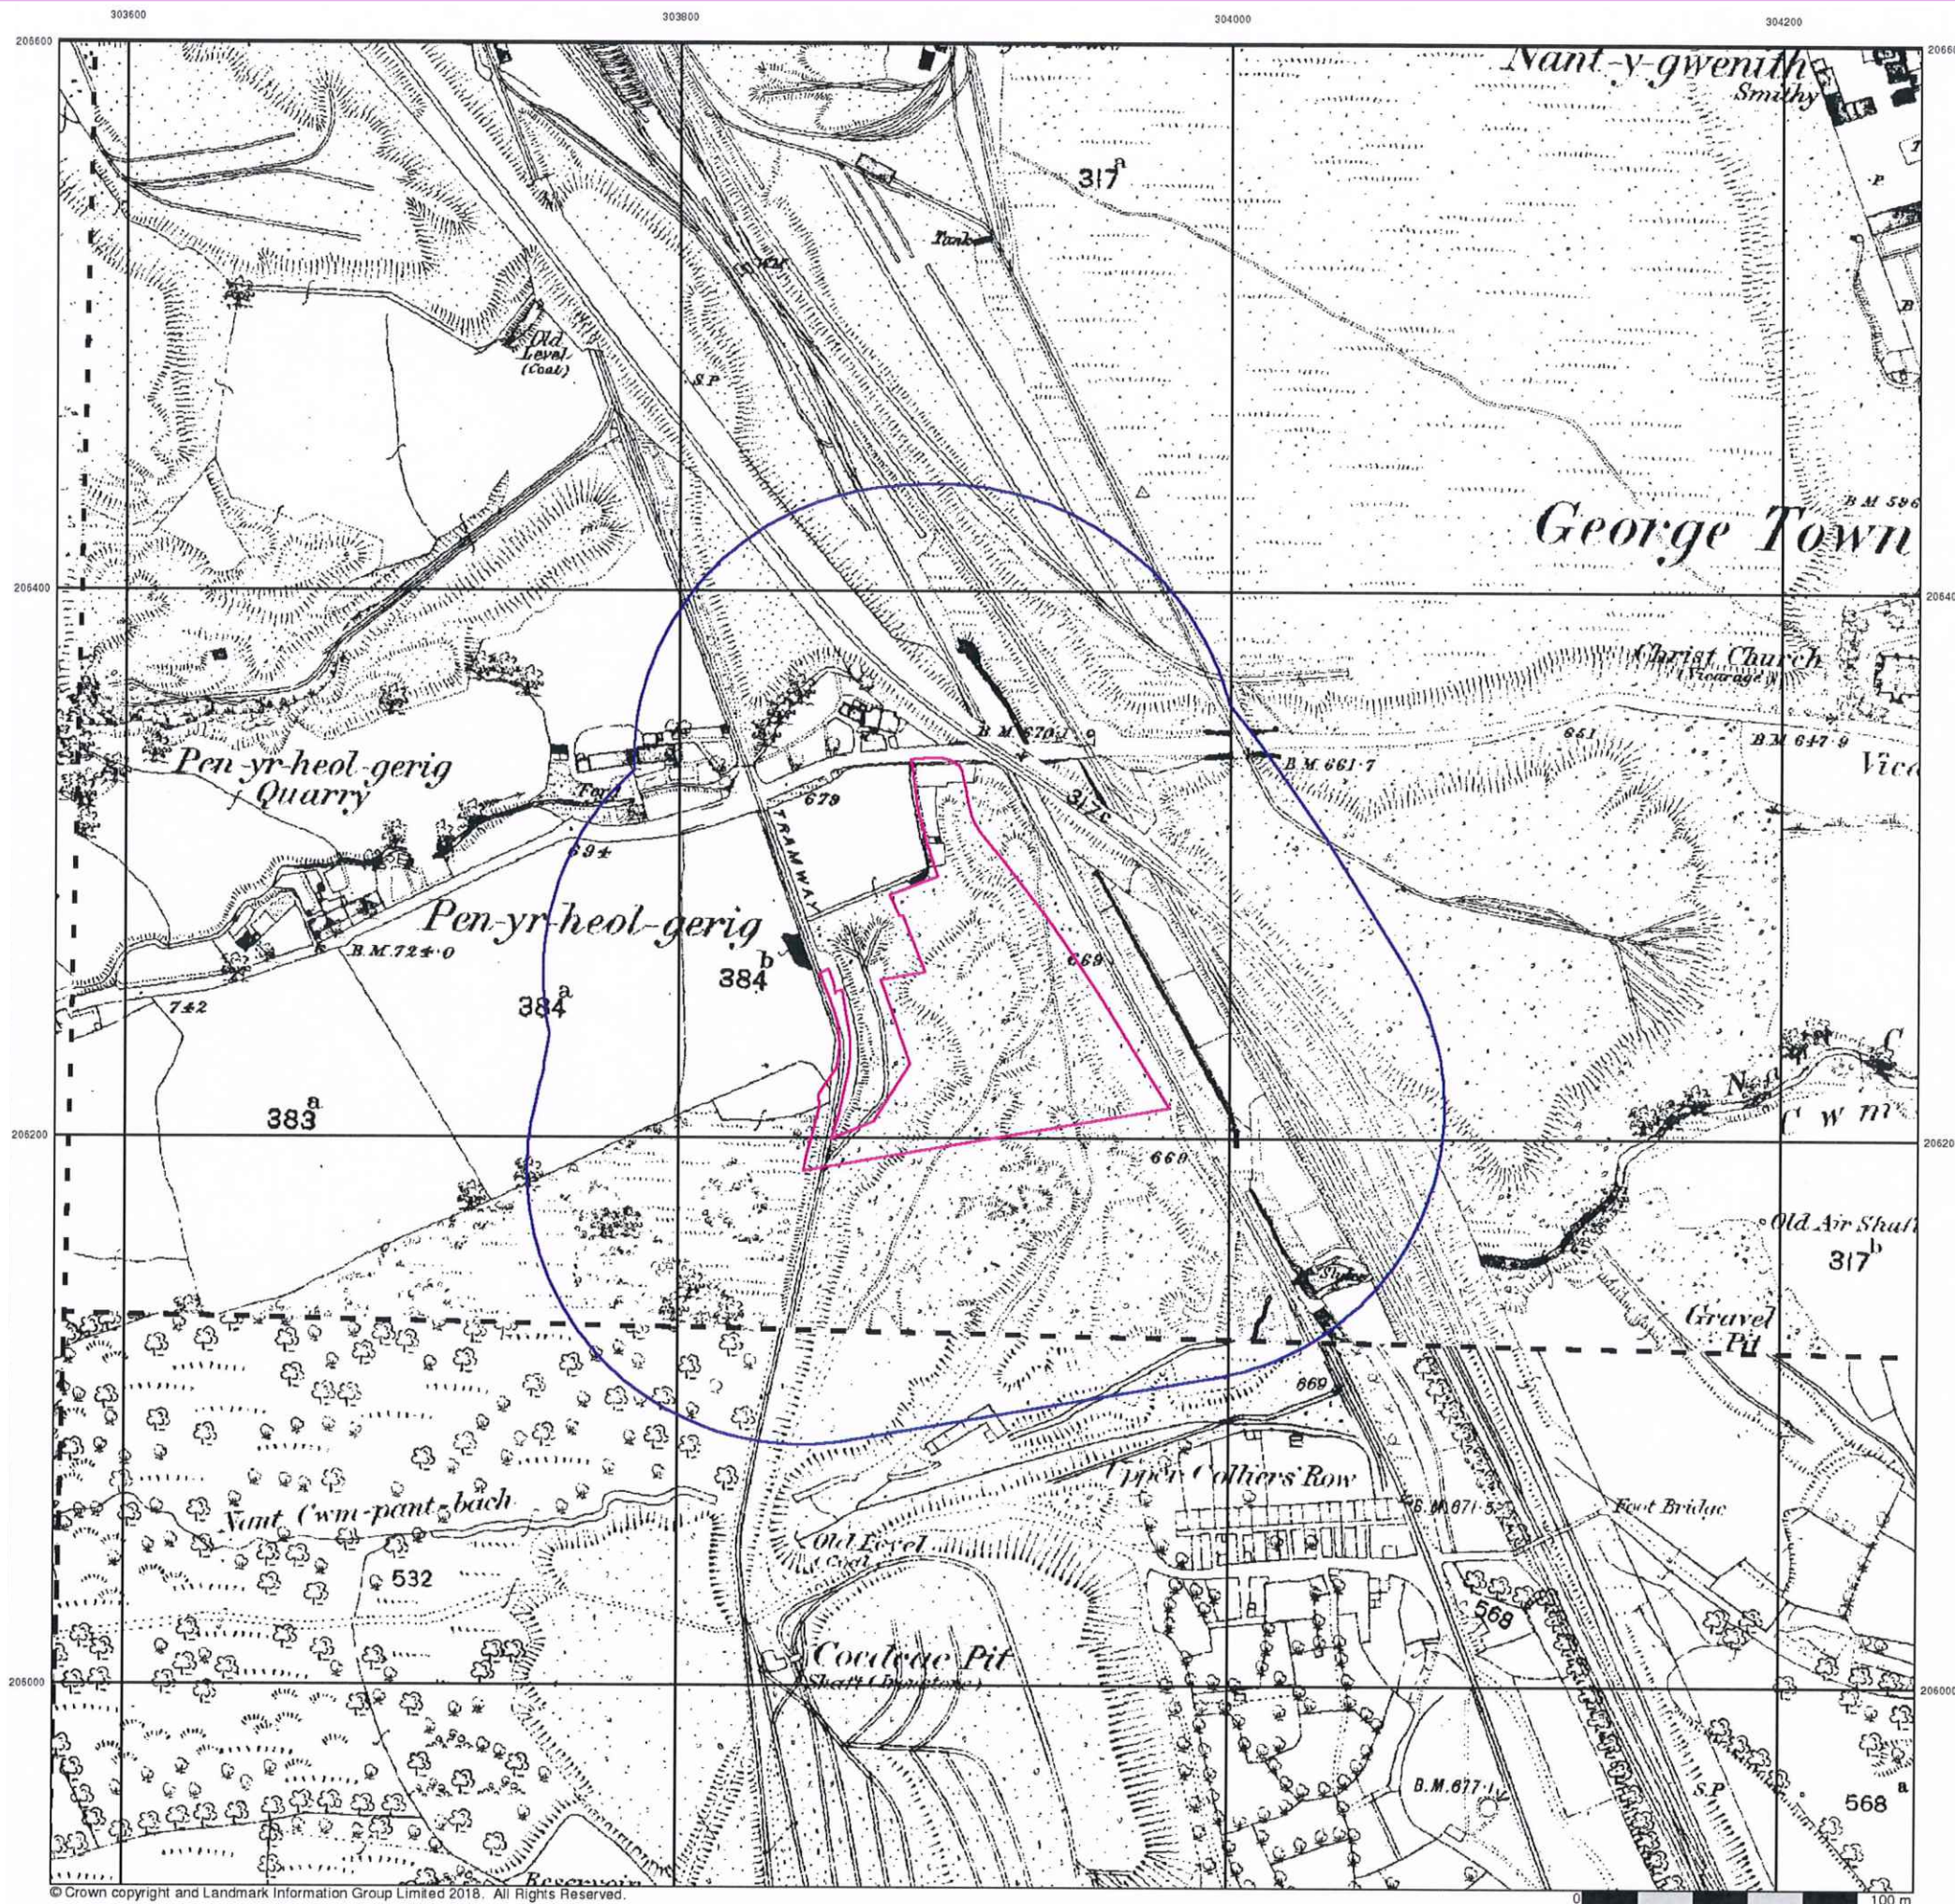
Drawing No: BC/MB/08.19.04.11.

A review of the history of the Site has been undertaken by means of research of the various editions of Ordnance Survey maps. The 1879 - 1880 Edition shows the Site to have been situated within a fairly industrial landscape of collieries with their associated tramways and spoil heaps (see *Extract from Ordnance Survey Sheet 1875-1881, drawing no. BC/MB/08.19.04.11*). The collieries variously mined coal, ironstone or both. A mainline railway was present along the eastern boundary of the Site, within 30m of it at its closest point. Local railways and tramways associated with the coal mining operations ran along both the western and eastern boundaries of the Site. A large area of cinder tip

associated with the Cyfarthfa Ironworks was present to the east of the Site and was within 60m at its closest. Aberdare Road formed the northern boundary of the Site with railway and tramway features immediately to the east. A large area of colliery spoil occupied the area to the south; it extended across almost the entire area of the Site itself. The finger of land that is the western part of the Site was a tramway. Beyond which there were agricultural enclosures and woodland. Pen-yr-heolgerrig Quarry was present 150m north-west of the Site.

## Extract from Ordnance Survey Sheet 1875-1881.

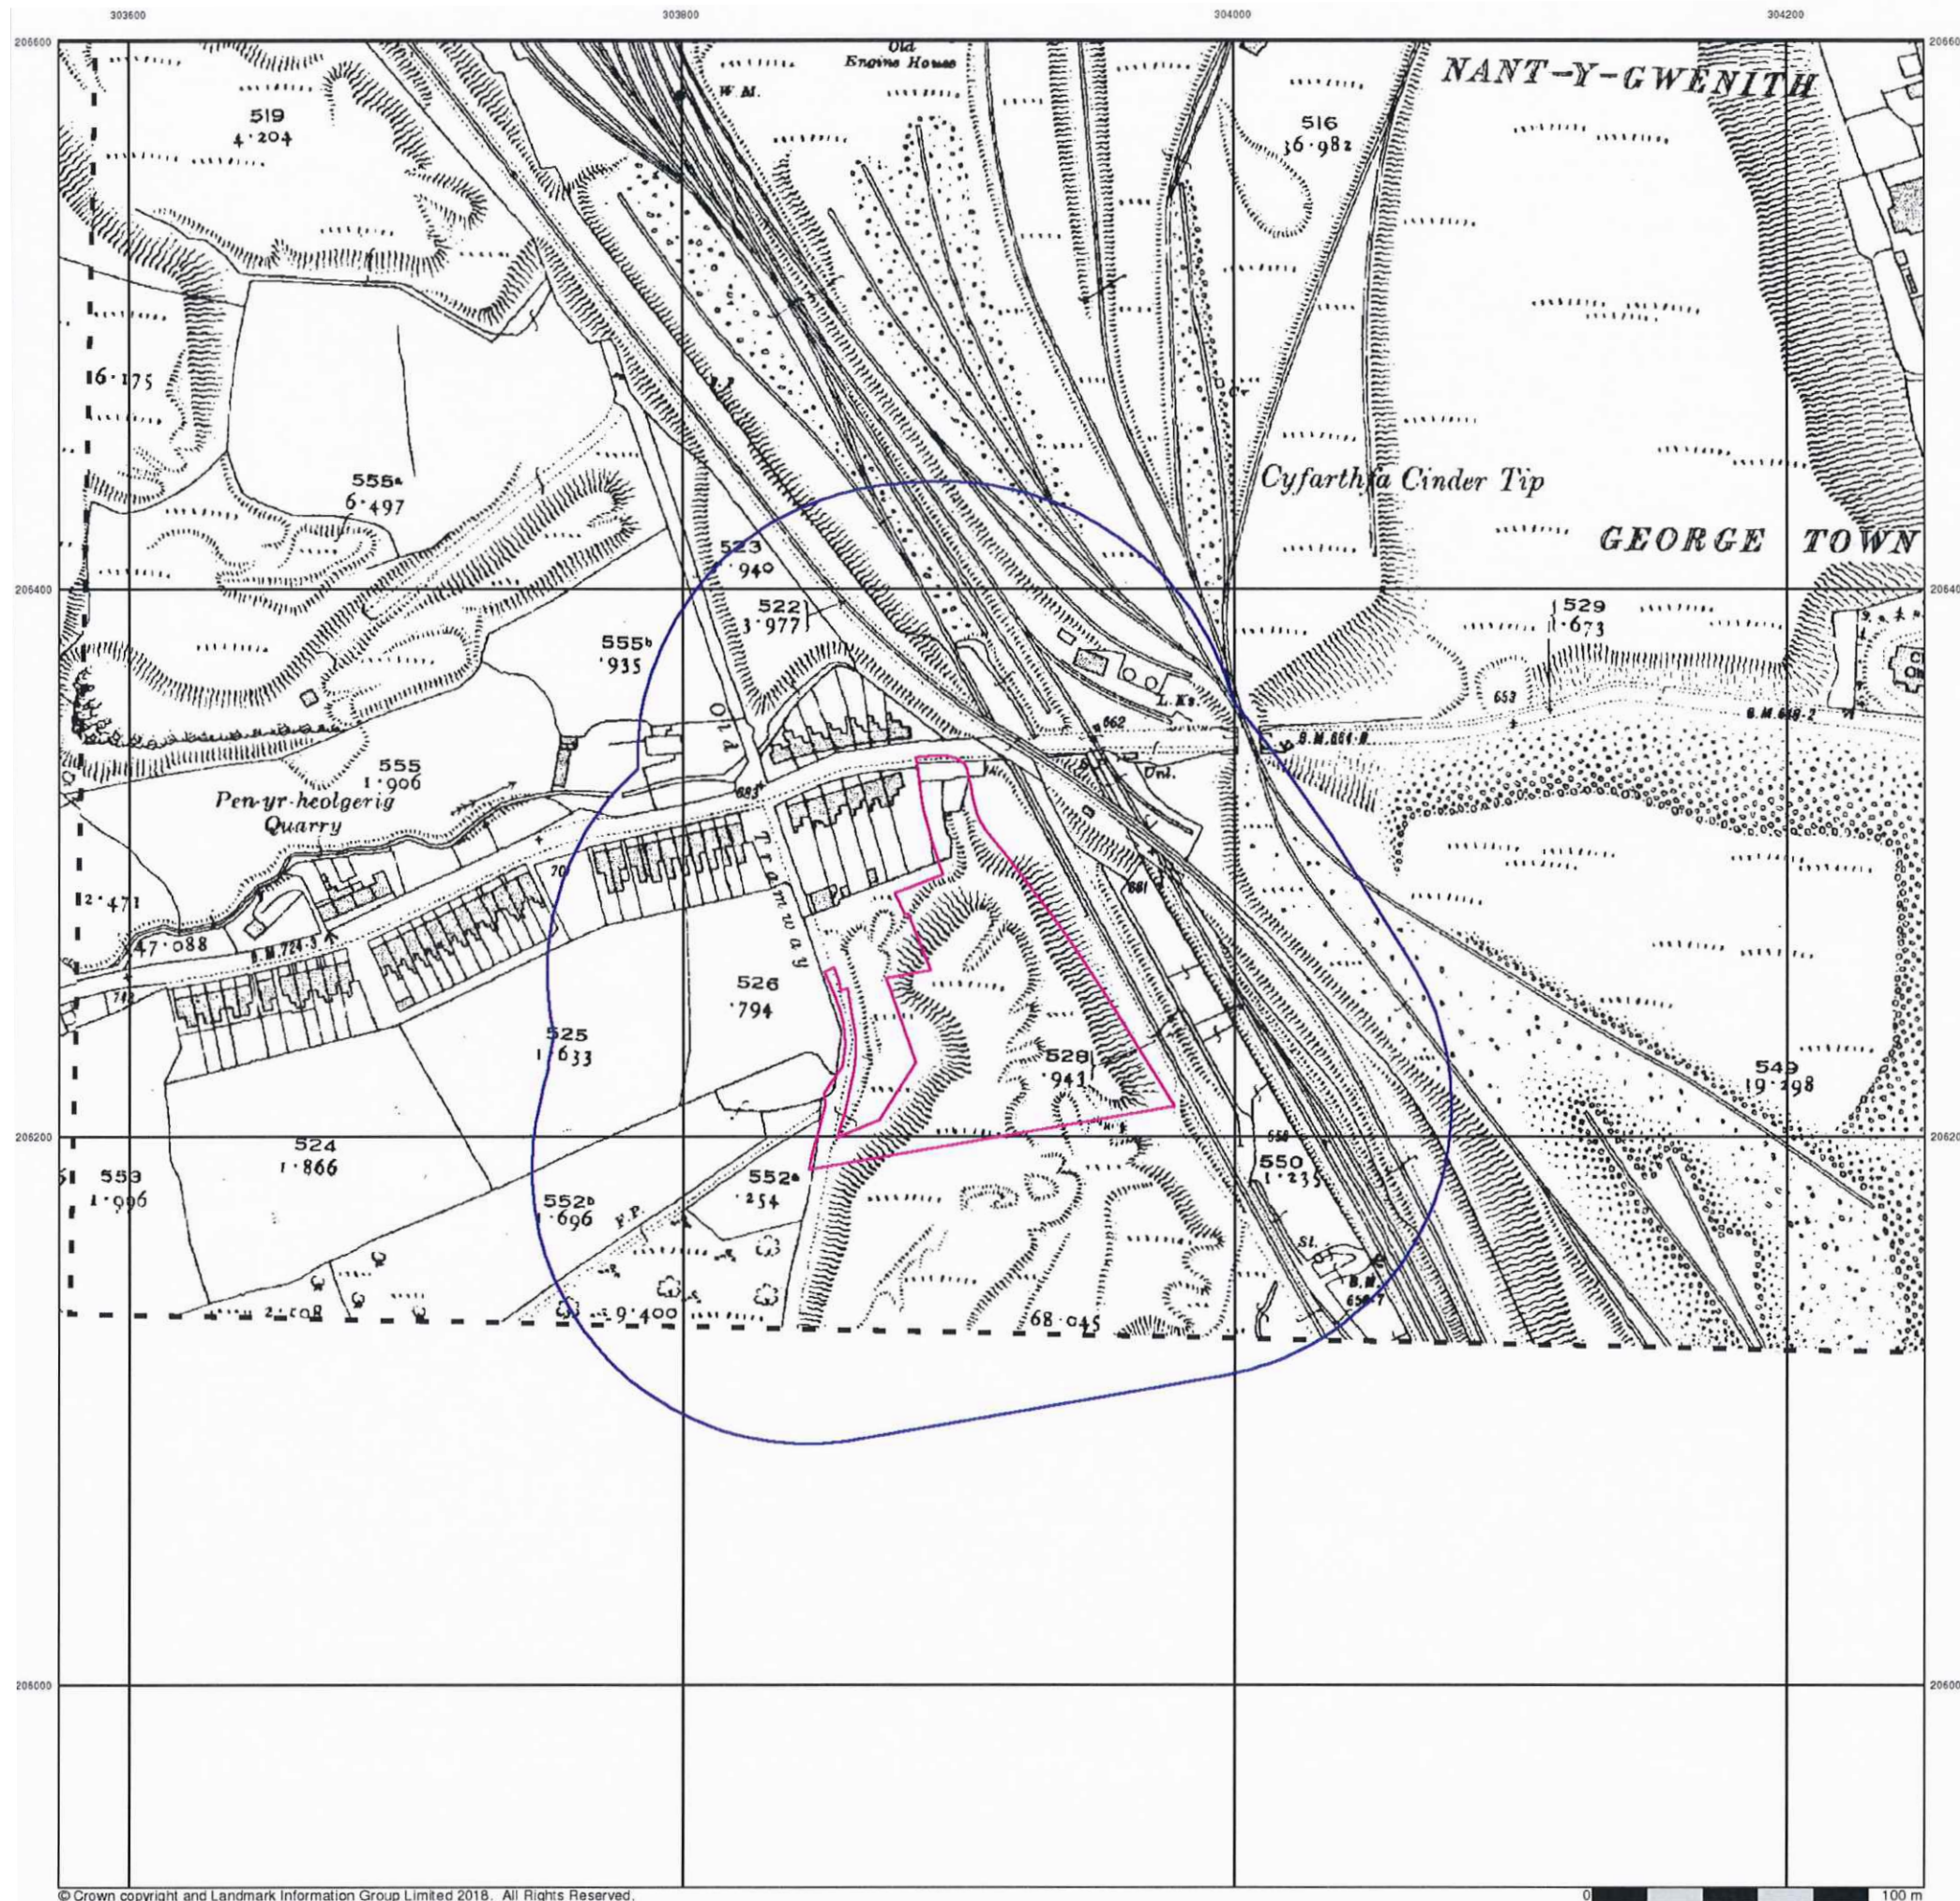
Drawing No: BC/MB/08.19.04.12.

This Edition shows the Site and the main features of the immediately surrounding area to have been largely unchanged from the previous edition (see *Extract from Ordnance Survey Sheet 1919, drawing no. BC/MB/08.19.04.12*). It is not evident from this edition whether the nearby collieries were still operating, but it is thought that they had all closed by this time. The Pen-yr-heolgerrig Quarry is identified on this edition. A series of terraced dwellings were present along Aberdare Road immediately to the west of the Site.

## Extract from Ordnance Survey Sheet 1919.
