Project: Proposed housing development

Location: Land off Gelligaer Road, Trelewis

**Proposed development on land off Gelligaer Road, Trelewis;**

**Mining Risk Assessment & Geotechnical Report**

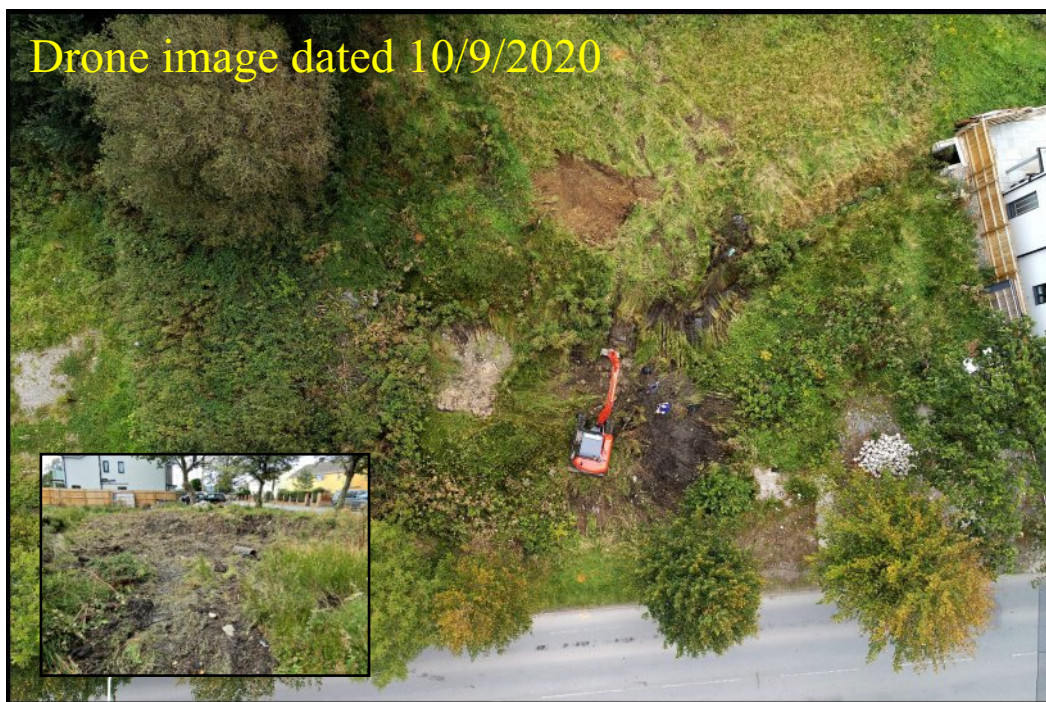
Drone image dated 10/9/2020

The site (Fig.1 and front cover) is located at National Grid Reference ST111967 at an elevation of some 155m AOD and lies to the south-east of Gelligaer Road, Trelewis. This is a greenfield site that is presently overgrown with brambles and scrub and lies some 1 - 1.5m below the level of the adjacent road (Front cover inset). It is bounded to the north-west by

Historical records (Figs 2, 3, 4 & 5) show the site as undeveloped on the Tithe, 1875, 1898, 1918, 1938, 1948 and 1951 editions, the 1945 aerial photograph and all subsequent Google images up to 2020 and the drone image on the front cover. The adjacent building to the south-west has been recently constructed and was also investigated by the author. A new housing estate has recently been constructed to the north-east of the site.

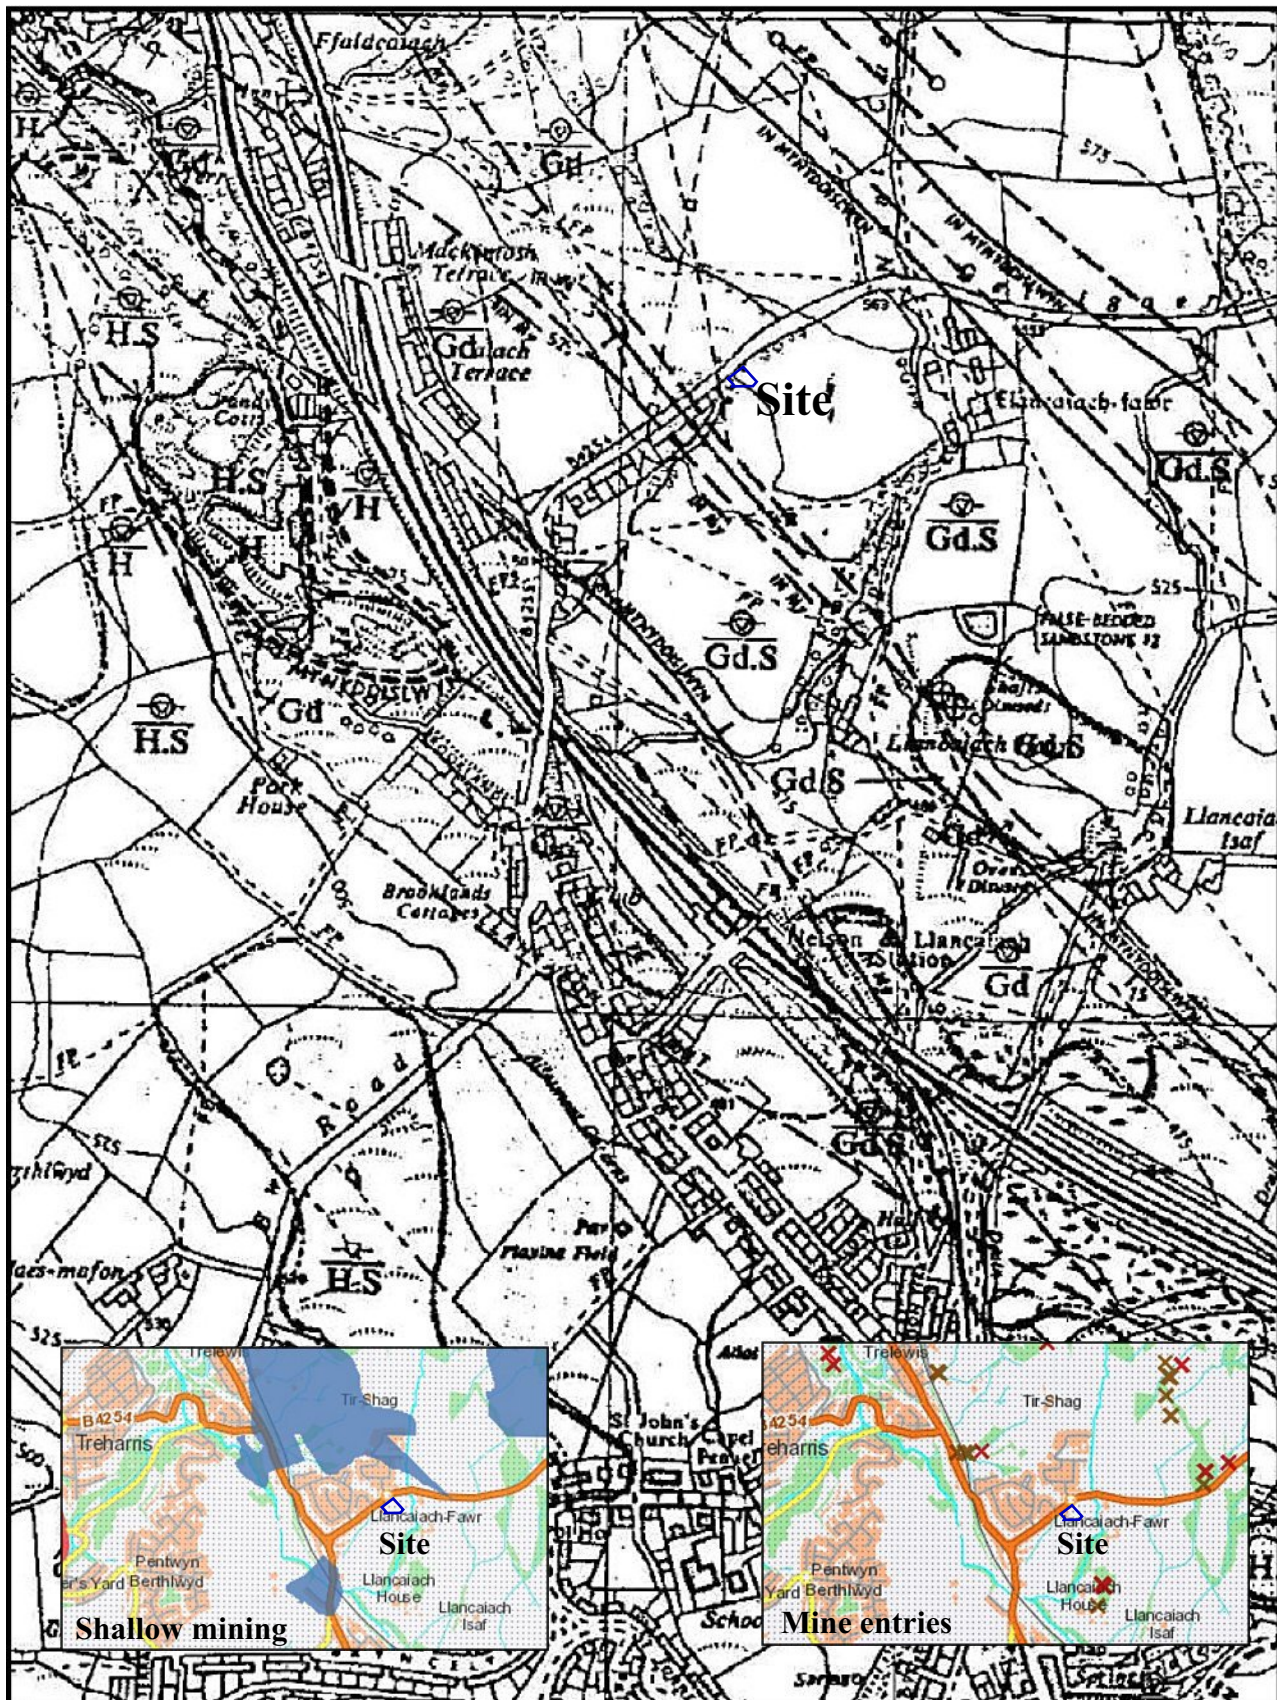
**Fig. 2** Proposed development off Gelligaer Road, Trelewis;  
Geological plan with mining details (inset)

The site is underlain by strata of Carboniferous Age belonging to the Grovesend Beds above the Mynyddislwyn Seam, which crops well to the west (Fig.2) beyond a faulted contact. These strata, which are not exposed at the site, comprise a sequence of mainly coarse grained and very thickly bedded, very wide spaced jointed, extremely strong gritstones overlying mudstones and siltstones associated with the Mynyddislwyn Seam and lie in a faulted trough on the south-western side of the Gelligaer Fault and north-eastern side of the Llanfabon Fault with a very gentle dip to the north into the Blackwood Syncline. The seam itself comprises a 1.5m thickness of coking quality coal and lies at a depth of some 40m below the site.

These strata are in turn indicated as overlain by a layer of glacial sand and gravel soils deposited in an extensive late glacial lake with Glacial till lower down the hillside by the Geological Survey (Fig. 2). In the event, all four trial pits proved a different sequence to that predicted by the Geological Survey with only glacial till underlying the site with a variable layer of colluvium above.

There are no recorded or suspected mine entries beneath or within influencing distance of the site (Fig. 2 and insets).

The shallowest recorded Coal Seam below the site is Mynyddislwyn Seam and the mining abandonment plans indicate that it has been completely worked out beneath the site and lies at a depth of some 40m. These workings were essentially completed by the turn of the Nineteenth century from Llancaich Colliery to the east. It is considered that these workings in the Mynyddislwyn Seam are at sufficient depth not to pose a threat to the proposed new development.

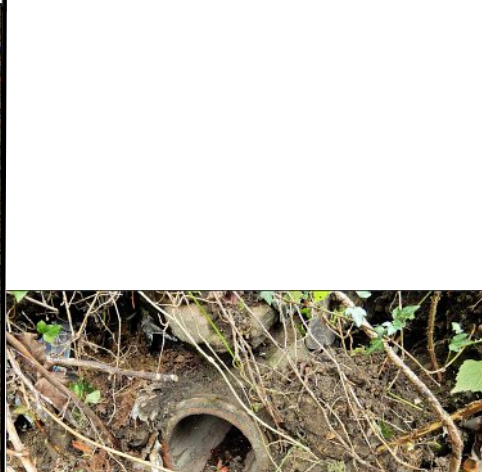
| | <p>0.00 - 0.20m increasing to 0.70m within the ditch. Black silty very organic silty sand; Organic topsoil.</p> <p>0.20 - 0.90m Orangish-brown, soft becoming firm, sandy, silty clay: Colluvium.</p> <p>0.90 - 1.20. Grey and green with orange mottling at the top, firm silty sand with rounded gravel, cobbles and boulders; Glacial till.</p> |
| <b>Water:</b> Dry | <b>Remarks:</b><br>Old drainage ditch. |

Trial pit TP 1 was excavated across the line of the watercourse to determine the amount of alluvium present and the results are presented in the records of TP 1. In the event, no alluvium was encountered nor was there any signs of the watercourse being active, nor was there any signs of 'rises' as indicated on the earlier maps. This includes the period from 2013 - 2020 when the site was being monitored for the earlier property development.

The investigation proved the presence of organic topsoil infilling the line of the watercourse as shown in the photograph accompanying TP 1 where the natural succession of colluvium down to glacial till was encountered. There is no way that the glacial till below the site can be the source of groundwater as it is effectively impermeable. This was taken to indicate that the watercourse had not flowed significantly in recent times.

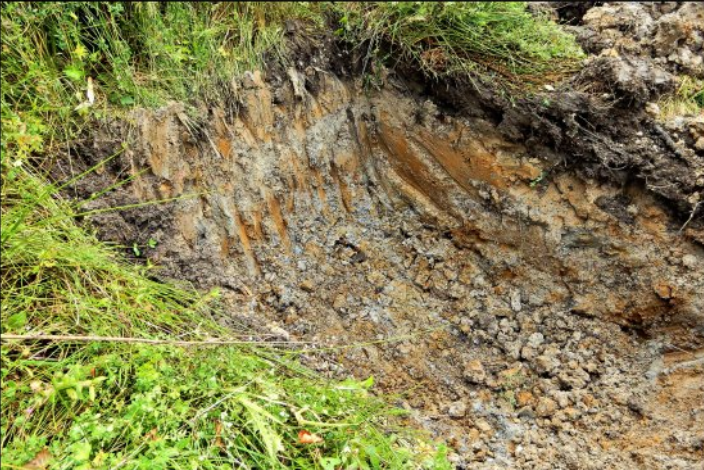
| | | <p>0.00 - 0.20m Black silty very organic silty sand; Organic topsoil.</p> <p>0.20 - 0.50m Orangish-brown, soft becoming firm, sandy, silty clay: Colluvium.</p> <p>0.50 - 1.20. Grey and green with orange mottling at the top, firm silty sand with rounded gravel, cobbles and boulders; Glacial till.</p> |

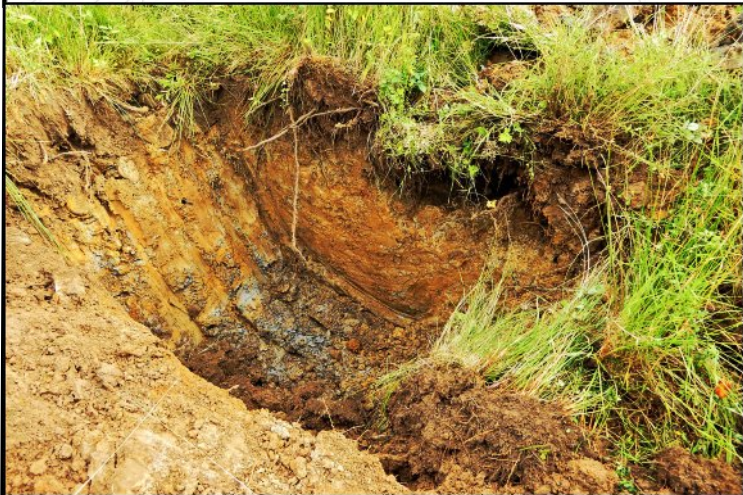
| | | <b>0.00 - 0.20m Black silty very organic silty sand; Organic topsoil.</b><br><b>0.20 - 0.90m Orangish-brown, soft becoming firm, sandy, silty clay: Colluvium.</b><br><b>0.90 - 1.20. Grey and green with orange mottling at the top, firm silty sand with rounded gravel, cobbles and boulders; Glacial till.</b> | |
