**WOODSTOCK, SOMERSET LANE, MERTHYR TYDFIL**

**BAT SURVEY**

**JUNE 2022**

### Bat Survey Report

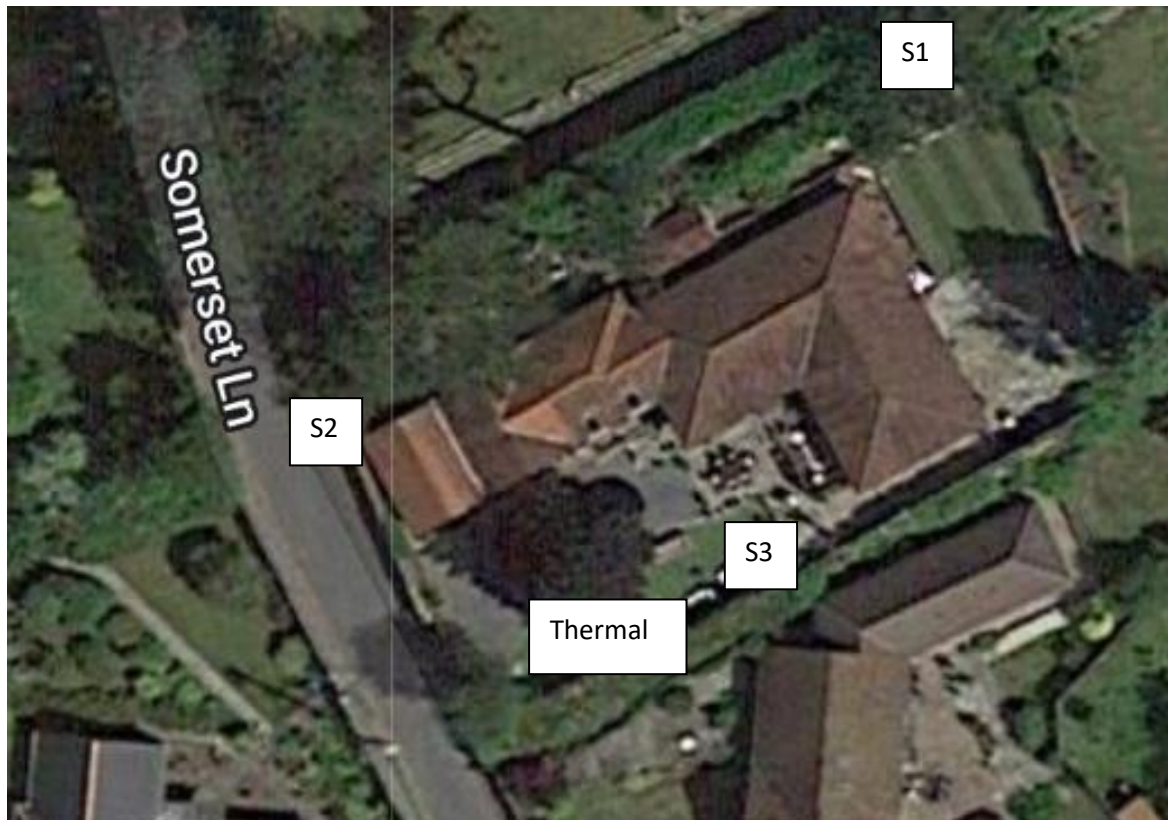
Figure 3: Approximate surveyor locations

A dusk survey was carried out on 10<sup>th</sup> May using surveyors ,positioned in such a way that as much of the building was visible to surveyors as possible. Surveyors were equipped with Batlogger M detectors.

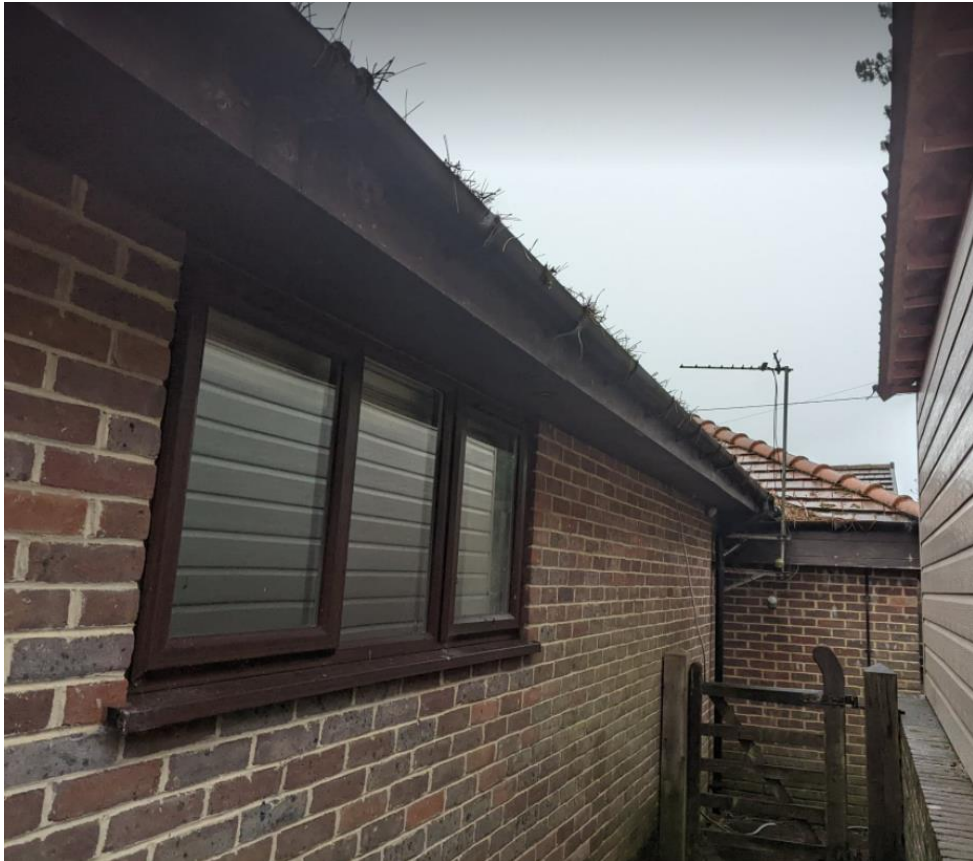
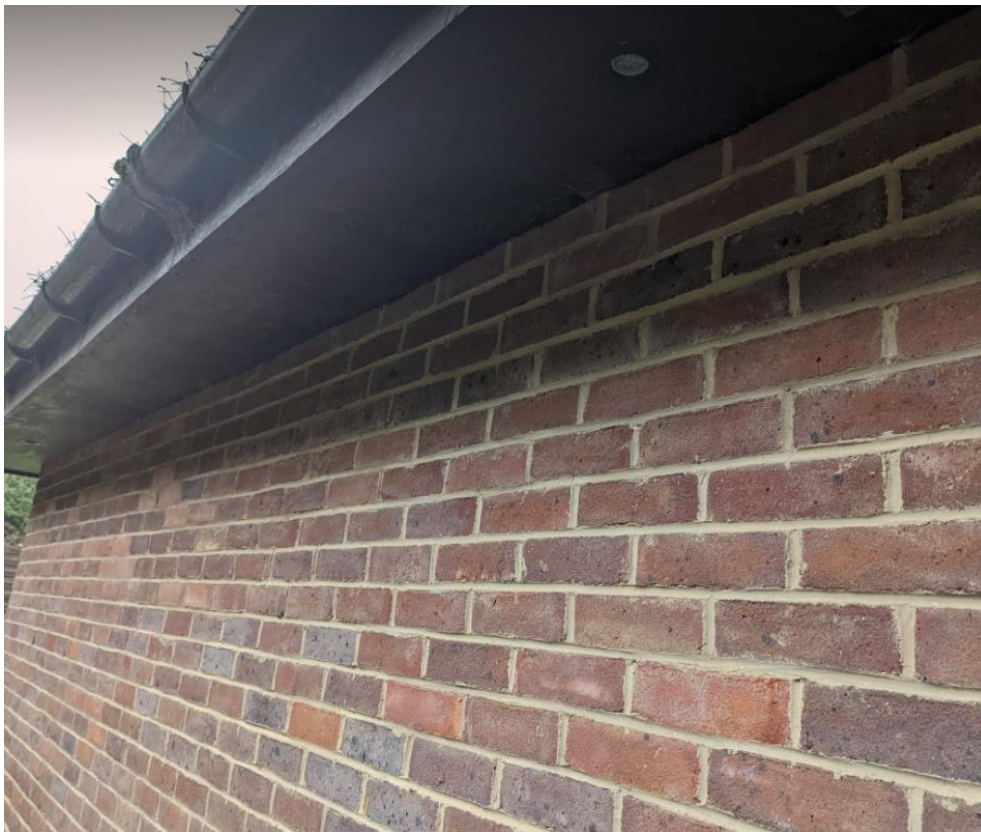
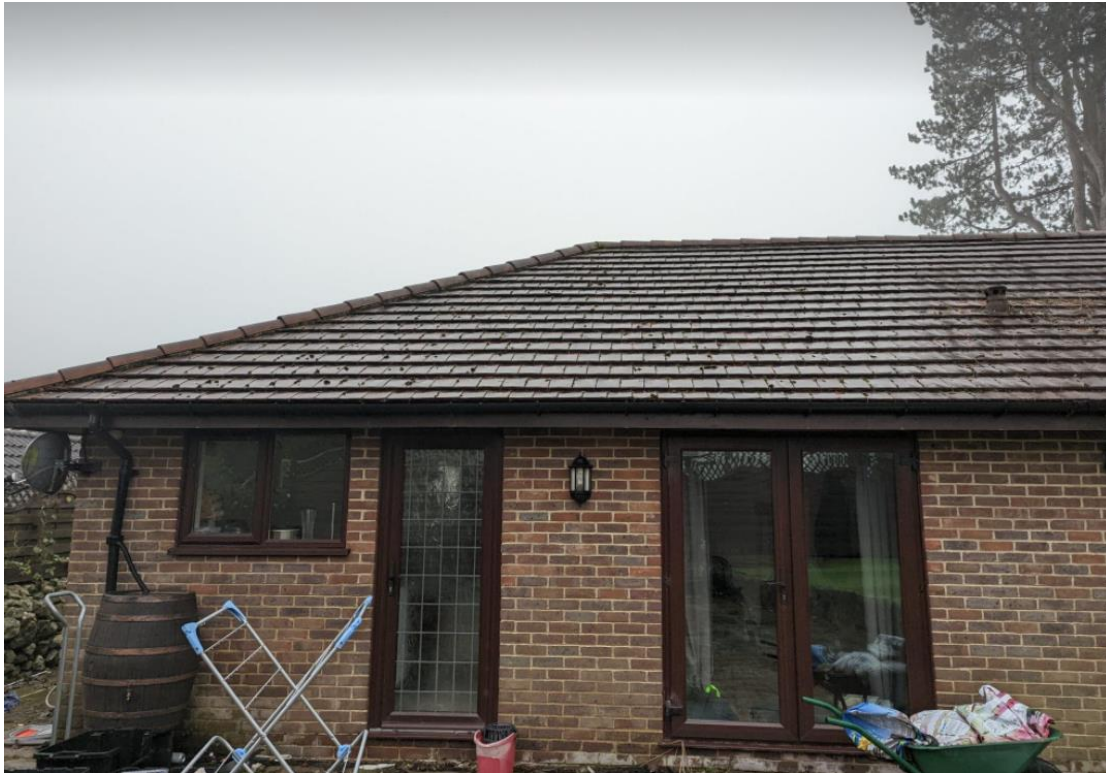
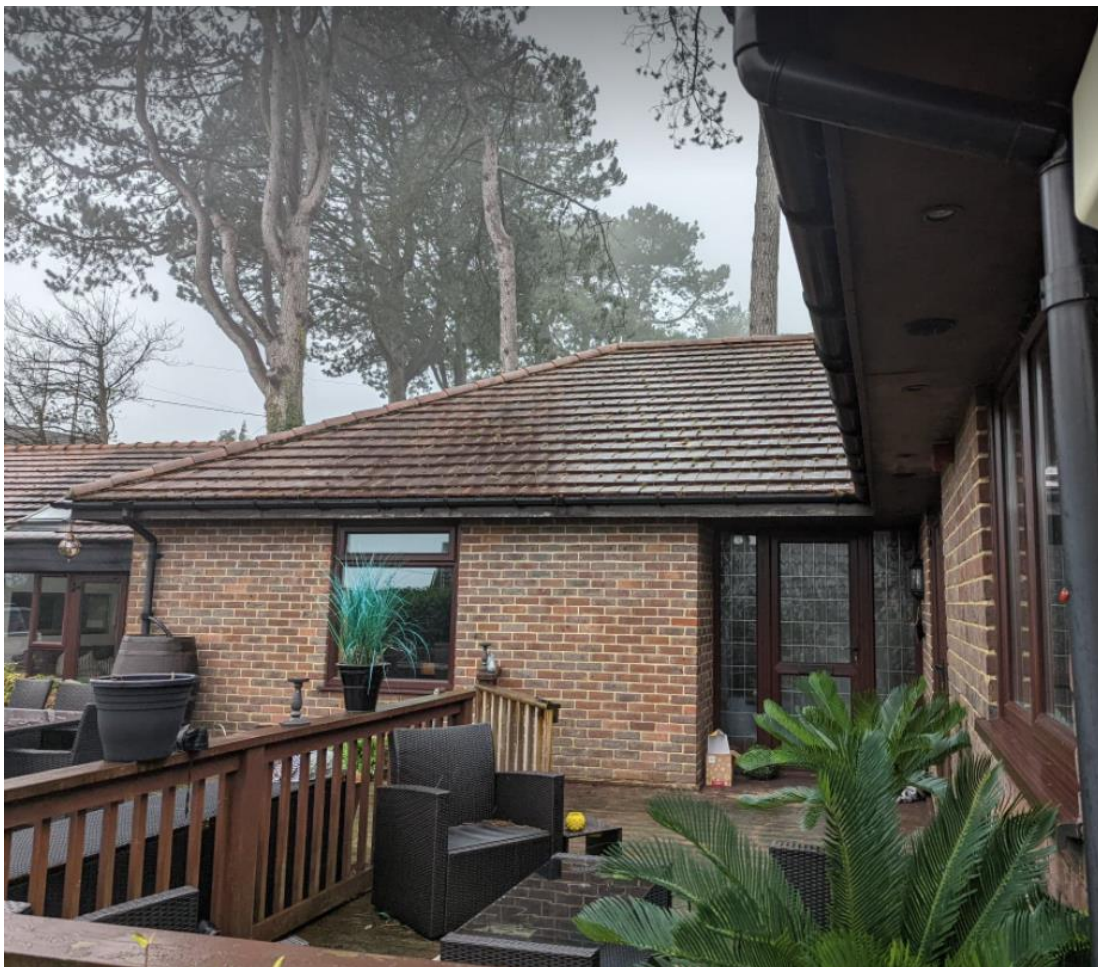
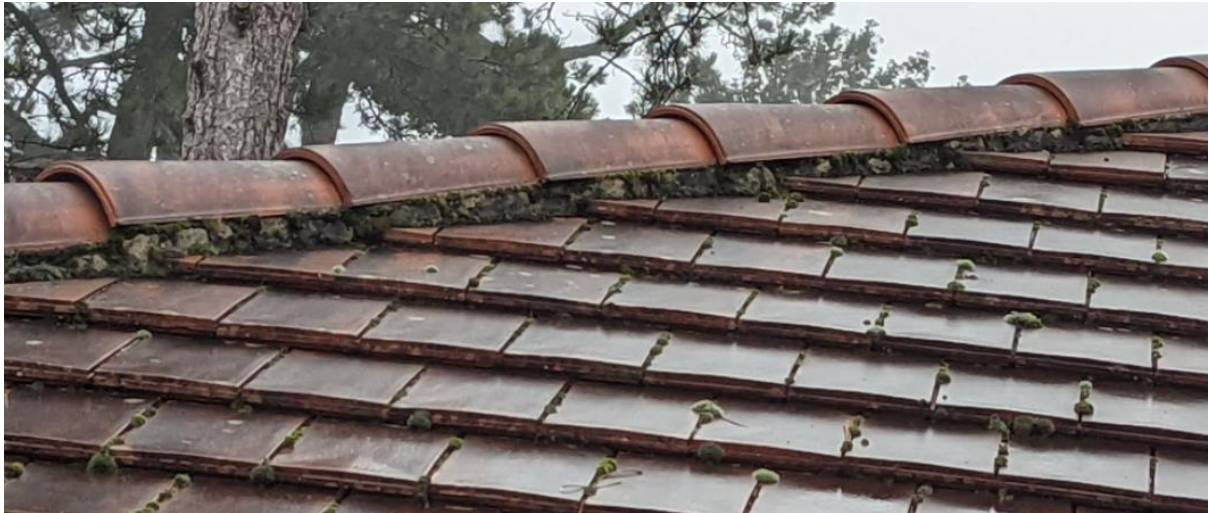
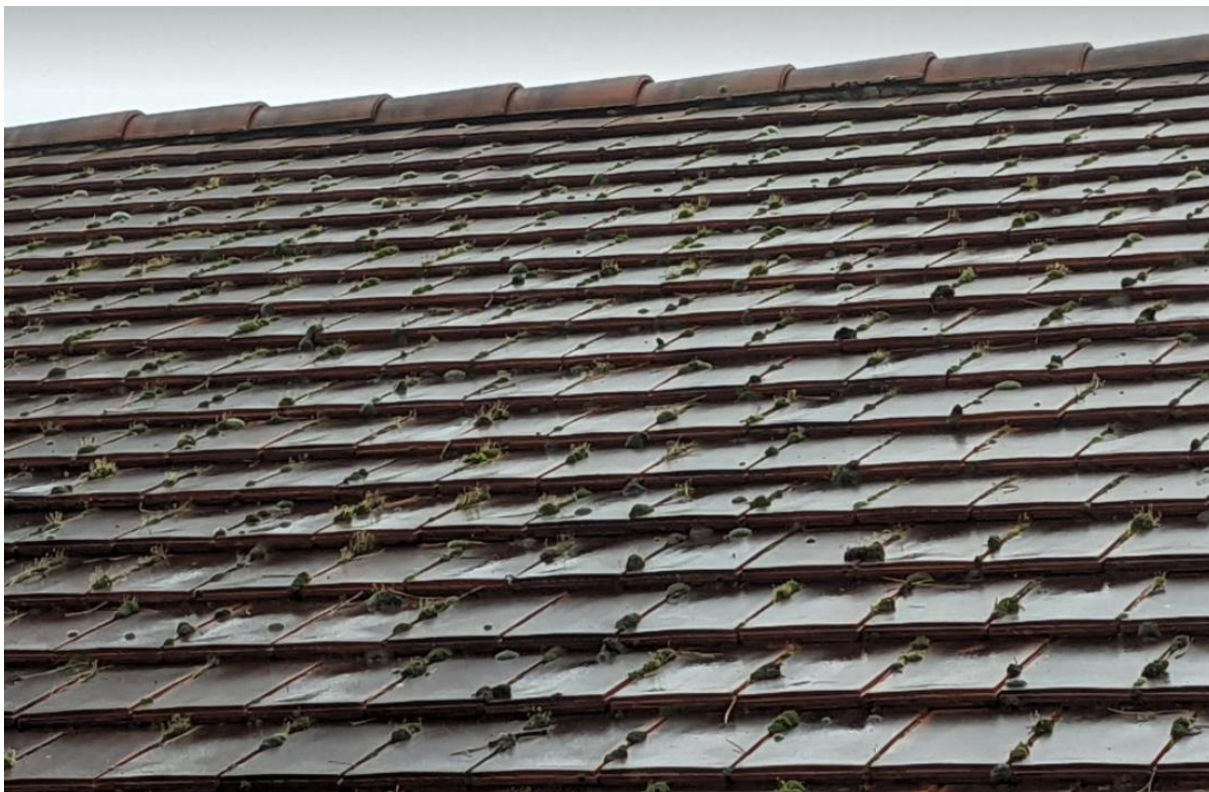
## APPENDIX A- SITE PHOTOGRAPHS

The survey carried out by BE Ecological Ltd revealed no droppings or evidence of bats on the exterior of the building, however, access and roosting potential for bats was identified in the form of:

- Small number of potentially lifted ridge/hip tiles

Please see appended plates for photographs of the property exterior. Other than these areas, the building appears to be relatively well sealed with no obvious gaps and no apparent slipped tiles on the pitches of the roof. There are a small number of gaps beneath fascias, however, these are extremely small and few and far between.

As such, the property was categorised as being of low potential for roosting bats and further emergence/re-entry surveys were recommended.

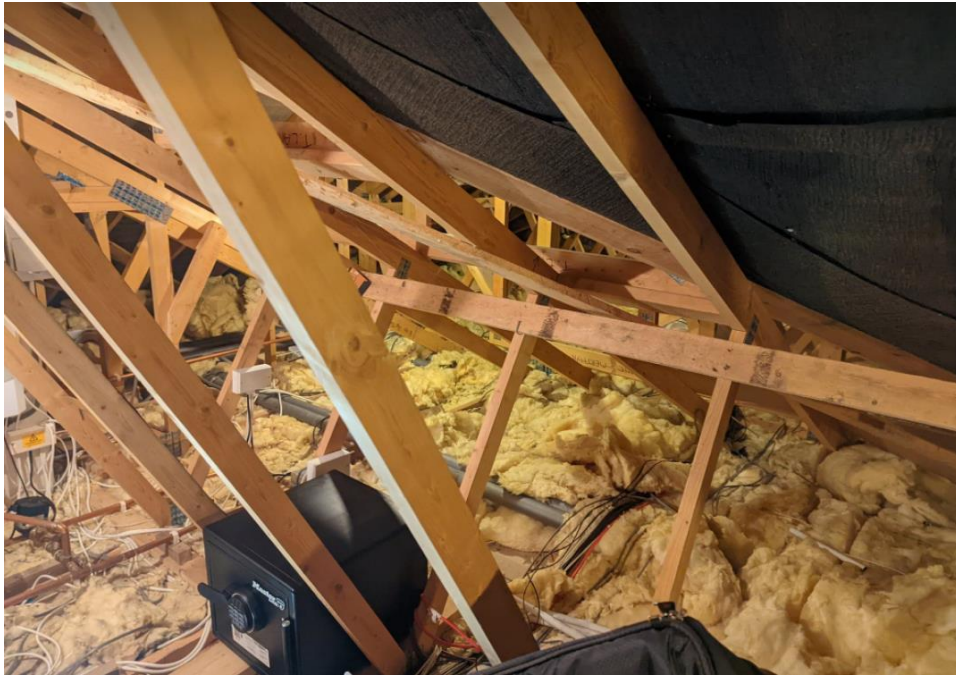
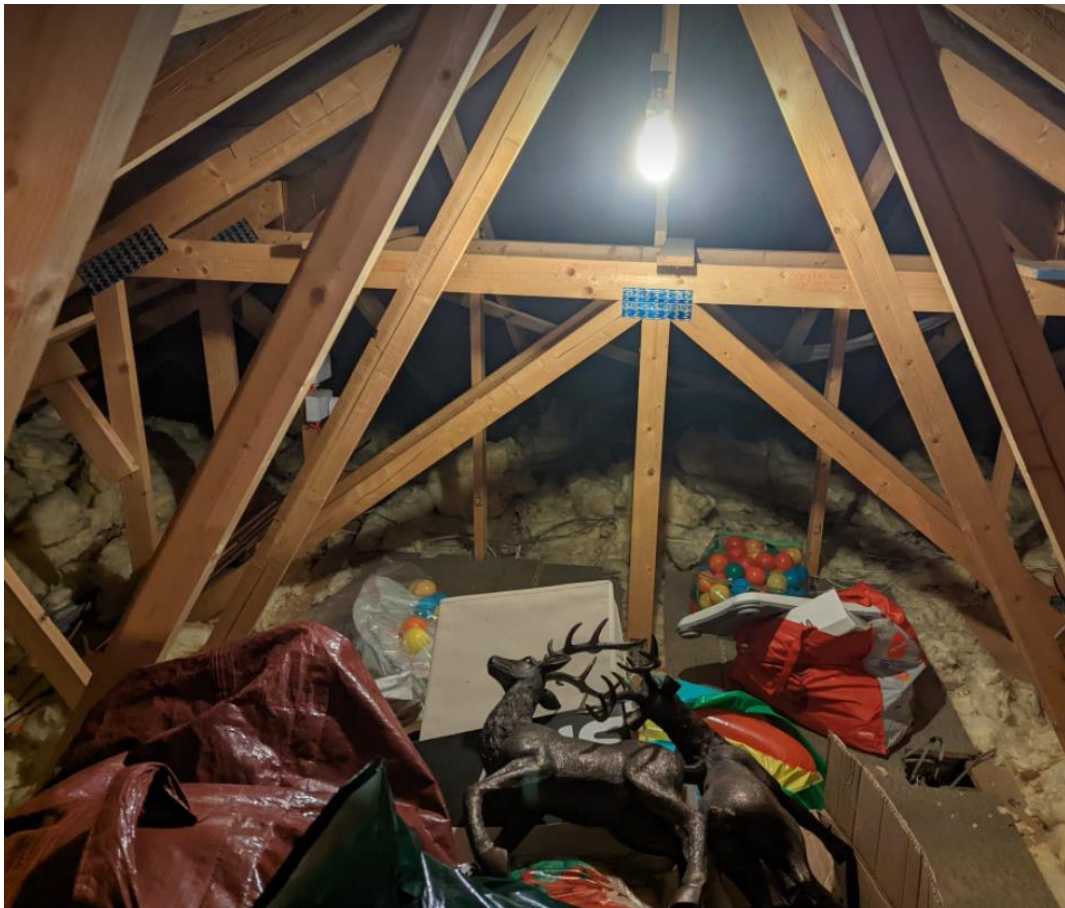
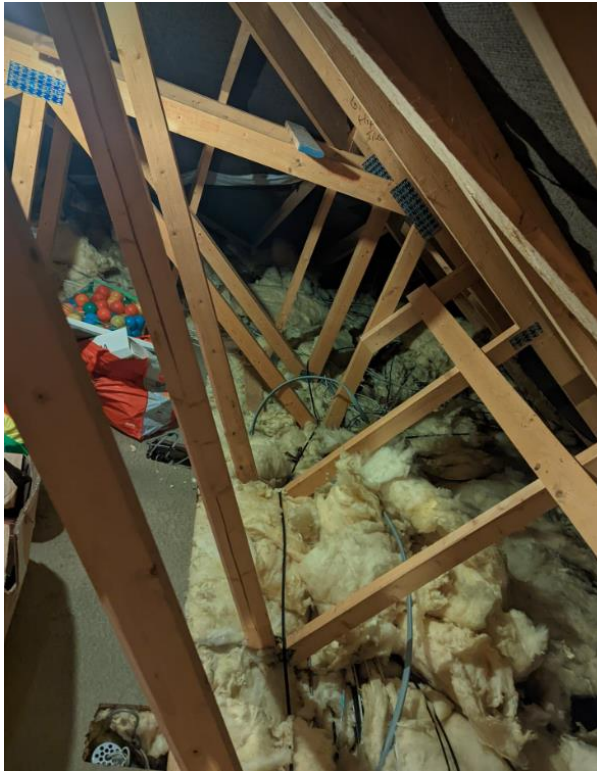
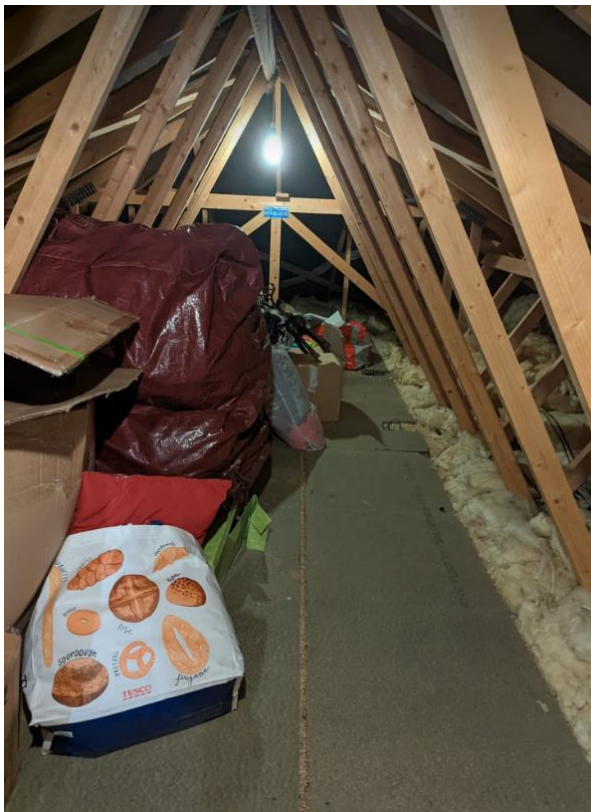
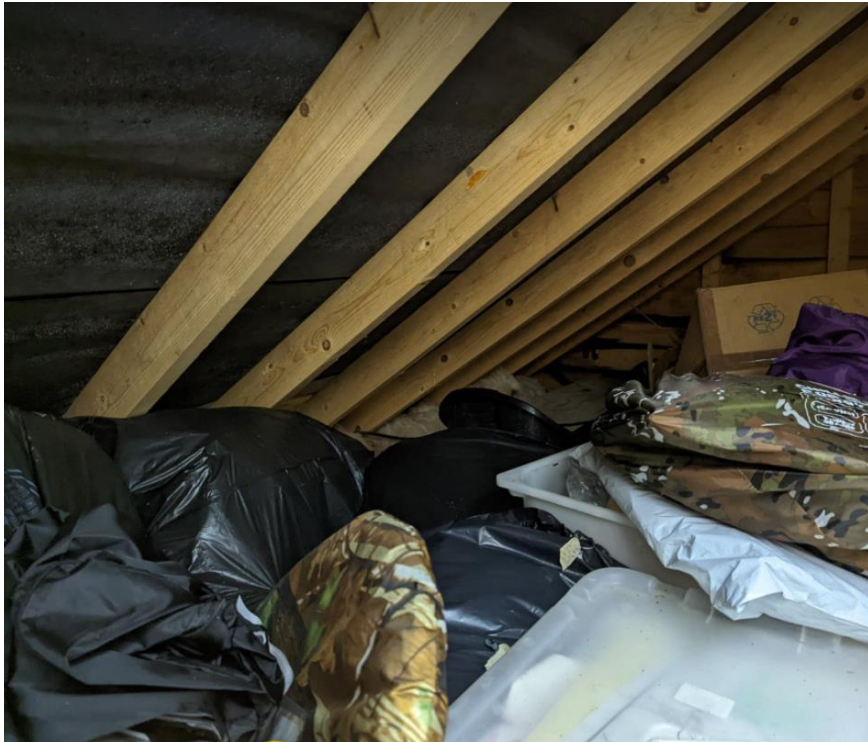
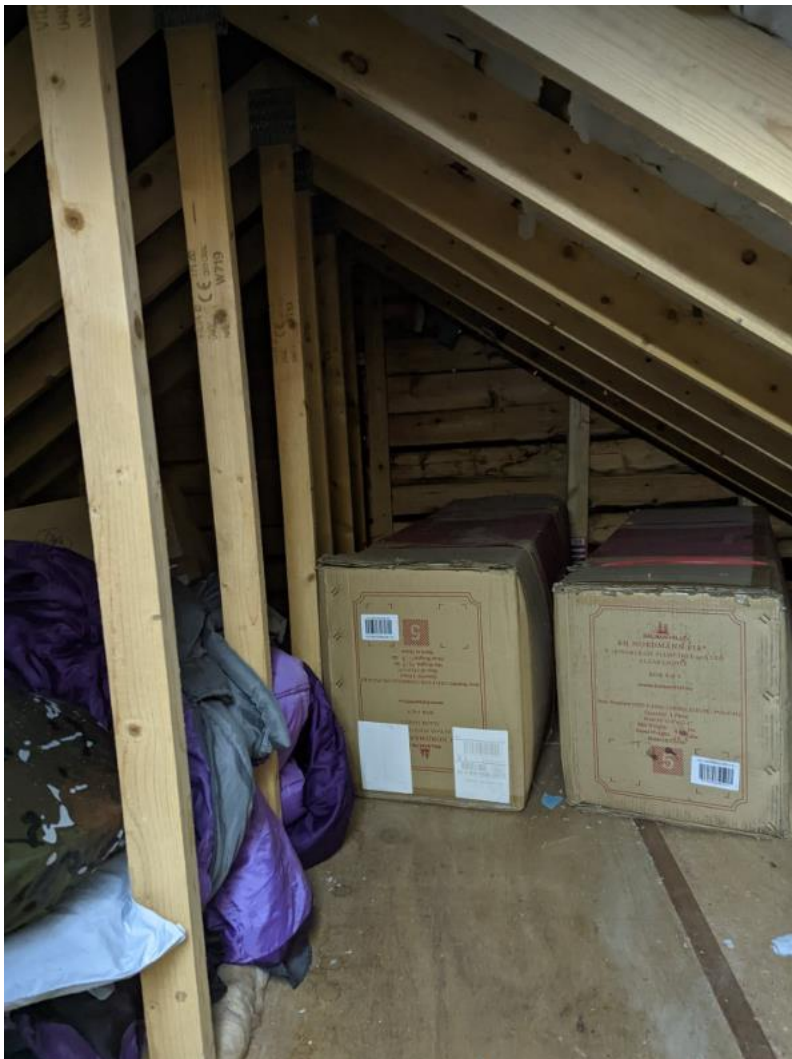
Internally, there were two roof spaces to inspect. The first is above the western section of the building. The roof space is extremely clean and currently used for storage. The void is of a typical rafter and purlin construction and is lined with bitumen felt. No bats nor evidence of bats was found in this location.

The larger of the two roof voids is found above the eastern section of the house. Again the void is of a typical rafter and perlin construction and is lined with bitumen felt. Again the loft is used for storage purposes. No bats or evidence of bats was found in this location.
