# BAT SURVEY REPORT

## HIGH STREET CHAPEL

| Project: High Street Chapel | | |
| Document Number | M005 - Bat Report-V1.2 | |

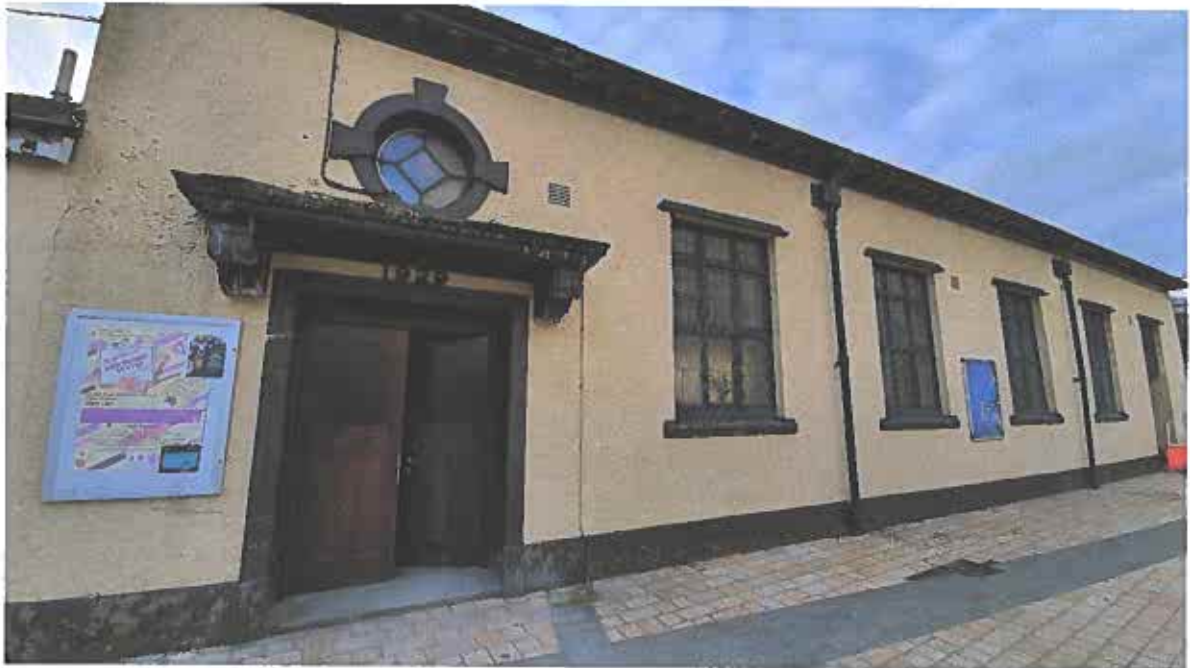
4.6

Photo 1: Overview of *Section A* of the building. The walls are rendered and have no potential for roosting bats. The photo below shows the windows covered in wire mesh.

4.11 There are potential access points throughout the large loft space above *Section A*. The lack of any roofing felt makes all areas within the loft space accessible for inspection. Though the building has access points that could be used by bats, the lack of any evidence implies the area is not being used by roosting bats; as a result, *Section A* is considered of negligible interest for roosting bats.

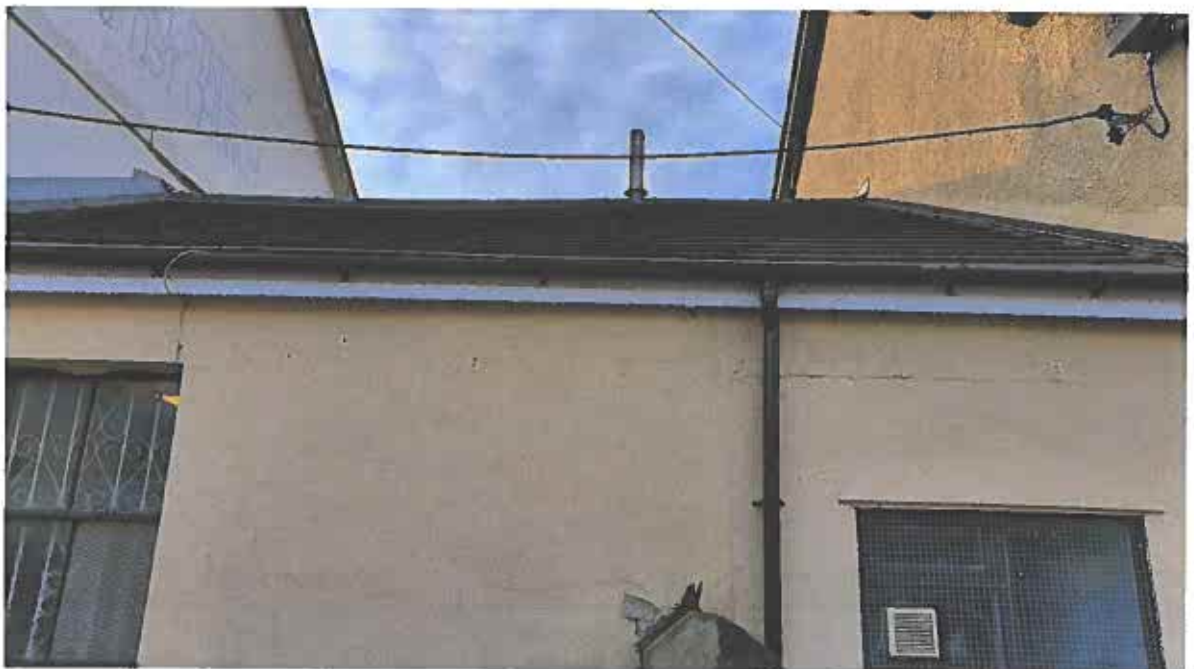
4.7

Photo 2: Overview of *Section B* of the building. The walls are rendered and have no potential for roosting bats. The photo below shows the windows covered in wire mesh.

4.12 Section B has recently had a new roof put on, the roof is lined with a breathable membrane and there appears to be insulation between the tiles and felt. The loft space and the roof are considered of negligible interest for roosting bats. Though the seller has potential access points in the door, the lack of any evidence implies the area is not being used by roosting bats; as a result, the seller has been designated as having negligible potential for bats.

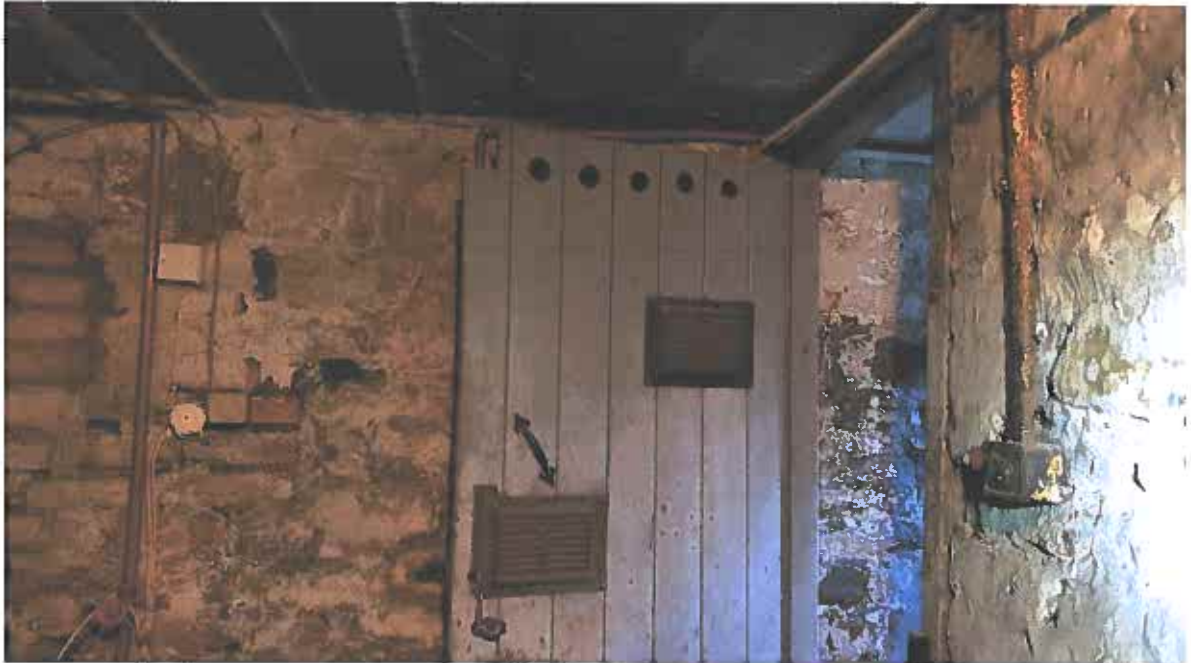
4.8

Photo 3: Access to the seller. The access door has holes along the top that could be used for access by roosting bats. No evidence of bats was found within the seller.

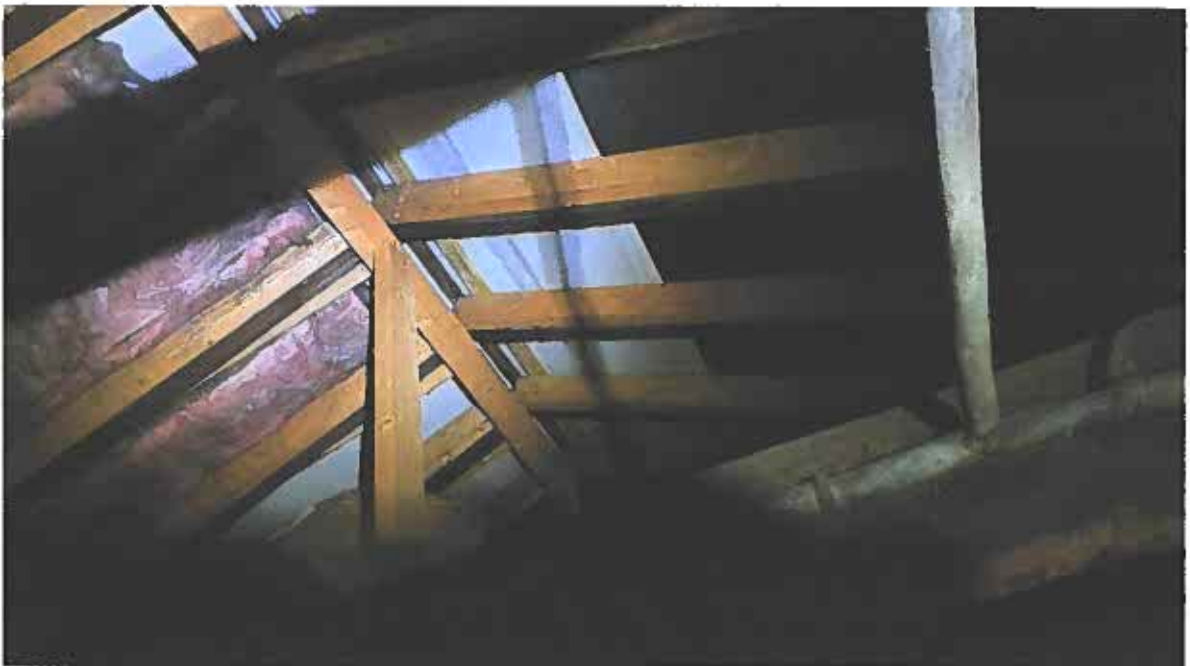
4.9

Photo 4: Shows the loft space above *Section B*, the space was heavily cobwebbed indicating a lack of internal activity. The roof is new and lined with breathable membrane and fibreglass insulation. No evidence of bats was found.

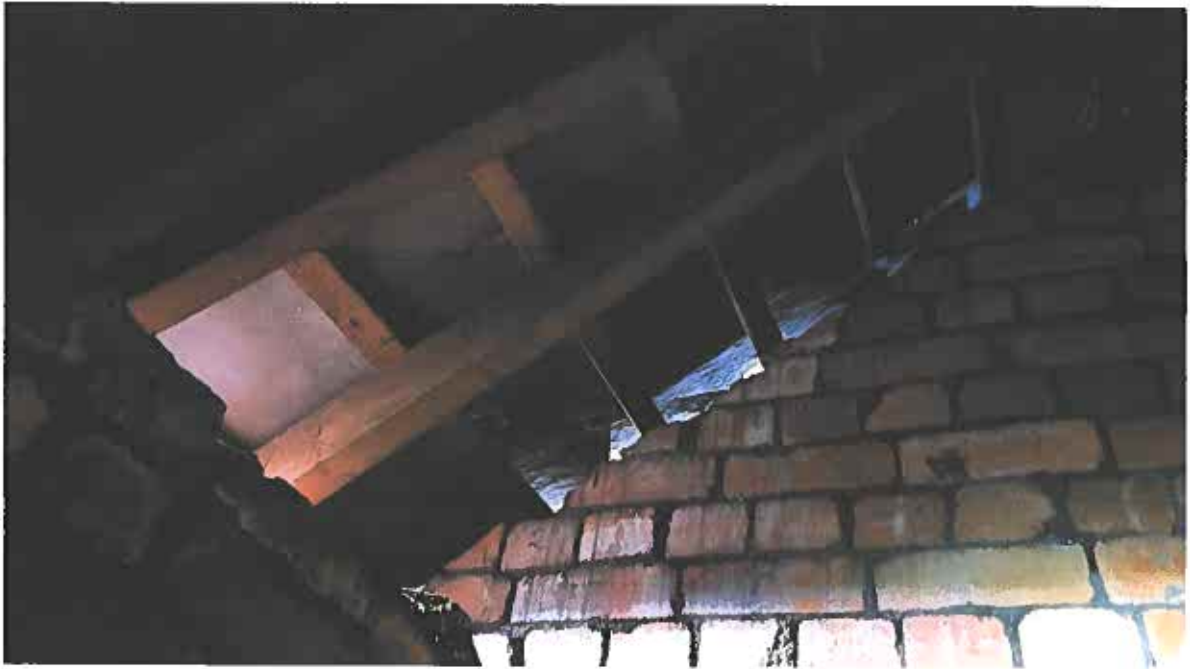
4.10

Plate 5: The western gable wall of *Section A* has significant external damage and there is access for bats throughout.

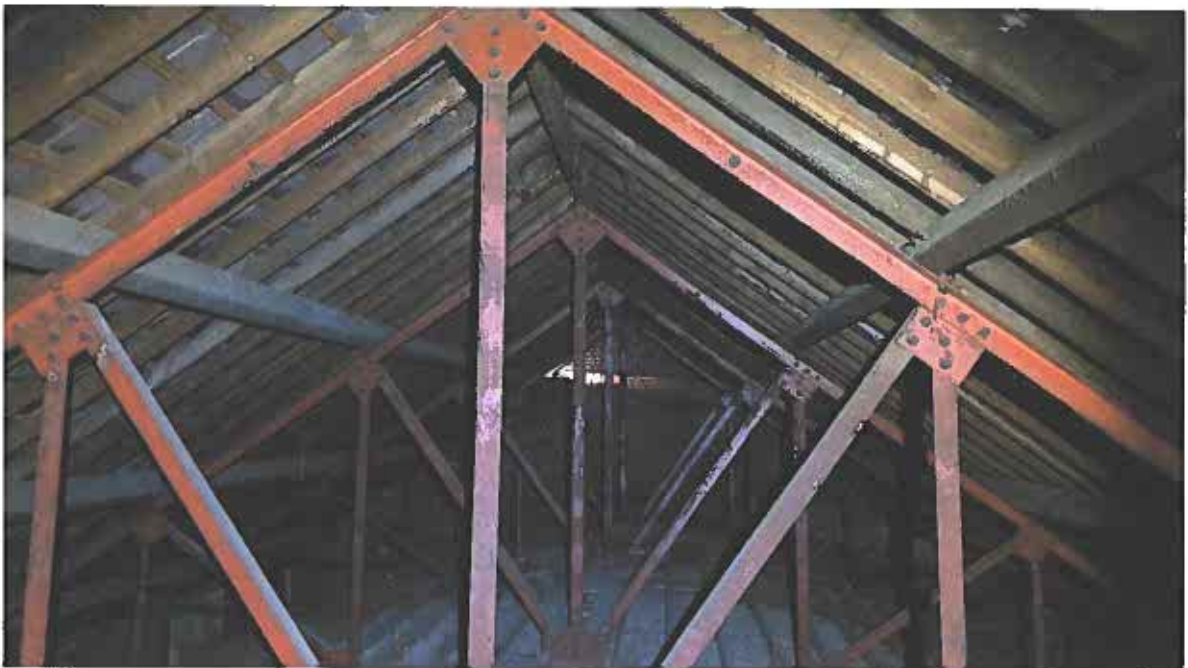
Photo 6: *Section A* loft space overview. The roof is unlined. No evidence of bat was found within the loft space, the loft was uncleaned and had clearly remained undisturbed for some time.
