**Ffos-y-Fran Final Restoration Strategy**

**Ecological Impact Assessment (EclA)**

**MERTHYR (SOUTH WALES) LTD**

December 2024

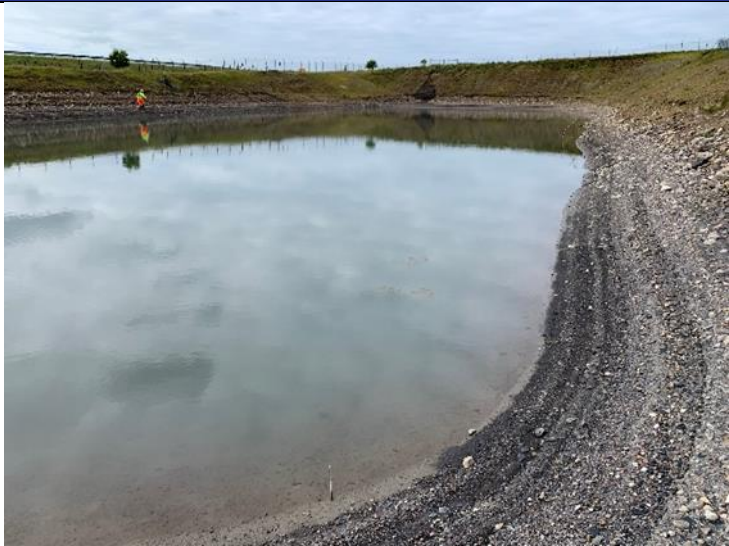
| Ref | Description | Image |
|---|---|---|
| P01 | <p>Settlement lagoon with riparian zone consisting of a combination of colliery silt and small pebbles, almost devoid of vegetation with the exception of three saplings of <i>Salix</i> spp. growing on extruding silt deposits. Patches of <i>Potamogeton</i> spp. are present in the centre and toward the margins, covering approximately 10% of surface area.</p> <p>eDNA result:Negative<br/>HSI Score:0.58 (below average)<br/>Lined (y/n):No</p> | |

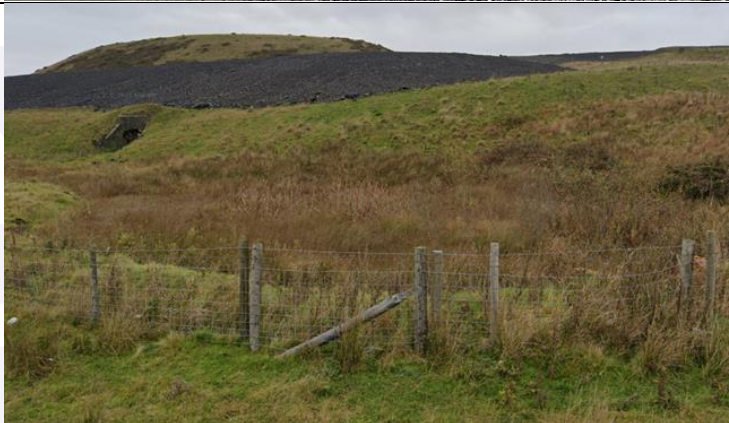
| Ref | Description | Image |
|---|---|---|
| P02 | <p>At the time of surveying (June) this pond was almost entirely vegetated, with minimal open water and had taken on the characteristics of marshy grassland. The dominant plants were rushes such as <i>Juncus effusus</i> and <i>Typha</i> spp. During the winter months it is likely that the water level increases, forming a more typical pond.</p> <p>eDNA result:Negative<br/>HSI Score:0.50 (Poor)<br/>Lined (y/n):No</p> | |

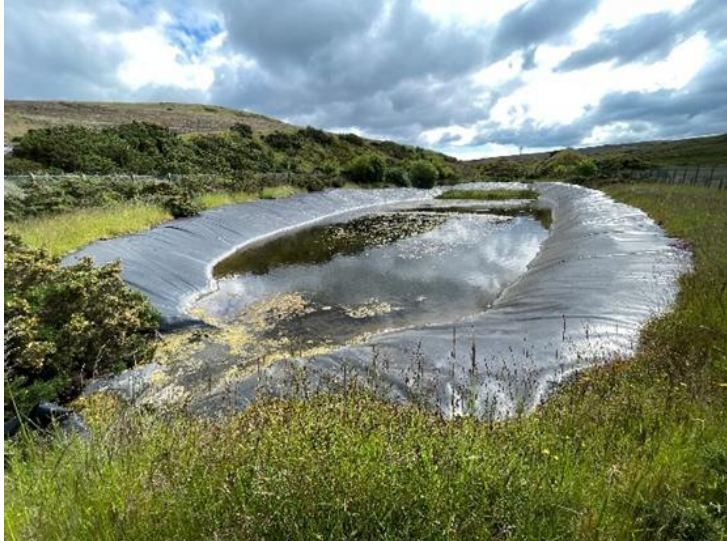
| Ref | Description | Image |
|---|---|---|
| P03 | <p>The riparian zone/banks were entirely of exposed pond liner with no vegetation. Approximately 20% of the eastern end of the pond area was composed of a solidly vegetated mat. This mat consisted of a diverse range of grasses (such as common Bent, <i>Agrostis capillaris</i>; crested dog's-tail, <i>Cynosurus cristatus</i> and Sweet Vernal-grass, <i>Anthoxanthum odoratu</i>), sedges (primarily <i>Carex</i> spp.), numerous saplings of eared willow (<i>Salix aurita</i>) and some small gorse. Submerged vegetation was dominated by <i>Elodea</i> spp. Which covered almost the entire bottom of the pond. Approximately 40-50% of the surface area was comprised of <i>Potamogeton</i> spp.</p> <p>eDNA result:Positive<br/>HSI Score:0.75 (Good)<br/>Lined (y/n):Yes</p> | |

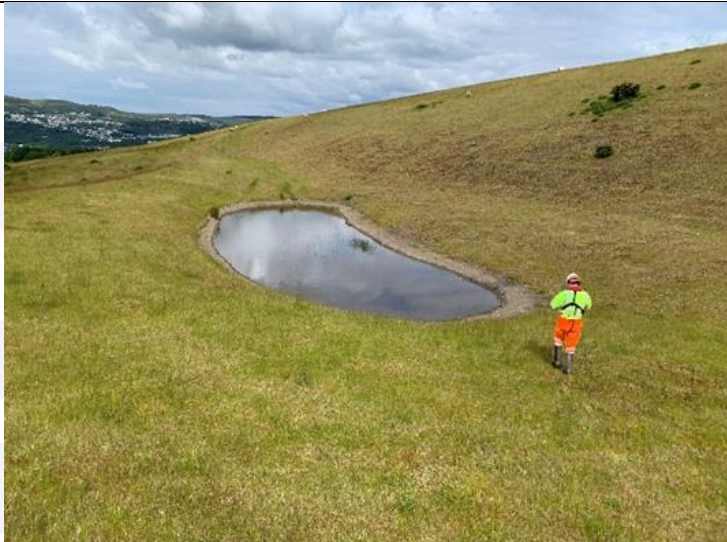
| Ref | Description | Image |
|---|---|---|
| P04 | <p>Set within a previously restored area of grazed grassland, the majority of the riparian zone was free of vegetation, consisting of bare stoney ground, with the exception of a single stand of <i>Juncus</i> spp. This species also comprised the only vegetation within the pond itself, in the form of an emergent stand of less than 5% of the area</p> <p>eDNA result:Positive<br/>HSI Score:0.51 (Below average)<br/>Lined (y/n):No</p> | |

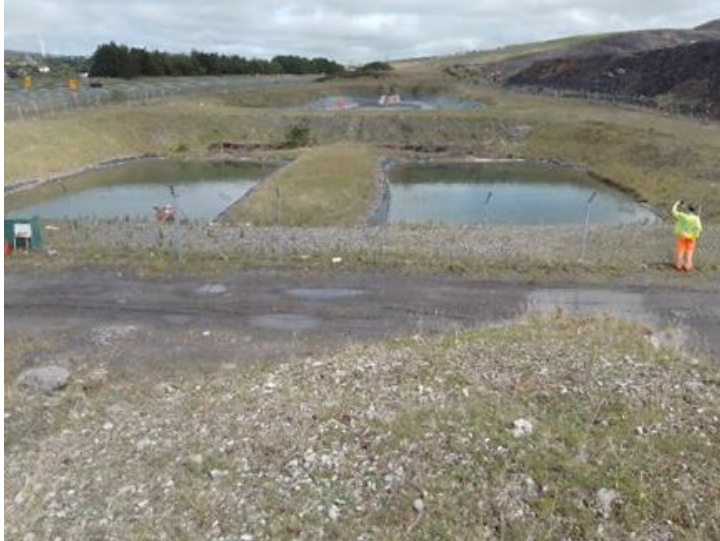
| Ref | Description | Image |
|---|---|---|
| P06 | <p>The banks of the largest of the three sub-divisions. At the northeastern end was a small strip of densely matted vegetation (primarily <i>Juncus</i> spp.) which formed approximately 5% of the pond area. Minimal aquatic vegetation was observed. The banks of the two adjacent smaller sub-divisions also consisted of exposed liner, though the degree of exposure was significantly less than the larger pond. Marginal vegetation in both these ponds was comprised of <i>Typha</i> spp. (less than 10% of the total area) and floating vegetation in the form of <i>Potamogeton</i> spp. covered approx. 20-30% of the surface of each.</p> <p>eDNA result:Negative<br/>HSI Score:0.47 (Poor)<br/>Lined (y/n):Yes</p> | |

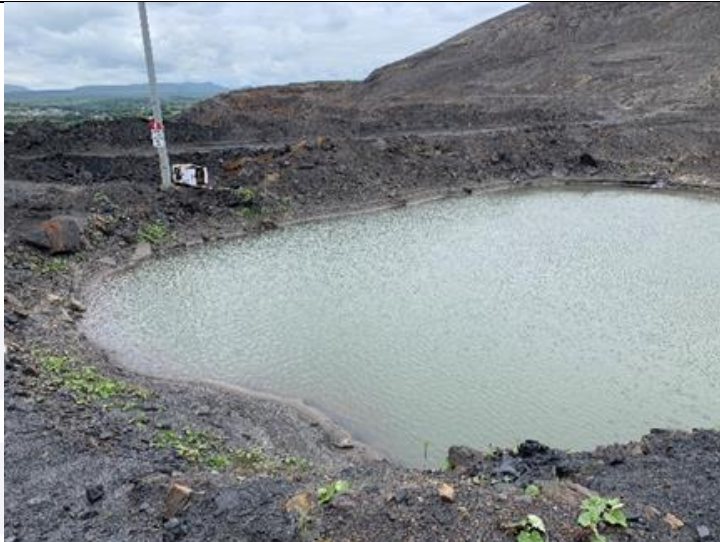
| Ref | Description | Image |
|---|---|---|
| P08 | <p>This pond contained minimal vegetation with the exception of coltsfoot (<i>Tussilago farfara</i>) growing within the colliery spoil which forms the banks and surrounding area. No aquatic vegetation was observed.</p> <p>eDNA result:Negative<br/>HSI Score:0.30 (Poor)<br/>Lined (y/n):No</p> | |

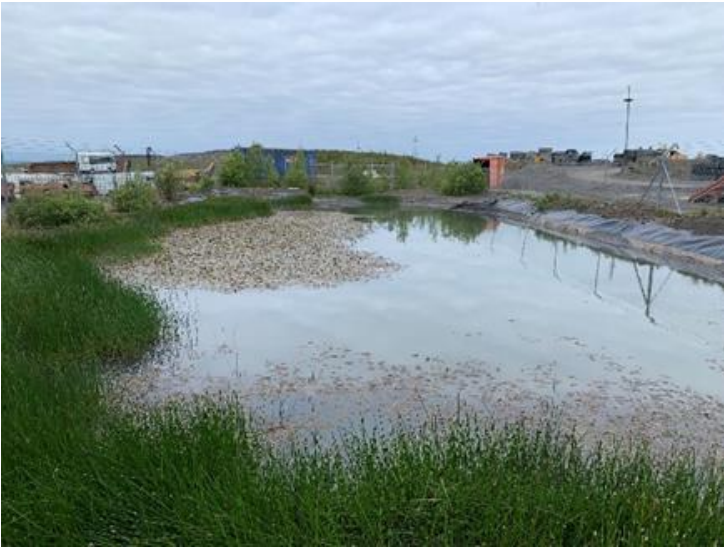
| Ref | Description | Image |
|---|---|---|
| P09 | <p>This pond was comprised of two adjacent sub-divisions. Both were surrounded by a short strip of exposed liner which transitioned into an area of silt deposit before the waters edge. Of the easterly of the two were several small overhanging bushes (<i>Salix</i> spp.) forming approximately 40% of the margin. The surface of this pond was largely covered by <i>Potamogeton</i> spp. interspersed with emergent <i>Juncus</i> spp. Leaves and a stand of <i>Typha</i> spp. The more westerly pond was largely of the same composition but contained significantly more <i>Juncus</i>, which formed a dense strip around approximately 40% of the margin.</p> <p>eDNA result:Positive<br/>HSI Score:0.45 (Poor)<br/>Lined (y/n):Yes</p> | |

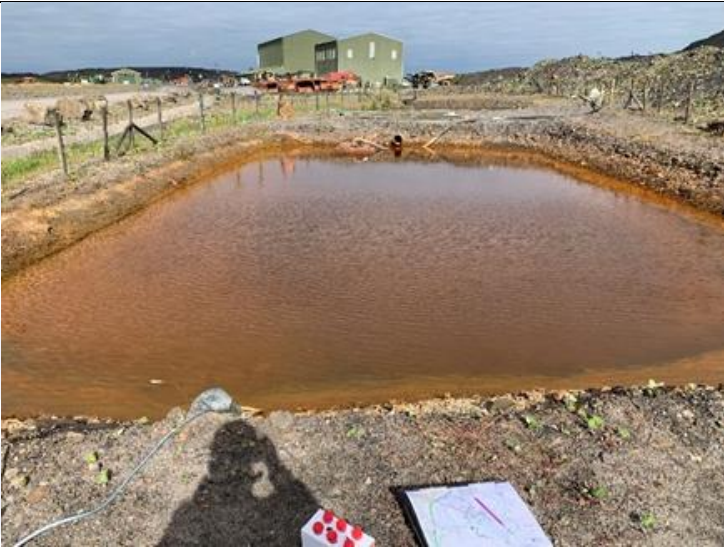
| Ref | Description | Image |
|---|---|---|
| P9a | <p>This washout lagoon was heavily coloured by ochre and contained no submerged or floating vegetation. There were small patches of <i>Juncus</i> and <i>Tussilago farfara</i> around the margins, making up less than 5%.</p> <p>eDNA result:Inconclusive*<br/>HSI Score:0.43 (Poor)<br/>Lined (y/n):No</p> <p>*Due to suspended sediment levels.</p> | |

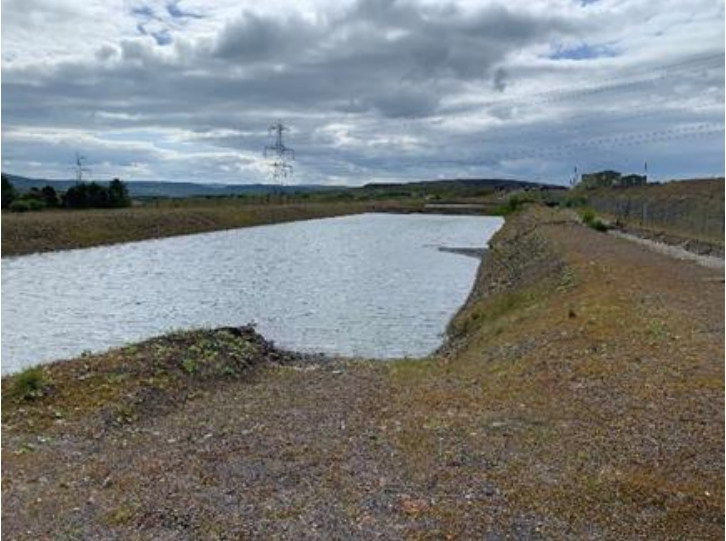
| Ref | Description | Image |
|---|---|---|
| P12 | <p>Largely similar to the adjacent pond 11, with the exception of dense marginal patches of <i>Equisetum</i> in the corners.</p> <p>eDNA result:Negative</p> <p>HSI Score:0.44 (Poor)</p> <p>Lined (y/n):No</p> | |

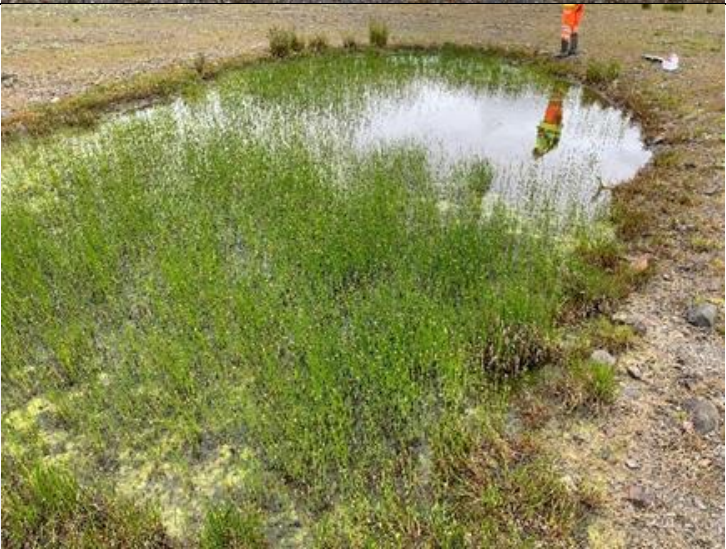
| Ref | Description | Image |
|---|---|---|
| P13 | <p>A shallow pond with minimally discernible banks on the top of OB2, much of the margin and surface was dominated by emergent <i>Juncus</i> interspersed with patches of algae.</p> <p>eDNA result:Negative</p> <p>HSI Score:0.45 (Poor)</p> <p>Lined (y/n):No</p> | |

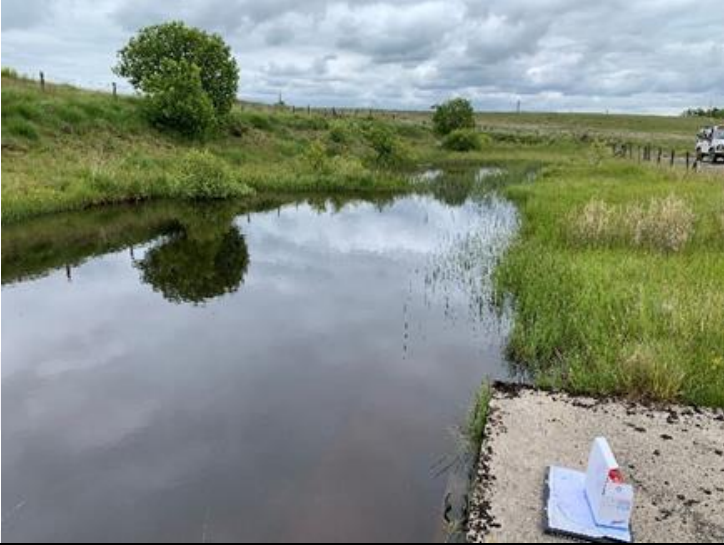
| Ref | Description | Image |
|---|---|---|
| P15 | <p>The margins of this pond were very well vegetated, primarily by <i>Equisetum</i> interspersed with <i>Juncus</i> and <i>Carex</i> as well as a few small <i>Salix</i> saplings. Submerged vegetation was limited but there were areas of <i>Elodea</i> spp. and some floating <i>Potamogeton</i> patches.</p> <p>eDNA result:Positive</p> <p>HSI Score:0.74 (Good)</p> <p>Lined (y/n):No</p> | |

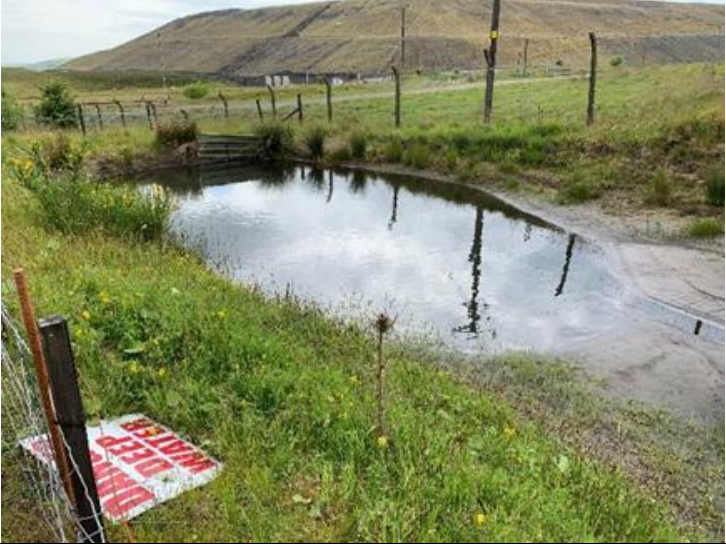
| Ref | Description | Image |
|---|---|---|
| P16 | <p>Approximately 50% of the area was predominantly exposed silt with a narrow channel of shallow water draining into a deeper section at the other end. The margins were well vegetated, primarily by grasses, a single gorse bush and patches of <i>Juncus</i>, with <i>Equisetum</i> occasionally protruding through the exposed silt deposits.</p> <p>eDNA result:Positive<br/>HSI Score:0.43 (Poor)<br/>Lined (y/n):No</p> | |

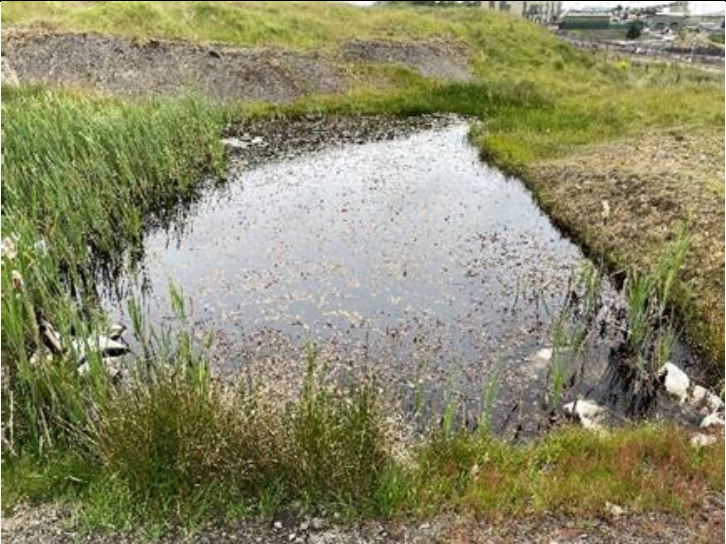
| Ref | Description | Image |
|---|---|---|
| P16<br>a | <p>Well vegetated with 50% of the margin consisting of a dense <i>Typha</i> stand with the remaining area comprised primarily of short grasses and small patches of <i>Juncus</i>. The majority of surface area consisted of a dense mat of <i>Potamogeton</i>.</p> <p>eDNA result:Positive<br/>HSI Score:0.64 (Average)<br/>Lined (y/n):No</p> | |

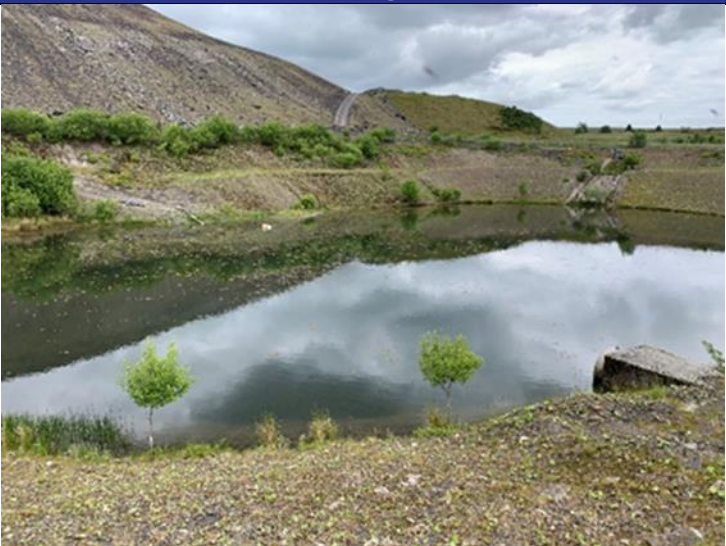
| Ref | Description | Image |
|---|---|---|
| P17 | <p>Wide banks covered with short and patchy grasses and mosses interspersed with coltsfoot. The margin was largely dominated by a thin strip of <i>Juncus</i> with occasional overhanging <i>Salix</i> bushes. Much of the surface area was covered by a thin mat of <i>Potamogeton</i>.</p> <p>eDNA result:Positive<br/>HSI Score:0.68 (Average)<br/>Lined (y/n):No</p> | |

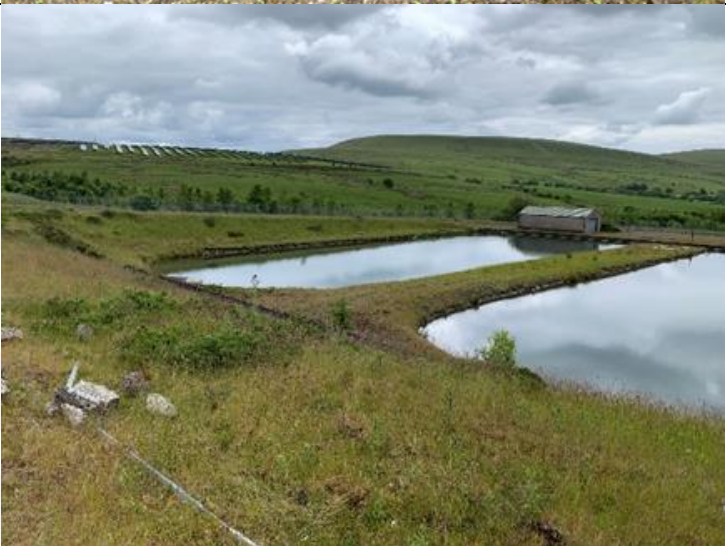
| Ref | Description | Image |
|---|---|---|
| P18 | <p>The banks of both sub-divisions were well vegetated, consisting mostly of very short grasses and forbs. Marginal vegetation was minimal with the occasional small stand of <i>Juncus</i> and <i>Typha</i>. Floating vegetation was also relatively minimal, with some small areas of <i>Potamogeton</i> toward the margins where the water was shallower.</p> <p>eDNA result:Positive<br/>HSI Score:0.65 (Average)<br/>Lined (y/n):No</p> | |

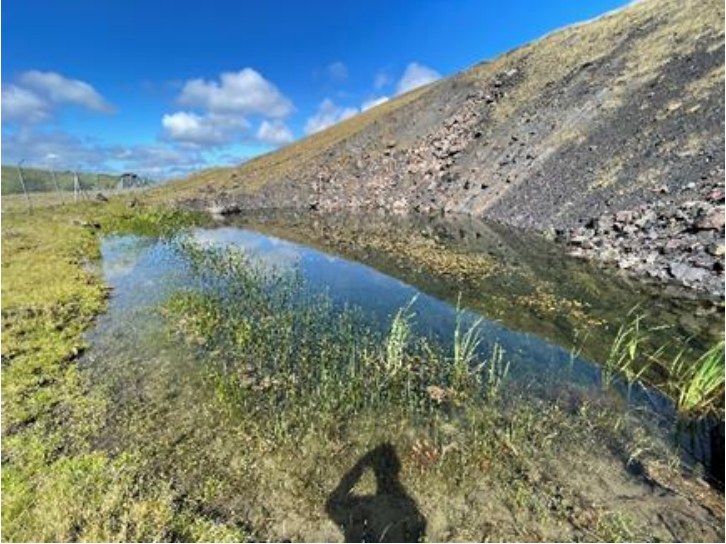
| Ref | Description | Image |
|---|---|---|
| P19 | <p>50% of the margin comprised a sheer wall where material has slipped from the adjacent OB3. The accessible margin showed no discernible bank, transitioning from grassland directly to shallow water, followed by a steep drop off into deep, clear water. Around the shallow marginal strip was submerged grass with emergent <i>Juncus</i> and the occasional <i>Typha</i>. Over the deepest section a mat of <i>Potamogeton</i> was evident.</p> <p>eDNA result:Negative<br/>HSI Score:0.58 (Below average)<br/>Lined (y/n):No</p> | |

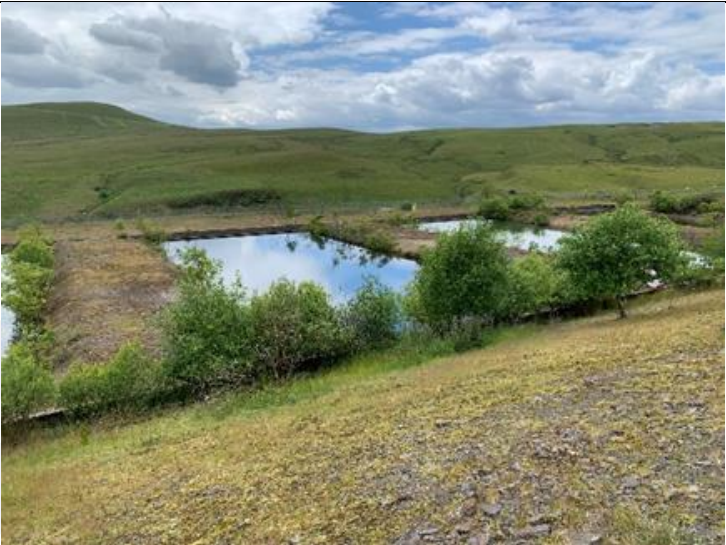
| Ref | Description | Image |
|---|---|---|
| P20 | <p>The banks of both sub-divisions were sparsely vegetated by short, dry and patchy grasses and mosses interspersed with lichen. Marginal vegetation was limited to small patches of <i>Juncus</i>. The dominant feature was the presence of large over-hanging bushes around much of water's edge, predominantly <i>Salix</i> and <i>Betula</i> with the occasional <i>Buddleja</i>.</p> <p>eDNA result:Positive<br/>HSI Score:0.68 (Poor)<br/>Lined (y/n):No</p> | |

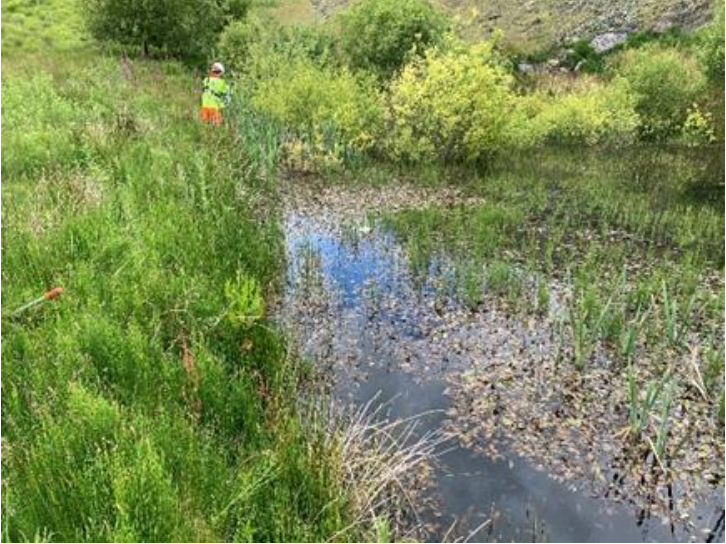
| Ref | Description | Image |
|---|---|---|
| P21 | <p>Fed by Bargod taf stream and formed in a depression at the foot of OB3. A high-quality and heavily vegetated pond with clear water. Much of the riparian zone is dominated by large <i>Salix</i> bushes surrounded by <i>Juncus</i> and tall ruderals such as rosebay willowherb (<i>Chamaenerion angustifolium</i>) and foxglove (<i>Digitalis purpurea</i>). The margins are dominated by a dense mat of <i>Equisetum</i> interspersed with <i>Juncus</i>, <i>Carex</i> and grasses (mainly <i>Cynosurus cristatus</i> and <i>Anthoxanthum odoratu</i>). The surface of the pond is largely covered by <i>Potamogeton</i> with emergent <i>Typha</i> and <i>Equisetum</i> scattered throughout.</p> <p>eDNA result:Negative<br/>HSI Score:0.75 (Good)<br/>Lined (y/n):No</p> | |

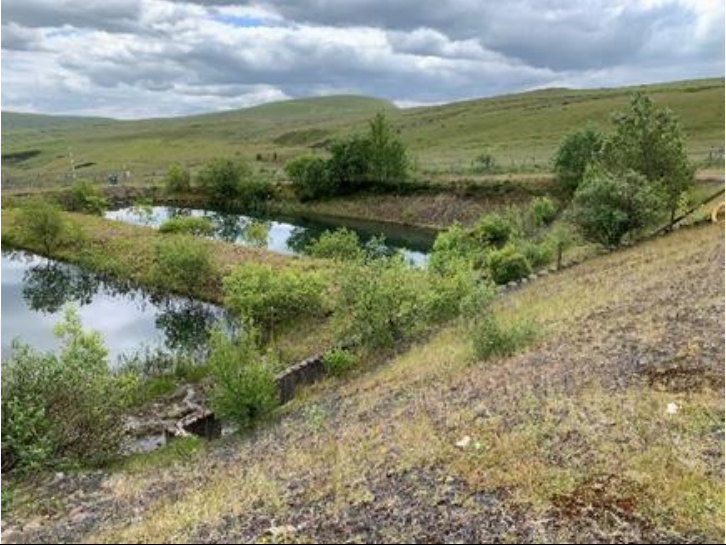
| Ref | Description | Image |
|---|---|---|
| P22 | <p>Both sub-divisions have similar characteristics, with banks dominated by <i>Salix</i> bushes and occasional <i>Buddleja</i>. The majority of the margins consist of a thin covering of <i>Typha</i>. Submerged and floating vegetation were not observed.</p> <p>eDNA result:Positive<br/>HSI Score:0.70 (Good)<br/>Lined (y/n):No</p> | |

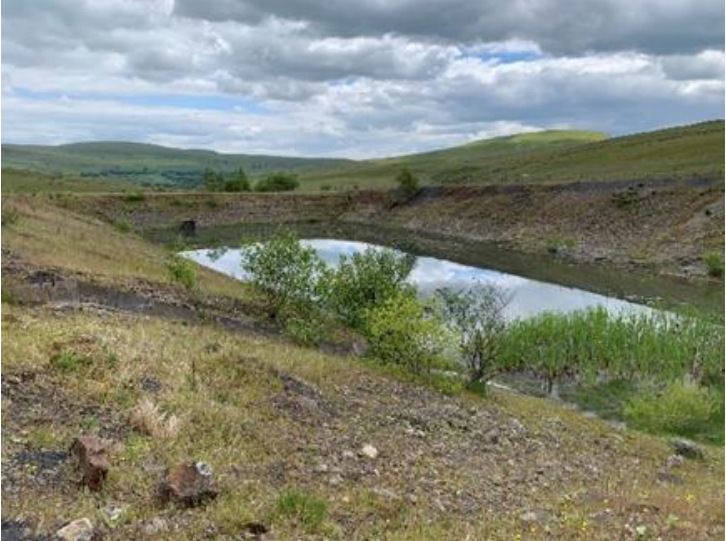
| Ref | Description | Image |
|---|---|---|
| P23 | <p>The banks were dominated by mosses and short grasses interspersed with <i>Tussilago farfara</i>, hawksbit (<i>Leontodon</i> spp.), thistles (<i>Cirsium</i> spp.) and <i>Equisetum</i>. Numerous self-set <i>Salix</i> and <i>Buddleja</i> bushes were also present along the banks. Marginal vegetation was generally minimal, with the exception of dense <i>Typha</i> stands growing on a silt deposit at the western end. Sparse mats of <i>Potamogeton</i> were present on the surface over much of the area.</p> <p>eDNA result:Negative<br/>HSI Score:0.60 (Average)<br/>Lined (y/n):No</p> | |

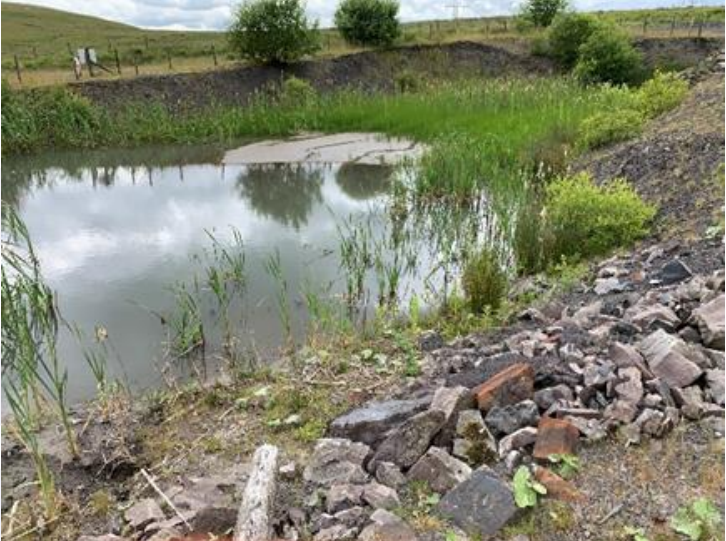
| Ref | Description | Image |
|---|---|---|
| P24 | <p>Banks consist mainly of coal spoil and fine gravel, with some areas of larger rubble deposits, thinly covered by short grasses and <i>Tussilago</i>, with self-set <i>Salix</i> saplings dotted throughout. <i>Typha</i> covers nearly the entire margin, with some small patches of <i>Juncus</i> growing on transitional silt deposits. The eastern half of the pond is largely un-vegetated open water, with the northern half divided equally between exposed silt followed by dense <i>Typha</i>.</p> <p>eDNA result:Negative<br/>HSI Score:0.66 (Average)<br/>Lined (y/n):No</p> | |

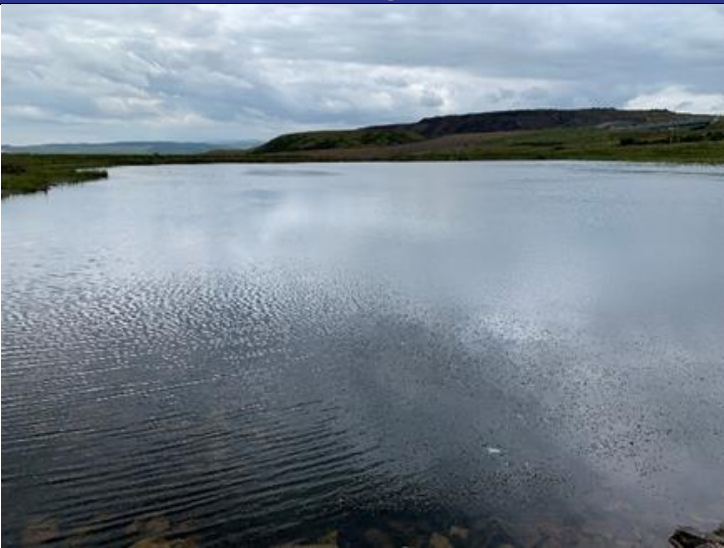
| Ref | Description | Image |
|---|---|---|
| P25 | <p>A large pond with characteristics of a small lake, set within a moorland habitat of grasses (Yorkshire fog, <i>Halcus lanatus</i>; Purple moor-grass, <i>Molinia caerulea</i>; Cotton grass, <i>Eriophorum angustifolium</i>), rushes (mainly <i>Juncus effusus</i>) and sedges (mainly yellow sedge, <i>Carex demissa</i>). Banks were shallow and poorly defined, dominated by <i>Juncus</i> transitioning into a rocky bed. Submerged vegetation was primarily of <i>Elodia</i> spp. and floating vegetation was absent.</p> <p>eDNA result:Negative<br/>HSI Score:0.47 (Poor)<br/>Lined (y/n):No</p> | |

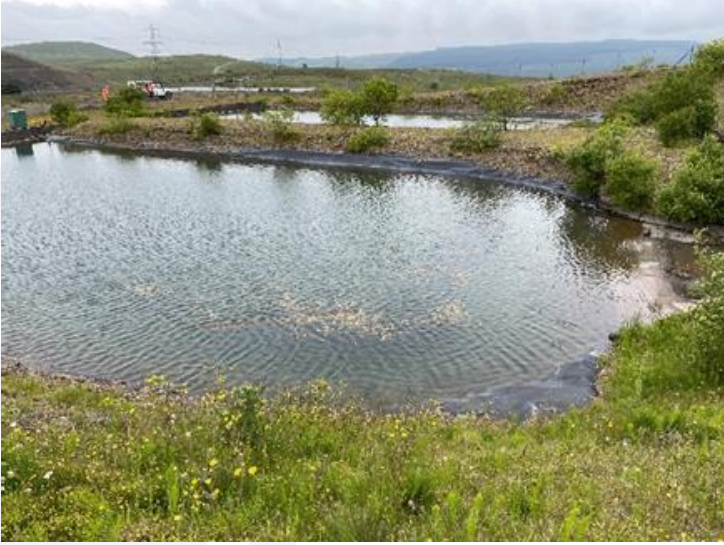
| Ref | Description | Image |
|---|---|---|
| P27 | <p>The banks were dominated by a sparse mixture of <i>Equisetum</i>, <i>Juncus</i>, Hawkbit (<i>Leontodon</i>), Bird's-foot trefoil (<i>Lotus corniculatus</i>) and white clover (<i>Trifolium repens</i>), interspersed with spear-thistle (<i>Cirsium vulgare</i>) and self-set <i>Salix</i> of varying sizes. A small strip of pond liner was exposed adjacent to the water's edge and marginal vegetation was largely absent. The more southerly of the two sub-divisions contained a thin mat of <i>Potamogeton</i> over approximately 20% of the area, whereas aquatic vegetation was absent from the more northerly sub-division.</p> <p>eDNA result:Positive<br/>HSI Score:0.61 (Average)<br/>Lined (y/n):Yes</p> | |

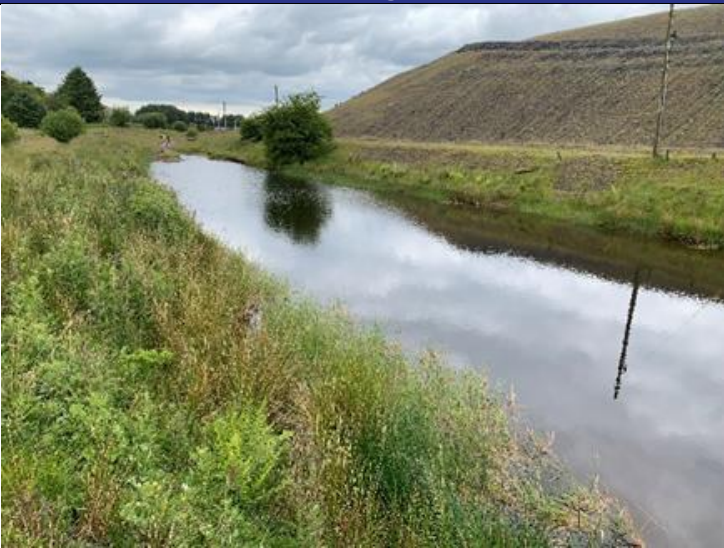
| Ref | Description | Image |
|---|---|---|
| P28 | <p>The pond is formed in a narrow depression along the route of the old railway track. The western edge is largely un-vegetated and of bare ground and small pebbles. The northern, eastern and southern banks are covered mainly by <i>Juncus</i>, with bracken (<i>Pteridium</i>) and spear-thistle (<i>Cirsium vulgare</i>). The pond itself was free of aquatic vegetation. In addition to the pond, a narrow drainage channel, with some open water, dominated by <i>Typha</i>, <i>Juncus</i> and <i>Eriophorum</i> runs adjacent to the northern edge.</p> <p>eDNA result:Positive<br/>HSI Score:0.68 (Average)<br/>Lined (y/n):Unknown</p> | |

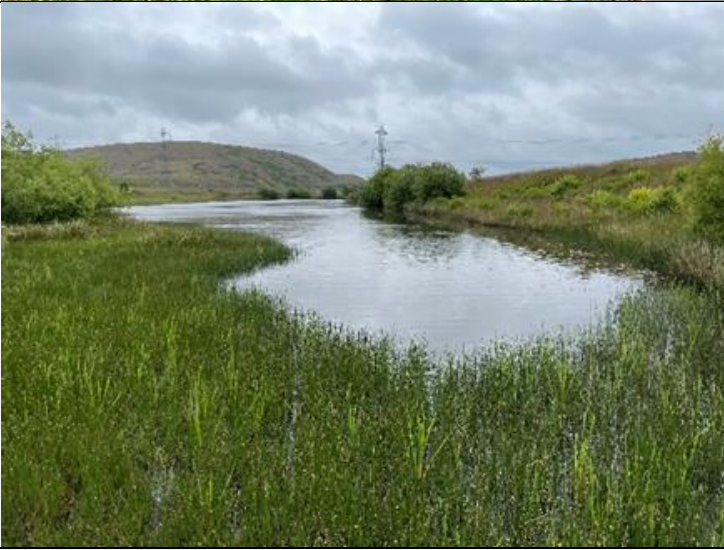
| Ref | Description | Image |
|---|---|---|
| P29 | <p>Within the central ecological zone, the northern and western edges of this large pond show no discernible bank, with dense <i>Juncus</i> transitioning into open water. This area is also interspersed with <i>Carex</i>, <i>Typha</i>, <i>Eriophorum</i> and large <i>Salix</i> bushes. The southern and eastern edges are defined by a grassy bank with <i>Pteridium</i>. Aquatic vegetation was limited to sparse areas of <i>Elodea</i> around the margins.</p> <p>eDNA result:Positive<br/>HSI Score:0.77 (Good)<br/>Lined (y/n):No</p> | |

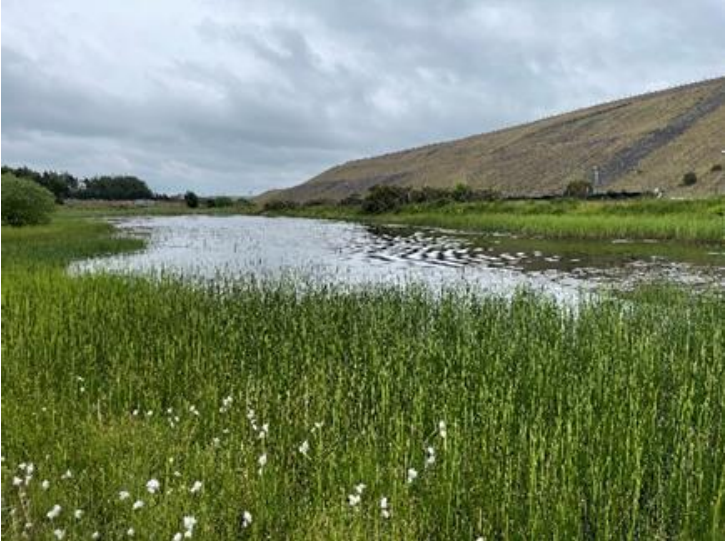
| Ref | Description | Image |
|---|---|---|
| P30 | <p>A large pond within the central ecological zone, very similar in composition to Pond 29, with the exception of a significant amount of <i>Equisetum</i> interspersed with <i>Juncus</i> and ground flora of <i>Sphagnum</i>. The bank along the eastern and southern edges contains some bushes of gorse (<i>Ulex</i>) and hawthorn (<i>Crataegus monogyna</i>) in addition to the <i>Salix</i>. The eastern and western margins are dominated by dense stands of <i>Typha</i>.</p> <p>eDNA result:Positive<br/>HSI Score:0.77 (Poor)<br/>Lined (y/n):No</p> | |

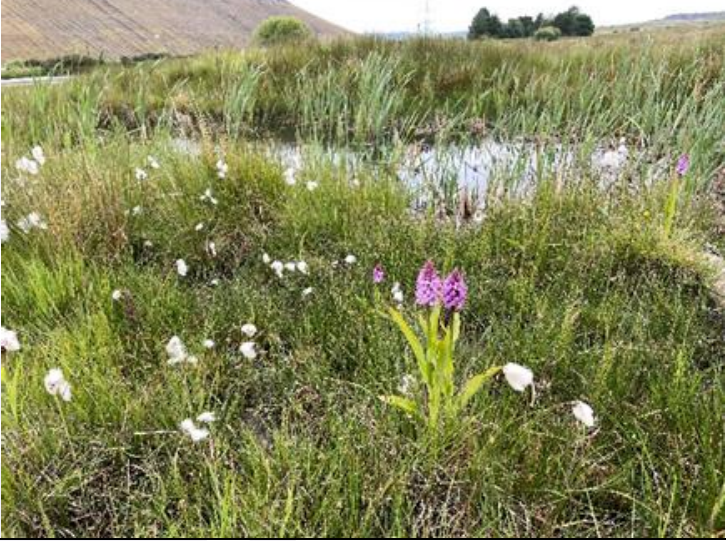
| Ref | Description | Image |
|---|---|---|
| P30<br>a | <p>A smaller pond within the central ecological zone with poorly defined banks covered by <i>Carex</i>, <i>Juncus</i>, <i>Eriophorum</i> and <i>Equisetum</i>. <i>Typha</i> grows around the margins and is sparsely emergent throughout the rest of the surface area.</p> <p>eDNA result:Positive<br/>HSI Score:0.62 (Average)<br/>Lined (y/n):No</p> | |
