CYFARTHFA CASTLE  
INTERNAL WORKS: HERITAGE STATEMENT  
ISSUE 01: OCTOBER 2025

# CYFARTHFA CASTLE; INTERNAL WORKS: HERTIAGE STATEMENT

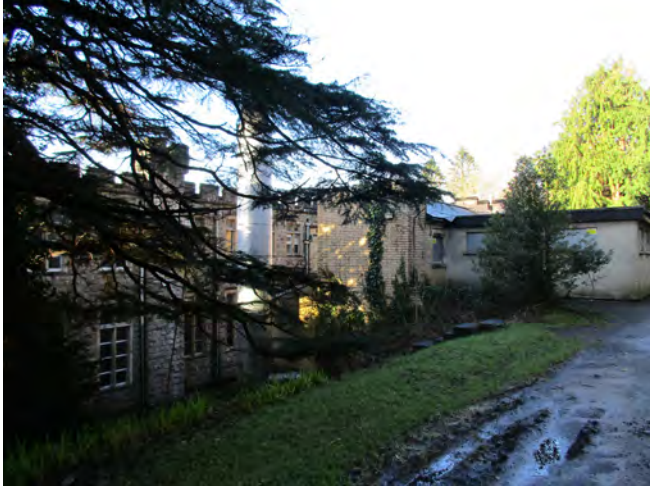
Rear elevation (partial), note the first floor extension to the rear of the School

While the new school wings broadly respected the footprint of the previous service buildings, there were dramatic changes to the plan on the western side of the Castle. A first floor extension was also added to the rear to provide WC facilities for the Girls School. This appears to have been altered, if not entirely replaced, during the mid-20th century.

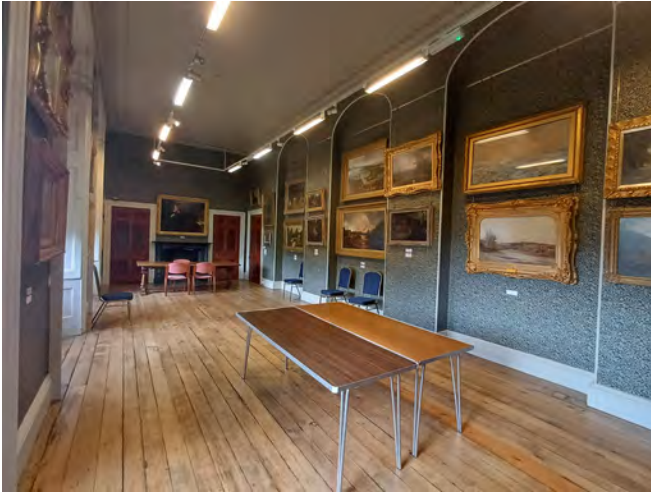
The Marriage Room, formerly the office from which William Crawshay could monitor the activities of the ironworks in the valley below. The room was redecorated and refurbished during the 1990s, with the wallpaper modelled on fragments found within the space. There is a large late-19th century safe hidden behind an internal door on the west wall.

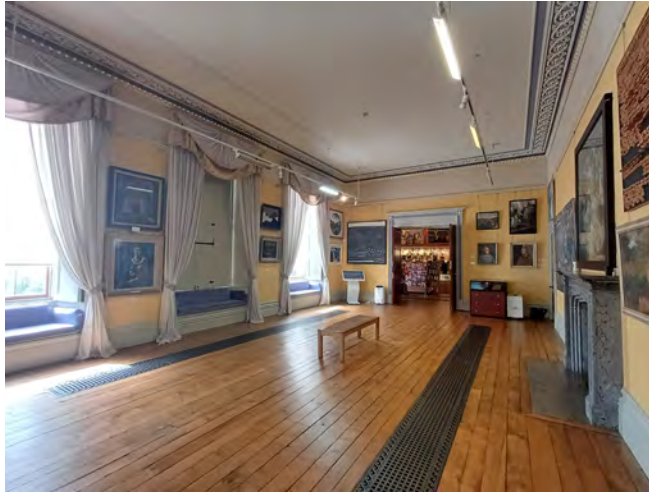
The Yellow Gallery (originally the library). The iron grills to the floor (also present in the entrance hall, Round Room, Red Gallery and former Dining Room) were inserted in 1912. All other features are presumed to be original to the room. The wallpaper in this space draws on typical Georgian details.

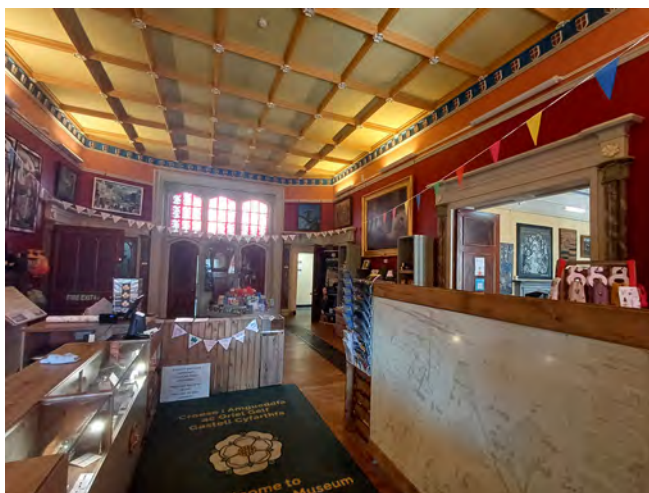
The Entrance Hall, re-decorated during the 1990s. The Baronial Gothic scheme was retained (or re-instated) during the refurbishment.

The entrance hall has a striking Baronial Gothic character, with heraldic bosses running around the perimeter at cornice level, two large tudor-arched fireplaces with crenelated surrounds, stained glass to the north and Gothic pointed arches over the entrance door and the connection to the WCs.

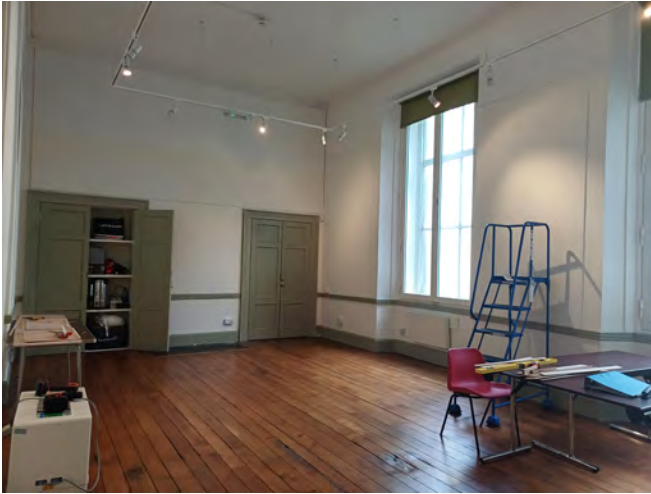
The Play Room Gallery, which was converted to serve as a gallery during the 1990s. The finish is plain compared to the other ground-floor rooms, but the space retains historic timber flooring, skirting, cornicing, doors and joinery.

Two key internal refurbishment schemes are known to have taken place within the museum; the 1992 refurbishment of the principal rooms and the 2013 refurbishment of the Play Room Gallery. During this time, care was taken to research and record the underlying historic fabric and where possible to retain and restore original features. The current interior finish is as rule, a pastiche, though the Marriage Room wallpaper is a direct recreation of fragments found during refurbishment works. The cornices, skirting, and picture rails throughout the ground floor spaces are presumed to be largely original.

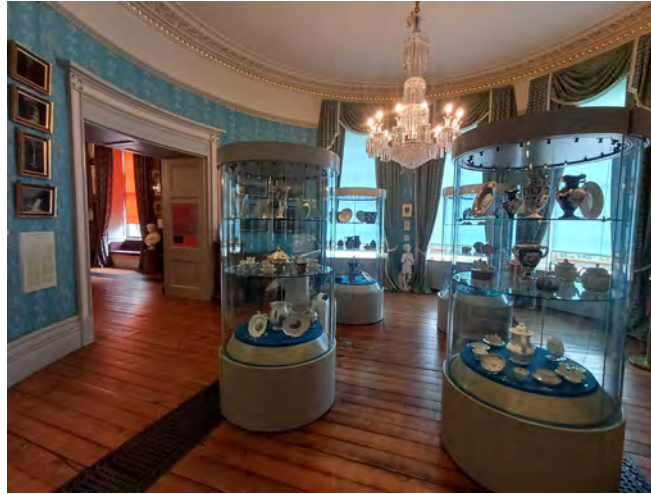
The Round Gallery at the south-east corner of the Castle. The design scheme within this room is based on one designed by Robert Adam for No. 1 Royal Crescent in Bath.

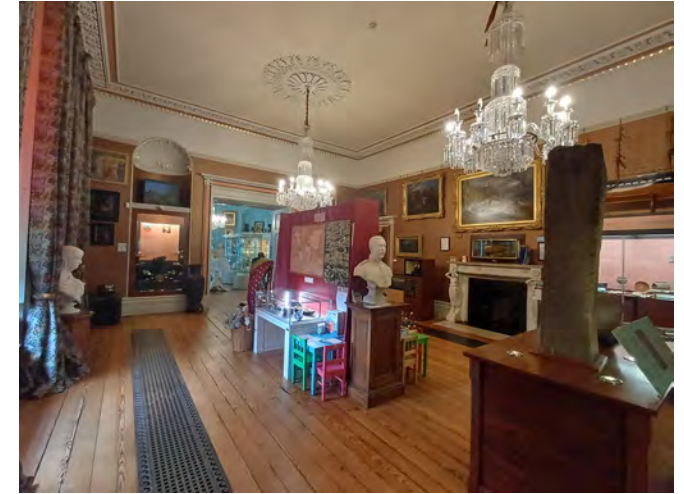
The Red Gallery, formerly a drawing room for the Crawshay family. The wall finishes are modern replicas, but all architectural features are presumed to be original.

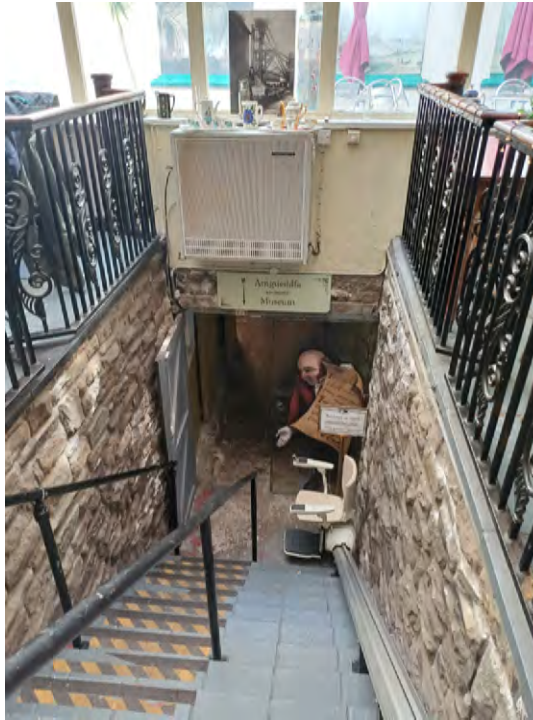
Looking down the modern stairwell in the cafe which leads to the basement.

To the north of the principal rooms at ground floor level is a cafe, which was created by infilling a section of the courtyard during the mid-late 20th century. The staircase in the centre of the cafe, which connects to the basement, is a modern insertion. However the east and west walls of the stairwell are of exposed masonry, and likely enclosed a small space at basement level before this section of the ground floor was broken out to insert the stairs.

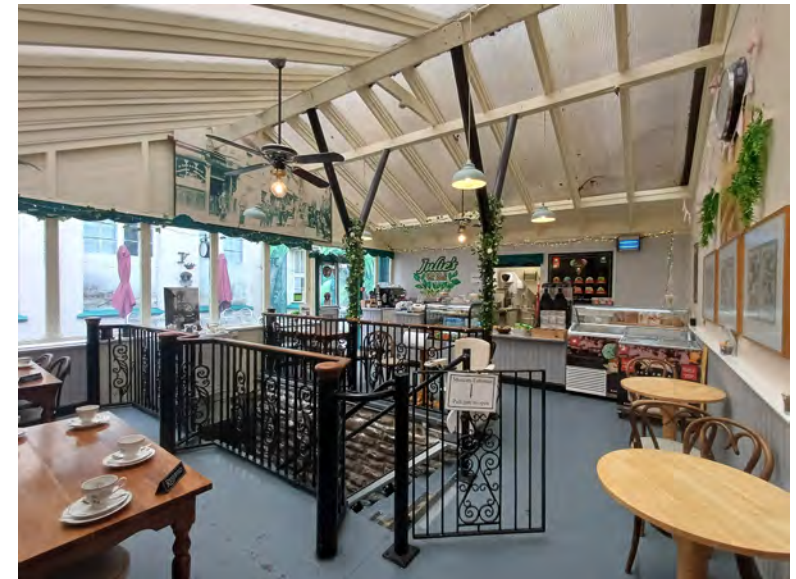
The café, a 20th-century infill structure in the courtyard.

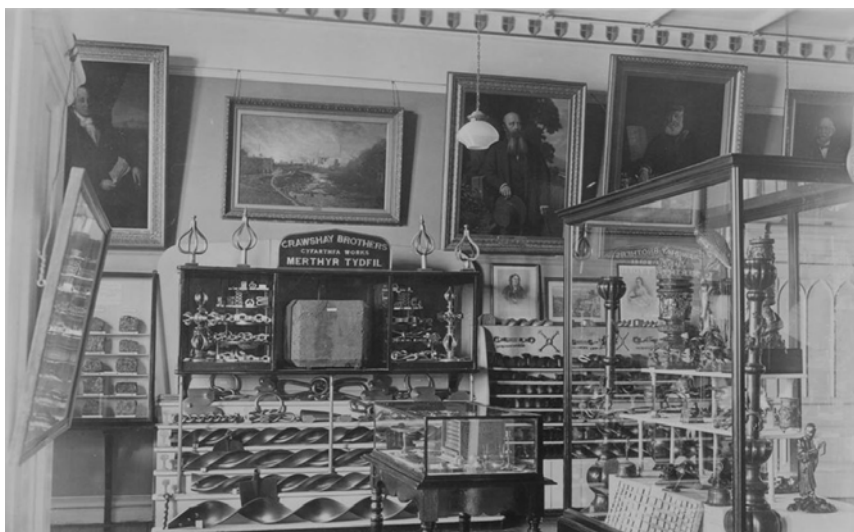
The interior of the Entrance Hall, between 1913–22 shortly after the Museum opened. The heraldic bosses and coffered ceiling shown here were retained or replicated during the 1992 refurbishment of the Museum.

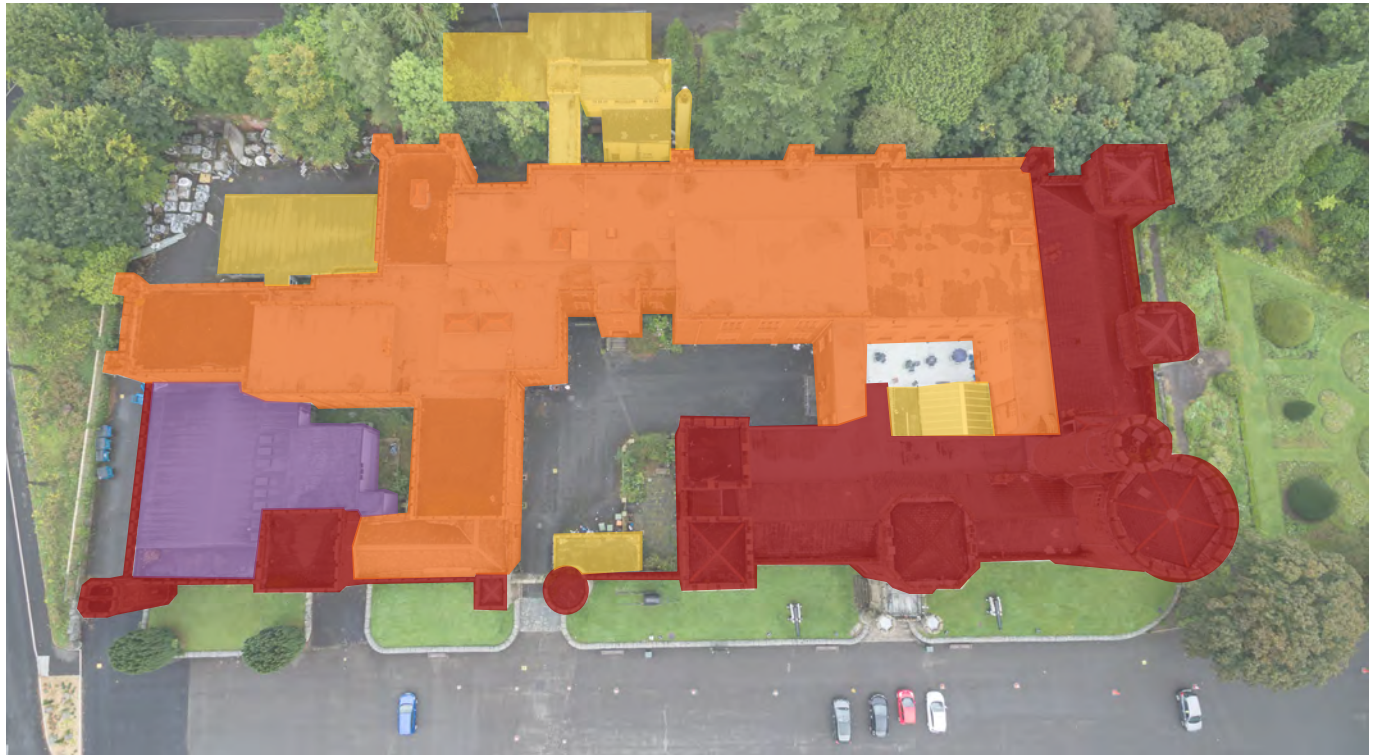
- 1825
- 1910
- Mid-20th Century
- Late 20th Century

Image captured in a drone survey of the Castle circa 2016, annotated to show the relative age of the built fabric.

The adjacent block plan illustrates the main phases of evolution for Cyfarthfa Castle. A full set of Historic Development Plans can be found in Appendix C.

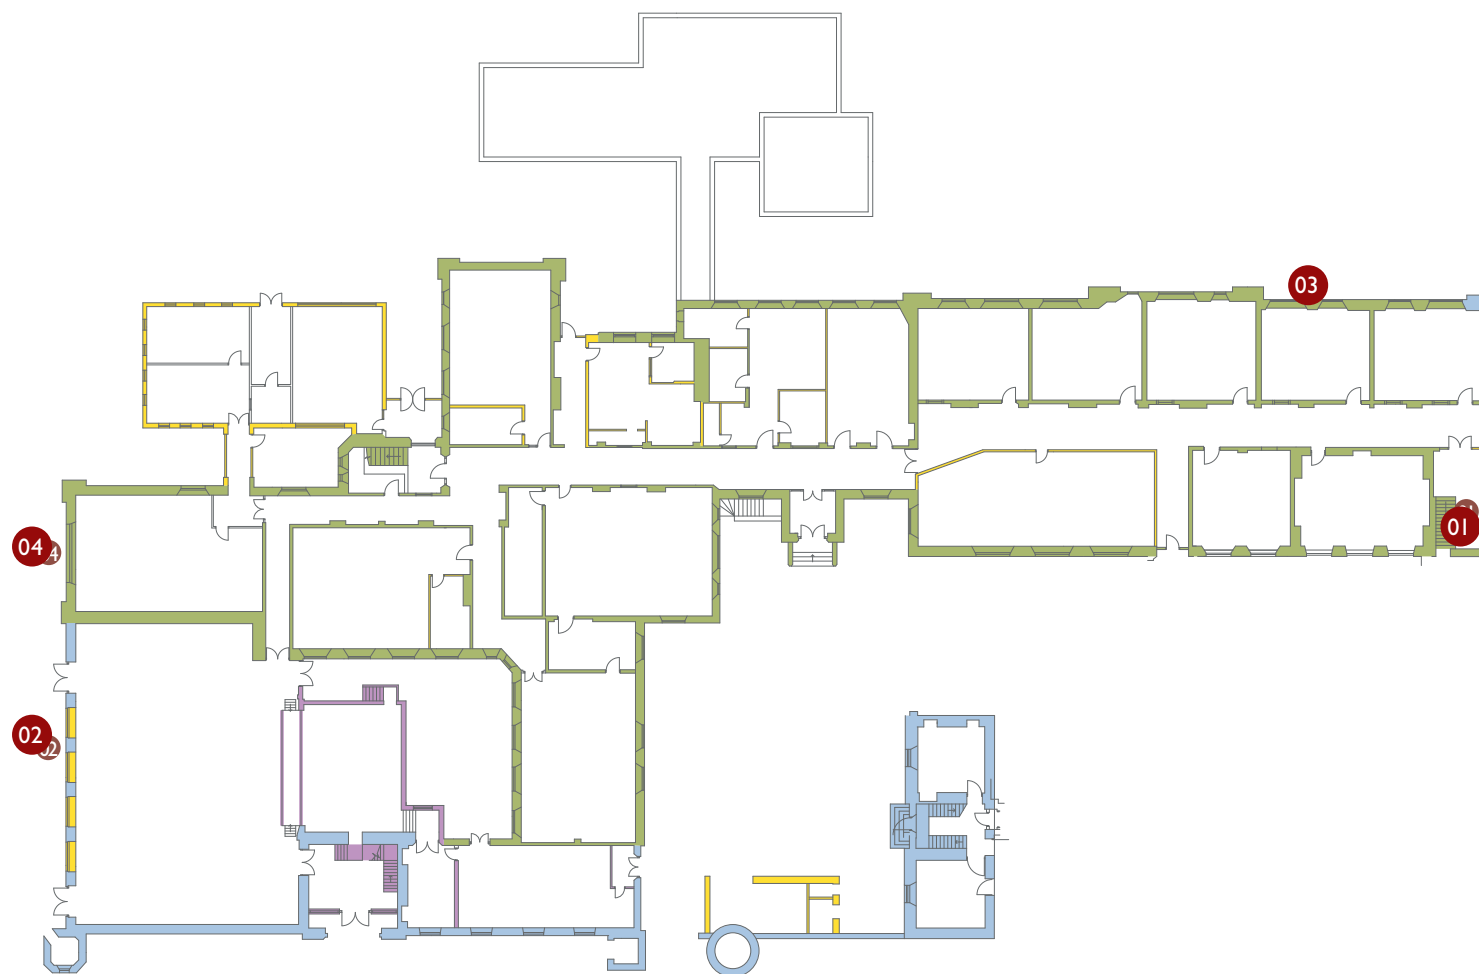
- 1825
- 1910
- c. Early 20th Century
- c. Mid-20th Century
- c. Late 20th Century

- 01 Staircase thought to contain historic handrail and railings from now lost main staircase.
- 02 Historic (1909) plans suggest that this wall was retained from the original castle. New openings made when gym was added.
- 03 Windows seem to have been replaced on an ad-hoc basis. Some original 1910 windows remain, but a full windows schedule is needed.
- 04 Thought to be an original 1910 window.
