## **Landscape Character and Visual Impact Assessment of Proposed Residential Development at Twyn yr Odyn, Merthyr Tydfil**

**Text, Plans, Photographs & Appendices**

**Prepared for Persimmon Homes East Wales**

**TDA/2539/LC&VIA/RhC/03.20**

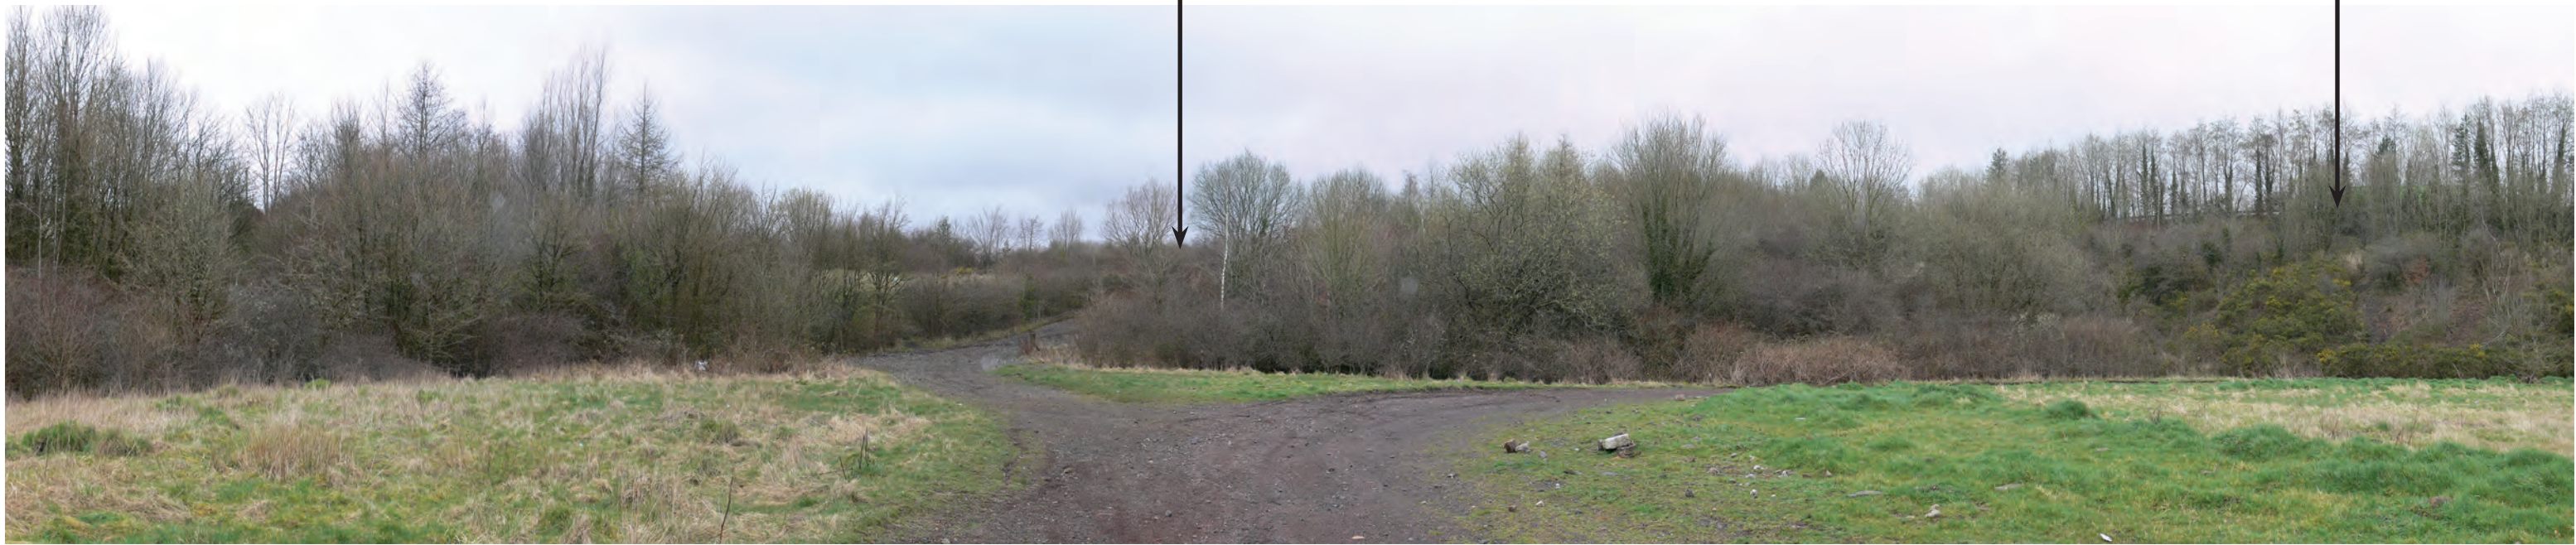
The site (screened)

Photo Viewpoint 1: Short range view looking north from a public right of way off Milbourne Close

- 4.9 **Photo Viewpoint 1** is a short-range view looking north from a public right of way off Milbourne Close. The site is screened by the natural topography of the area and boundary vegetation.

**Developments visual impact: no change**
- 4.10 **Photo Viewpoint 2** is a short-range view looking north from a public right of way off Milbourne Close. The site is clearly visible.

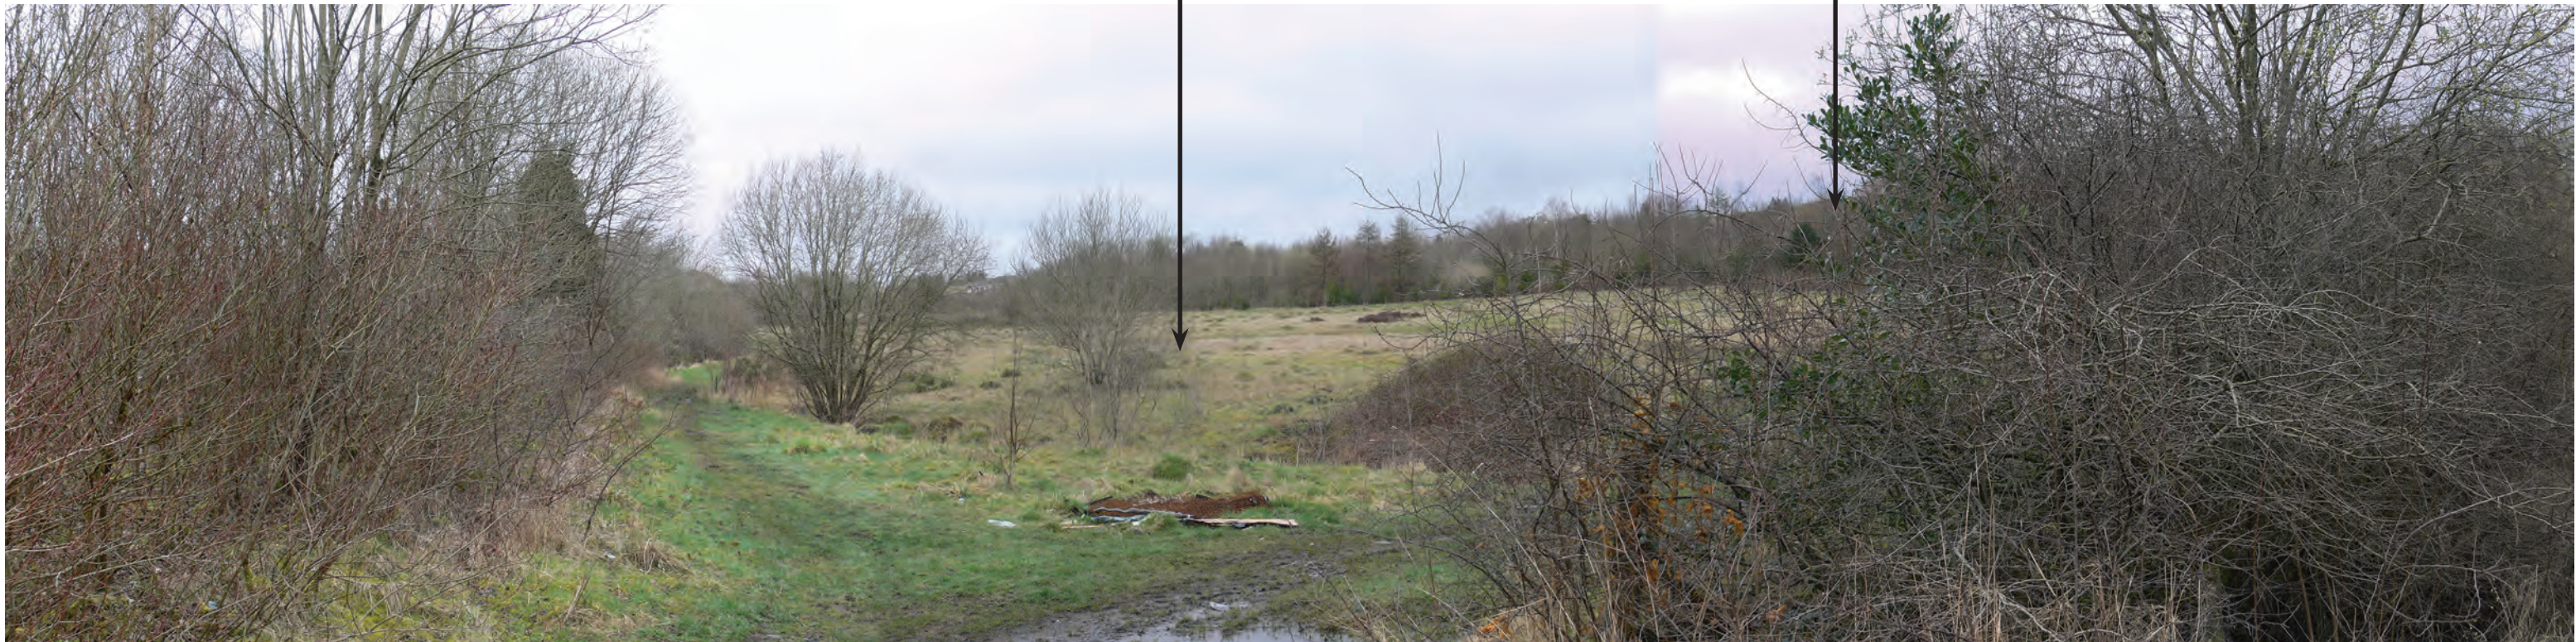
The site

Photo Viewpoint 2: Short range view looking north from a public right of way off Milbourne Close

**Developments visual impact: moderate adverse impact**
- 4.11 **Photo Viewpoint 3** is a short-range view looking south west from a public right of way off Oak Tree Rise. The site is screened by intervening vegetation

6.6 With regards to photo viewpoints 2, it was noted that the viewpoint is immediately adjacent to the site boundary, as such any visual impact is highly localised.

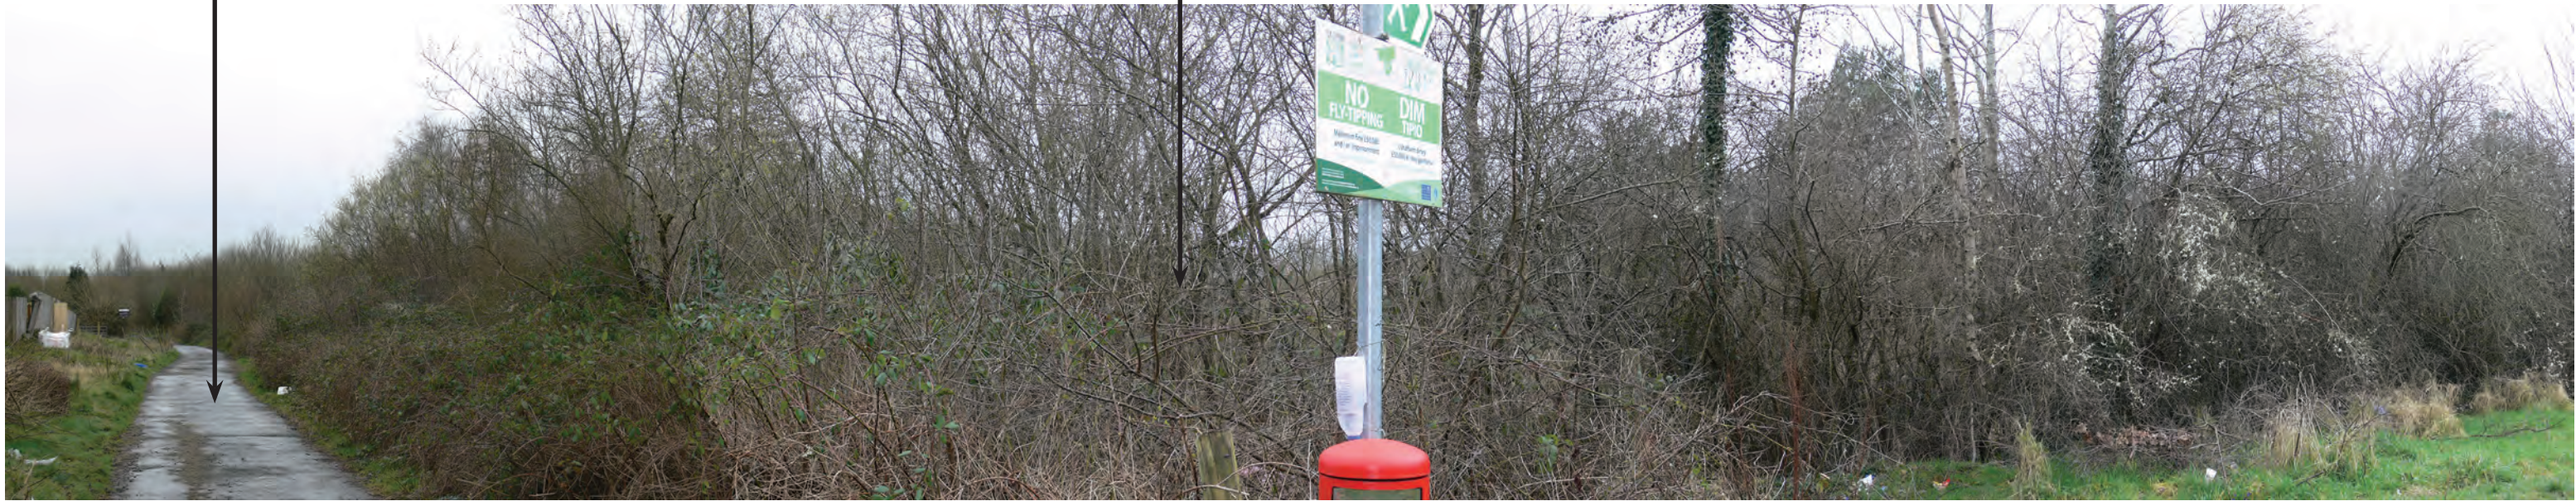
The site (screened)

Photo Viewpoint 3: Short range view looking south west from a public right of way off Oak Tree Rise

**Developments visual impact: no change**
- 4.12 **Photo Viewpoint 4** is a short-range view looking south from a public right of way adjacent to Ty Cwm Extra Care. The site is screened by intervening residential properties and vegetation.

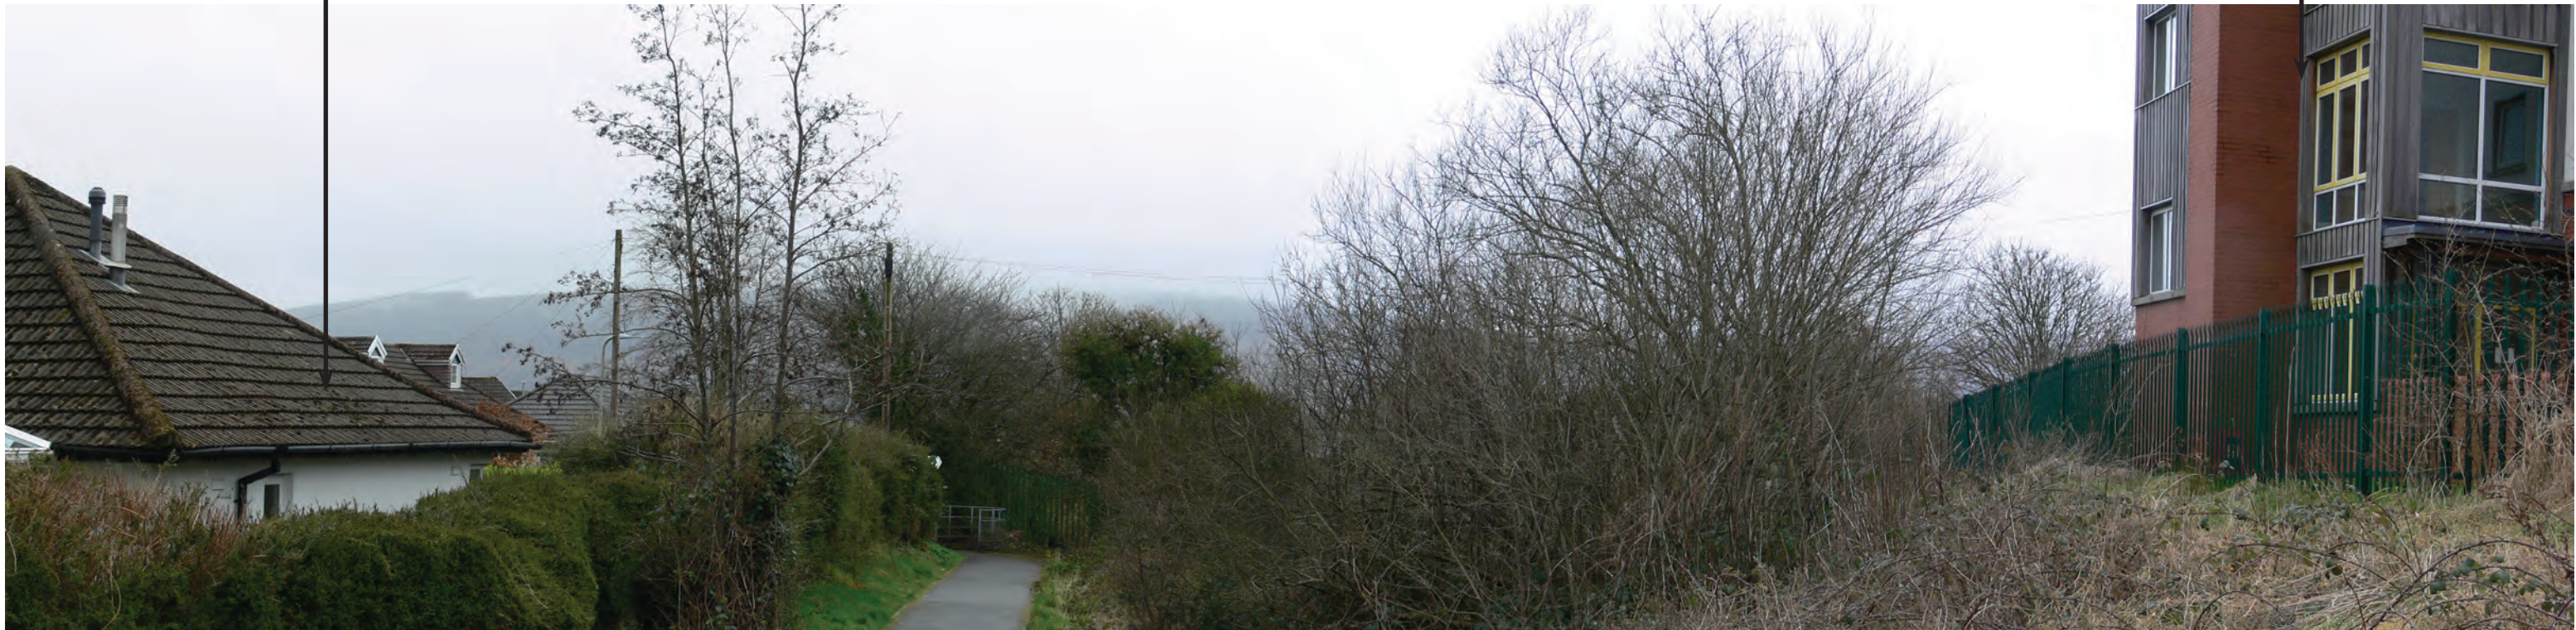
Approximate location of site (screened)

Photo Viewpoint 4: Short range view looking south from a public right of way adjacent to Ty Cwm Extra Care

**Developments visual impact: no change.**
- 4.13 **Photo Viewpoint 5** is a short-range view looking south east from Gilfach Cynon. The site is screened by the natural topography of the area and intervening residential properties.

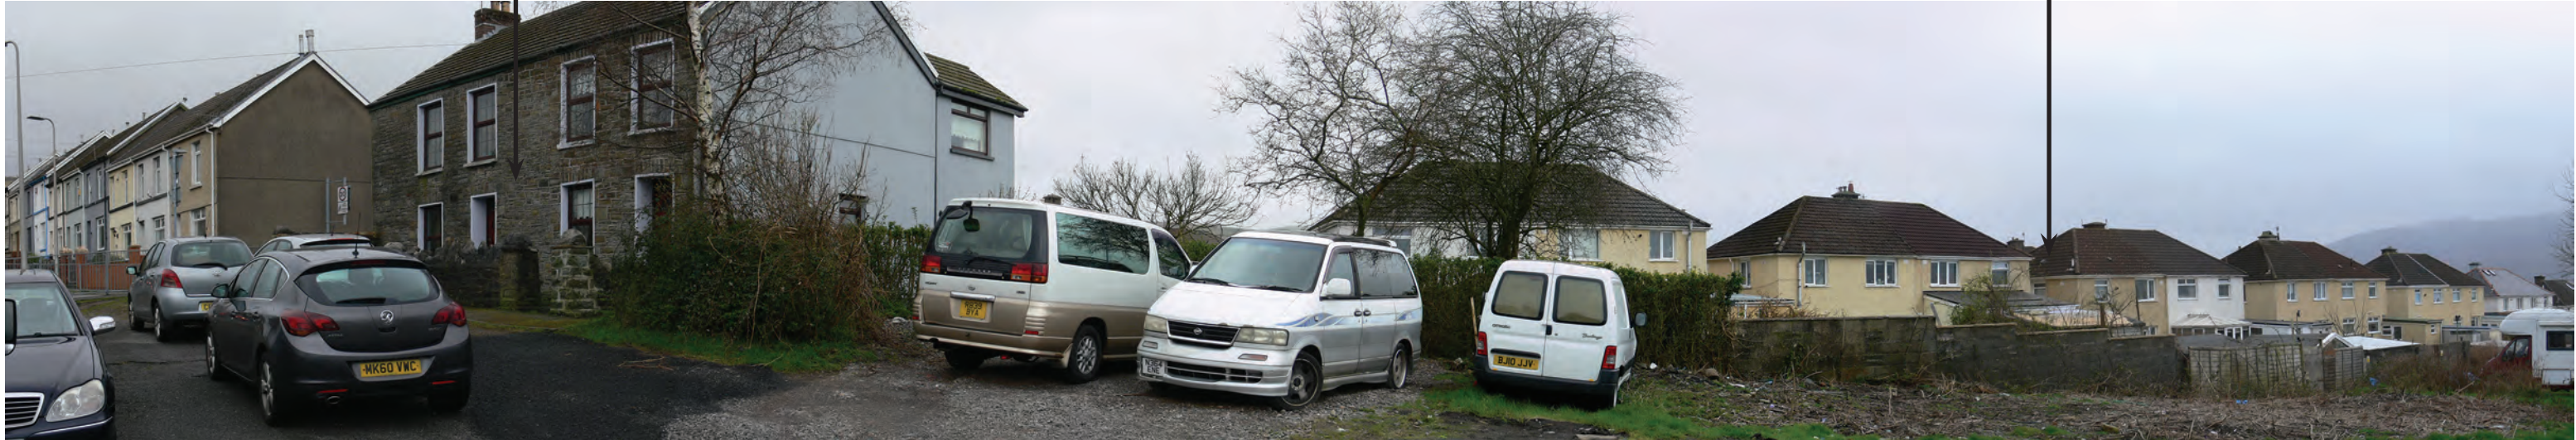
Approximate location of site (screened)

Photo Viewpoint 5: Short range view looking south east from Gilfach Cynon

**Developments visual impact: no change.**
- 4.14 **Photo Viewpoint 6** is short-range view looking south east from Wallhead Road. The site is screened by existing residential properties and intervening vegetation.

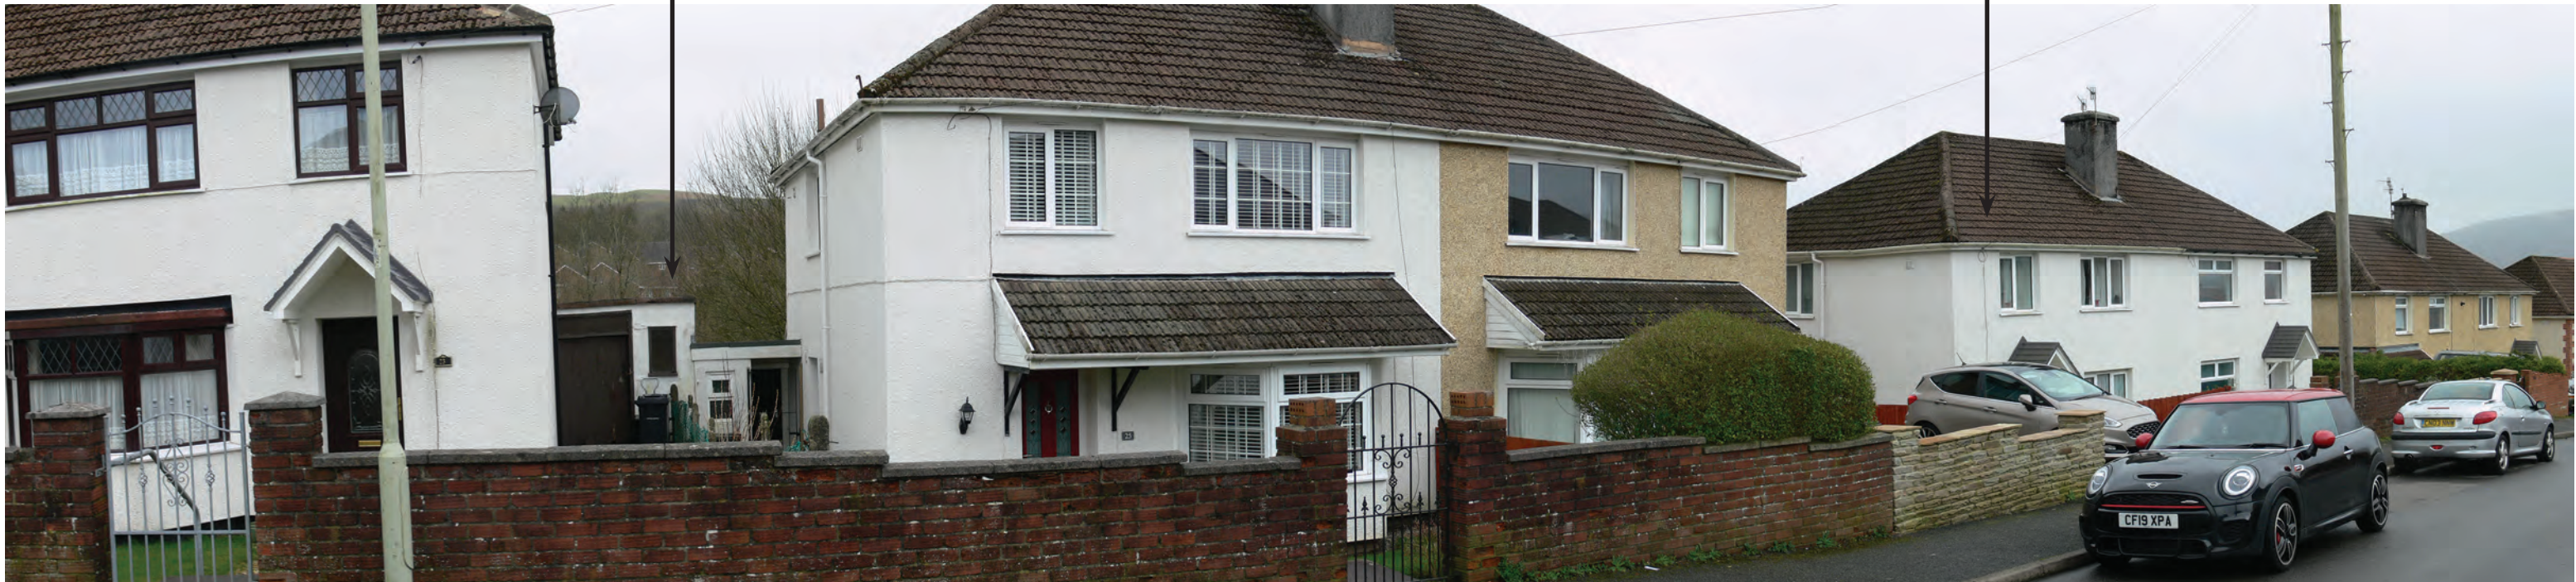
The site (screened)

Photo Viewpoint 6: Short range view looking south east from Wallhead Road

**Developments visual impact: no change.**

6.7 With regards to Photo Viewpoint 6, it was noted that small glimpses of the future residential development may be possible through gaps in the existing residential properties on Wall Head Road. However, as the surrounding residential properties are already clearly visible, glimpses of additional dwellings would not be out of context and the development would not be visually incongruous.
