DECEMBER 2025, ISSUE 01

# Cyfartha Castle

*Urgent Repair Works: Heritage Impact Assessment*

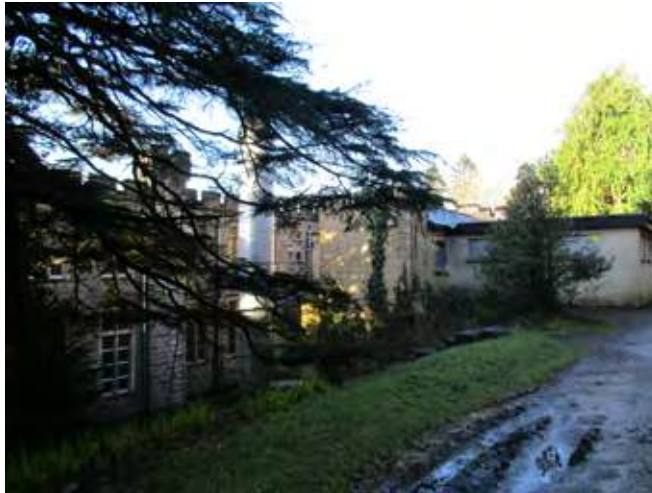
Rear elevation (partial), note the first floor extension to the rear of the School

While the new school wings broadly respected the footprint of the previous service buildings, there were dramatic changes to the plan on the western side of the Castle. A first floor extension was also added to the rear to provide WC facilities for the Girls School. This appears to have been altered, if not entirely replaced, during the mid-20th century.

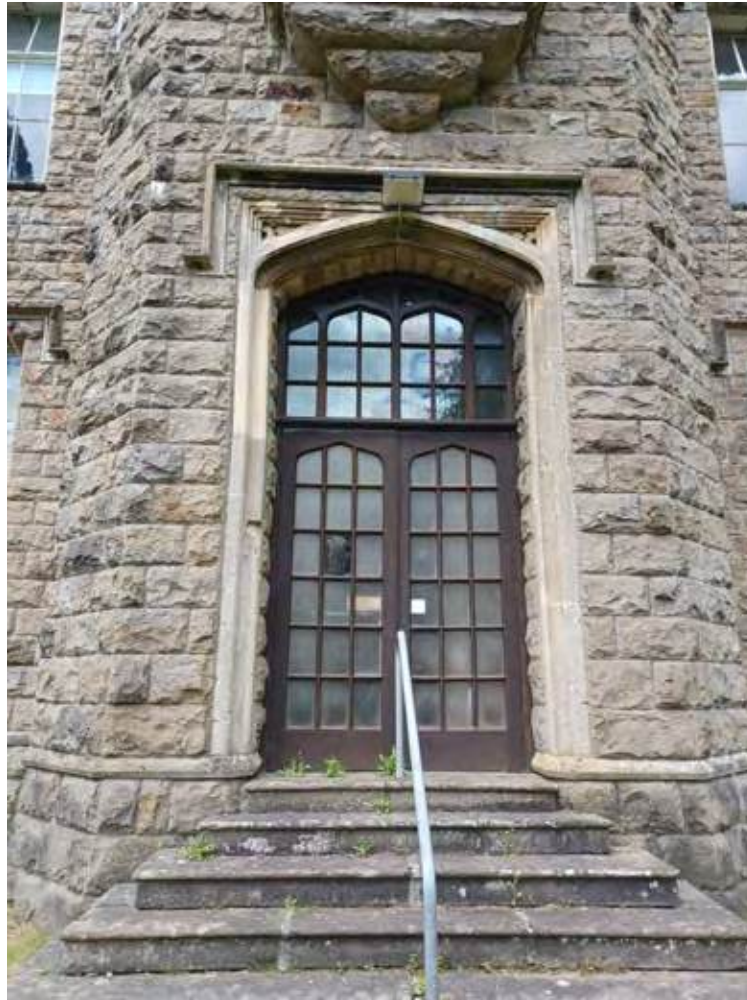
The door to the south-eastern facade, which is a 20th-century replacement proposed to be removed as part of the scope of works.

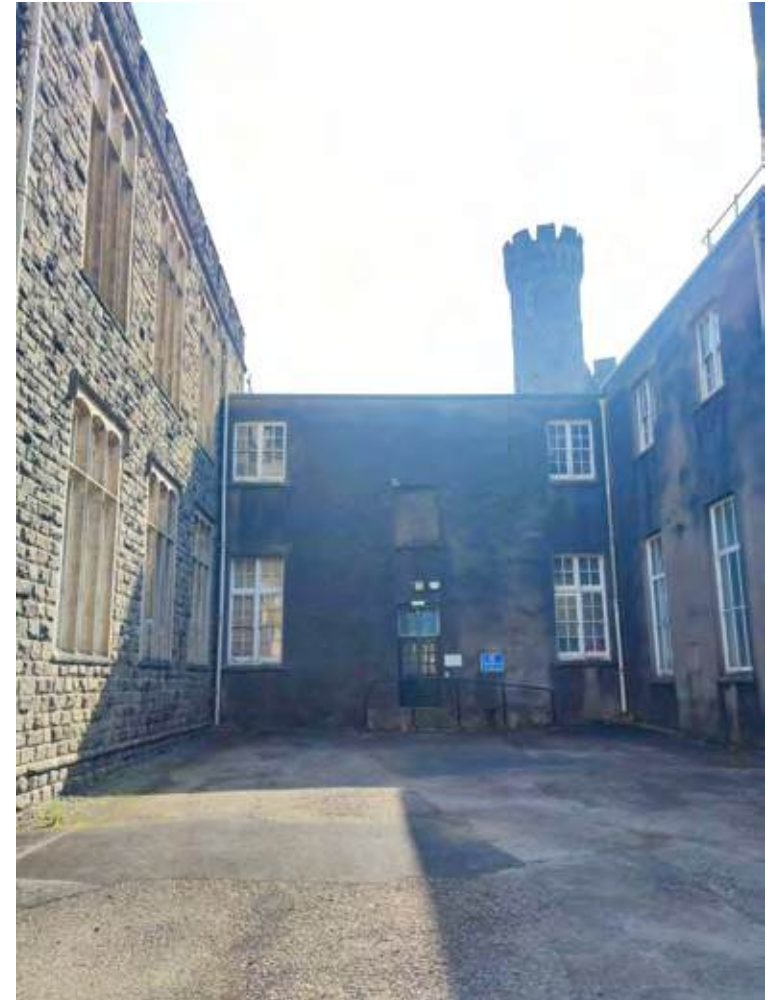
Looking east within the main courtyard towards the set of historic double doors proposed for replacement.

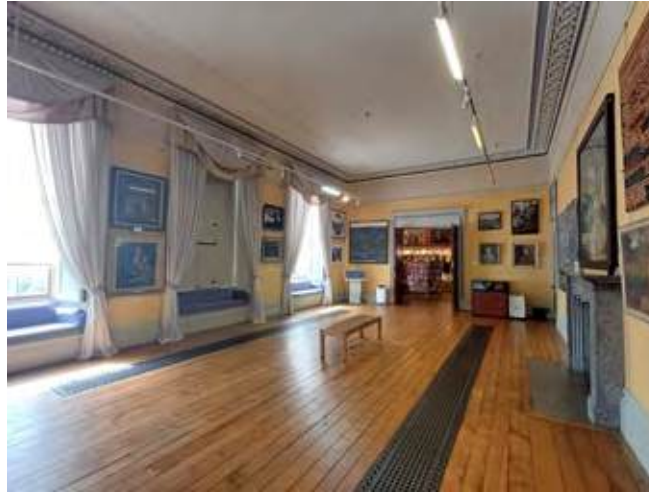
The Yellow Gallery (originally the library). The iron grills to the floor (also present in the entrance hall, Round Room, Red Gallery and former Dining Room) were inserted in 1912. All other features are presumed to be original to the room.

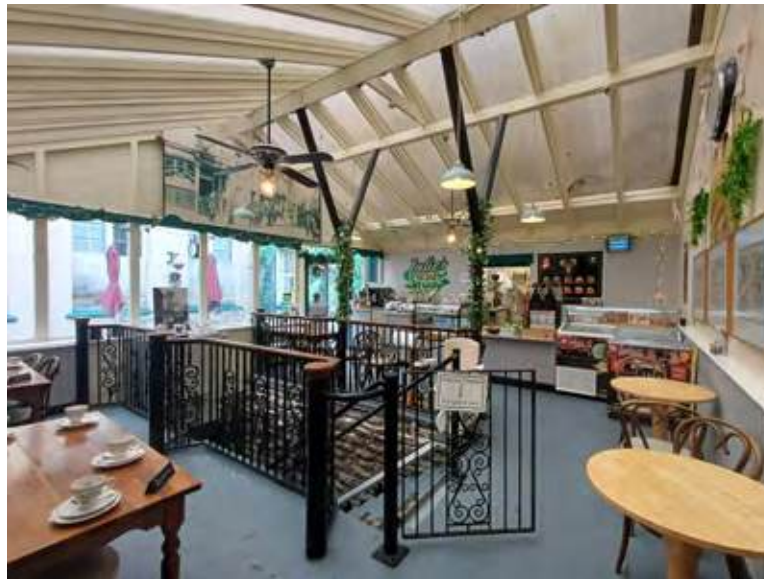
To the north of the principal rooms at ground floor level is a café, which was created by infilling a section of the courtyard during the mid-late 20th century. The staircase in the centre of the café, which connects to the basement, is a modern insertion. However the east and west walls of the stairwell are of exposed masonry, and likely enclosed a small space at basement level before this section of the ground floor was broken out to insert the stairs.

The café, a 20th-century infill structure in the courtyard.

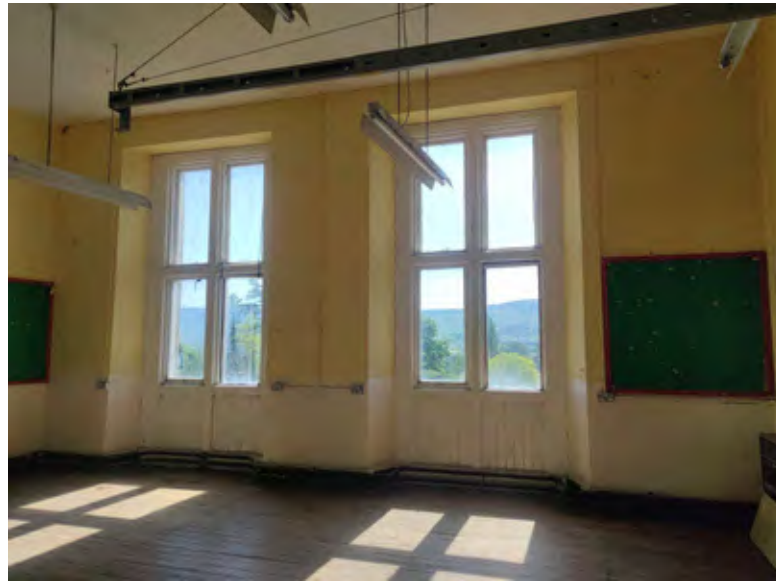
Room 1.41 - the proposed location for a new loft hatch.

- Installation of new steel beams beneath existing structural deck and new dropped ceiling to conceal steelwork within first floor spaces over room 1.55A and part of corridor 1.31C
- Localised, like-for-like repairs and timber reinforcements to eastern and southern roofs and area of stair landing within Caretaker's House
- Installation of internal loft access hatch within room 1.41 to provide access for inspections and maintenance

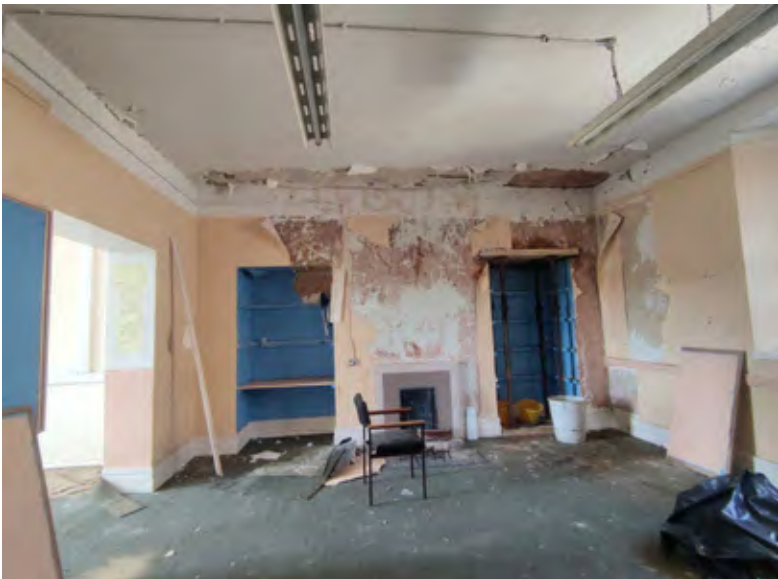
Looking west within room 1.55A at first floor level (where structural interventions are proposed to the ceiling).

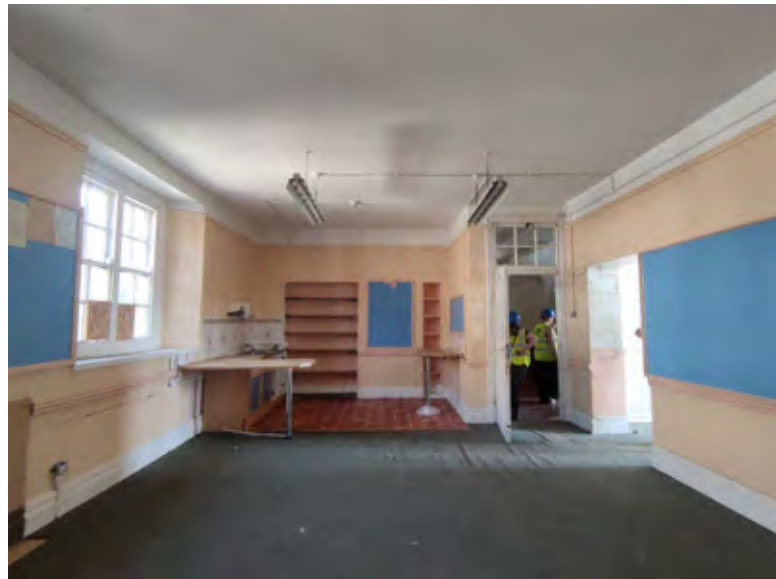
Looking east within room 1.55A.

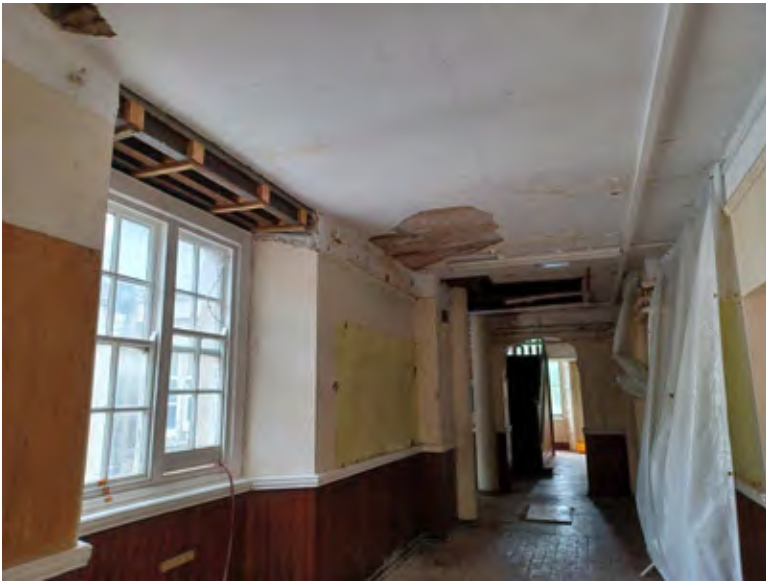
Looking east within corridor 1.31C., where structural works are proposed to the ceiling.

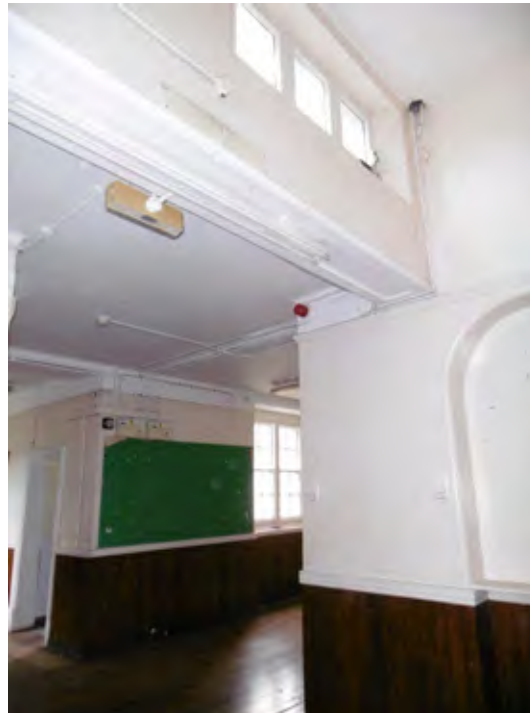
Looking south-west within corridor 1.31E at first floor level.  
The high level window is proposed to be altered as part of the proposed works.

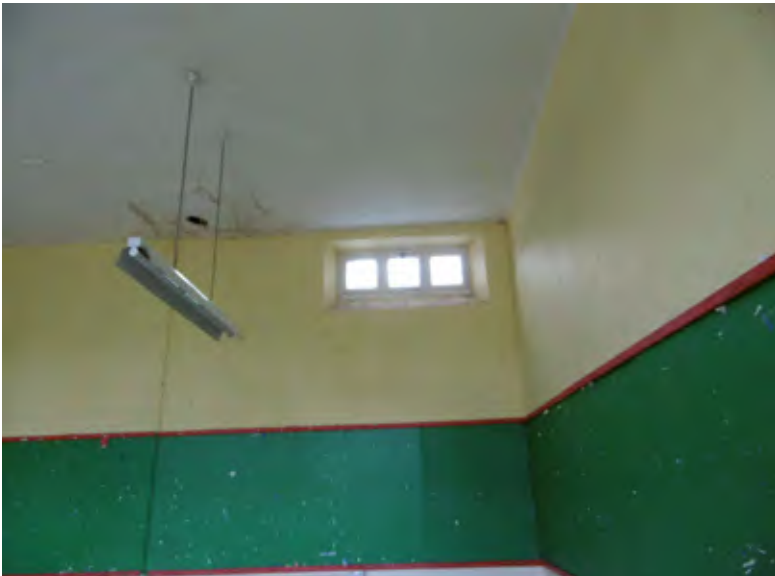
Looking up towards the high level window (W-1.48-03) within room 1.48.  
The window is proposed to be altered.

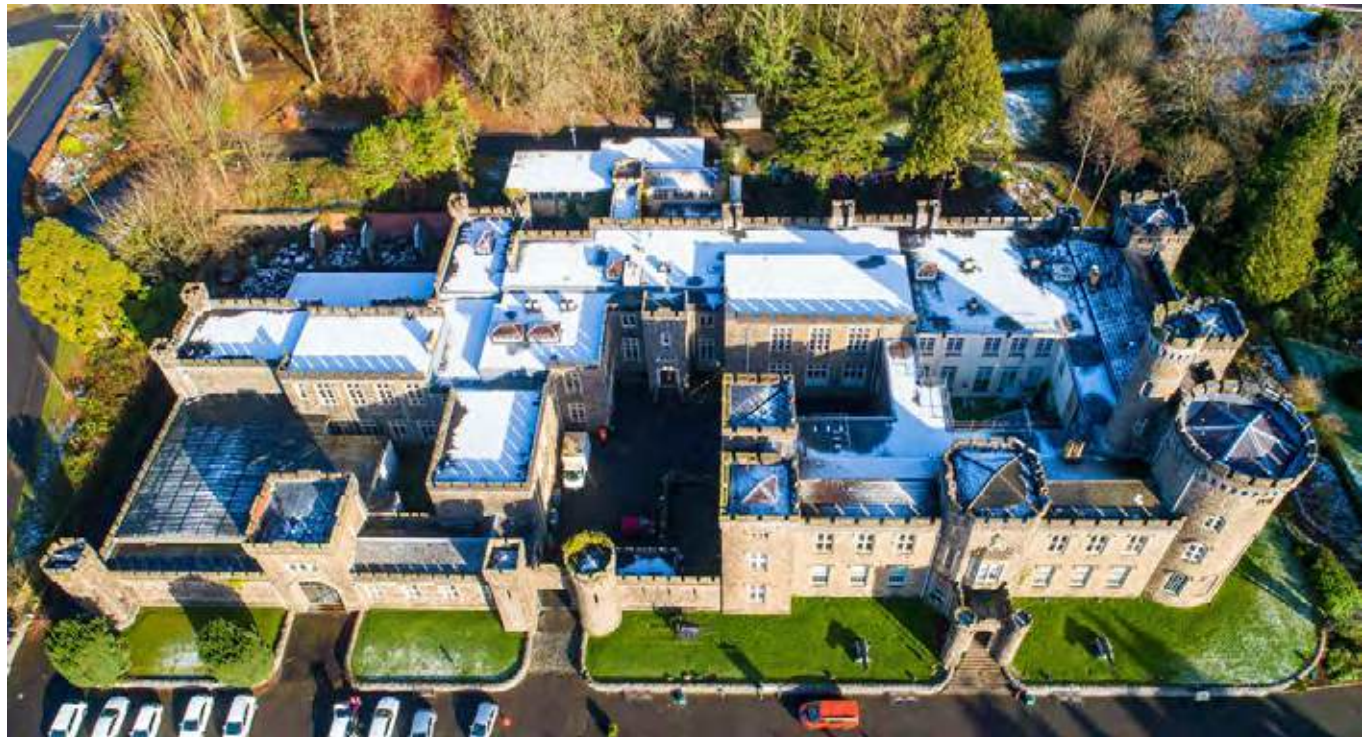
The roof of Cyfarthfa Castle as shown in drone imagery (2024).

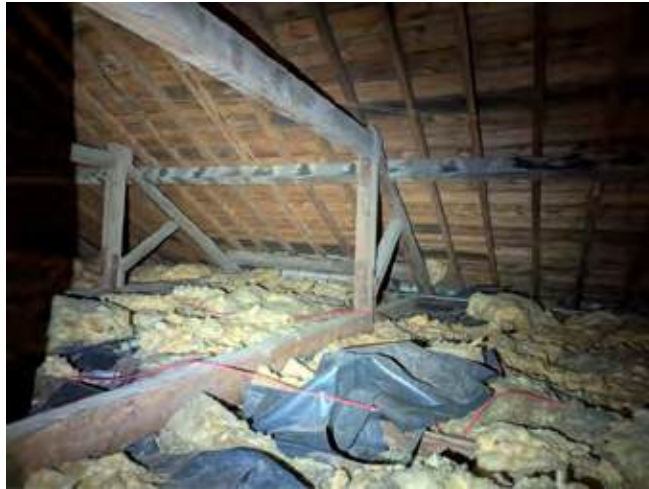
Roof R.1.7 (south-east range)

There are shallow roof voids within the pitched-roof ranges. The fabric within the voids suggests that the principal elements of the original trusses have been largely retained, whilst the rafters, battens and sarking boards have been replaced.

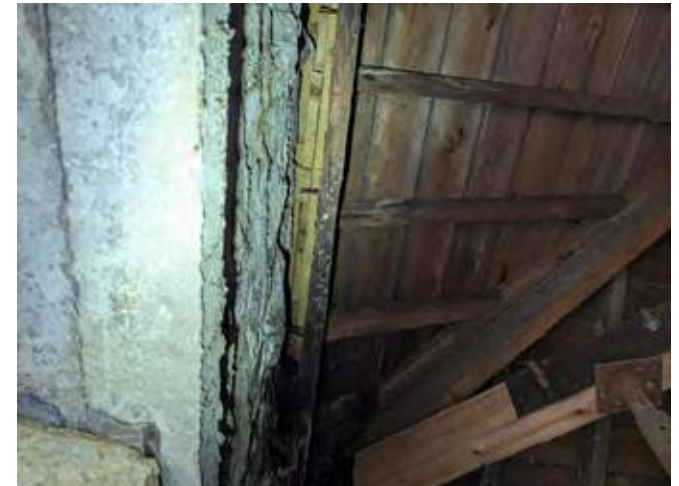
Underside of roof covering in void R.1.9 (the pitch of this roof is proposed to be altered to allow for more effective water run-off).

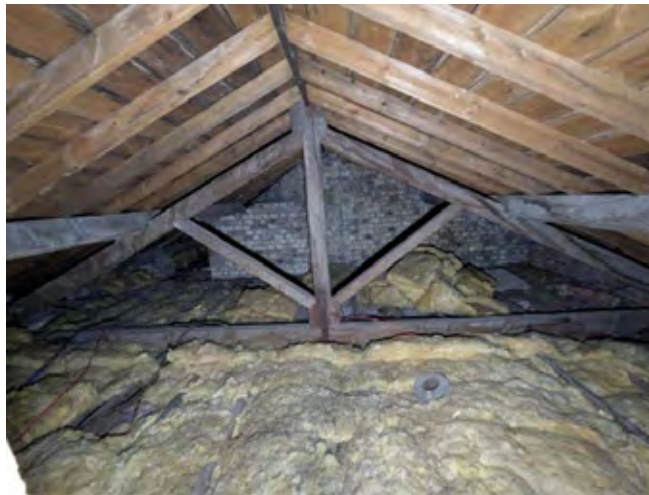
Interior of roof void R.1.20 (south range)

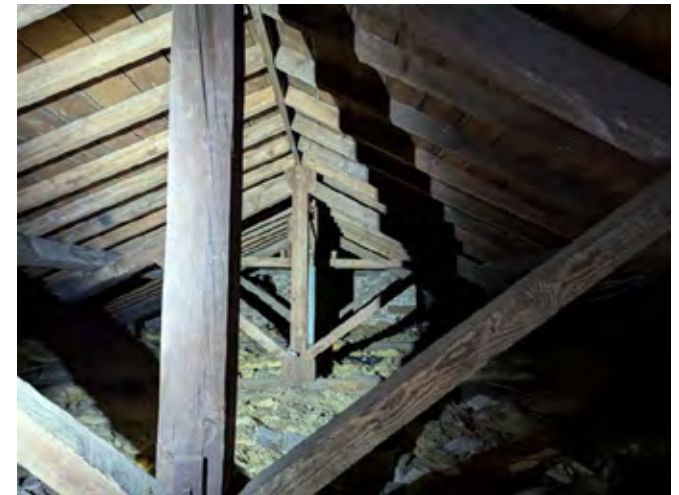
Interior of roof void R.1.15 (south range)

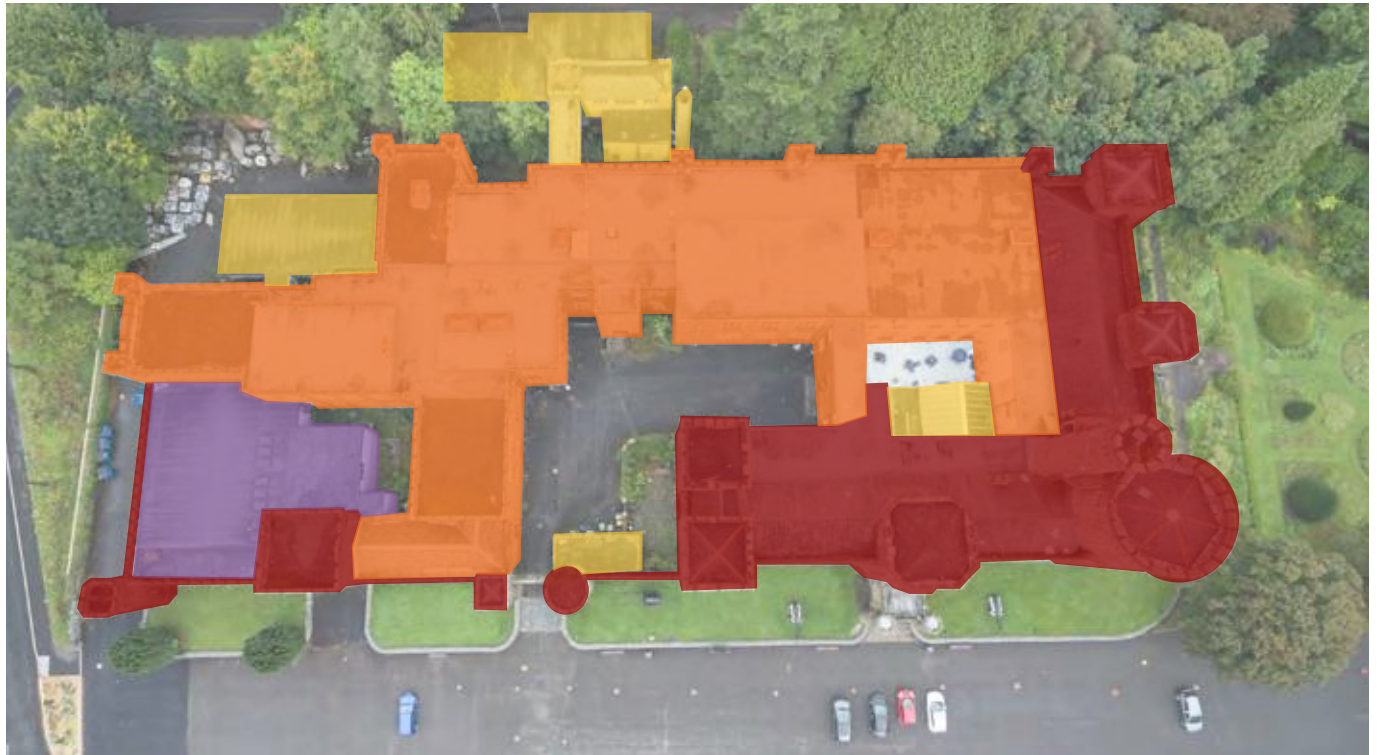
Image captured in a drone survey of the Castle circa 2016, annotated to show the relative age of the built fabric.

The adjacent block plan illustrates the main phases of evolution for Cyfarthfa Castle. A full set of Historic Development Plans can be found in Appendix C.

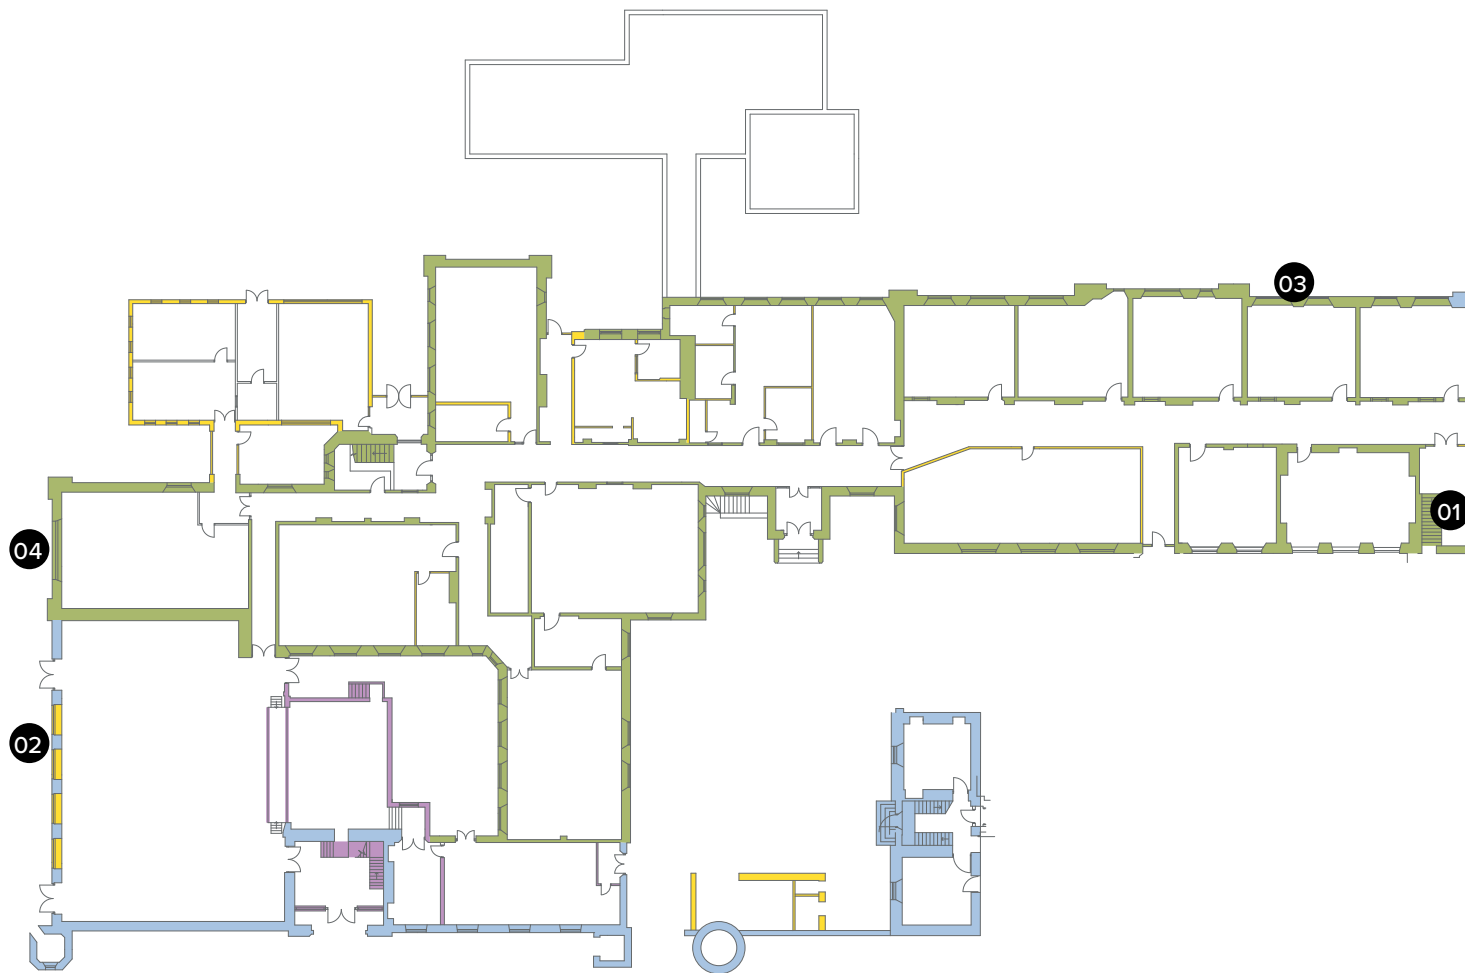
Cyfarthfa Castle Ground Floor (Former School)

- 1825
- 1910
- c.Early 20th Century
- c.Mid-20th Century
- c.Late 20th Century
- 01 Staircase thought to contain historic handrail and railings from now lost main staircase.
- 02 Historic (1909) plans suggest that this wall was retained from the original castle. New openings made when gym was added.
- 03 Windows seem to have been replaced on an ad-hoc basis. Some original 1910 windows remain, but a full windows schedule is needed.
- 04 Thought to be an original 1910 window.

*Note - even if original fabric survives here - the original layout of the georgian building is much altered and the fenestration is also much changed.*
