**WEBSTER HOUSE, DYNEVOR STREET, MERTHYR TYDFIL**

**BAT SURVEY  
ISSUE 1, VERSION D**

**JUNE 2022**

### Bat Survey Report

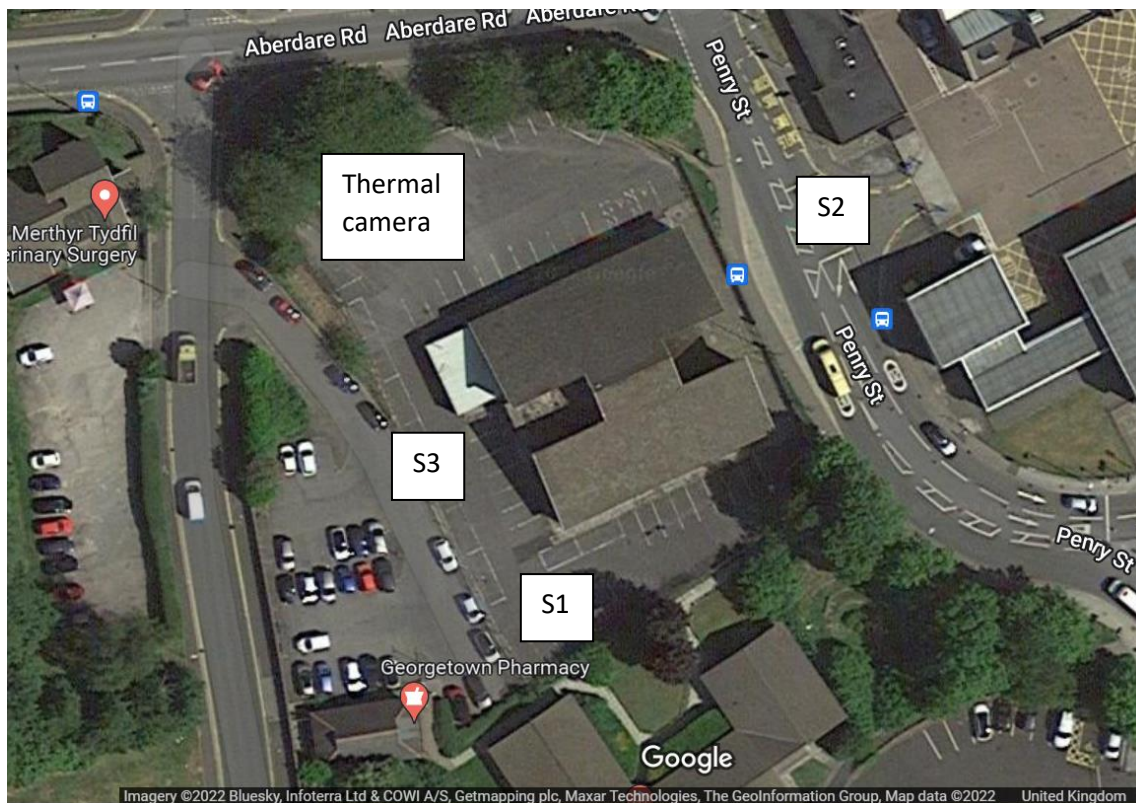
Figure 3: Approximate surveyor locations

A dusk survey was carried out on 3<sup>rd</sup> May 2022 using three surveyors and a thermal imaging camera, positioned in such a way that as much of the building was visible to surveyors as possible. Surveyors and cameras were equipped with Batlogger M detectors.

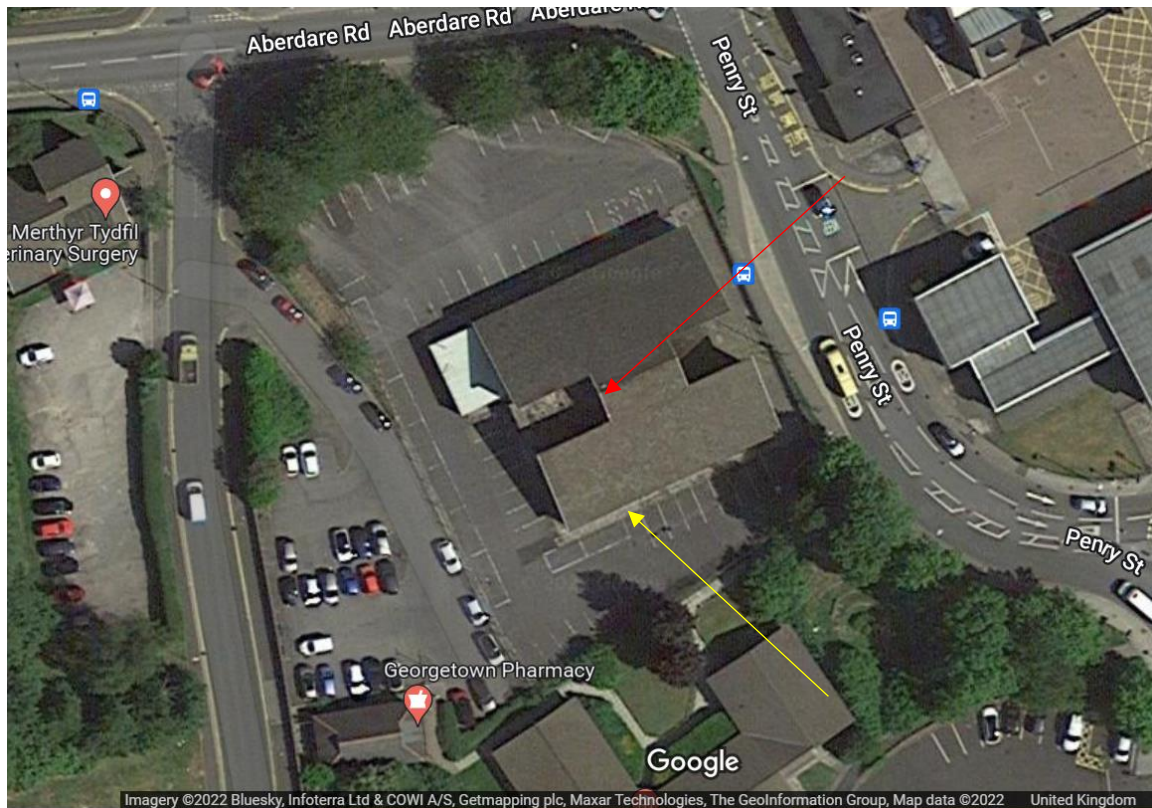
Figure 6: :Location of roosts (soprano pipistrelle (arrowed red)); unidentified bats found in pillar during works (arrowed yellow)

Given the locations the bats were seen, it is possible that they are just roosting on the exterior of the building (beneath barge board, beneath soffit/pillars).

A gap will be left on the rear of the building between the wall and barge boards. Access points for crevice-dwelling bats can be as small as 15-20mm high x 20-50 mm wide. These gaps will be left at the two locations where bats were encountered (figure 6).

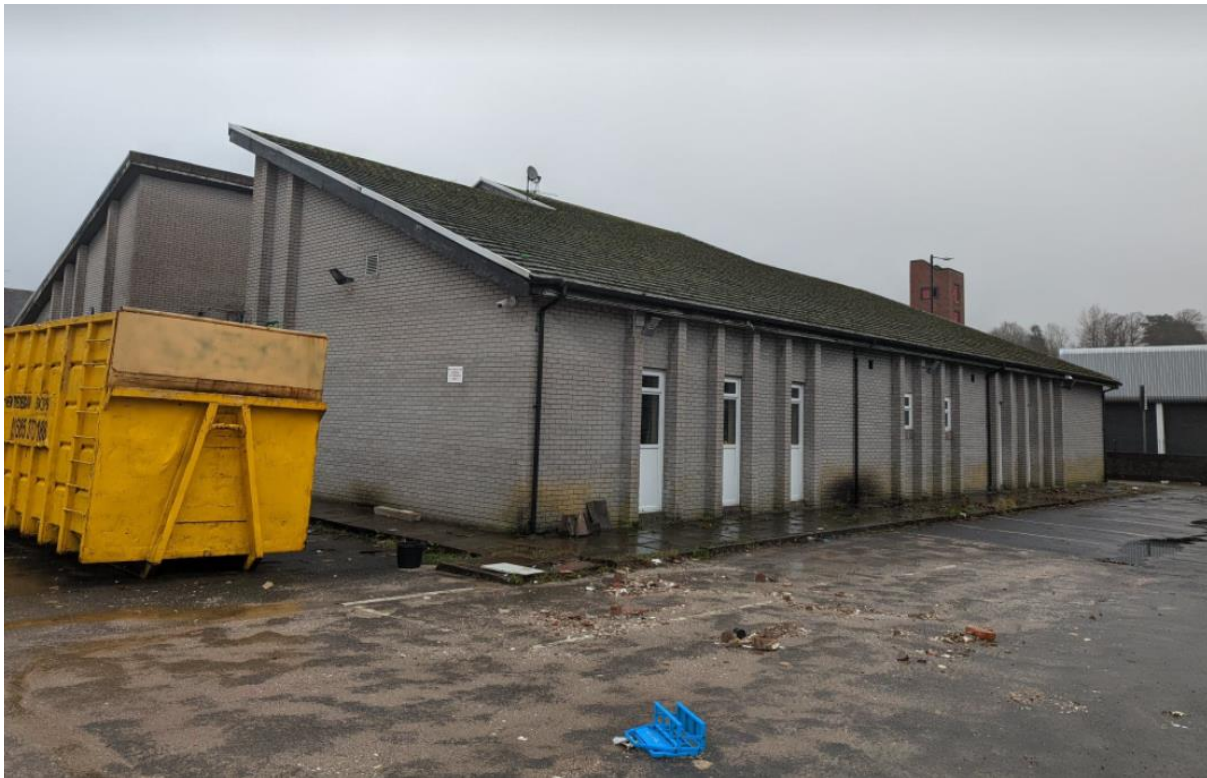
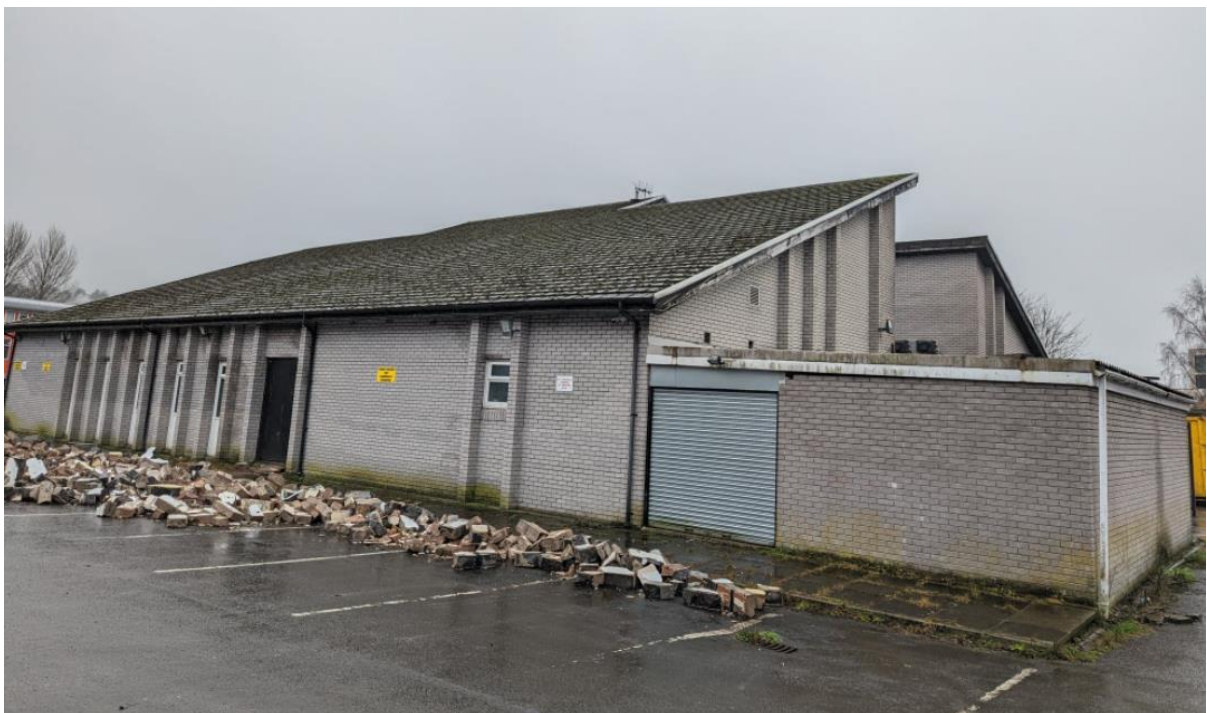
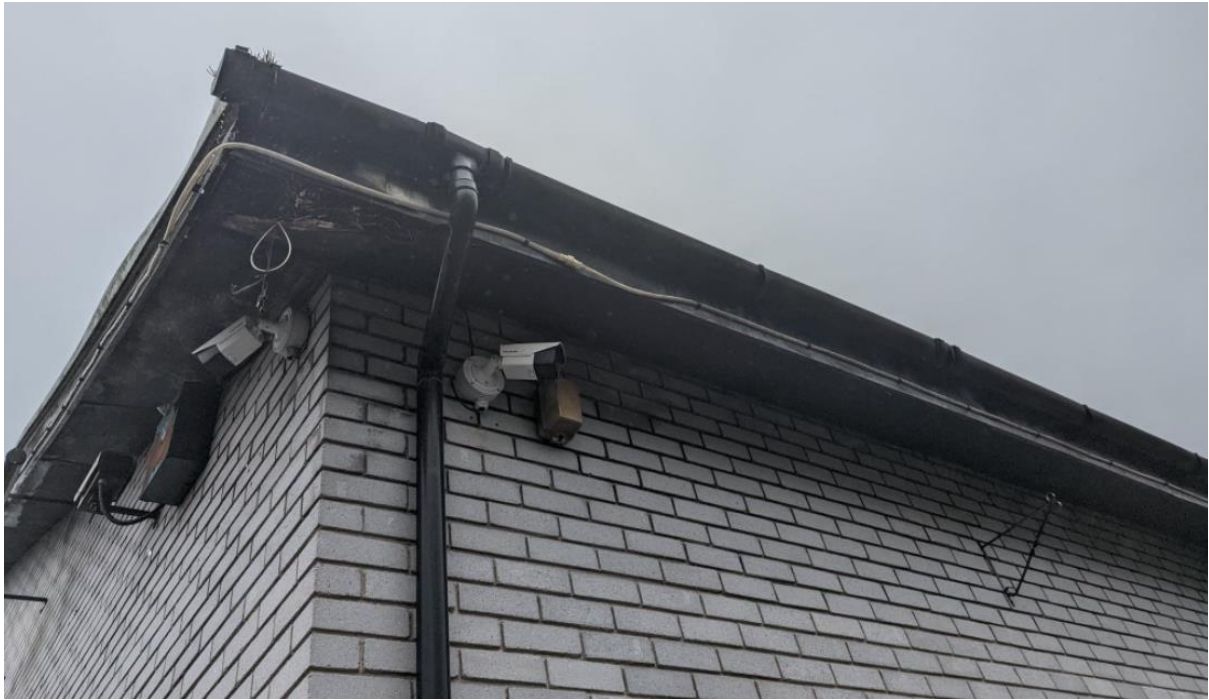
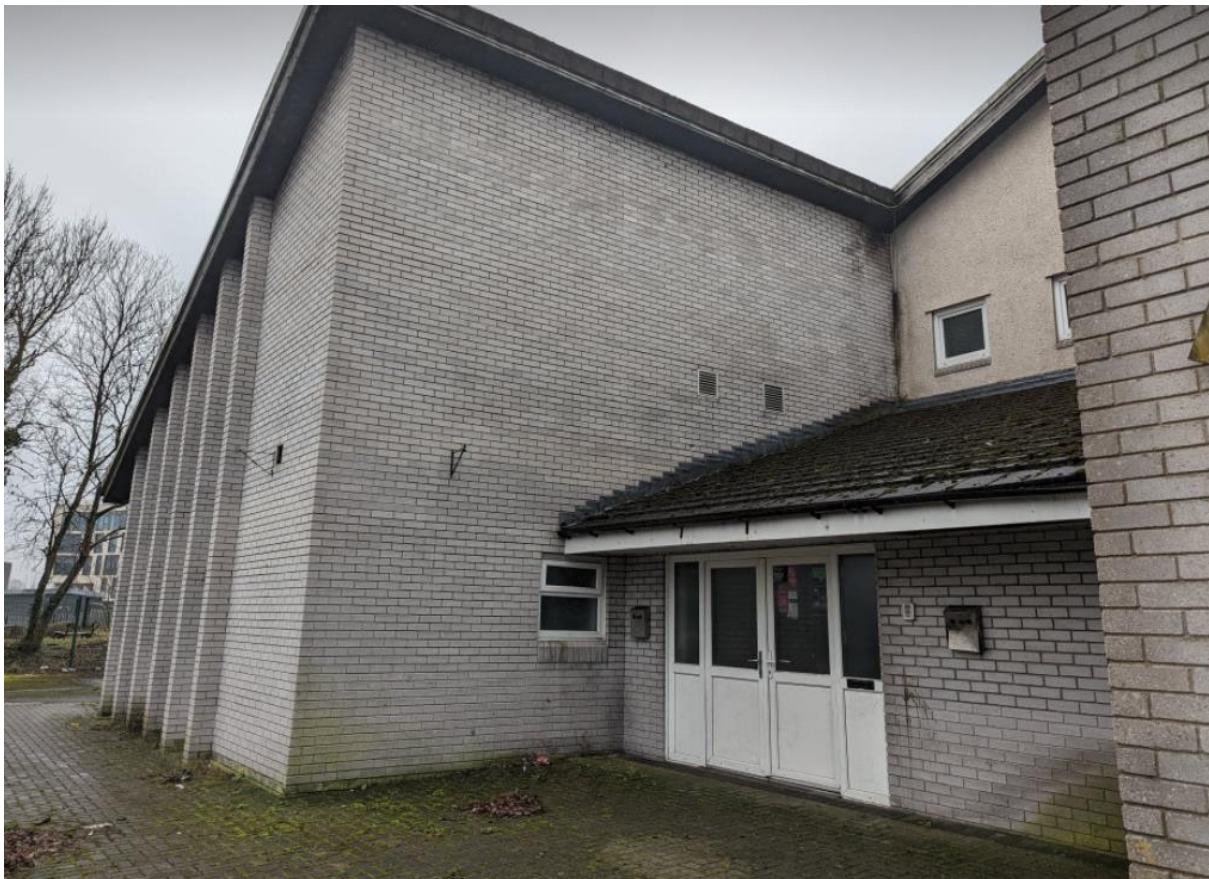
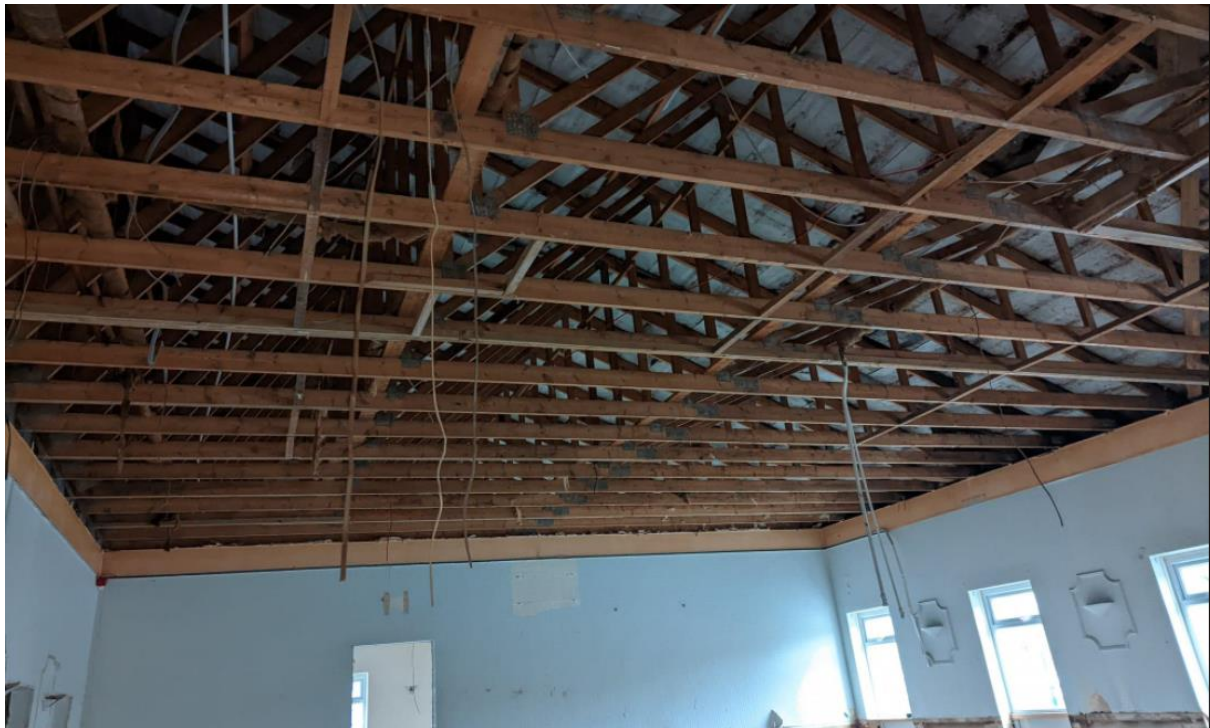
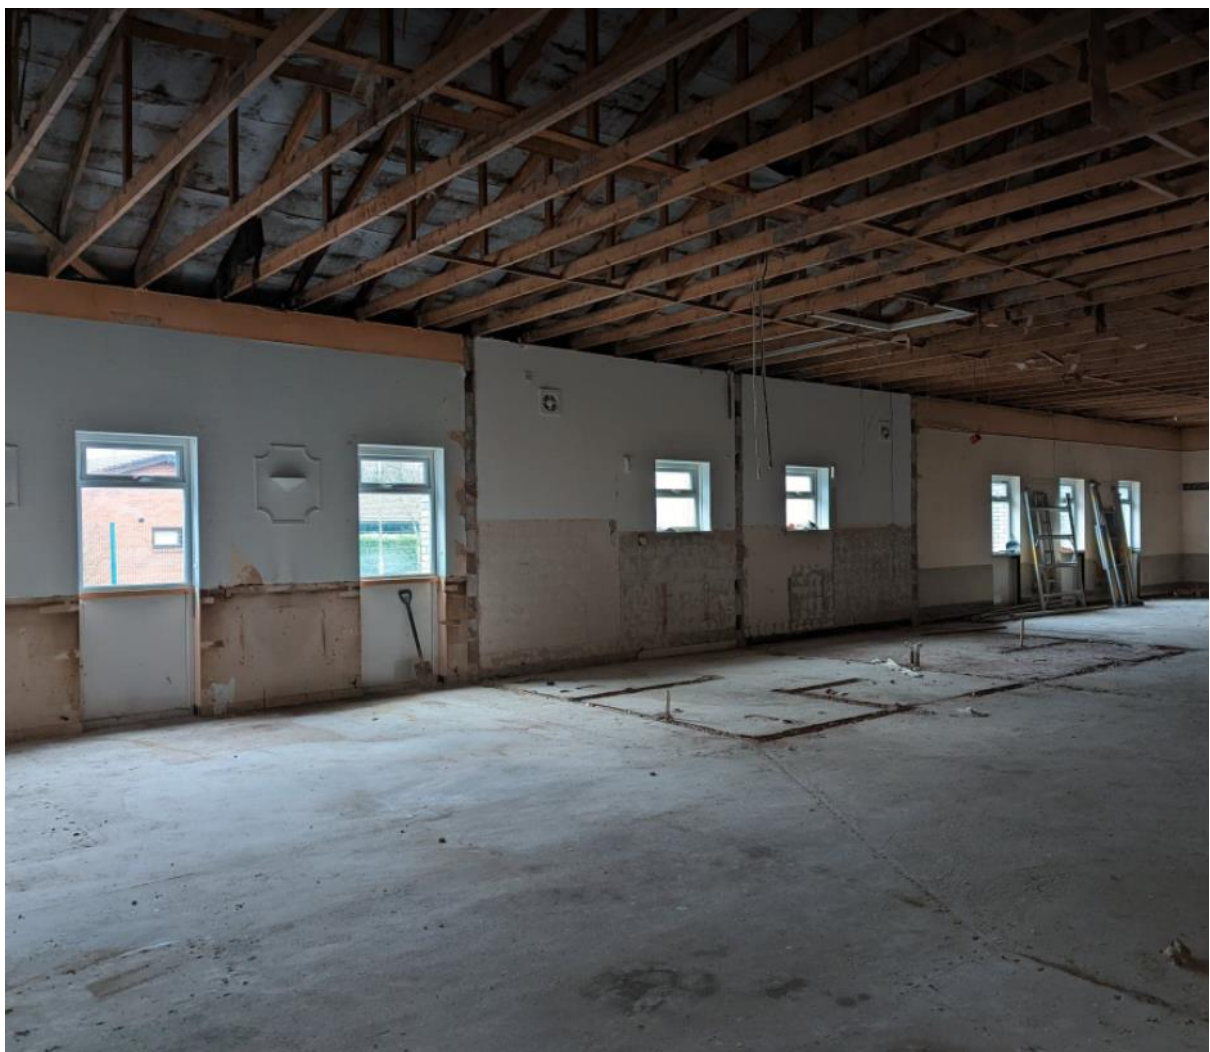
## APPENDIX A- SITE PHOTOGRAPHS

- Small number of potentially slipped slates
- Small number of gaps at soffit level (generally the soffits are tight, however a very small number of gaps were noted)

Please see appended plates for photographs of the property exterior. Other than these areas, the building appears to be well sealed.

Internally, the property has already been gutted. The roof is unlined and the ceiling timbers are still in place. There are puddles on the ground where the roof is leaking in places. There is access to all areas of the building where the roof spaces would have been originally due to each section being connected.

The building is now a shell and in a state of disrepair.
