# Knotweed Management Plan

**Produced by: The Knotweed Company Limited**

**KMP Reference: TKC3051 v1.2**

**Site address:** Land off Swansea Road, Merthyr Tydfil CF48 1HS

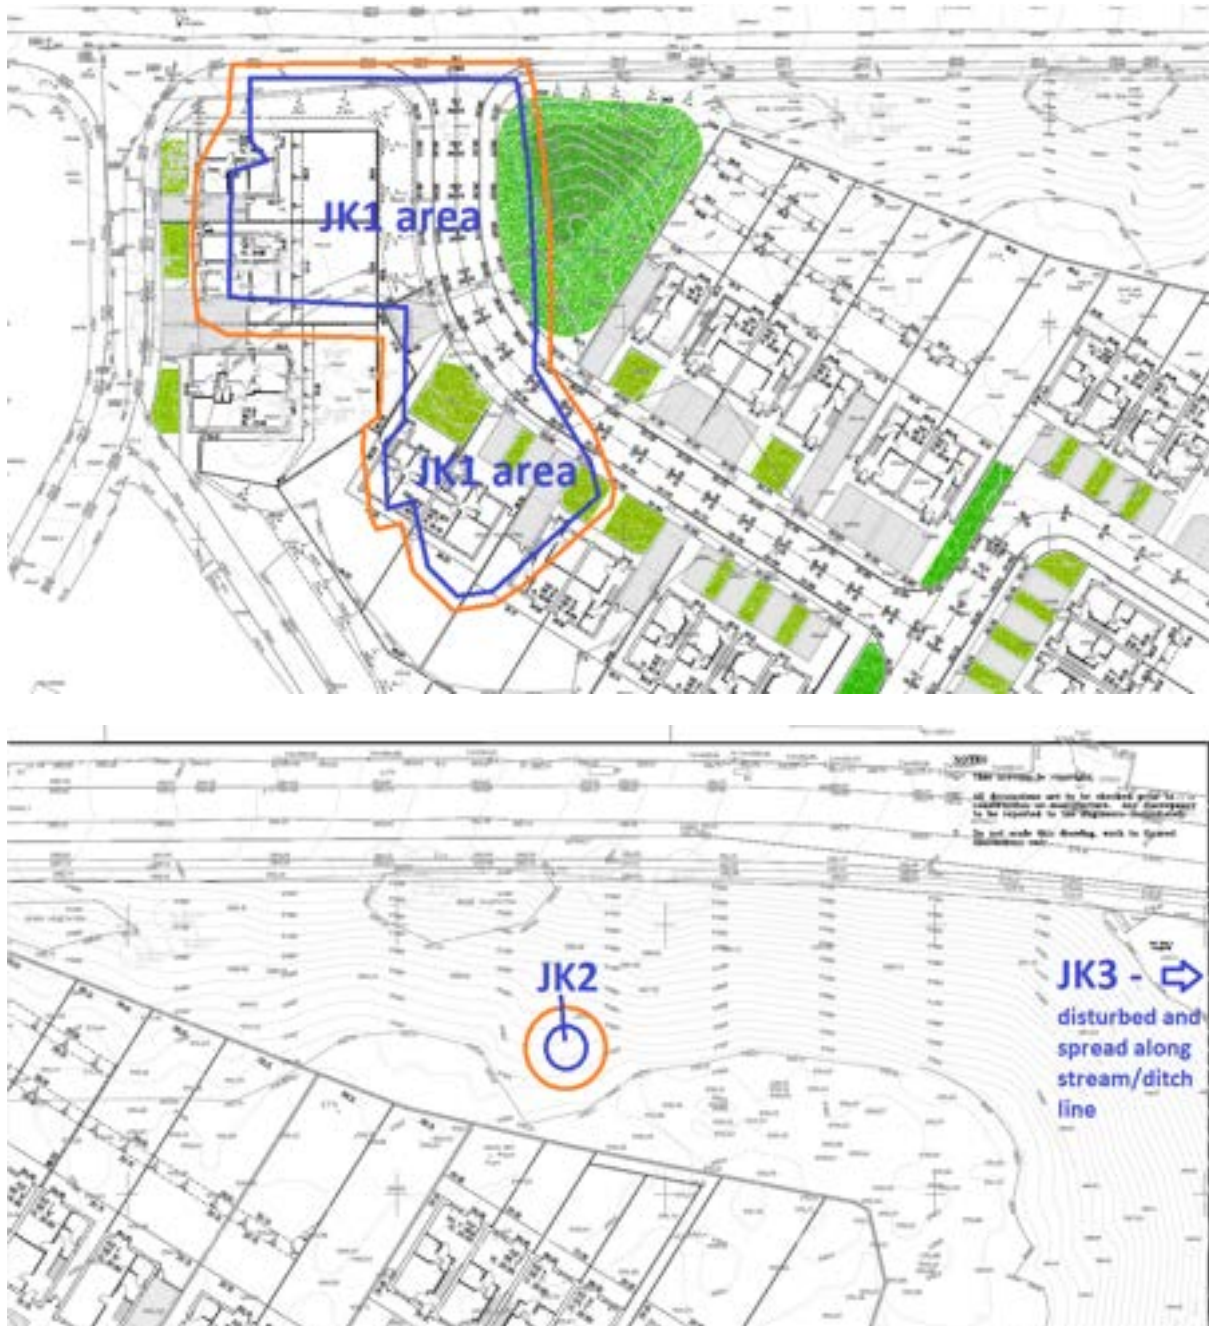
## Appendix I – Site Plan

Blue outline indicates visible extent of the Japanese knotweed, however the rhizome spread beyond this (orange line) may vary between 2-7m. In the woodland/scrub area in part of Jk1 for example the rhizome spread would typically be greater than a more open area.

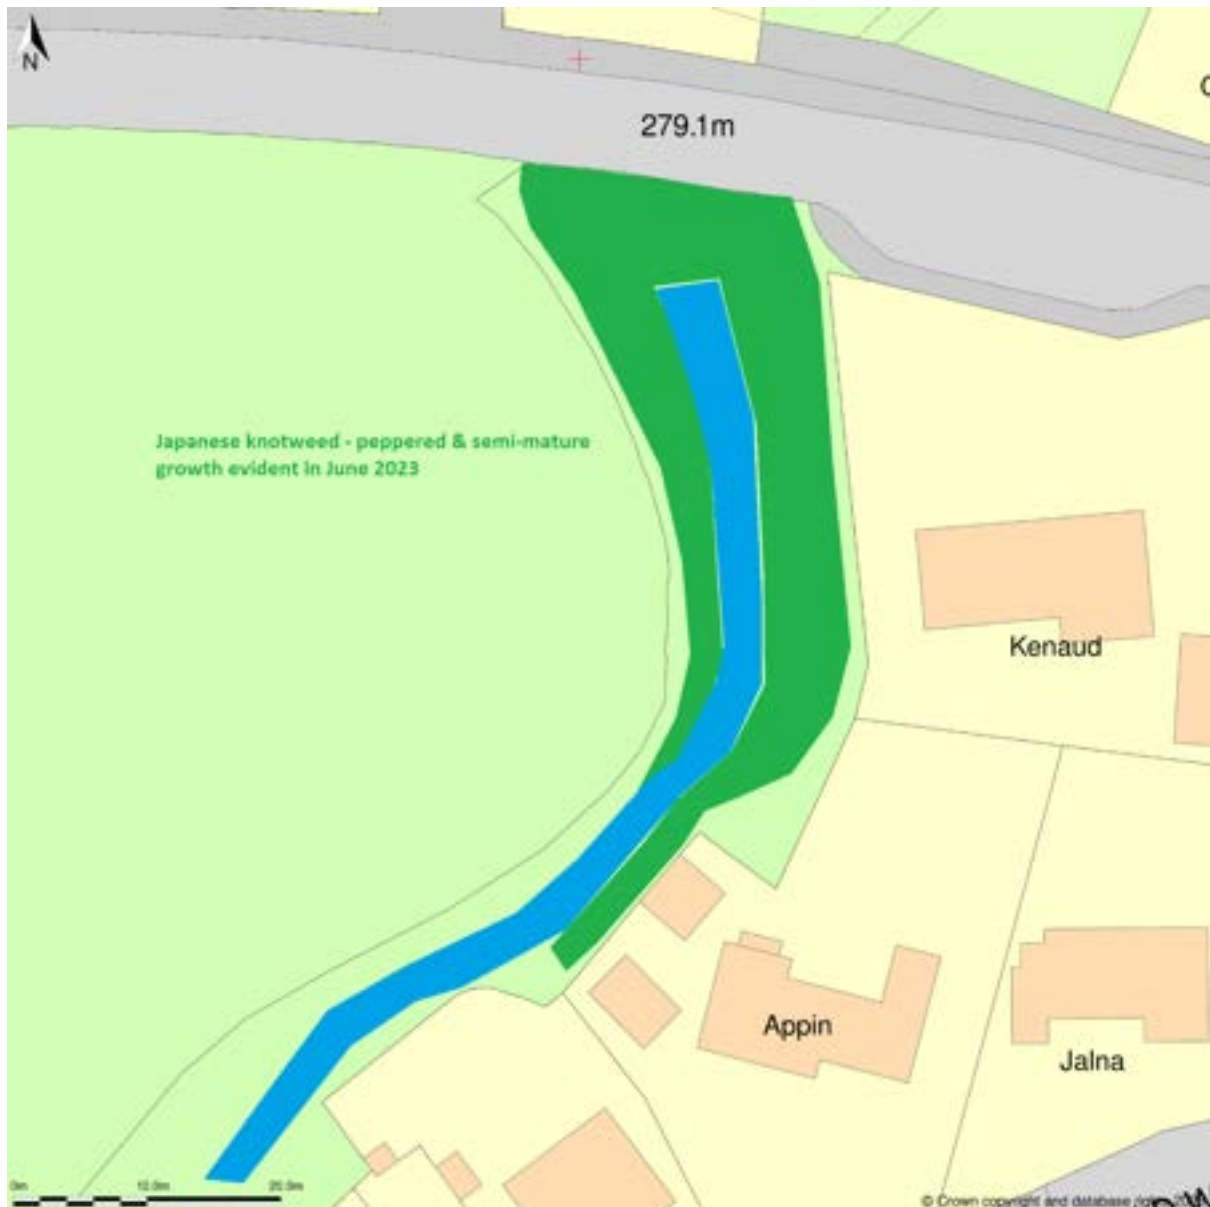
**JK3 area as plotted in June 2023.**

We found a spread of Japanese knotweed over approximately 544m<sup>2</sup> on both sides of the stream where works had been carried out. It is quite possible that more growth will subsequently emerge. The growth was a mixture of peppered and semi-mature growth.

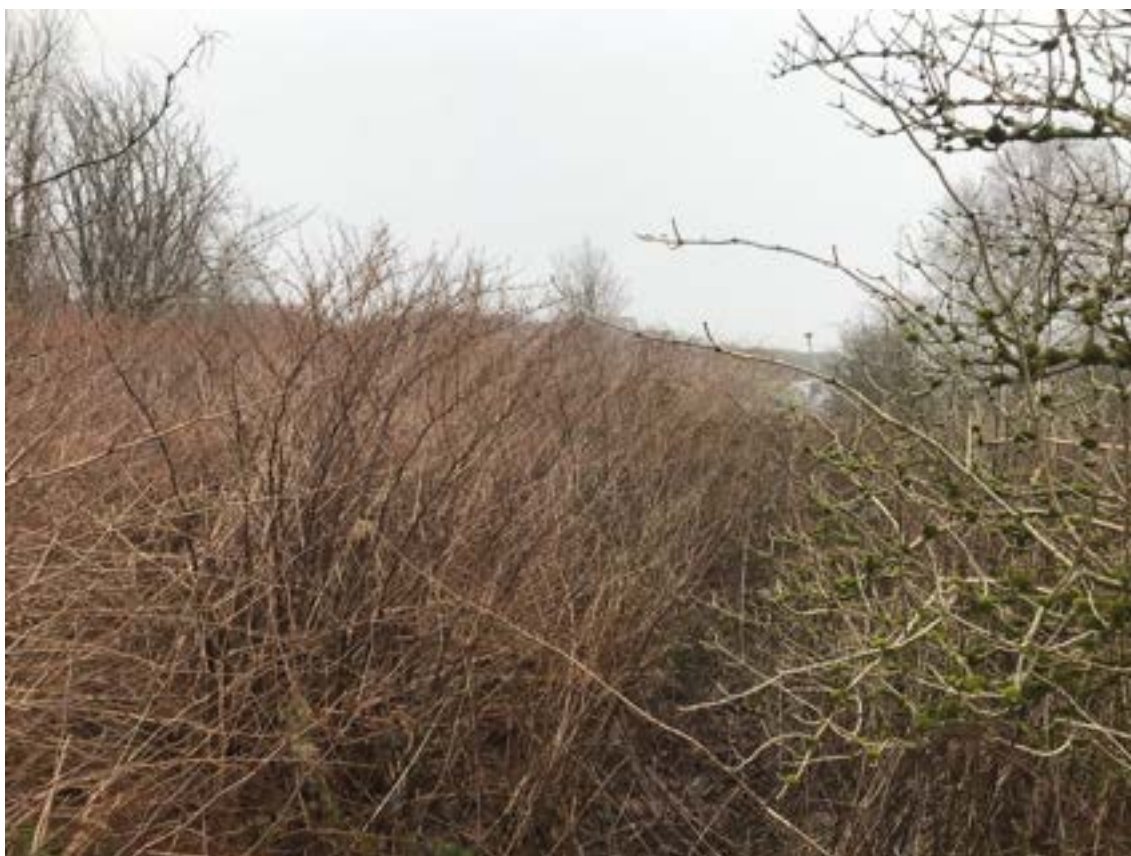
Part of JK1 – before the dead canes were cut

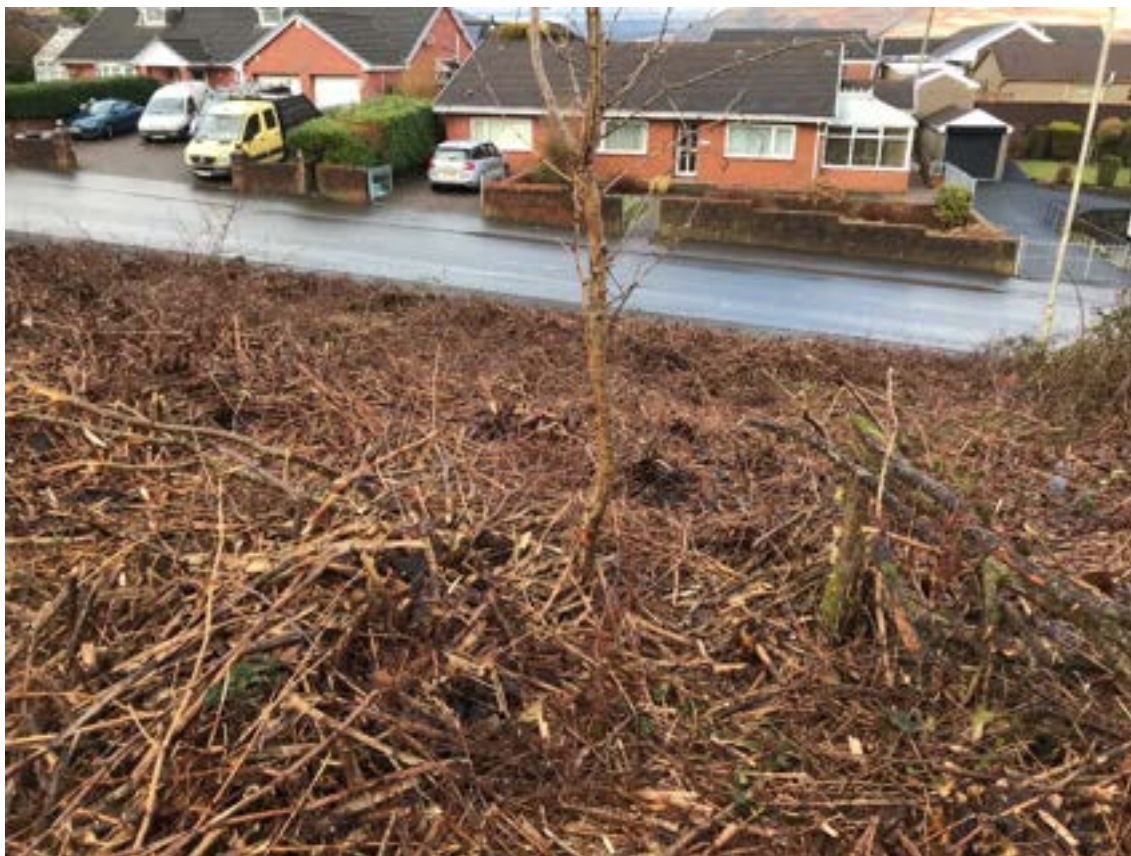
Part of Jk1 – looking onto Swansea Road

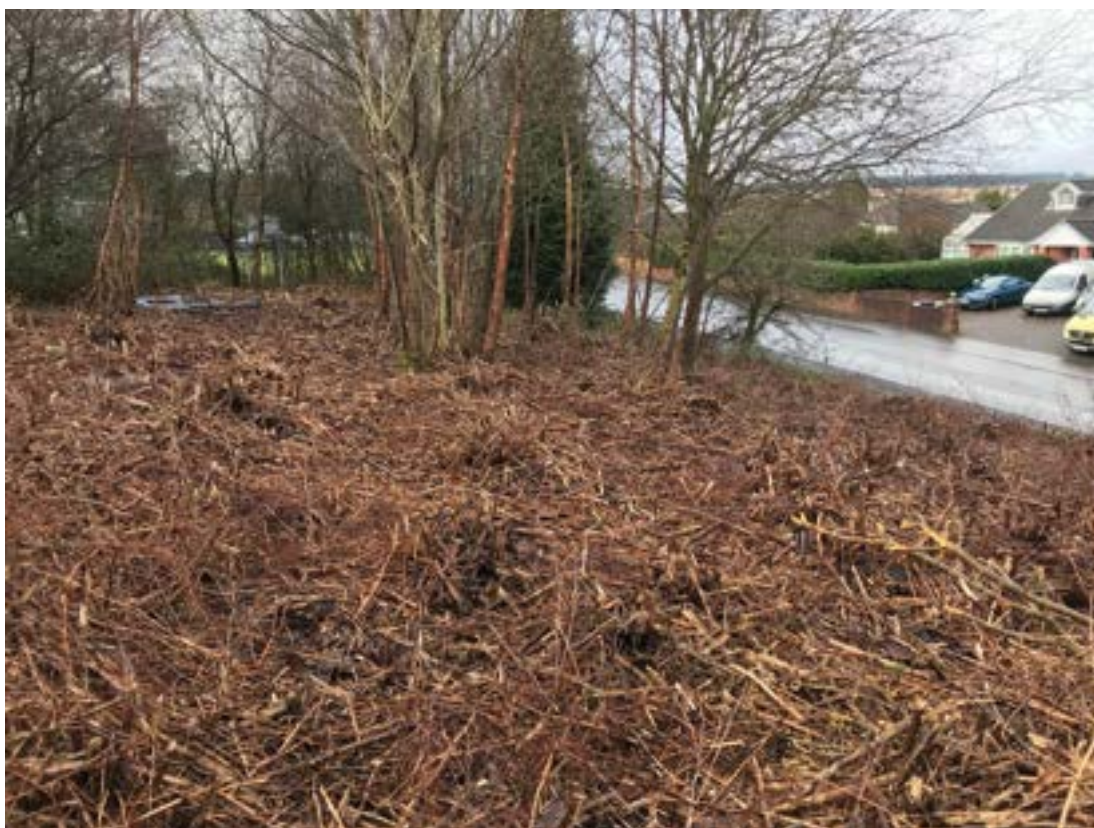
Part of Jk1 – looking into the scrub area (more Japanese knotweed)

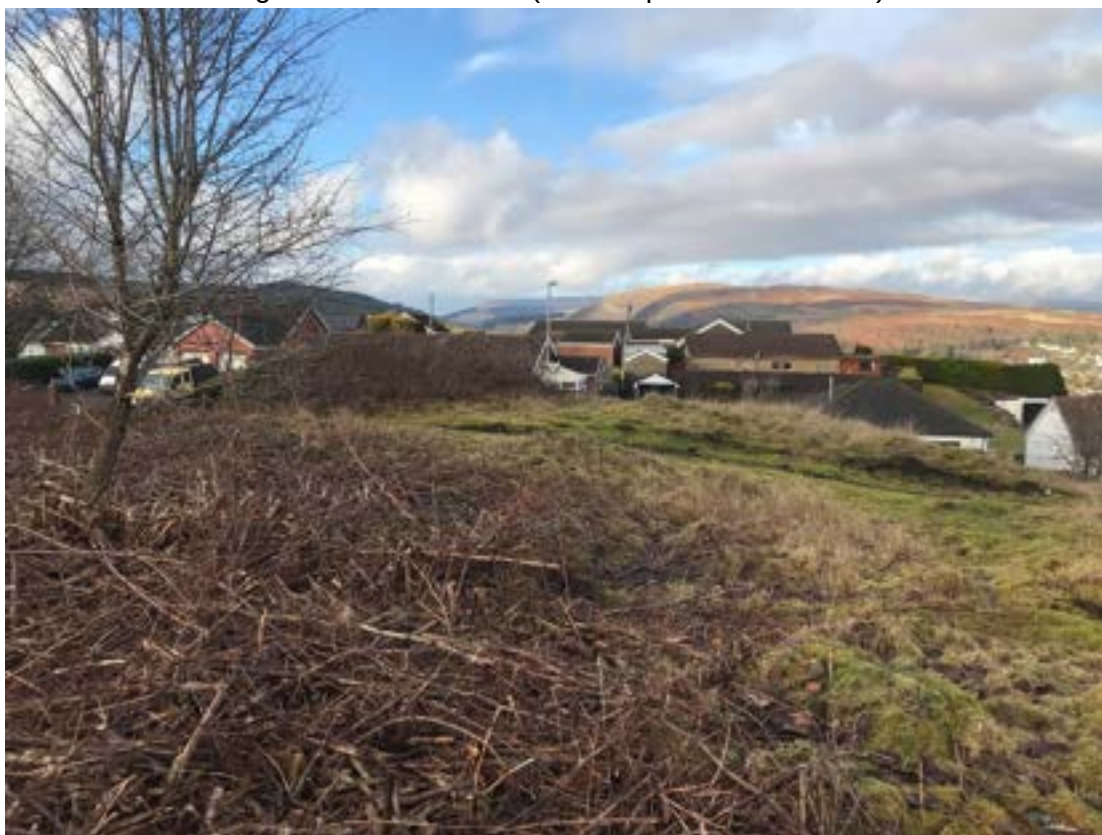
Edge of JK1 onto the site

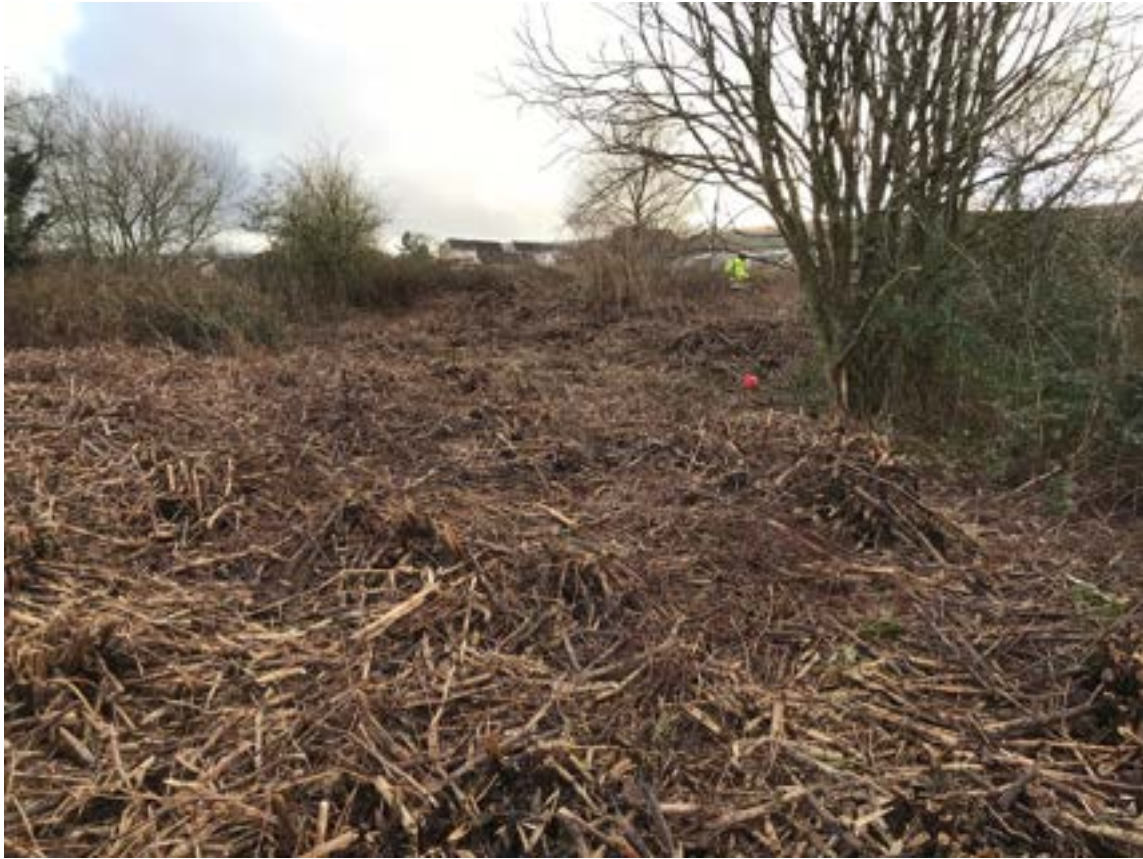
Top of JK1 – operator is working at the edge of the stand

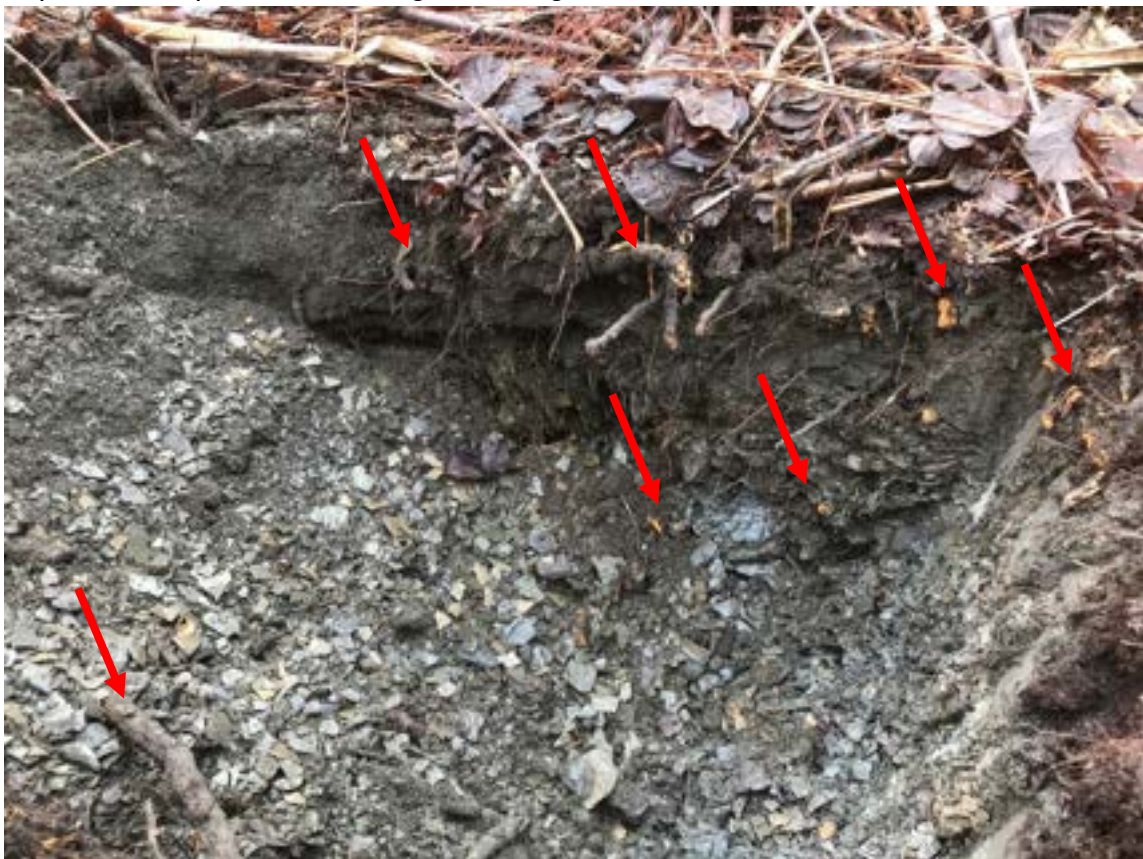
Soil sampling hole in JK1 area. Orange knotweed rhizomes visible throughout. Note main rhizome network in top 300mm.

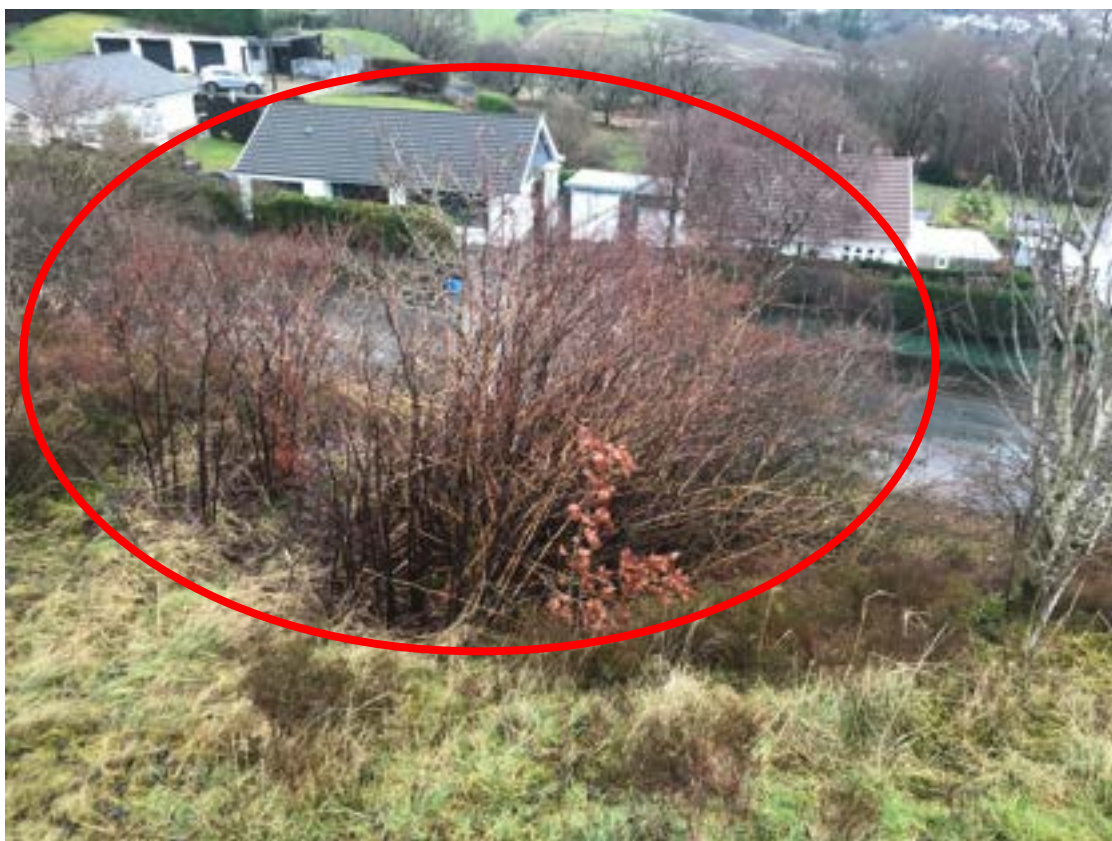
JK2 on bank.

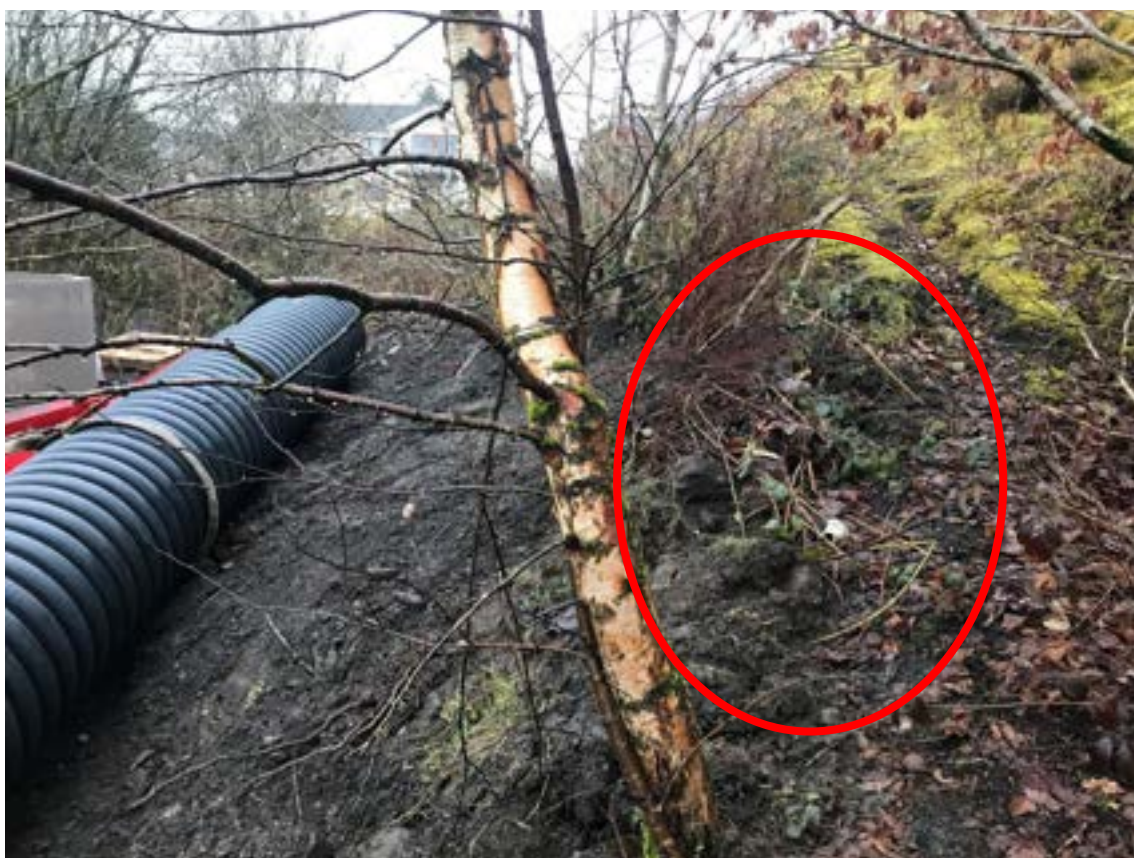
JK3 – scattered viable knotweed rhizomes, etc. across area. Surface shoots placed in circled area, rhizomes seen throughout working area.

During our formal survey in February 2023, we found a contractor was working along the stream bed and had significantly disturbed the Japanese knotweed area (JK3). Loose rhizomes were visible in the working area. We spoke to the team on site, and they said that they knew about the knotweed and had put the growth to one side. At the point they indicated were some knotweed stems and rhizomes, but these would only have been an insignificant proportion of the knotweed stand. We spoke to the team again and advised them to ensure that all machinery, etc. was thoroughly decontaminated before leaving the site.

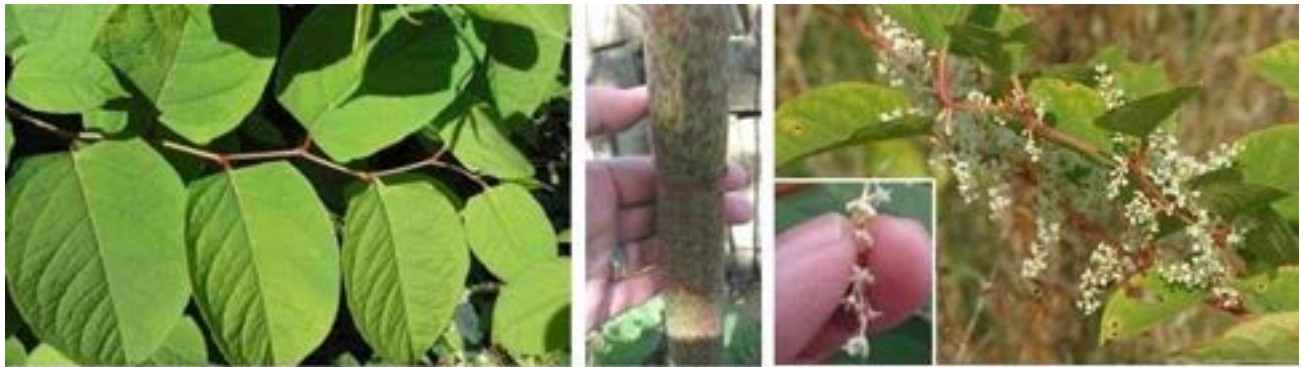
**Identification of existing Japanese knotweed growth (above):**

Leaves – shield shape; Leaf stems – zig-zag; Main stems – bamboo-like, green with red/pink speckles; Flowers (August/September) – tiny, creamy-white, formed in clusters.

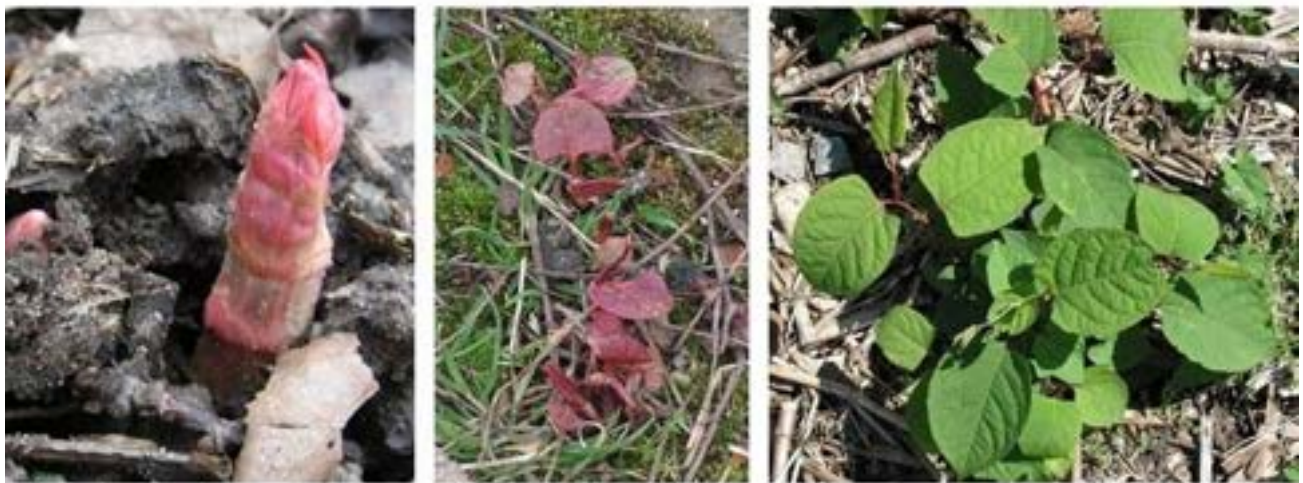
**Identification of emerging Japanese knotweed growth (above):**

Shoots – red/pink, resemble asparagus spears; New leaves – red, gradually turning to green.

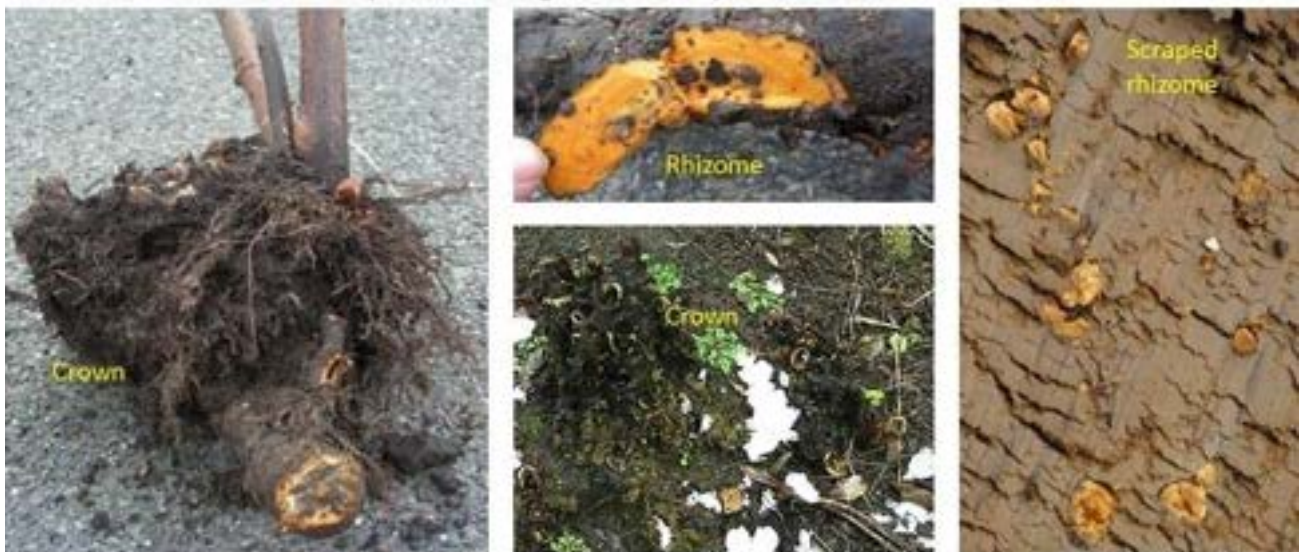
Crowns – knotty mass, top often visible, hollow stems (sometimes red/brown buds) emerging;

Rhizomes – dark brown, fleshy exterior, orange interior, snaps like a carrot.
