**18 HIGH STREET, MERTHYR TYDFIL**

**BAT SURVEY**

**18 HIGH STREET, MERTHYR TYDFIL****Bat Survey Report**

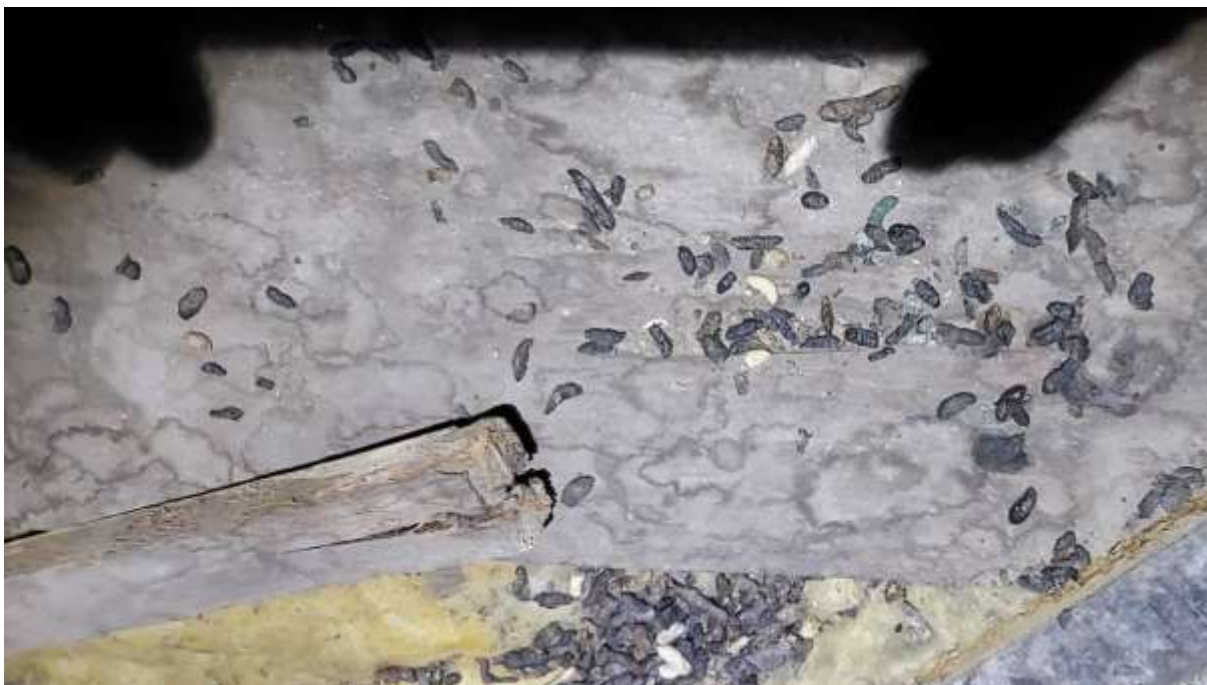
Plate 2- photograph of rat droppings

No bats or evidence of bats was found in this location. Lots of evidence of rats was found in this location, however, the rat droppings appear to be old. It is thought likely that rats are entering the void either via wall cavities or over the wall plates from the adjoining properties.

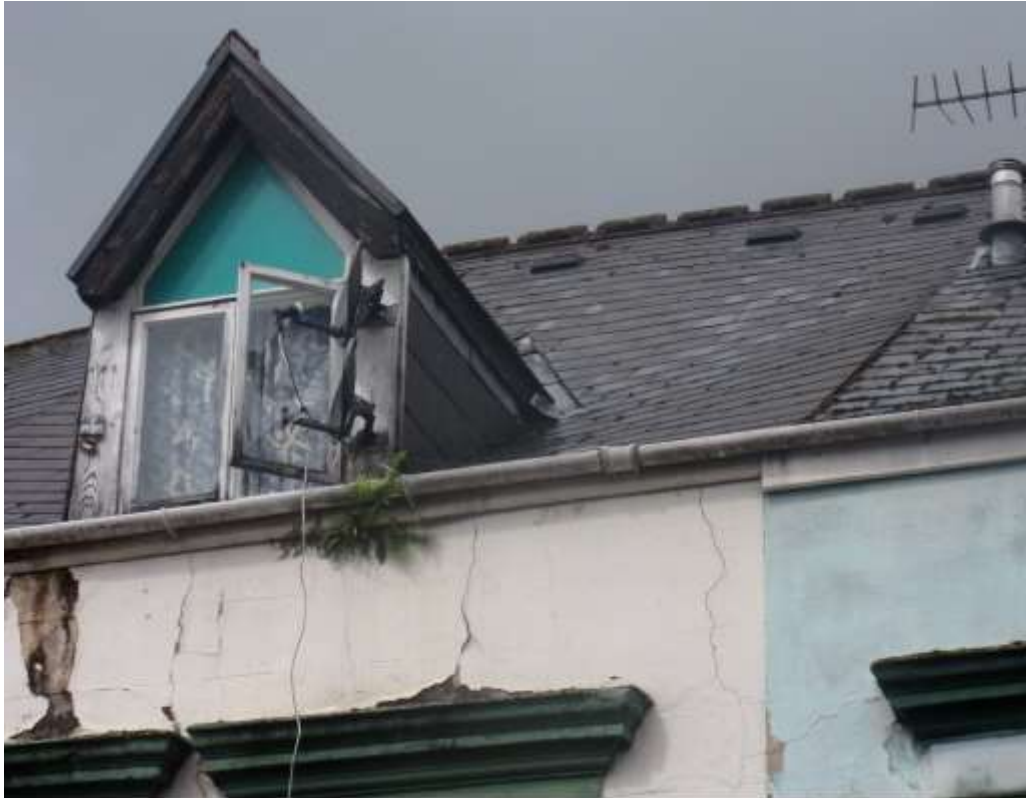
**Plate 3- Photograph of front elevation**

The property forms part of a terrace of houses and commercial buildings. The property is a stone rendered structure with a slate roof, the ridge of which generally runs from north east to south west.

There is a roof window on the north west elevation and a dormer window on the south eastern elevation.

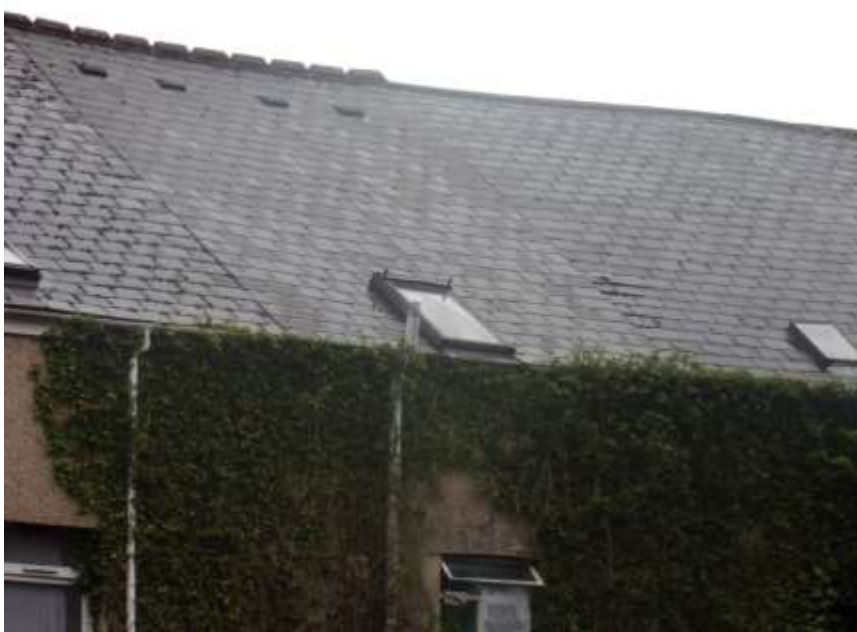
**Plate 6- photograph of rear roof**

The roof appears to be in good order and has been replaced in recent years. However, as the property is the subject of a heritage grant, the roof must be replaced with welsh slate.

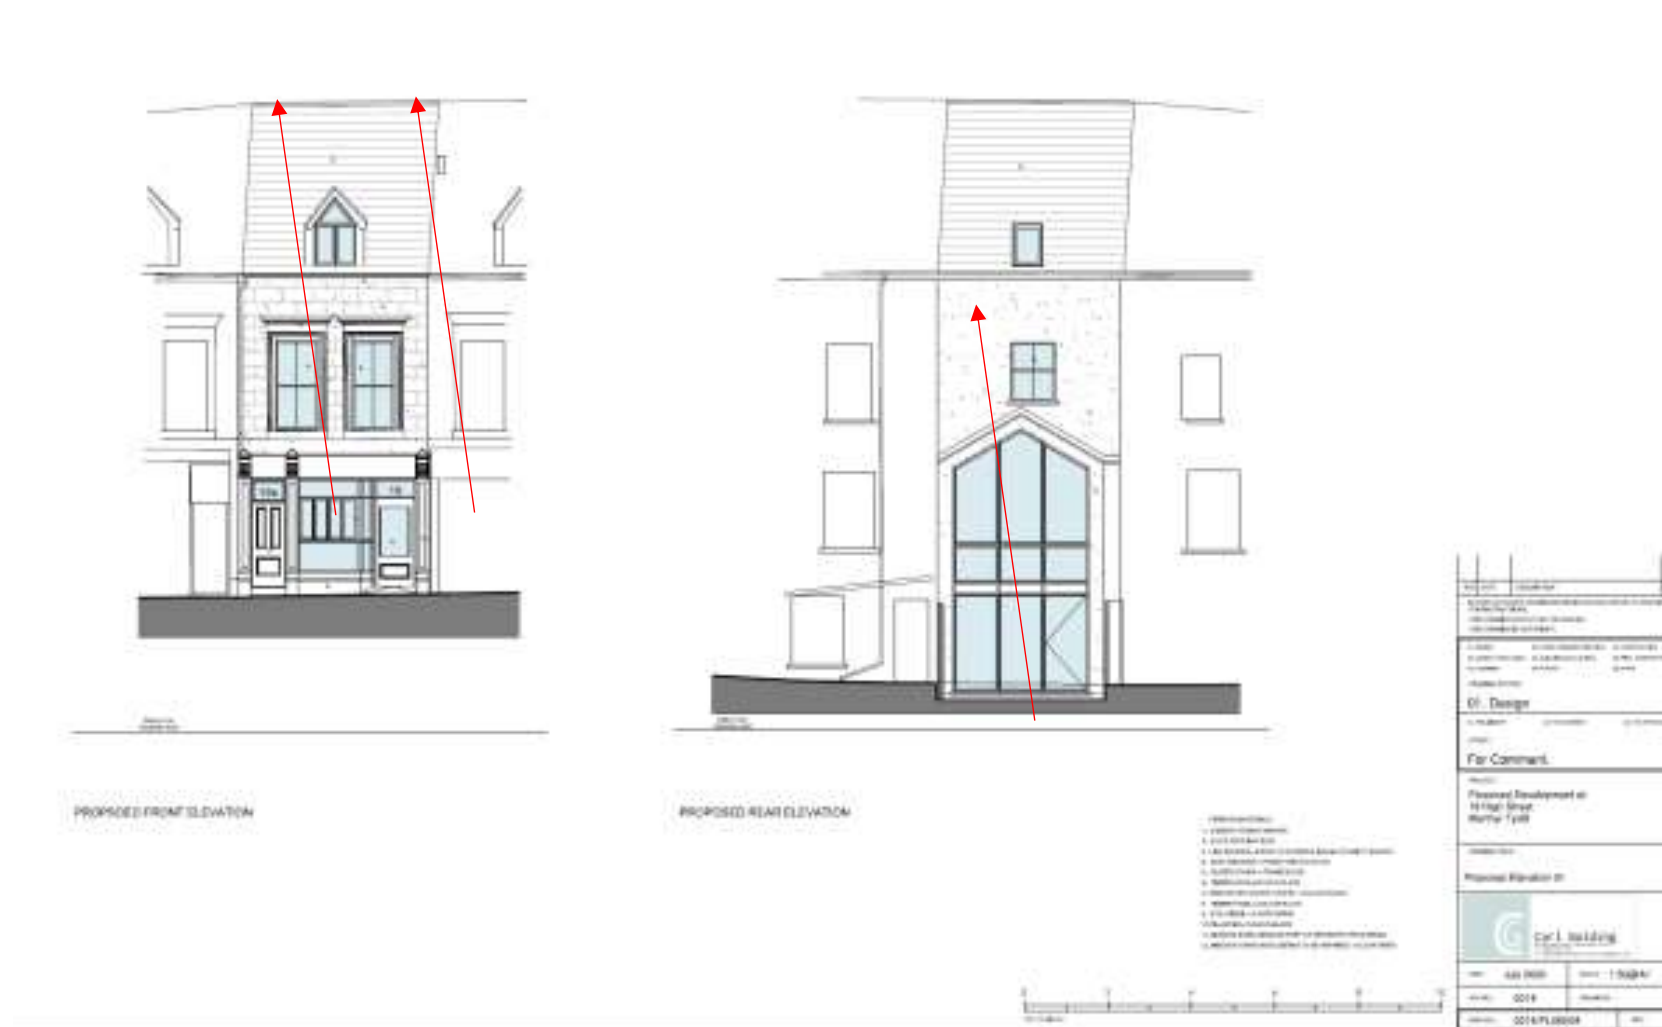
**Appendix B- Drawings showing enhancements (modified ridge tile arrowed red) (sparrow terrace arrowed yellow)**

Two modified ridge tiles will be installed on the property to allow bats access to the roof void at these locations. A small section of the ridge tile will be cut out in order to facilitate this. This will be overseen by the supervising ecologist.

A Schwegler 1SP Sparrow Terrace or the following <https://www.nhbs.com/sparrow-terrace-nest-box> will be attached to the rear elevation of the property.
