**TYLA-GLAS FARM, BEDLINOG, MERTHYR TYDFIL**

**BAT SURVEY**

**ISSUE 1, VERSION B**

**OCTOBER 2022**

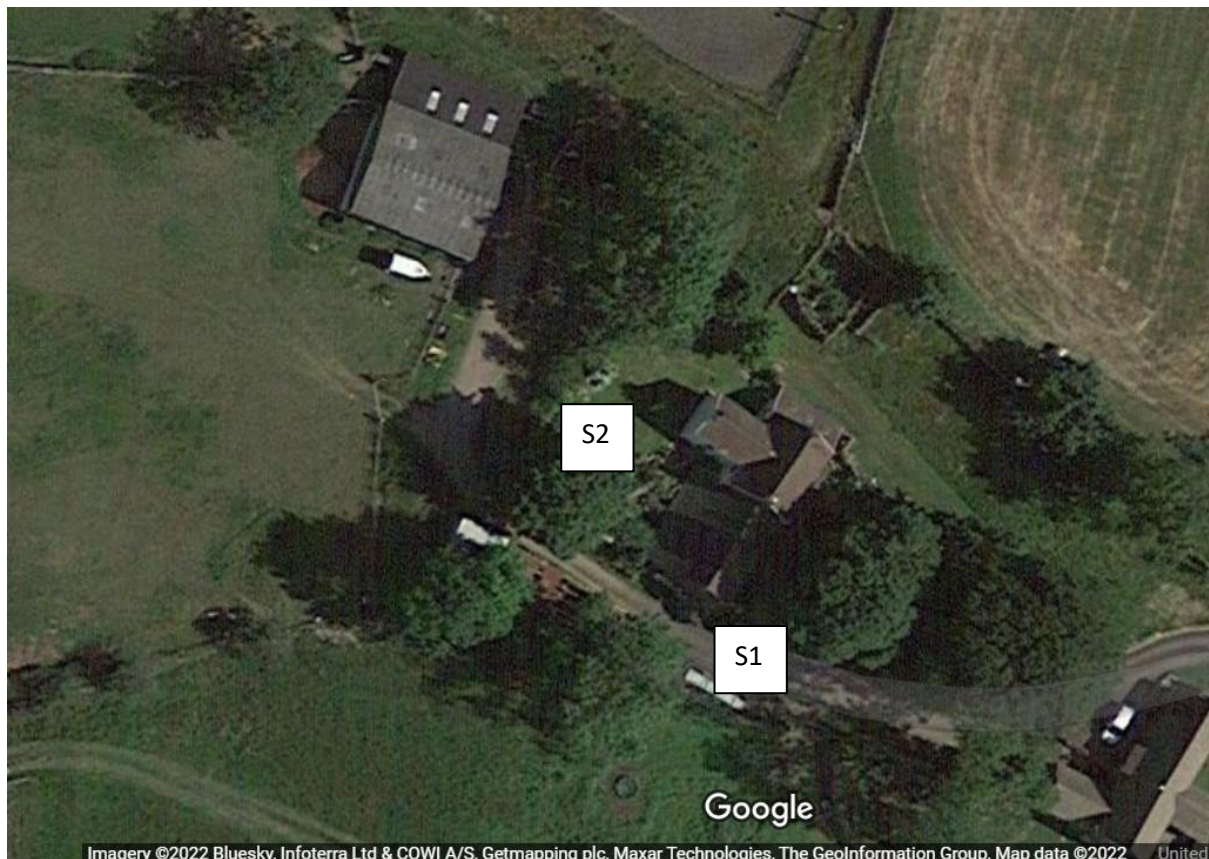
**Figure 3: Approximate surveyor locations**

A dusk survey was carried out on 25<sup>th</sup> May 2022 using surveyors, positioned in such a way that as much of the building was visible to surveyors as possible. Surveyors were equipped with Batlogger M detectors.

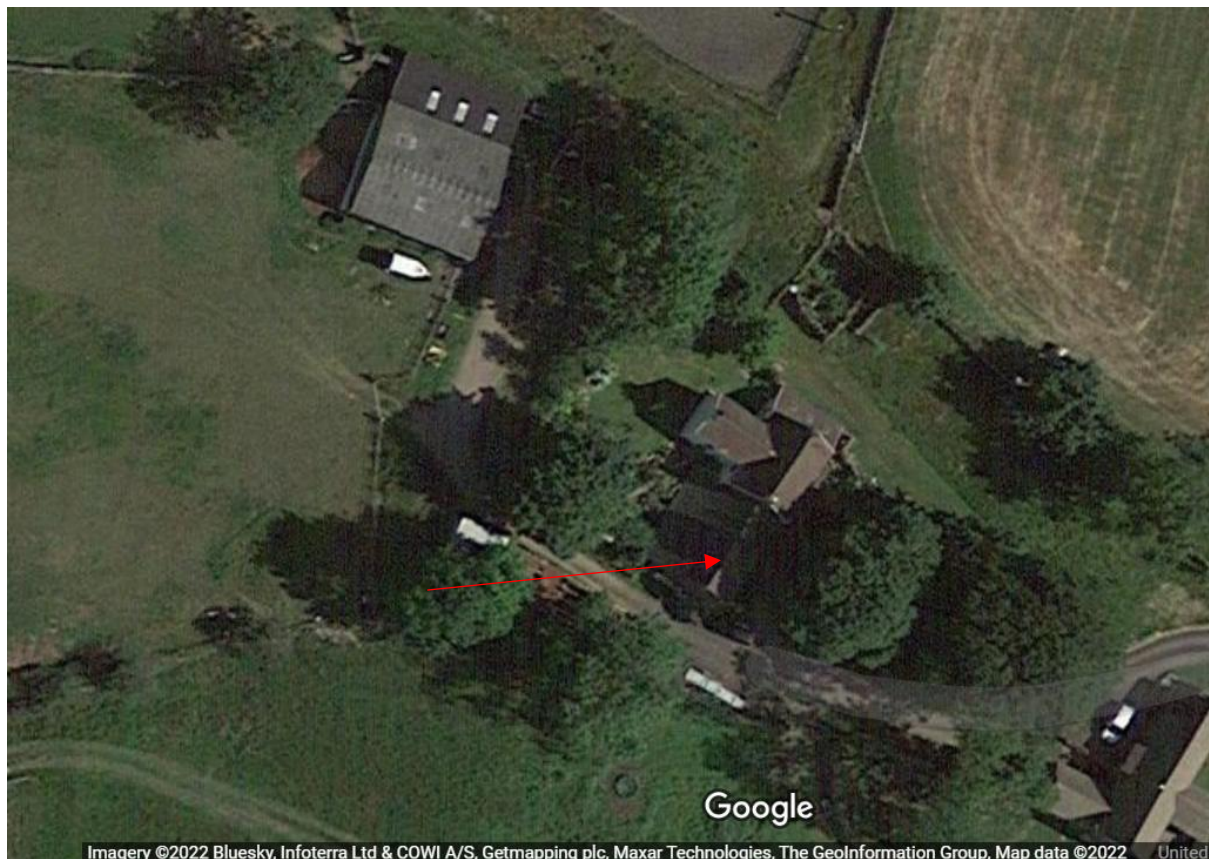
Figure 1: approximate location of static bat detector

A static bat detector (Anabat Express) was placed within the barn from the 15<sup>th</sup> May 2022-31<sup>st</sup> May 2022.

Based on the data above, it is considered that the barn is used by brown long-eared bats on a frequent basis and It is at least a day roost for a single brown long-eared bat.

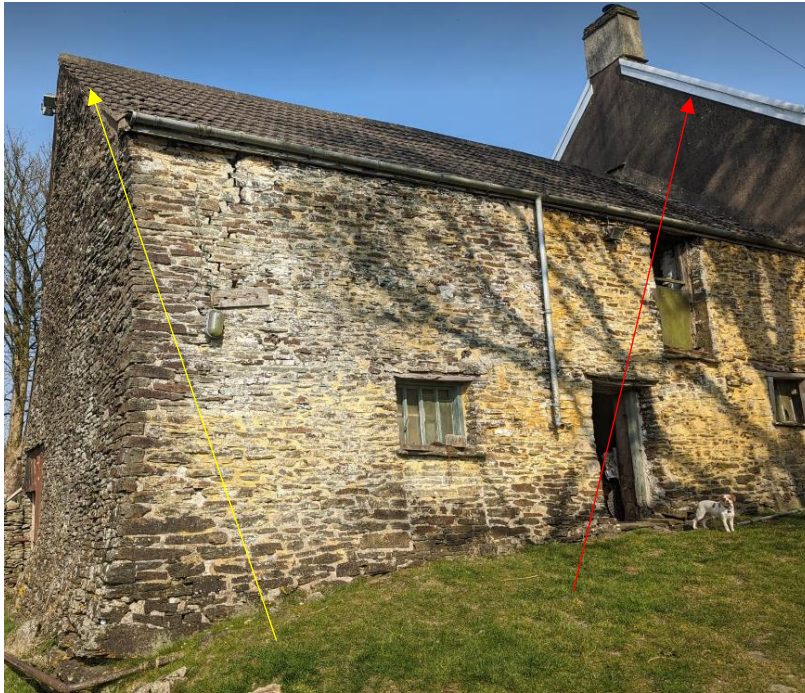
Figure 4: Common pipistrelle emergence points

The first bat call heard was a common pipistrelle bat, heard at 21:40, the bat was seen emerging from the barge board of the attached farm house before commuting east (figure 4, arrowed red). This was shortly followed by a further one common pipistrelle bat, all of which commuted north and east.

Immediately after this, two common pipistrelle bats were seen emerging from a gap in the stone work above the right hand wall plate of the south west gable of the barn (figure 4, arrowed yellow).

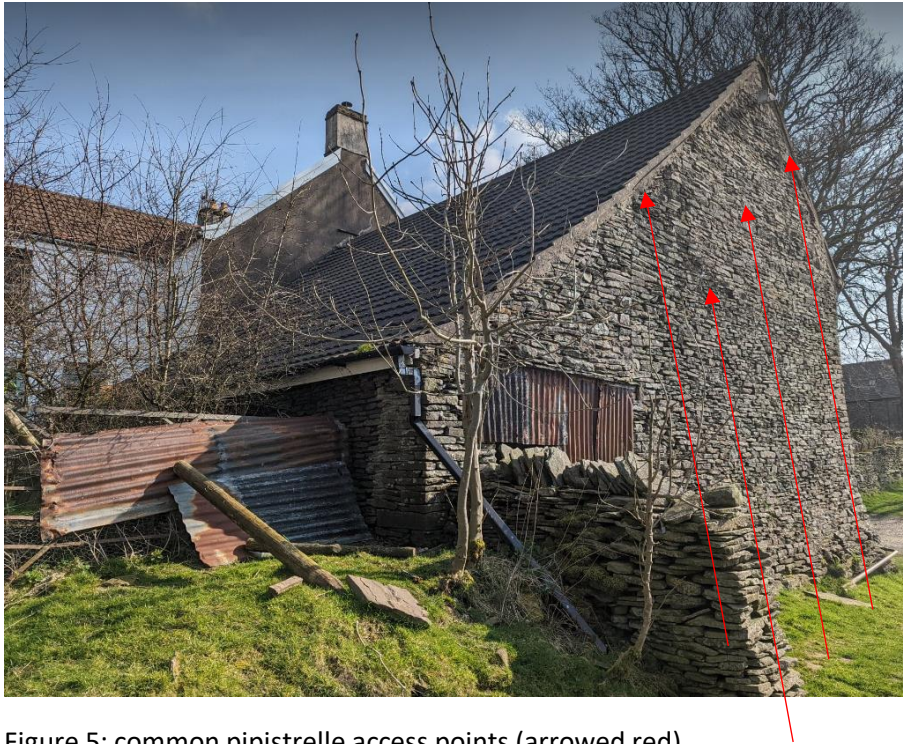
Figure 5: common pipistrelle access points (arrowed red)

The first bat heard was a common pipistrelle approximately 10 minutes post sunrise, the bat was seen emerging from the same location it had done on the previous survey (figure 4, arrowed red) before commuting over the top of the farmhouse to the north. This was shortly followed by a further 34 common pipistrelles emerging from the gable of the farmhouse. The majority of the bats again emerged from tiles adjacent to the north eastern face of the chimney of the farmhouse with some emerging from beneath the barge boards.

Four common pipistrelles emerged from the barn under survey before commuting east (figure 5, arrowed red).

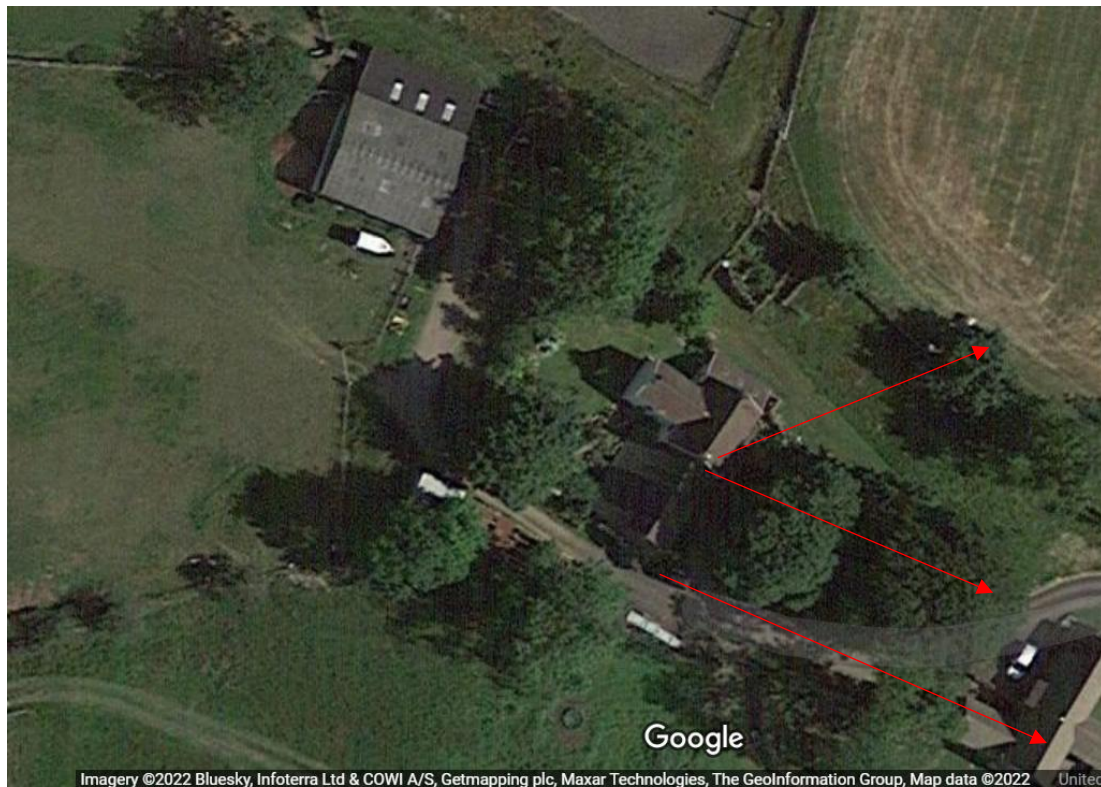
Figure 6: Identified flight paths

#### 4.6.3 Identified flight paths (arrowed red)

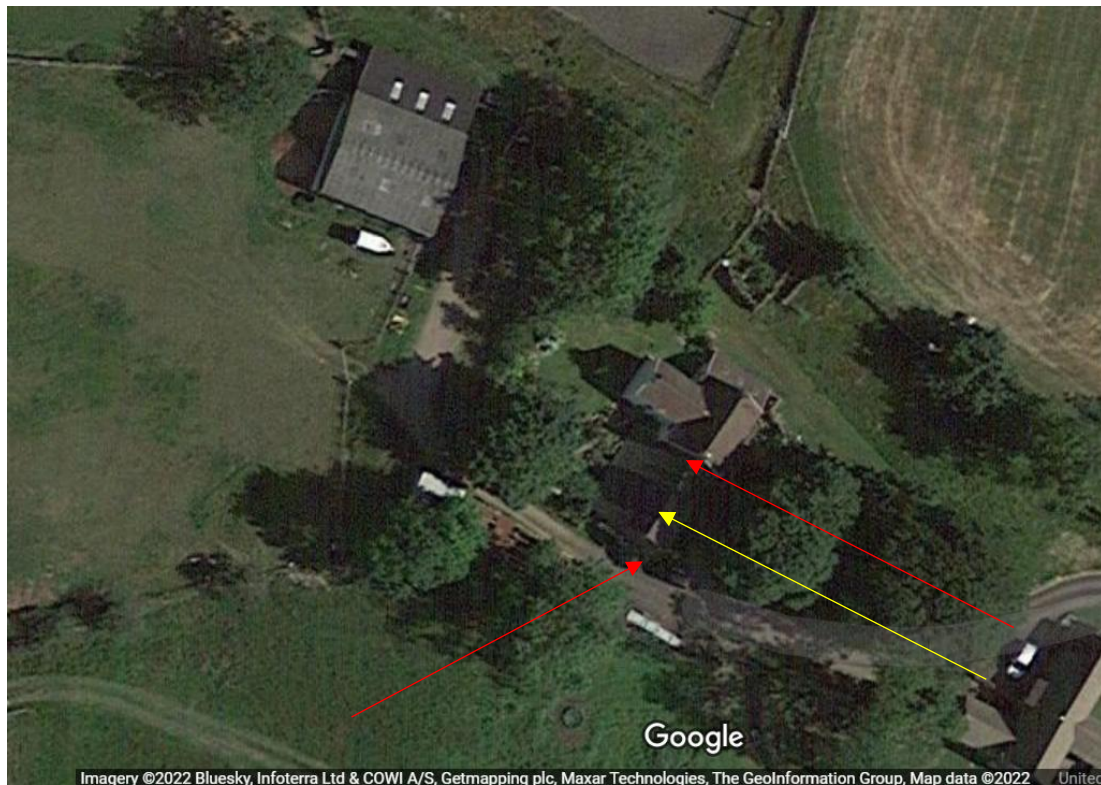
Figure 7: location of roosts common pipistrelle arrowed red; brown long eared arrowed yellow (location in barn only; bat never seen emerging only roosting on underside of roof)

The farmhouse was identified as a roost for up to two common pipistrelle bats. The barn was identified as a roost for two common pipistrelle bats and a single brown long-eared bat.

The farm house was identified as a maternity roost for up to 35 common pipistrelle bats and the barn was identified as a roost for up to four common pipistrelle bats.

The barn was identified as a roost for two common pipistrelle bats.

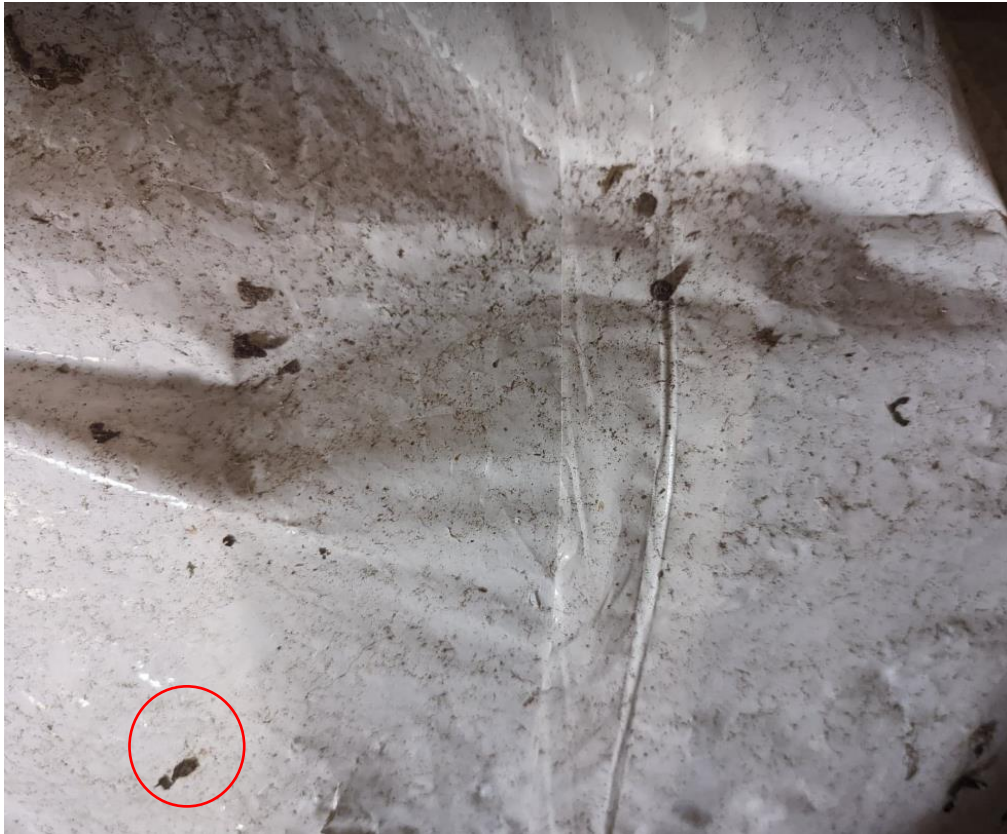
A scattering of droppings commensurate with a pipistrelle species was found throughout the barn (individual droppings on storage items). A single aggregation of droppings possibly commensurate with a brown long-eared species was found in the south western end of the barn below the ridge beam.

**Plate 11- photograph of individual dropping (bottom left corner circled red)**

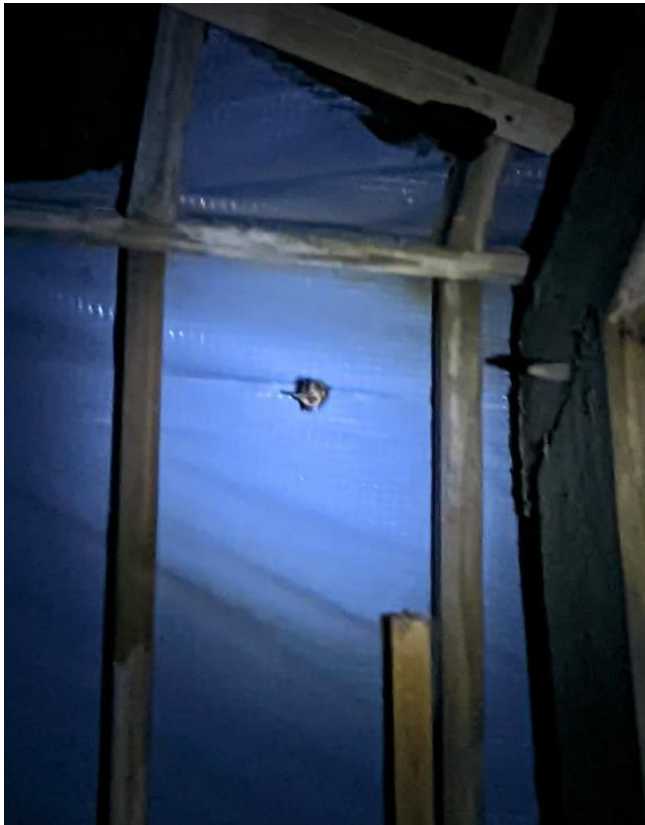
On arrival the barn was inspected for the presence of bats, along with a check of the static detector that had been deployed on the 25<sup>th</sup> May 2022. A single brown long-eared bat was noted hanging from the plastic membrane above the small aggregation of droppings to the south western end of the barn.

**Plate 12- photograph of brown long-eared bat found in barn**
