**12 GLYNCOED TERRACE, TRAMROADSIDE SOUTH,  
TWYNYRODYN**

**INITIAL BAT INSPECTION SURVEY (INCLUDING BIRDS)**

**MARCH 2025**

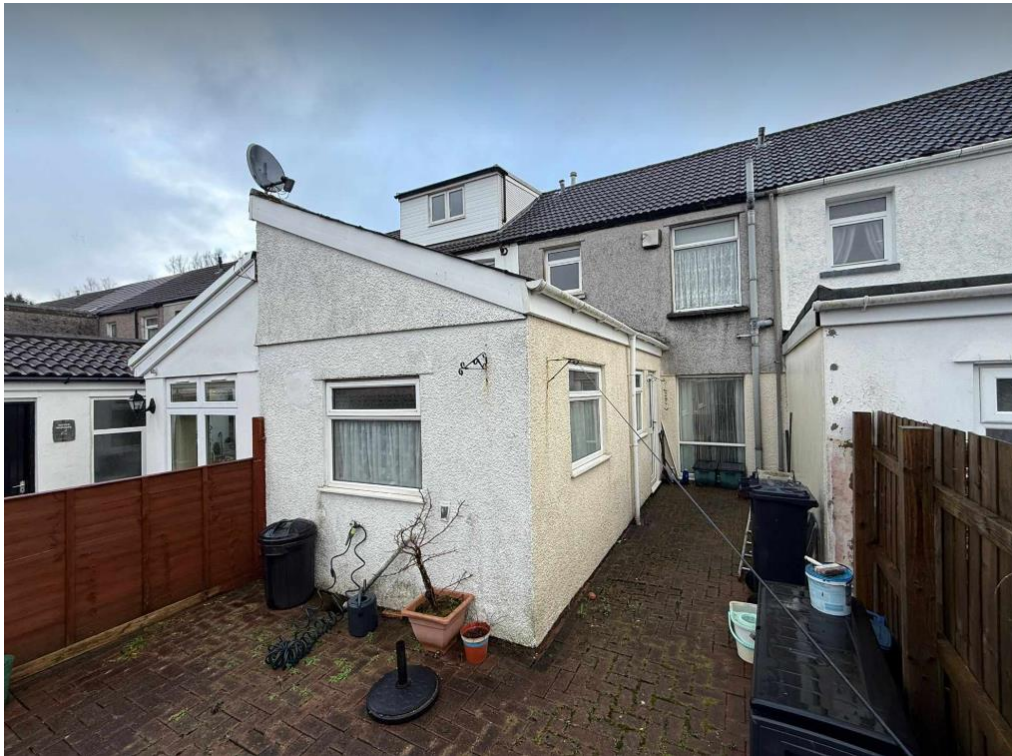
**Plate 1- photograph of extension**

There is a small single storey extension to the rear of the property that comprises of rendered brick beneath a mono-pitched slate roof.

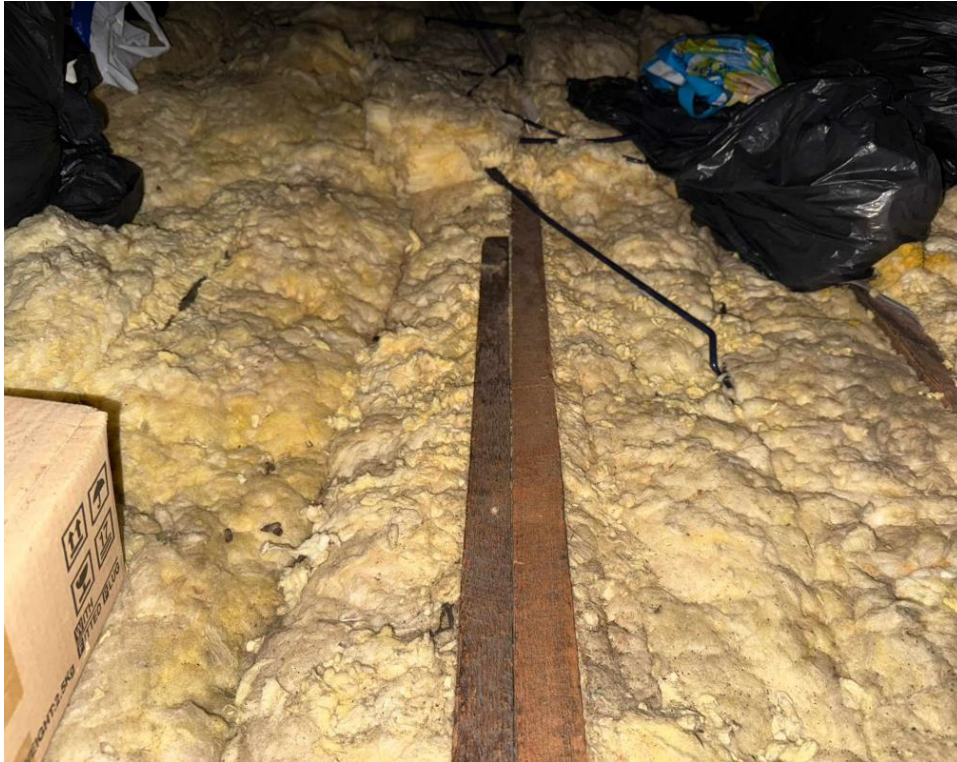
Internally, the roof space is of a typical rafter and perlin construction. The roof is lined with bitumen felt and insulated at joist level with fiberglass insulation. The roof is currently used for storage. No obvious light ingress' were noted from the interior, however, a number of rat droppings were identified within the loft space.

**Plate 2- rat droppings in loft**

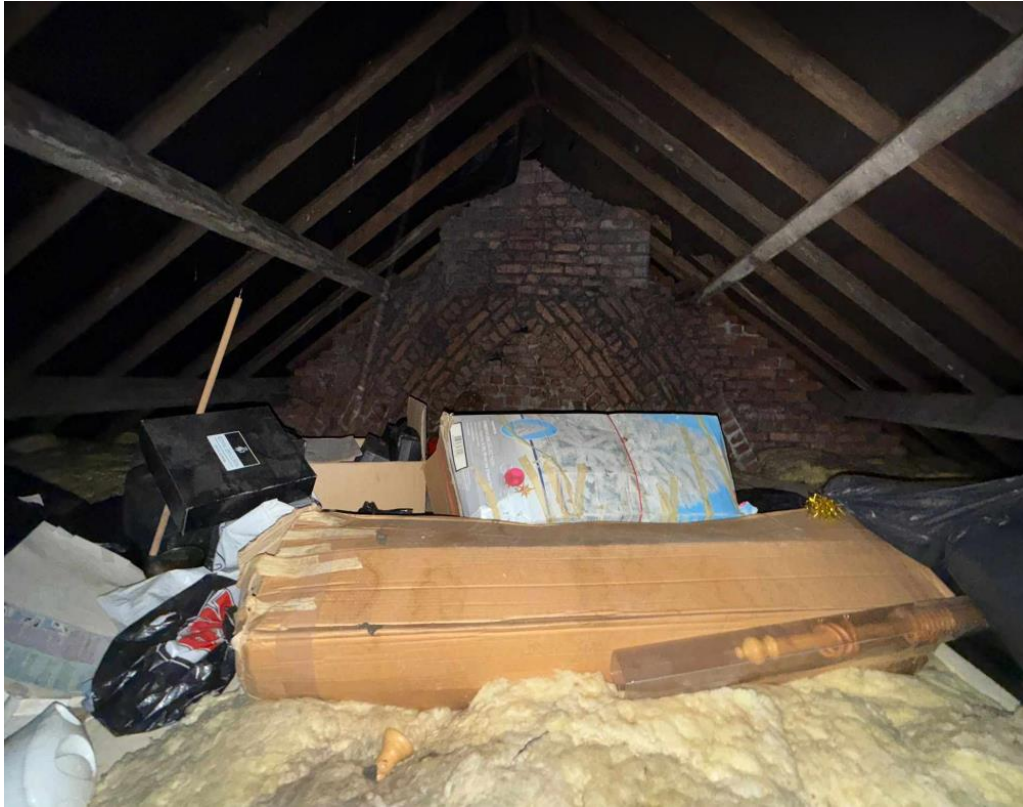
No bats or evidence of bats were noted. Please see appended plates for photographs of the roof space interior.

**Plate 3- photograph of roof void**

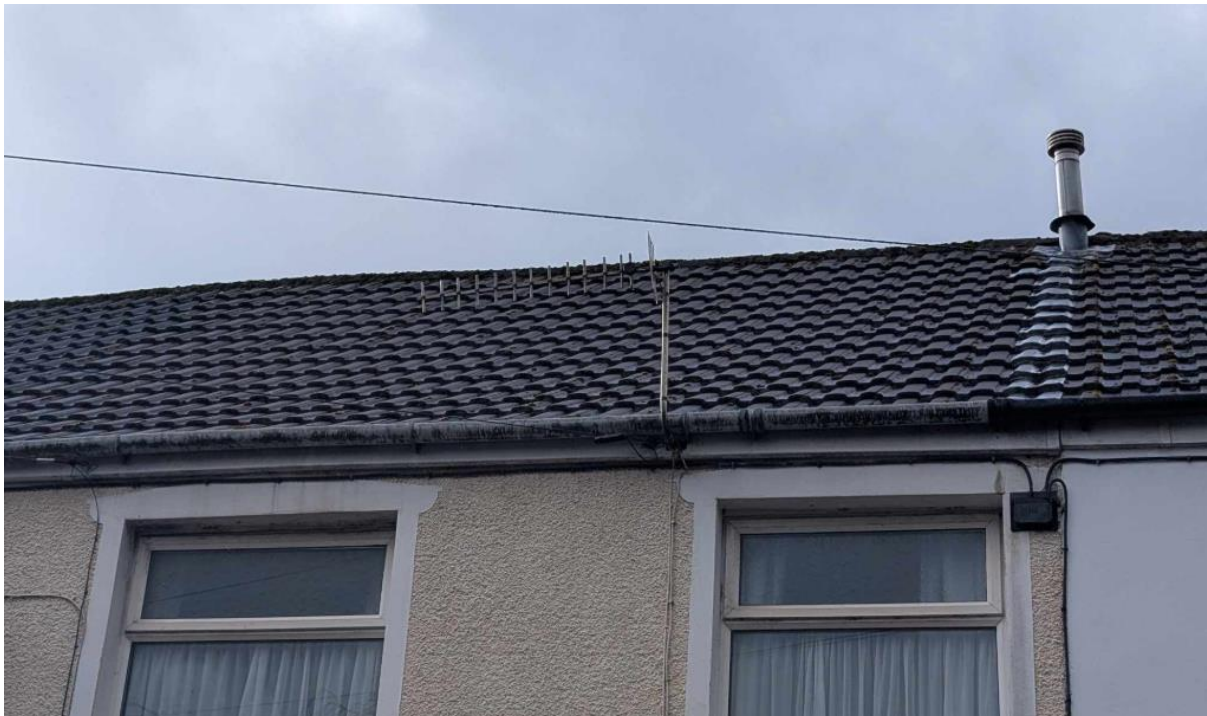
The building is a brick and block built rendered terraced property beneath a clay tile roof. The ridge of the property generally runs from north east to south west.

**Plate 4- Photograph of front elevation**

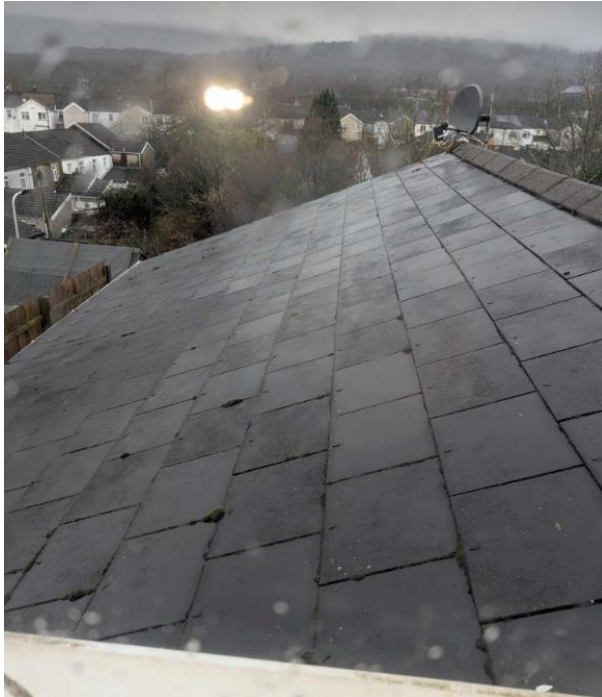
Generally the tiles of the house and the slates of the extension appear to be generally tight fitting.

**Plate 5- photograph of extension roof**

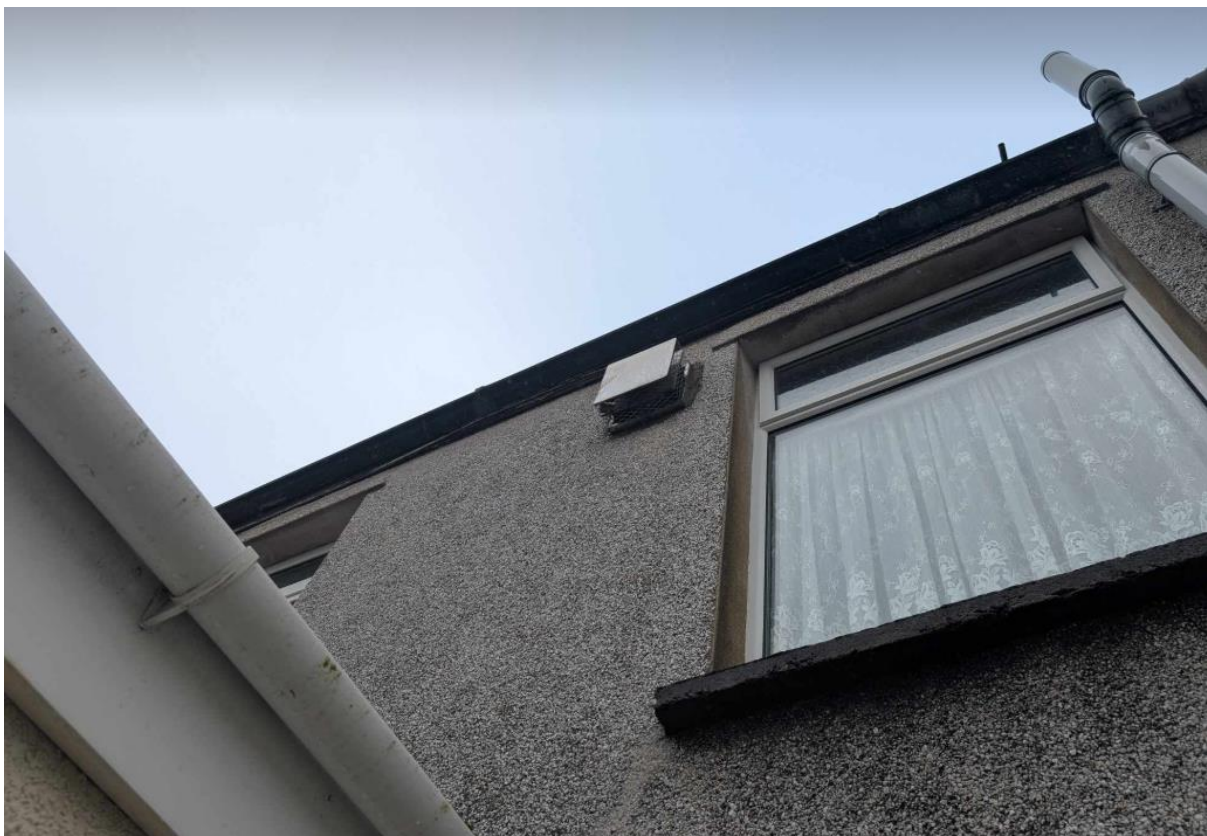
- Small gaps beneath fascias

It is considered that given the small number of access points present, it is necessary to class the building as being at least of low potential for roosting bats.

**Plate 6- Photograph of gap beneath rear fascia board**

As the works have the potential to disturb roosting bats should they be present, at least one activity survey will be required to be undertaken between May and August.

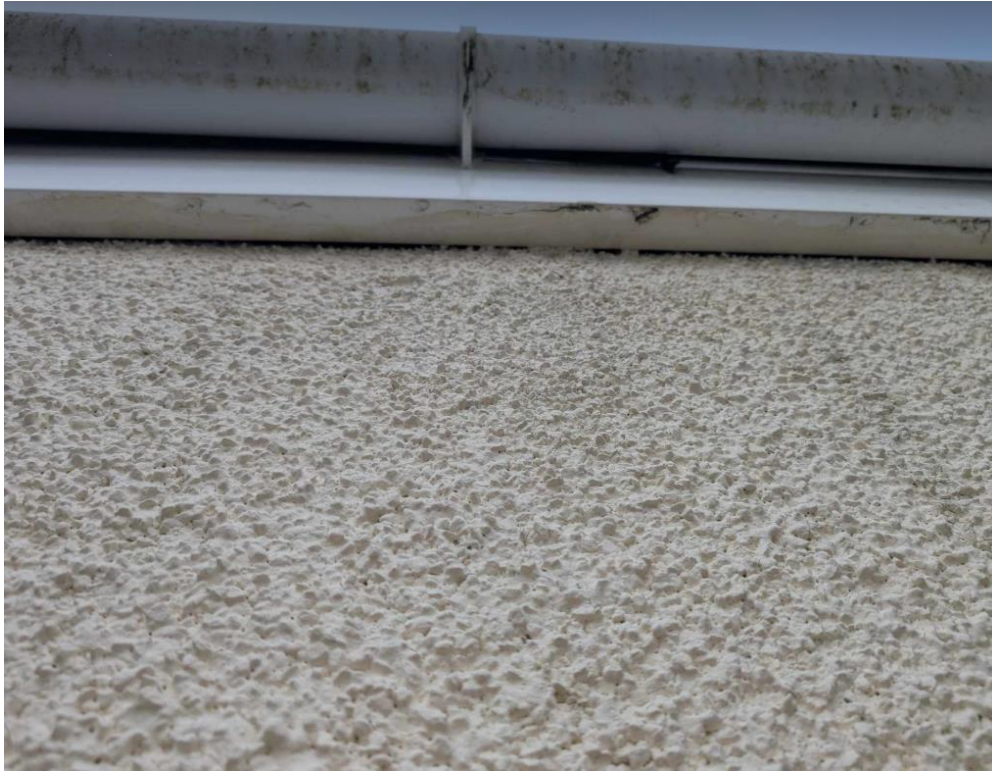
**Plate 7- photograph of gap beneath fascia board of extension**

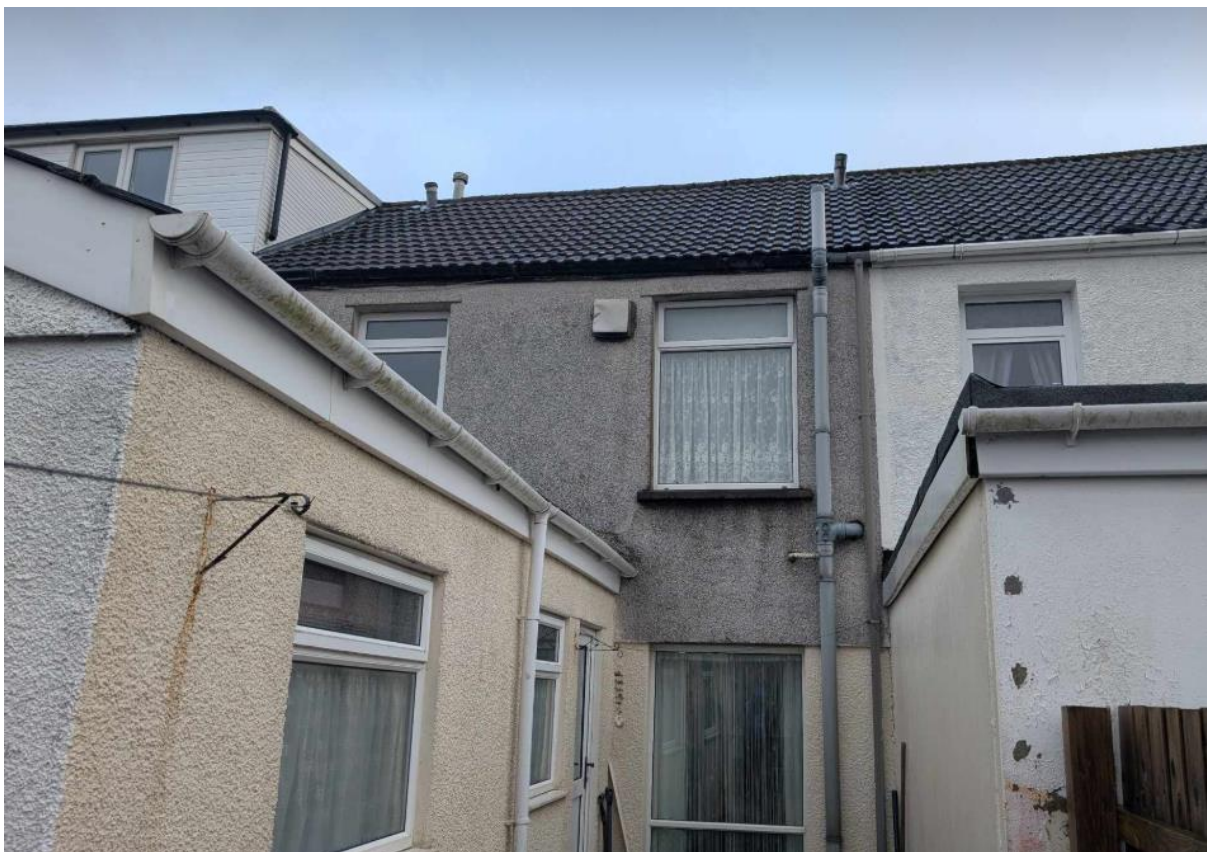
**Plate 8- photograph of rear roof**
