JOB  
TITLE *Brynhyfryd Chapel  
Thomas Street  
Treharris*

DRAWING  
TITLE *Proposed Elevations*

DRAWING No. *SD481 06B*  
SCALE *1/100*  
DATE *Nov 23*

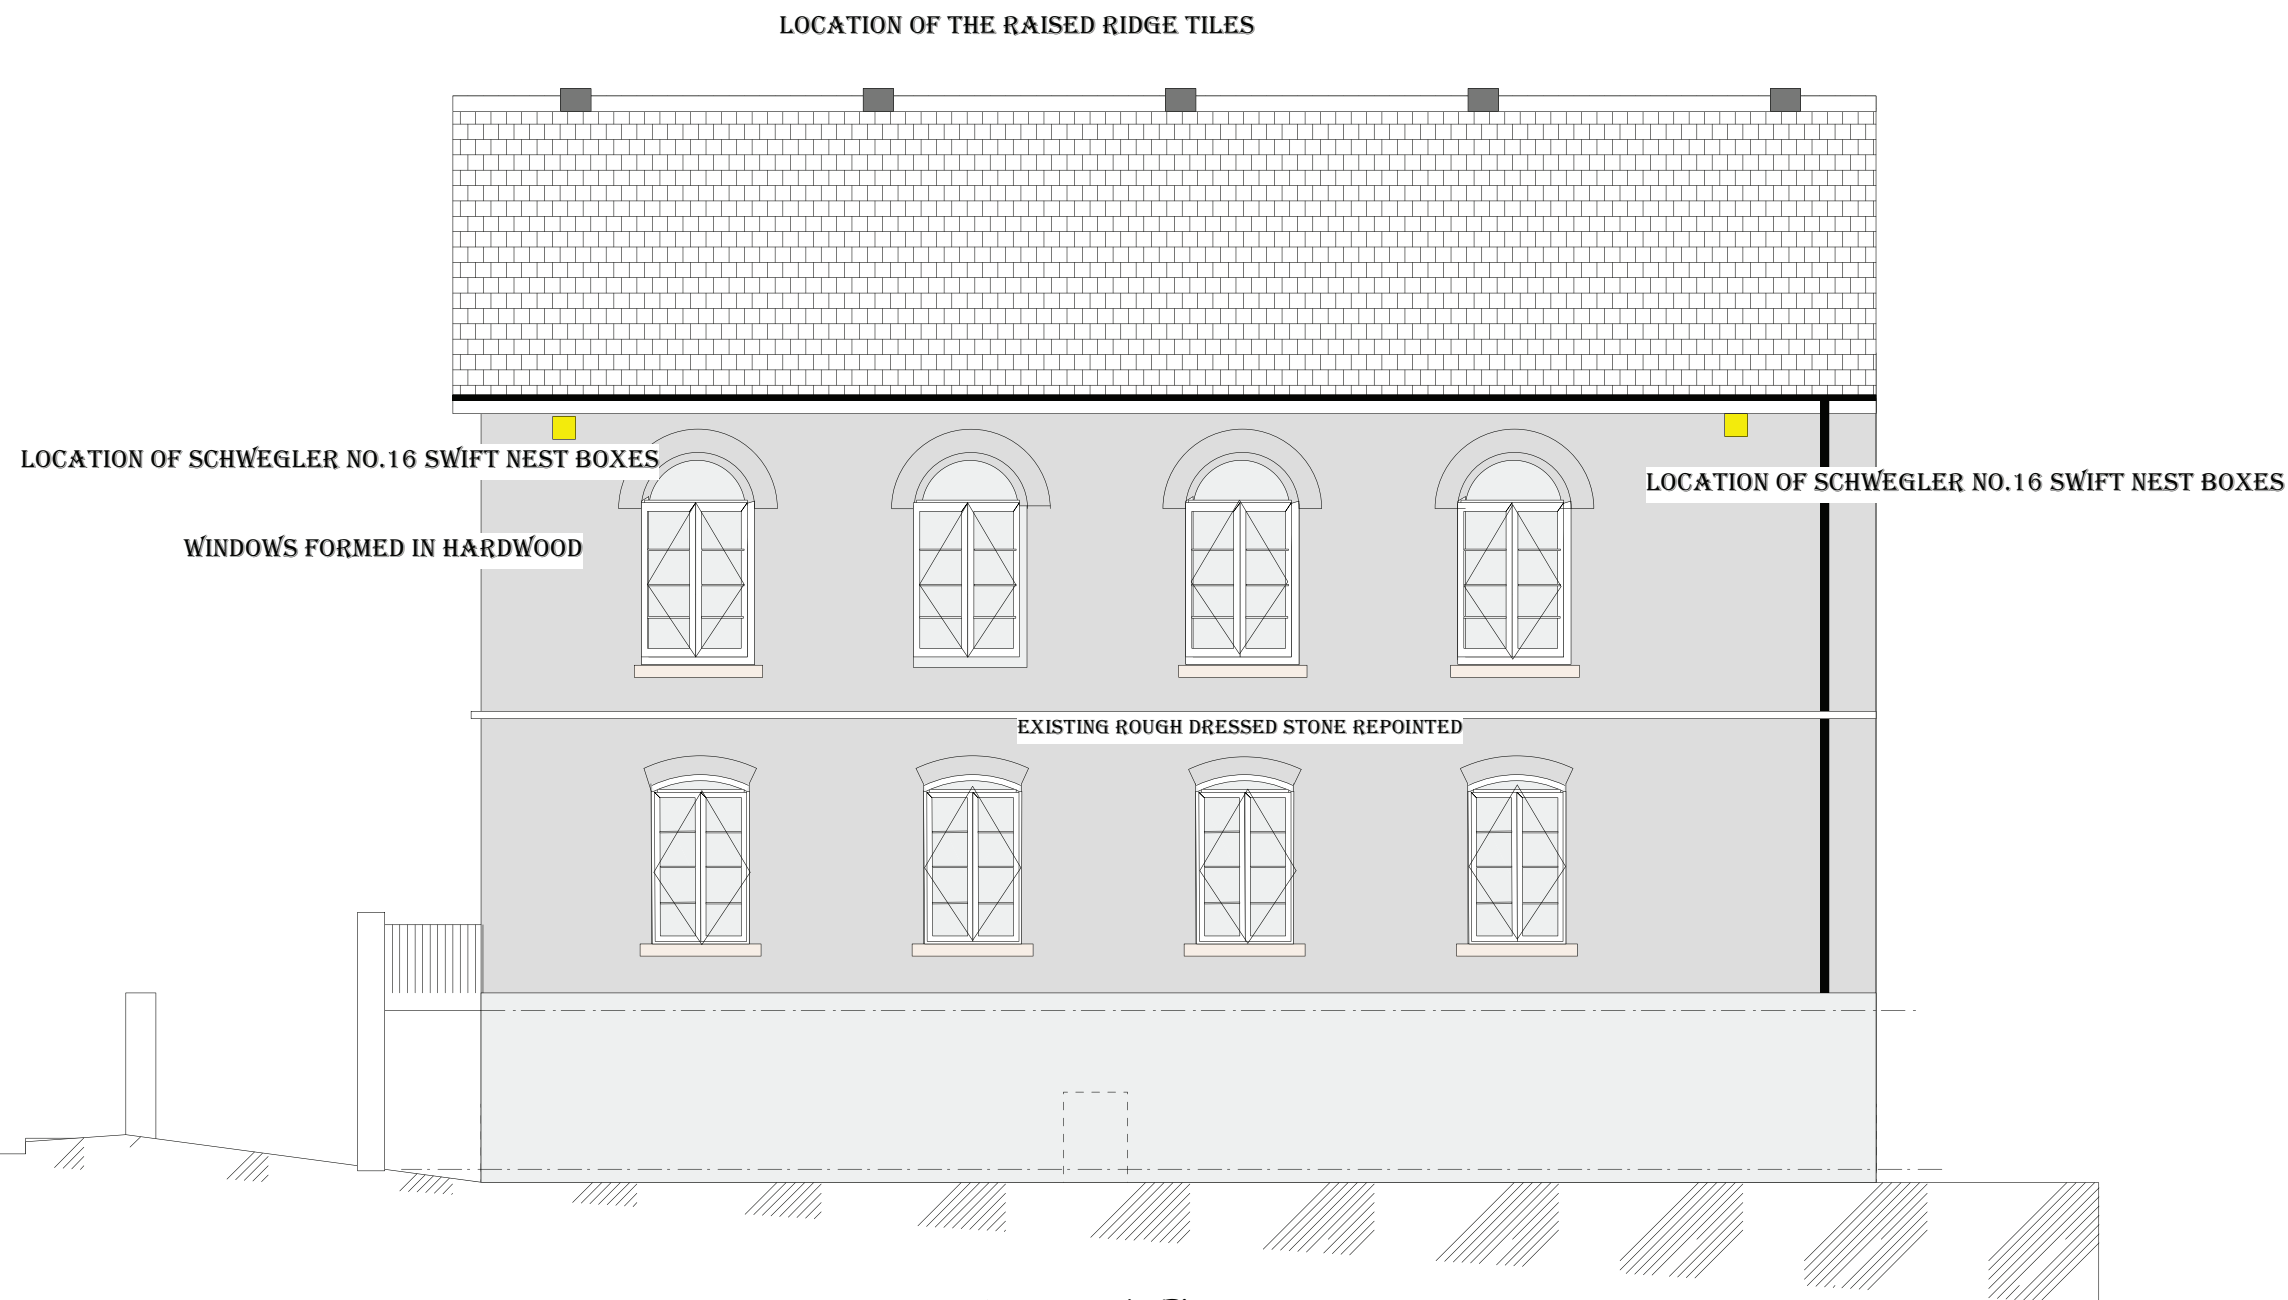
Lower Side Elevation

WORKS TO EXTERNAL ENVELOPE  
REPAIRS TO SLATE ROOF COVERING,  
REPOINT EXTERNAL WALLS.  
RENDER REAR WALL AFTER REMOVAL OF ANNEX, PAINTED TO MATCH SANDSTONE

LOCATION OF THE RAISED RIDGE TILES

Velux MC06 78 x 118cm  
Conservation roof windows
