**Bat Scoping Survey:** Wesley Methodist Church, South Street, Dowlais,  
Merthyr Tydfil, CF48 3DS

**Instructed by:** Karl Lewis of LeTrucco Design Limited

**Reported by:** Ecological Services Ltd  
10 Mount Pleasant, Llanelly Hill, Abergavenny, Monmouthshire, NP7 0NT

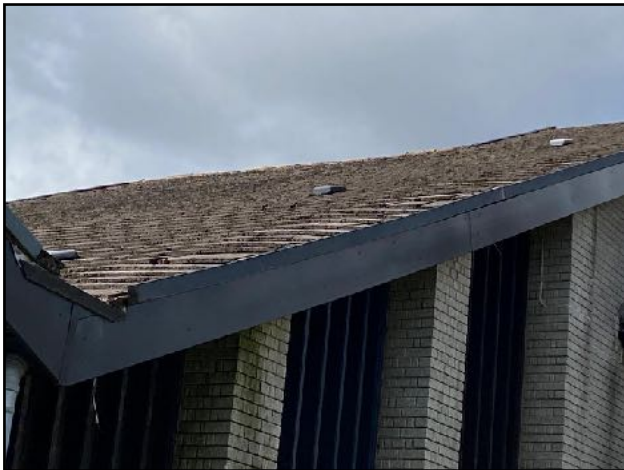
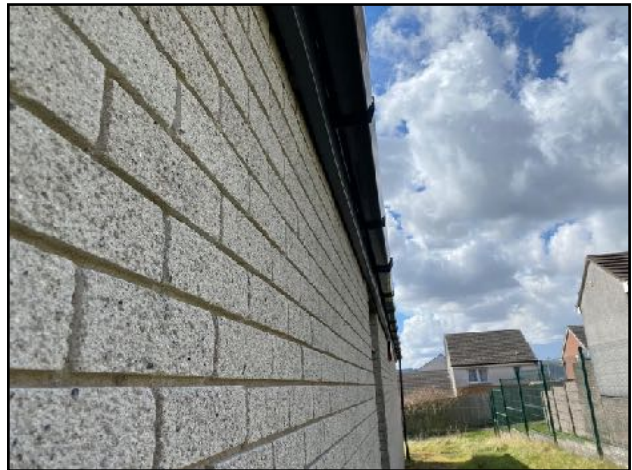
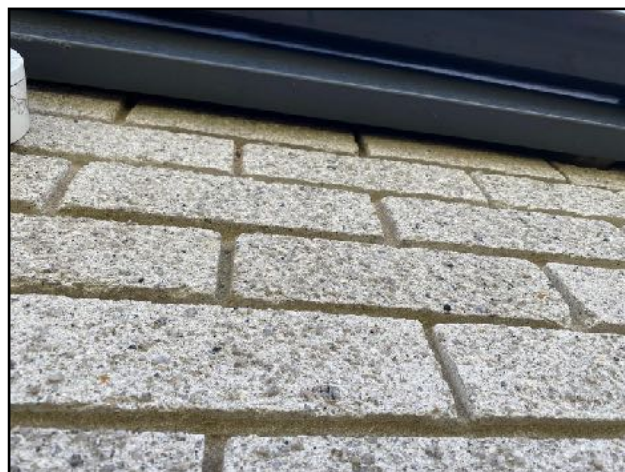
**6.3** Due to the condition of the building, there were several opportunities for bats to access and use the building and those that were available were deemed as having low-moderate potential. There were areas of slipped tiles and raised ridge tiles; apertures around the roof line and the roof dormer and an aperture along the entire length of fascia on the northern elevation of the building.

**6.4** Examples of apertures allowing access to cavities in the building:

**8.2 There is roosting potential for bats in the building and the building was deemed to offer low-moderate potential for bat use. At least two bat activity surveys are recommended to establish the presence of bats within the building.** A minimum of **five** experienced bat surveyors will be used to adequately cover the building during the emergence surveys. The surveys will conform to the “*Bat Surveys for Professional Ecologists, Good Practice Guidelines 2016*” and will be undertaken in the core maternity season for bats of May to August inclusive. The surveys will be undertaken in weather conditions conducive for bat activity. Suitable bat monitoring equipment will be used to acoustically analyse any bat calls which are present to allow for accurate species identification. **Once the further surveys are completed, detailed mitigation and enhancement measures can be designed into the development.**
