Merthyr Tydfil County Borough  
Council  
Rhydycar Bridge, Merthyr Tydfil  
**Ecological Addendum Report**

Document Ref: EAR-MTCBC-2201

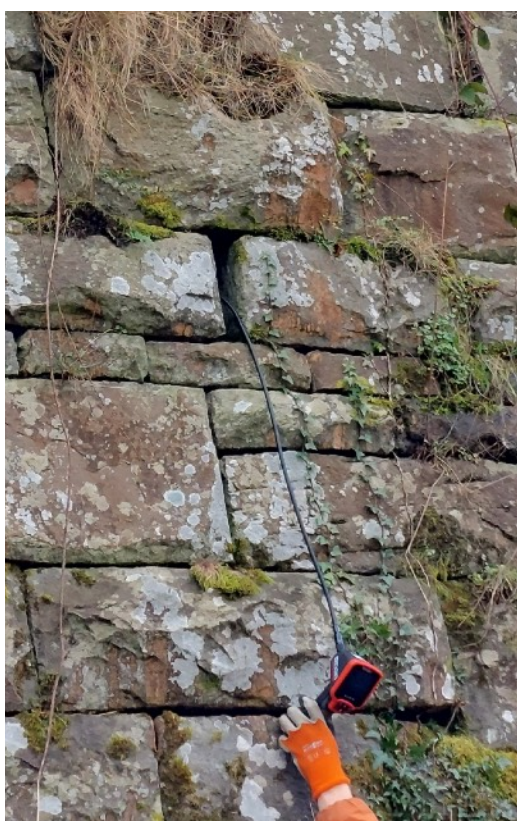
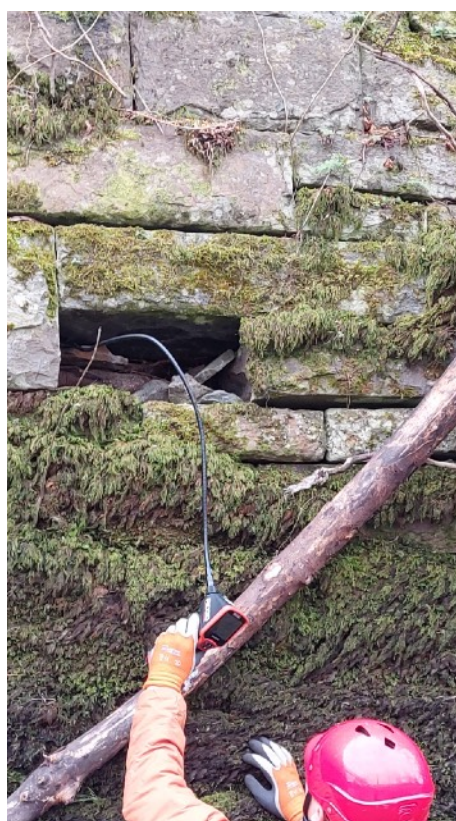
Plate 1. Example of endoscoping smaller feature suitable for a small number of bats (left) and larger, deeper feature suitable for multiple bats (right)

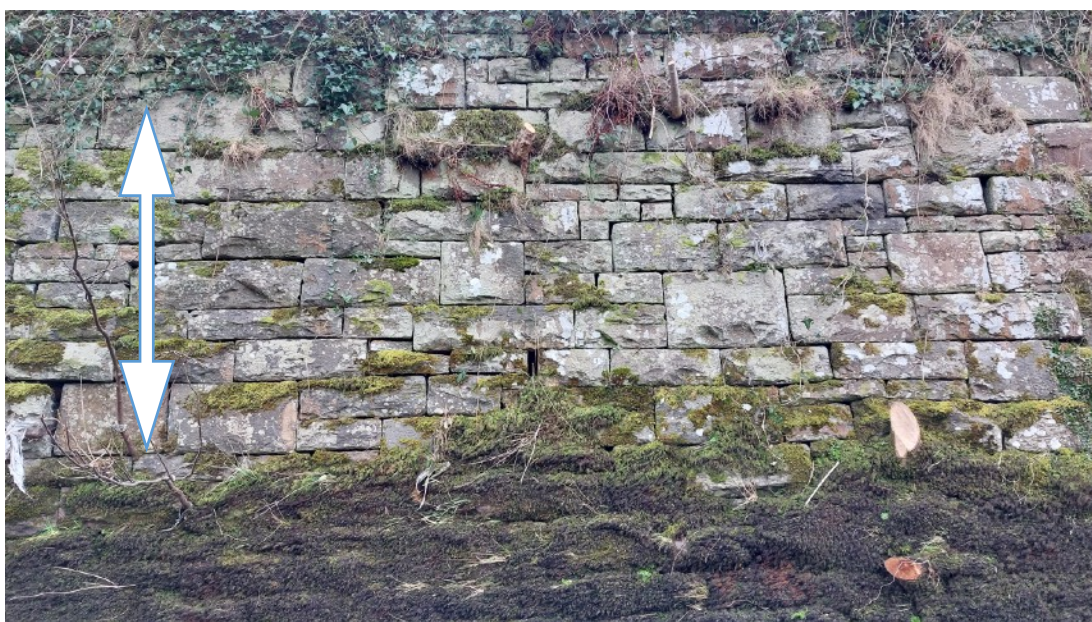
Plate 2. Retaining wall structure showing habitable band of crevices

- ix. During the physical inspection it was noted that crevice suitability for bats was limited to a band approximately 1.5m wide in the middle of the wall (see Plate 2.). Areas below the band were vegetated with mosses and bryophytes and seemed to delineate the high-water mark during high water and flood events. Crevices in this area were overgrown and wet and did not provide suitable roosting habitat for bats. Areas above the band depicted in Plate 2, were also unsuitable to bats with crevices filled with detritus, soil and exhibited damp seepage from the ground above the wall. It is likely rainwater percolates amongst the masonry in the top half of the wall.

- x. All suitable crevices within the central band were inspected internally with the endoscope. No direct evidence of bats was identified (e.g. bats, droppings, staining etc.). Crevices generally extended 15 -20cm into the bank, however on occasion up to 100cm where a second cavity existed beyond the first row of stone blocks. Generally, features were considered suitable to support small numbers of bats on an irregular basis. The deeper crevices could potentially support multiple bats. The wall lies within a built up area with significant street lighting present, however the river does provide a sub-optimal commuting corridor for bats. Therefore, the structure as a whole was considered to be of moderate potential to support roosting bats (including for hibernation).

- i. The survey of the retaining wall found the wall had numerous features capable of providing shelter for individual bats as well as a small number of larger crevices suitable for multiple bats. While no direct evidence of use by bats were found, and only a narrow band of the retaining wall provides conditions suitable for roosting bats, the retaining wall was considered to be of moderate potential overall.
- ii. The works will not directly impact the retaining wall and no features will be lost or altered in the long-term, however there will be increased disturbance during construction (see Appendix II).

- iii. In terms of the planned proposals, works will involve the removal and replacement of existing bridge with a new footbridge. Given the potential of the gaps in the masonry to provide roosting opportunities for local bats, there is a chance of adverse impacts to bats as a result of disturbance without appropriate mitigation. In order to reduce the impacts of disturbance on any bats which may roost within the wall, works should take place between March and November to avoid the hibernation period.

- iv. It is recommended that one emergence/re-entry survey is undertaken during the appropriate time of year (May - August) in accordance with current guidelines (BCT, 2016). A second pre-commencement endoscope or emergence/re-entry survey should then be carried out within 7 days of the start date.

- v. Given the nature and location of the features, it is likely to be difficult to see bats emerge from the wall and hear their calls. Therefore, it is also recommended to conduct the first emergence/re-entry survey with aid of a thermal imaging camera to help confirm presence/ likely absence of roosting bats.
