**Bat Survey:** Rhydycar, Merthyr Tydfil, CF48 1DH

**Instructed by:** Welsh Government

**Reported by:** Ecological Services Ltd  
10 Mount Pleasant, Llanelly Hill, Abergavenny, Monmouth NP7 0NT

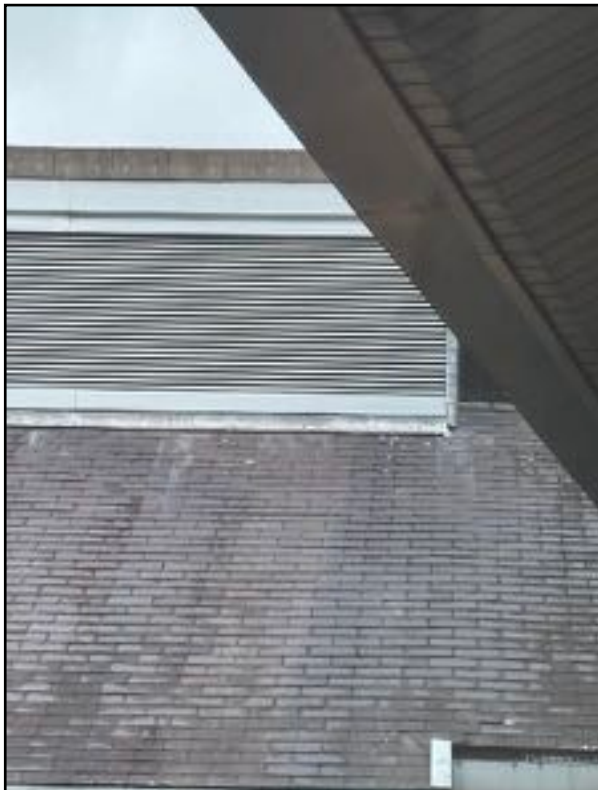
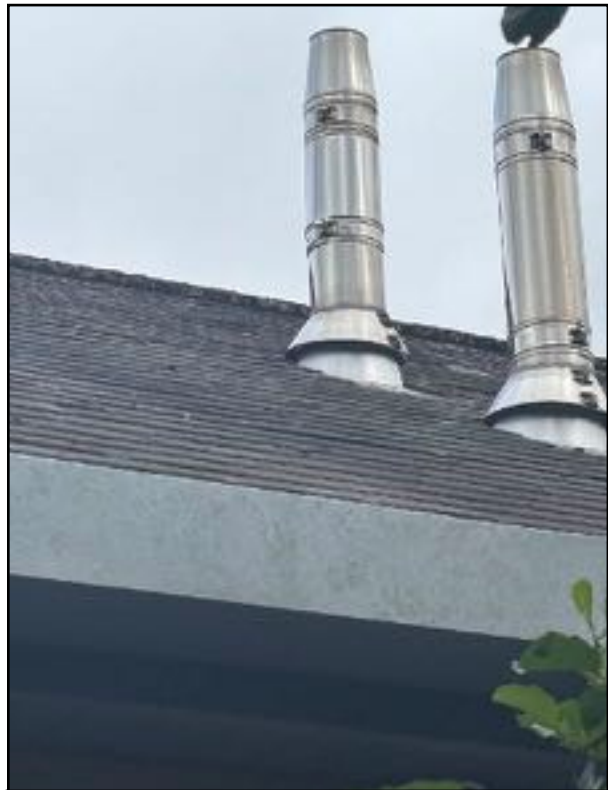
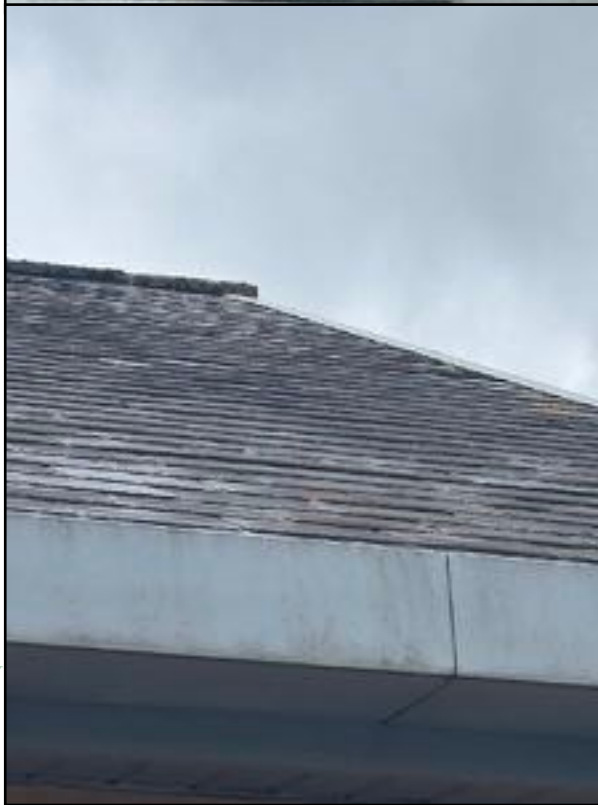
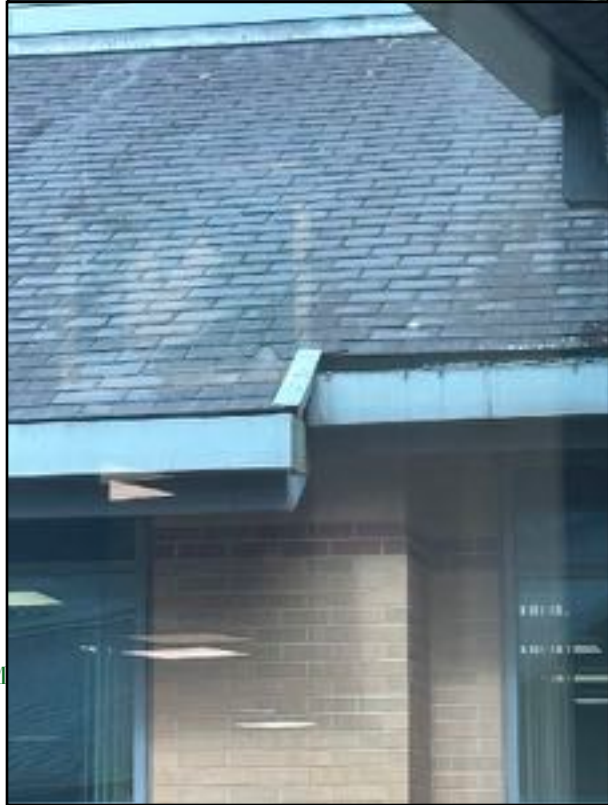
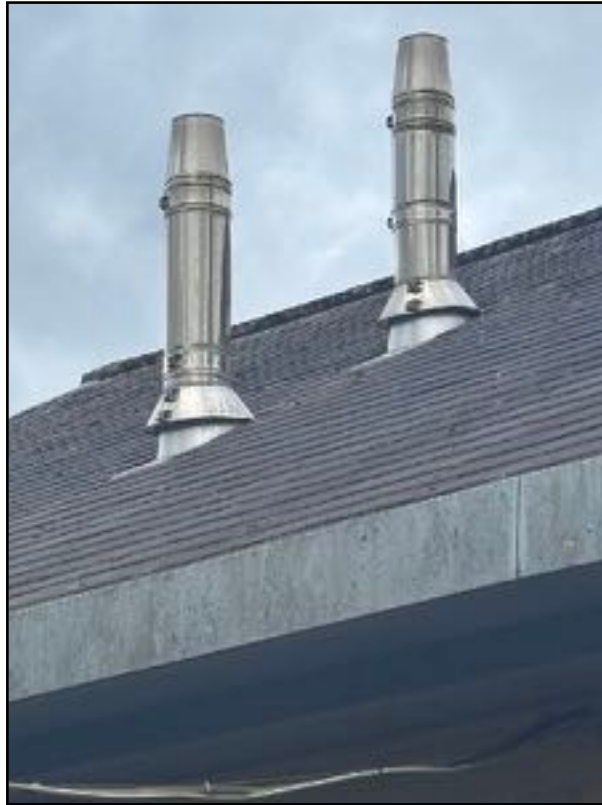
**6.3 Due to the age and condition of the buildings, there were a limited number of opportunities present for bats to access and use the buildings and those that were available were deemed as having low potential for roosting bats. There were a small number of slightly raised slates on the roofs of the buildings; areas of slightly raised lead flashing and slight apertures around the roof-lines.**

**6.6 Examples of apertures allowing access to cavities in the buildings:**

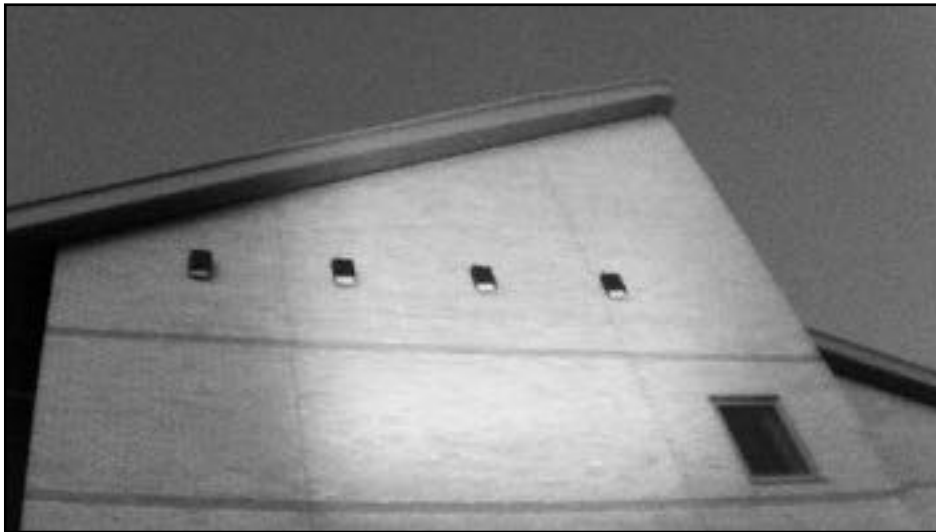
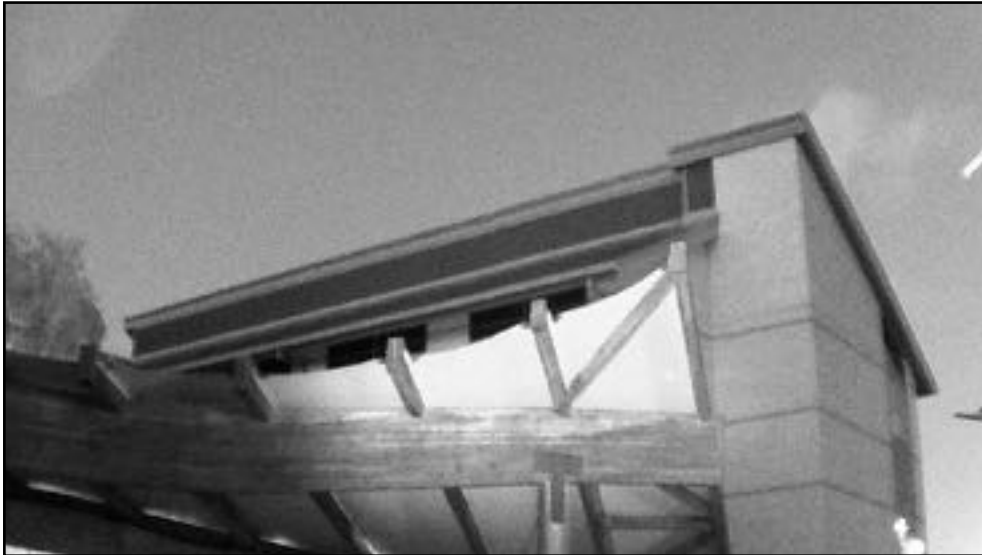
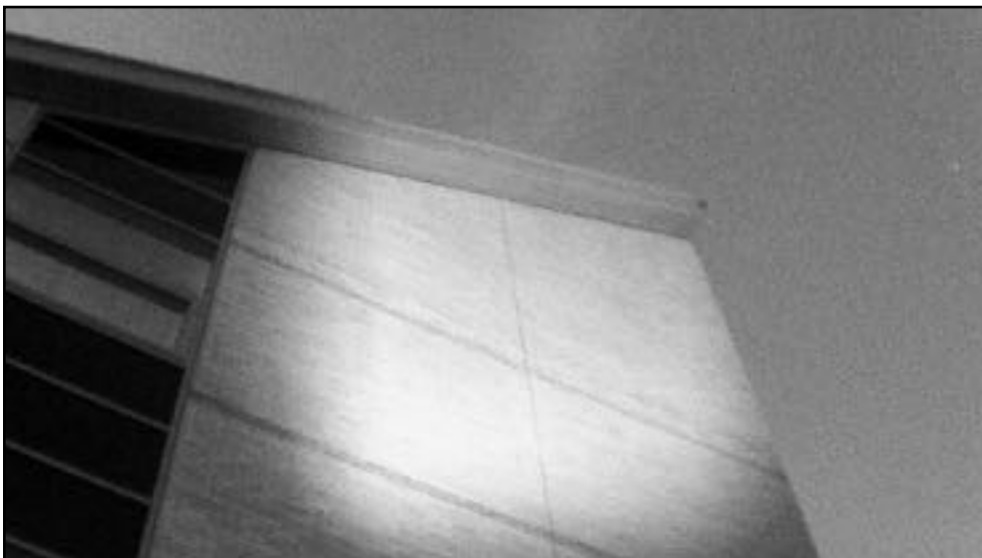
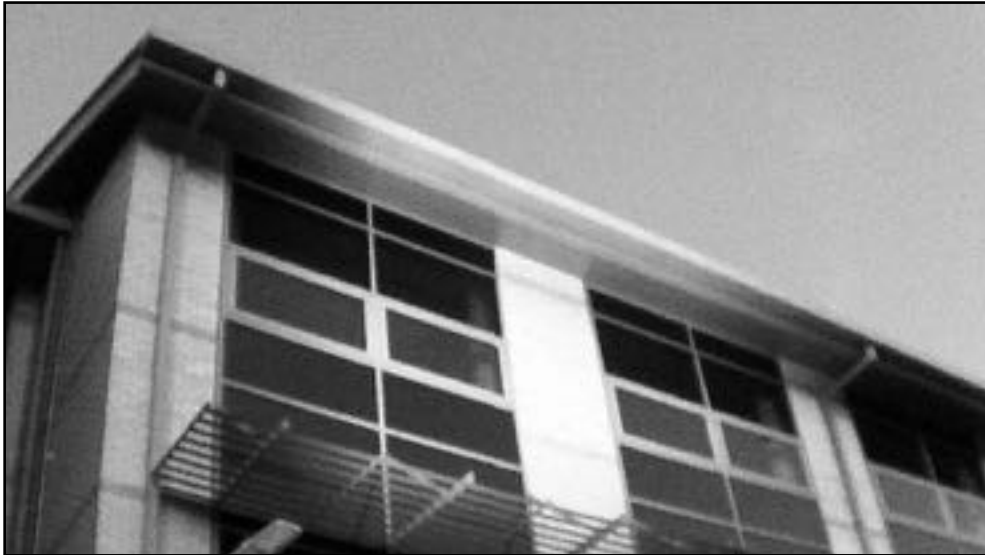
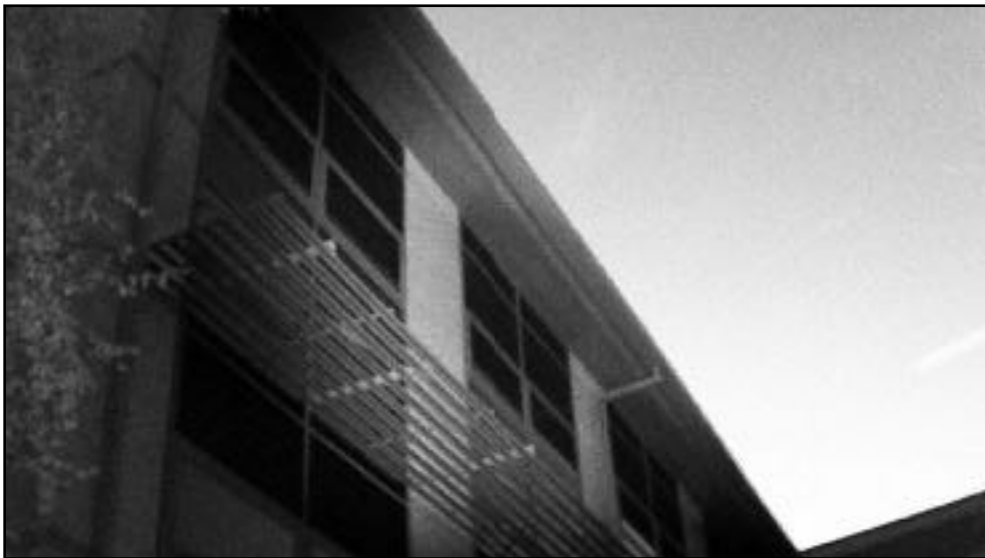
#### 8.11 Examples of NVA Still Shots:

**No bats were observed emerging from the building.**

**8.8** During the emergence survey, a very low number of bat calls were recorded. A small number of Common Pipistrelles were observed foraging to the rear of the building and a Noctule was detected but was not observed.
