**Bat Inspection & Emergence Survey Report**  
**Treharris Co-op**  
**Bowman Riley**  
**July 2023**  
**IES/2023/070/Version 2.0**

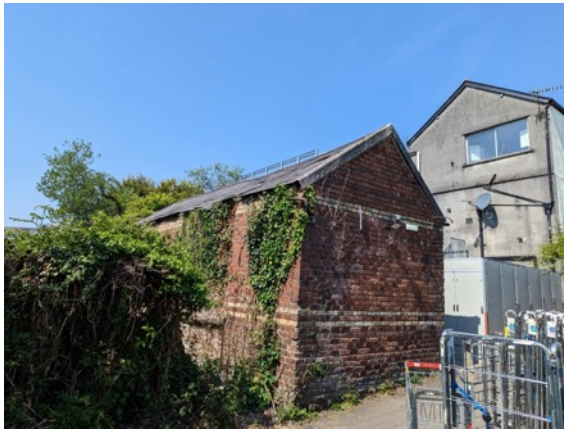
Plate 1: South-east elevation.

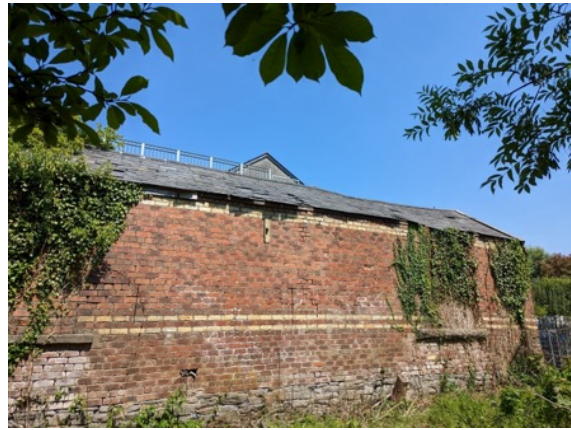
Plate 2: Southern elevation.

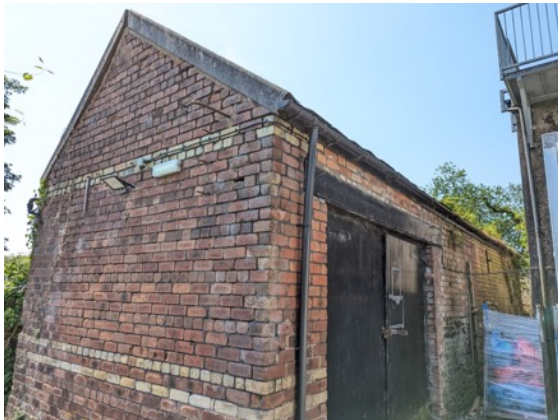
Plate 3: North-east elevation.

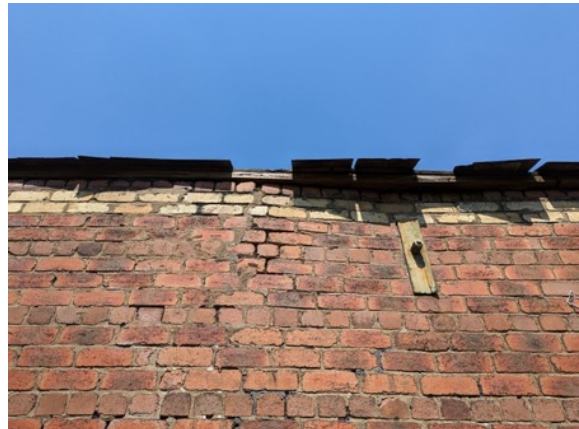
Plate 4: Tiles missing and cracks where mortar missing.

4.2.4 No evidence of bats using the building was found at the time of the inspection. The building is considered to be of moderate suitability to support roosting bats, in accordance with the BCT guidelines.<sup>2</sup> There are several access points which could provide roosting

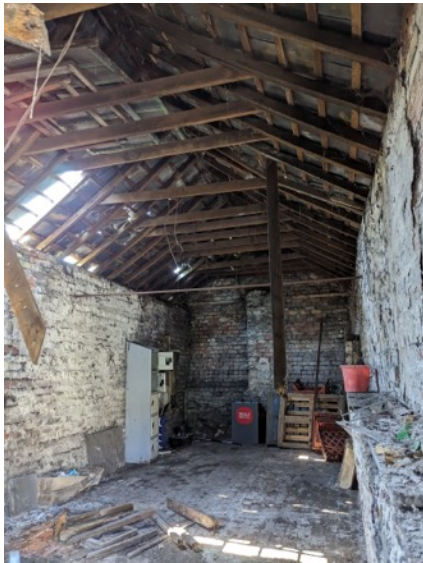
Plate 5: Building interior.

4.2.6 There is some limited hibernation potential within the building in crevices which could not be inspected fully for health and safety reasons.

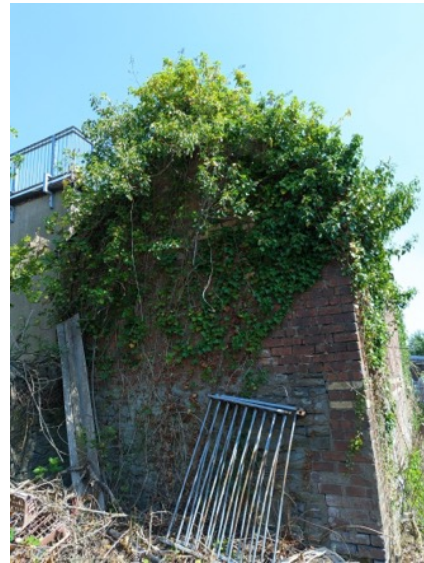
Plate 6: South-west elevation with ivy growing.

4.2.7 No evidence of nesting birds was noted at the time of the survey, and the building provides very limited opportunities for this group, mainly within the ivy on the building.

5.2.3 Any vegetation suitable to support nesting birds should be cleared outwith the breeding bird season (March-August inclusive). If this is not possible then a check for active nests should be carried out no more than 48 hours before the clearance takes place. This should be carried out by a suitably competent and experienced ecologist.

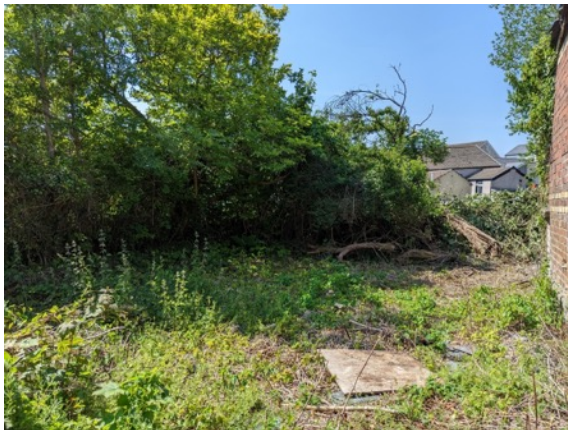
Plate 7: Shrub and ruderal regrowth around the building.

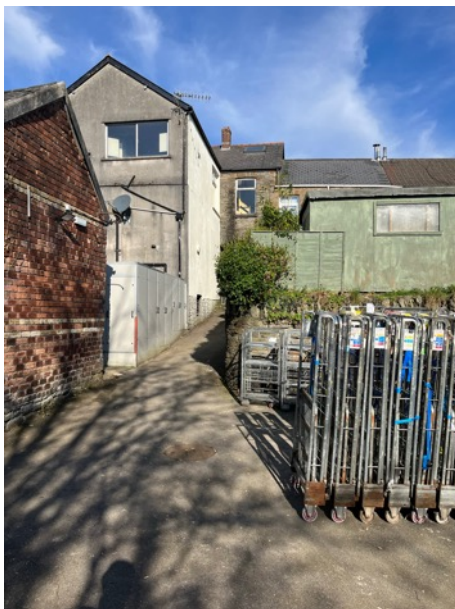
**5.3.2** It should be noted that the proposals are for the removal of the building with no replacement structure. This limits the availability of locations for compensation and enhancement opportunities to the rear elevation of the Co-Op building, since there are no other suitable trees or structures within the red line boundary. This is shown in Plate 8 below:

Plate 8: Bat and bird boxes can be affixed to the area of rendered wall below the eaves.

- The provision of an externally mounted hibernation bat box on the rear elevation of the Co-Op building. This should be woodstone or similar construction. Please note - a specific box has not been recommended due to supply chain issues (currently no Schwegler boxes are available in the UK and no lead time for supply is available).

- The provision of an externally mounted woodstone or similar summer bat box on the rear elevation of the Co-Op building. NHBS has a number of variations in stock, and as long as the box is not wooden, any of these variations will be suitable<sup>3</sup>.
- A single woodcrete or similar construction bird box should be provided on the rear elevation of the Co-Op building. This should be suitable for either sparrows and blue tits (eg: <https://www.nhbs.com/vivara-pro-seville-32mm-oval-woodstone-nest-box>) or robin (eg: <https://www.wildcare.co.uk/woodstone-barcelona-open-nest-11277.html>). Again, the exact type is not specified due to ongoing supply issues with nest boxes.

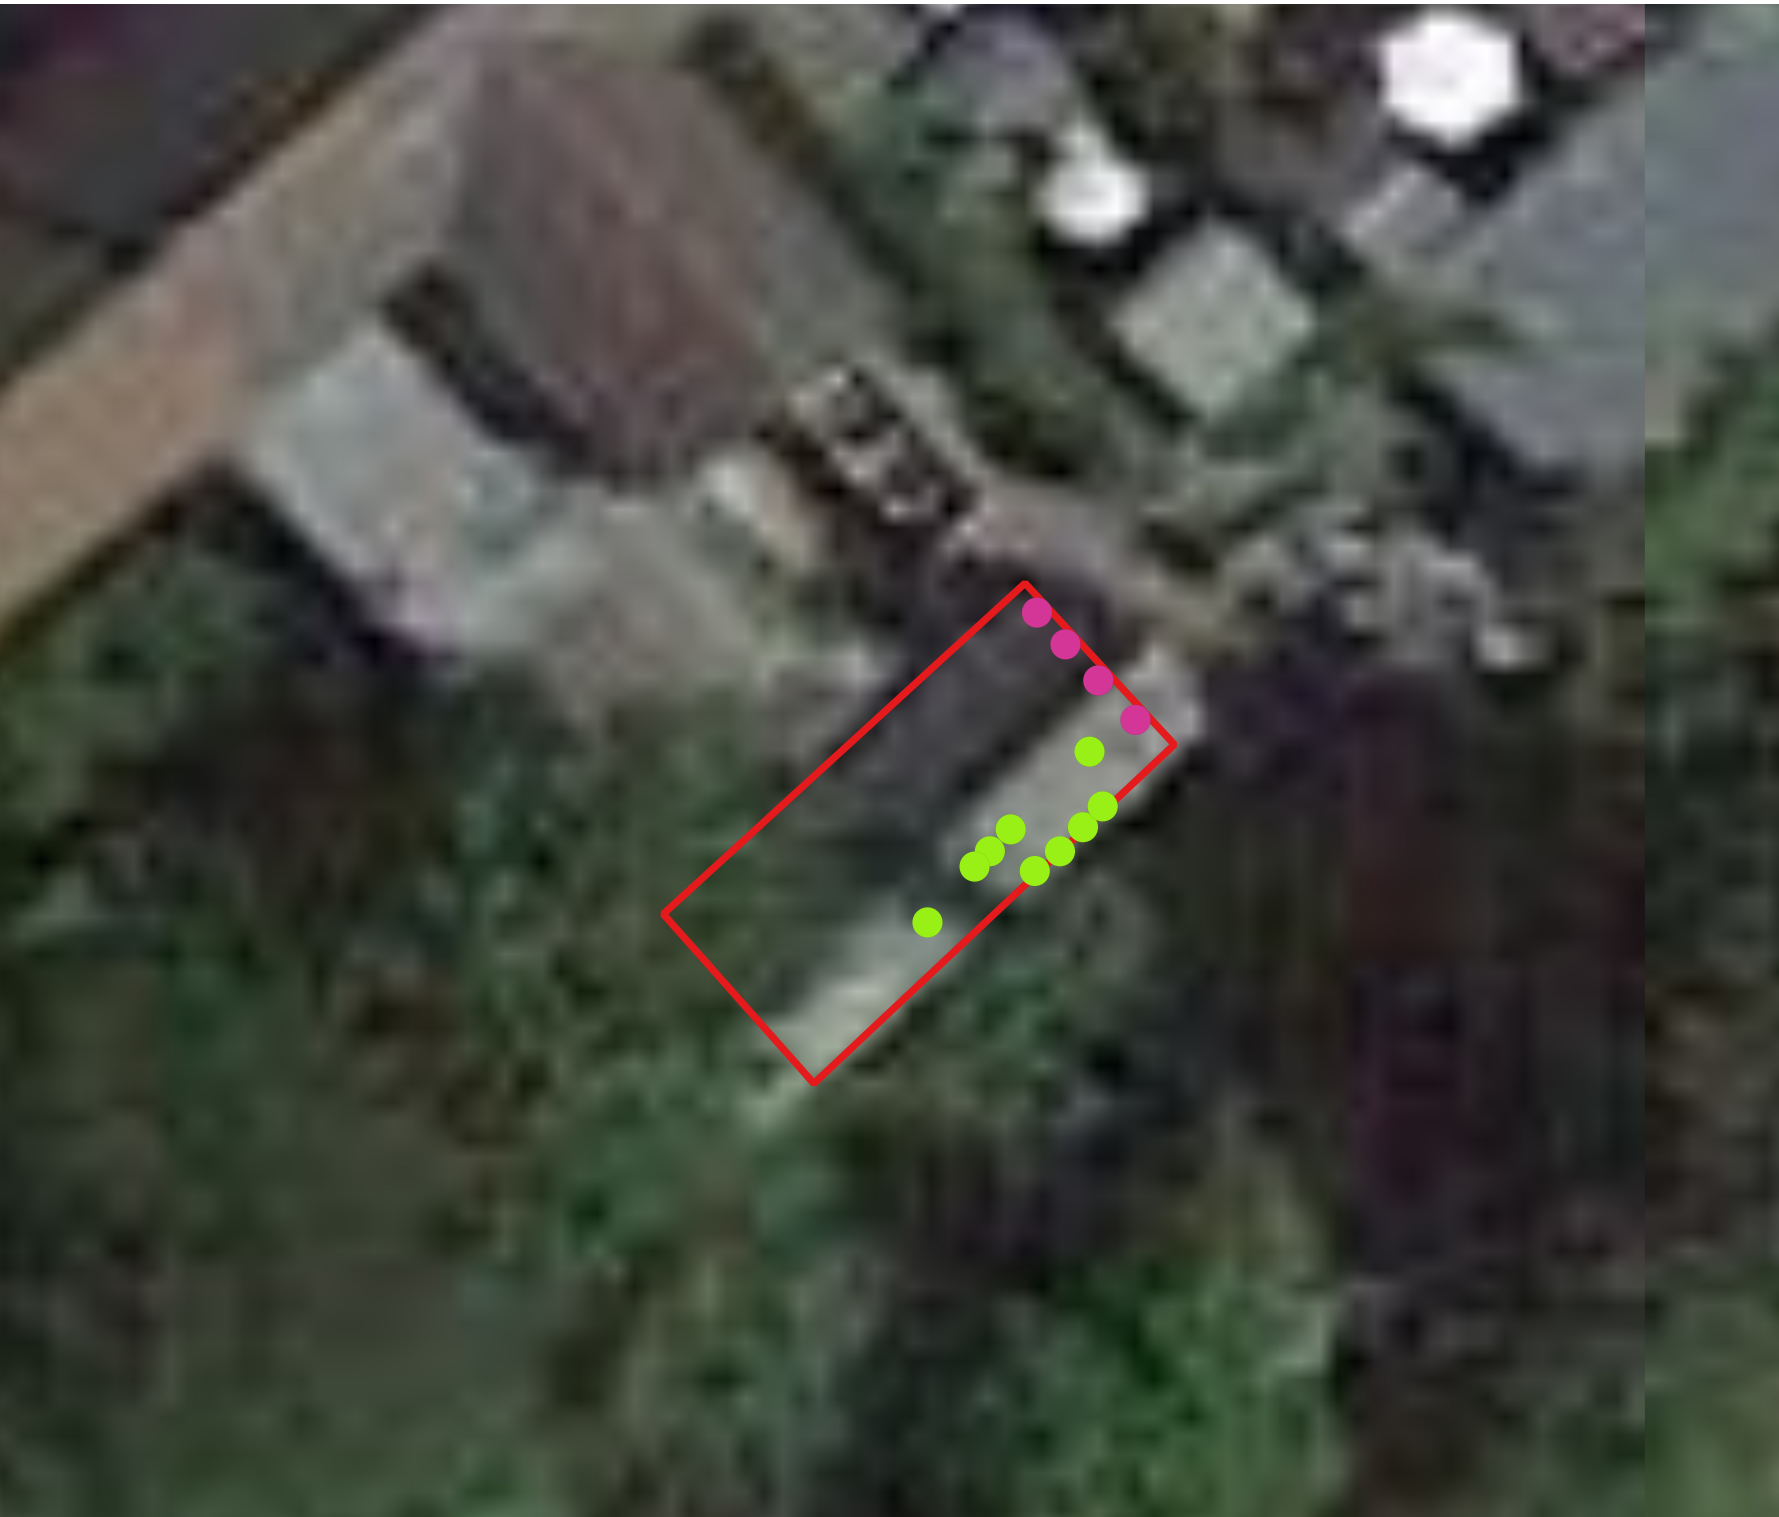
Figure 2: Internal and External Inspection

4.2.3 Potential access points are shown on **Figure 2**.

- Key
- Site Boundary
  - Access Points
  - Missing Tiles
  - Running Gap under Dry Verge
