**Ty Brynseion,  
Dowlais, Merthyr Tydfil**

## **Bat and Nesting Bird Survey Report**

**September 2026**

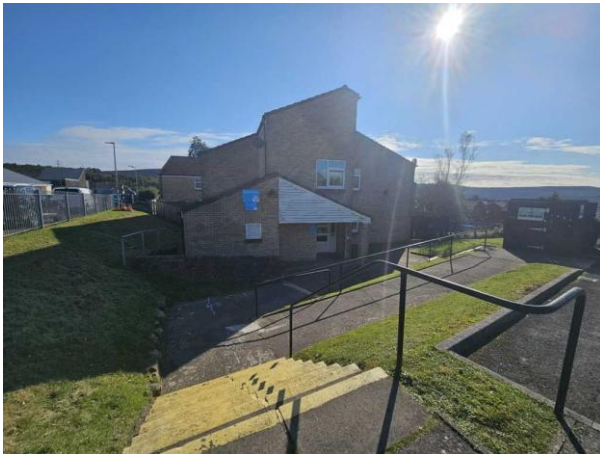
Photo 3: Northern elevation

| Windows and doors | The windows and doors have uPVC frames. All windows and doors appear well sealed with no visible gaps (Photos 3 and 10). |

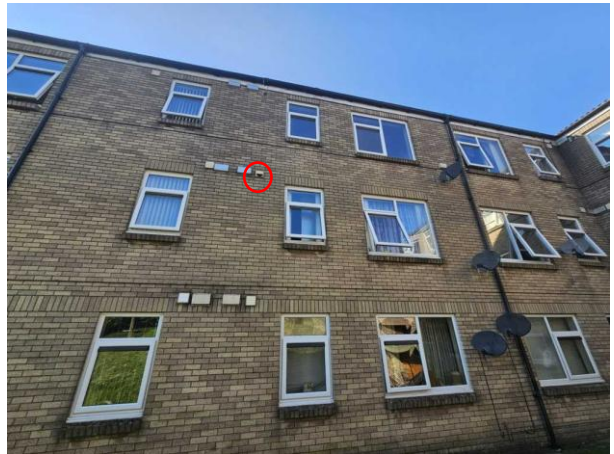
| Vents | There are multiple vents across all floors on the southern and eastern elevations. Vent stacks are also present on all roof sections. Many vents are damaged or missing (Photos 4 and 10). |

Photo 4: South-east elevation, example of broken vent and well-sealed windows

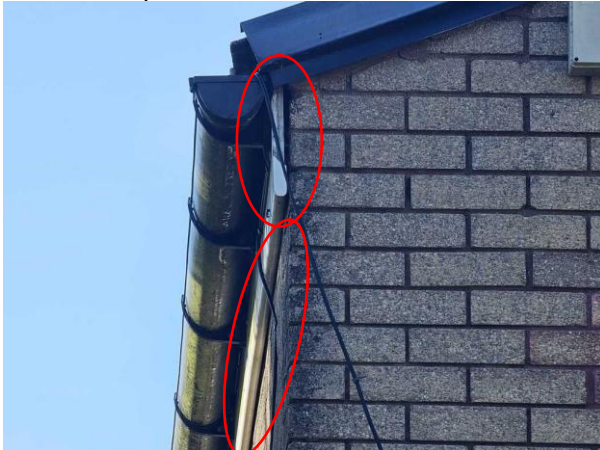
| Soffits, Fascias and Bargeboards | The barge boards and fascias across all elevations have visible gaps beneath or are missing entirely (Photo 5). |

Photo 5: Gaps behind fascia boards

To compensate for the loss of fascia access, eight soffit boxes will be installed across each elevation of the building (see Drawings 3 and 4). These will be positioned to provide suitable replacement access points for crevice dwelling bats and to maintain continuity of roosting opportunities.

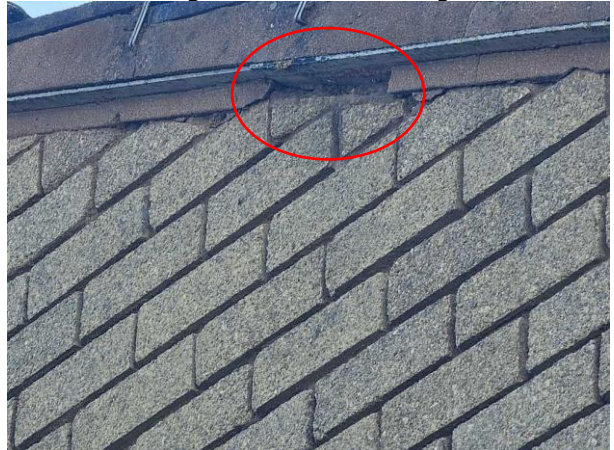
| Roof | The roof is multi-pitched, with interlocking curved tiles in good condition and few visible gaps overall. Plastic anti-wildlife spikes are installed along the edge of each tile run; however, some are bent or missing, creating gaps that may allow access between the roofing felt and tiles, potentially leading into the roof void (Photos 7 and 9). Notably, there are additional gaps at the apex on the southern elevation pitch, and a large section of missing mortar along the edge of the western elevation, compromising the tile seal in that area (Photos 6 and 8). |

Photo 6: Missing mortar on western gable

- **PRF 1:** Gaps created by missing mortar along the edge of the roof tiles and at the roof apexes, which may provide access beneath the tiles (Photos 6 and 8).
- **PRF 2:** Bent or missing anti-wildlife spikes along the roof tile runs, potentially allowing entry to the space between tiles and the 1F bitumen roof lining (Photo 7).
- **PRF 3:** Gaps beneath bargeboards and fascias, which could lead into crevice spaces suitable for bat roosting (Photo 5).
- **PRF 4:** Missing or damaged vents on the southern and eastern elevations, which may provide entry into the wall cavities or other enclosed spaces (Photo 10).

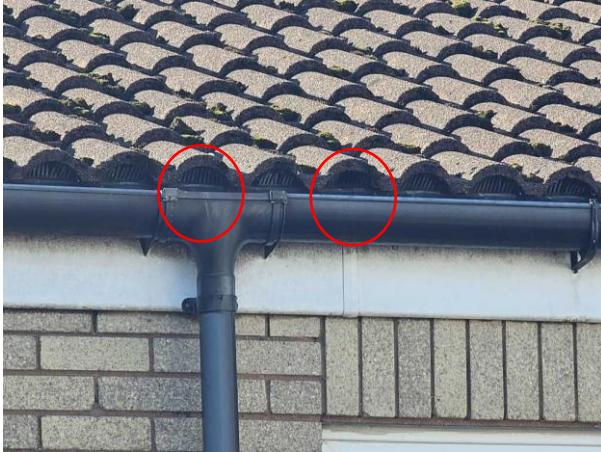
Photo 7: Interlocking tiles with missing wildlife spikes

- Gaps created by bent or missing plastic anti-wildlife spikes along the roof tile runs (Photos 7 and 9);
- Missing mortar along the edge of the western elevation roof tiles (Photo 6);
- Gaps beneath or around bargeboards and fascias on all elevations (Photo 5);
- Lifted lead flashing at the joint of the single-storey extension on the north-east elevation and around vent stacks (Photo 9);
- Damaged or missing vents across the southern and eastern elevations (Photos 4 and 10); and
- Gaps within the brickwork due to missing mortar on all elevations (Photos 6, 8 and 11).

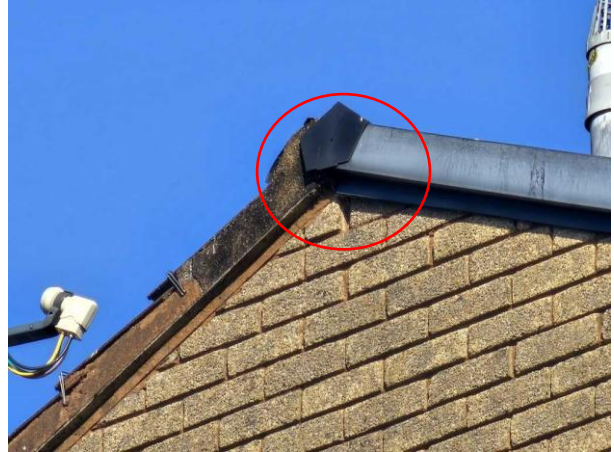
| External Walls | External walls are constructed of brick and mortar across all elevations, gaps due to missing mortar are present within the brickwork on all elevations (Photos 8 and 11). |

Photo 8: Gap at apex on southern elevation and missing mortar between bricks

- **PRF 5:** Lifted lead flashing around the vent stacks and at the north-east elevation joint, creating small gaps (Photo 9).
- **PRF 6:** Gaps in masonry caused by missing mortar in the brickwork, along all elevations (Photos 8 and 11).

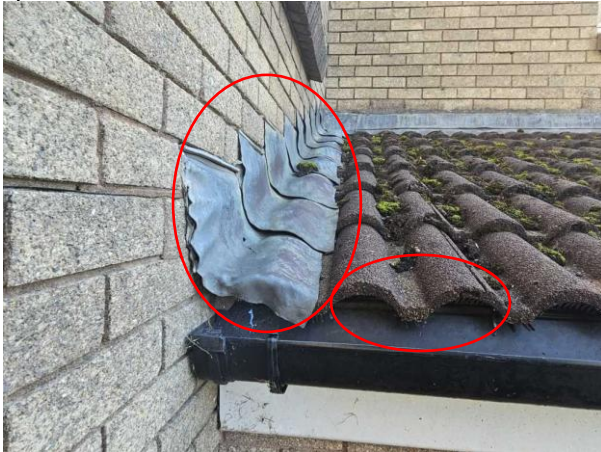
Photo 9: Lifted led flashing and missing wildlife spikes

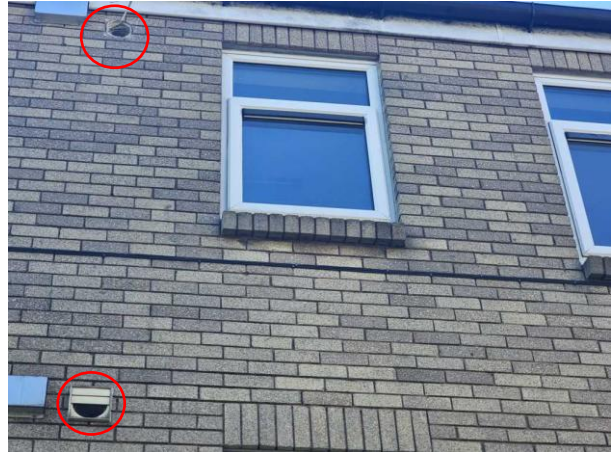
Photo 10: Broken and missing vents

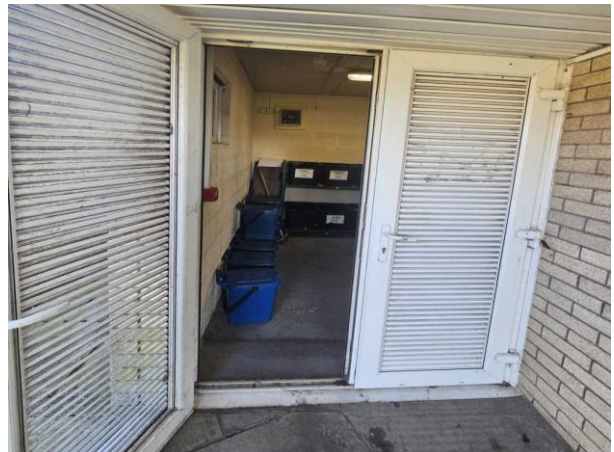
Photo 12: Well-lit plant room on northern elevation

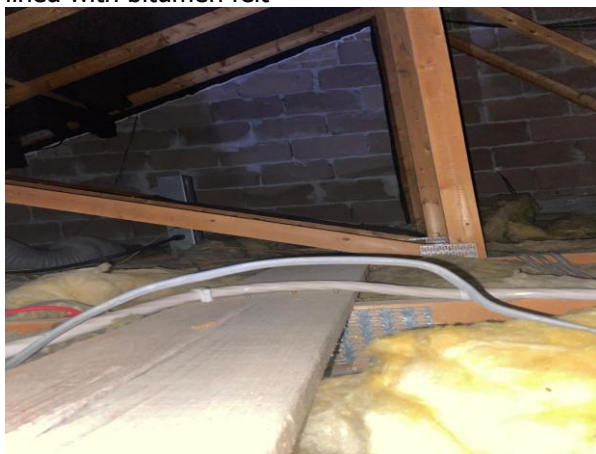
Photo 13: Internal loft space on eastern elevation, lined with bitumen felt

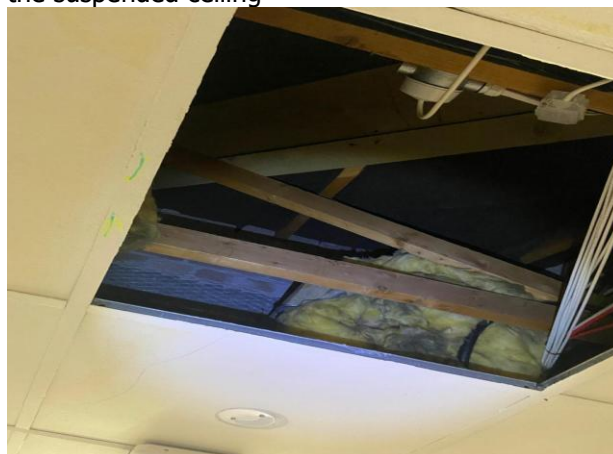
Photo 14: View into a section of the loft void above the suspended ceiling

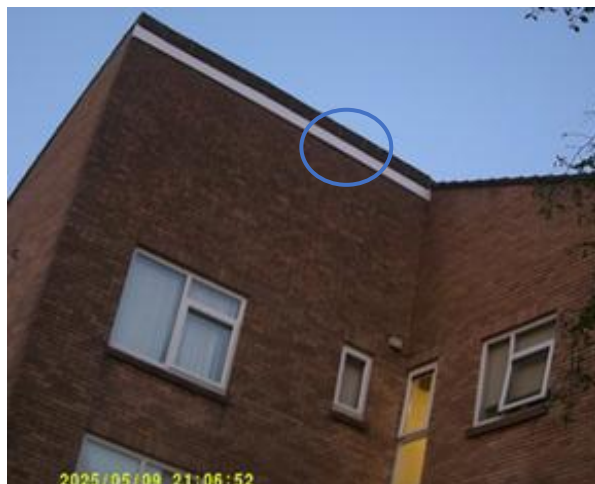
| | <b>Survey 1a: Dusk Emergence</b> | <b>Survey 1b: Dusk Emergence</b> |
|---|---|---|
| <b>Emergences/ Re-entries</b> | No bats emerged from or interacted closely with the building. | One common pipistrelle was observed re-entering under the fascia on the western elevation (Photo 15). |

Photo 15: Photo showing common pipistrelle roost location on the western elevation

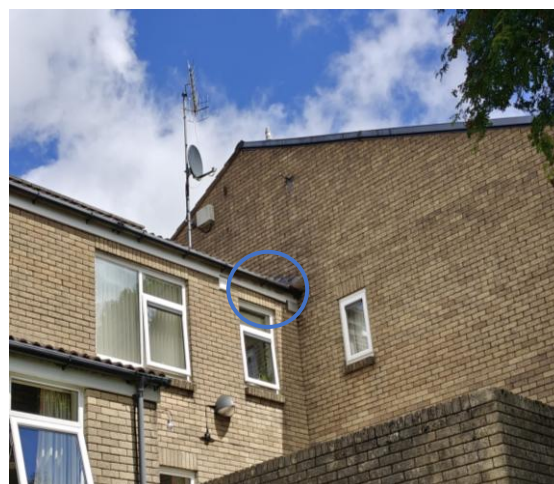
| | <b>Survey 1a: Dusk Emergence</b> | <b>Survey 1b: Dusk Emergence</b> |
|---|---|---|
| <b>Emergences</b> | No bats emerged from or interacted closely with the building. | Two common pipistrelles were observed emerging and one re-entering under the fascia on the southern elevation (Photo 15). |

Photo 16: Photo showing common pipistrelle roost location on the southern elevation

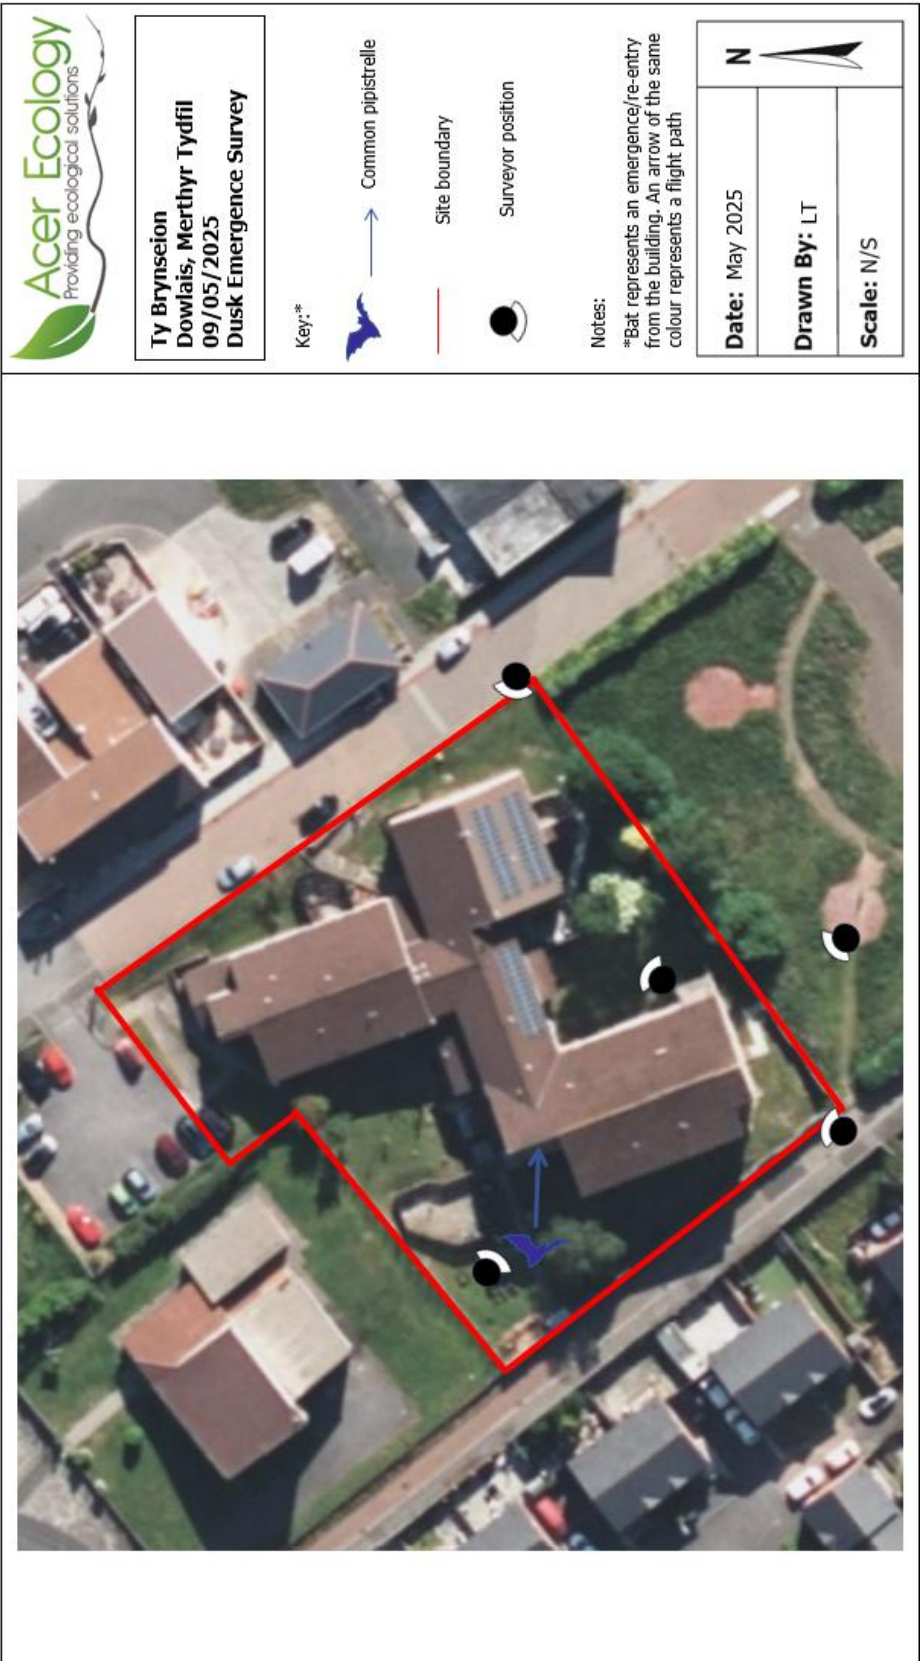
Survey 1B: 09/05/2025

Plan 5: Dusk Emergence Survey Results

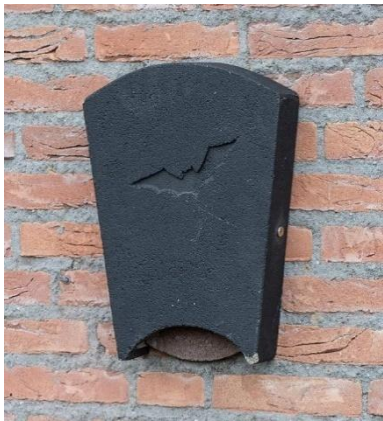
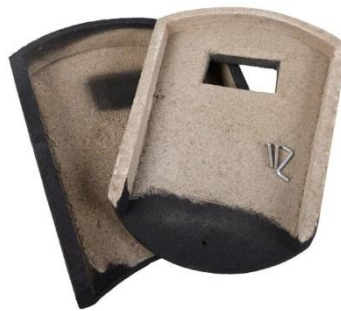
## Appendix 8: Beaumaris Woodstone Bat Box

This bat box is made entirely from woodstone, a robust material comprising concrete and wood fibres. This means that, not only does the box have excellent insulating properties maintaining a more consistent temperature throughout the year, it also provides excellent protection from predators. The Beaumaris box has a single narrow cavity which makes it suitable for crevice roosting bats such as the common pipistrelle, soprano pipistrelle, Nathusius' pipistrelle, Brandt's bat and whiskered bat. The interior of the box has a rough surface for bats to cling to and the front of the box features a subtle but attractive imprint of a bat in flight.

Suitable for attaching to external walls and should be sited as high up on the façade as possible, at a height of at least 3m from the ground. Avoid siting under artificial lights. Bats prefer to change roosts to benefit from varying ambient temperatures, so bat boxes should ideally be clustered in small groups.

- Height: 39cm
- Width: 29cm
- Depth: 6cm
- Weight: 4.4kg

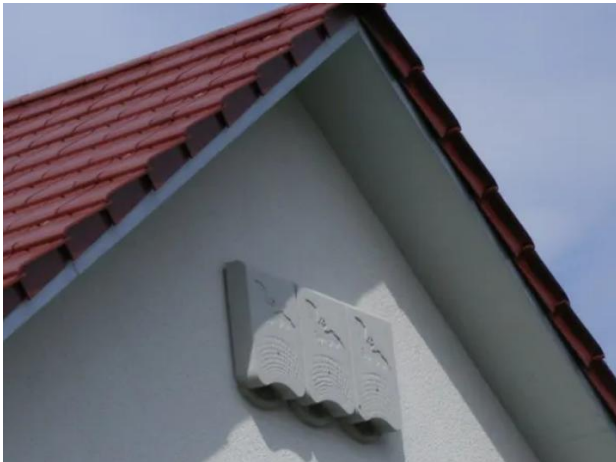
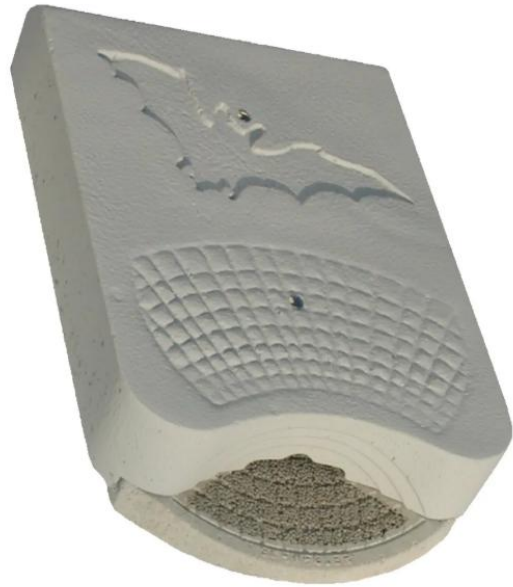
This box is designed to allow the safe hibernation of bats during the winter and for the formation of colonies and raising young in the summer. It has a layered structure of bat roost materials, coupling excellent insulation with good airflow. It has textured surfaces and varied hanging depths, making it suitable for different species. The entrance is designed with good grip on the approach and entry making it suitable for juvenile and inexperienced bats.

This roost is suitable for typical building-inhabiting species such as Pipistrelles, Serotines, Noctules or Bechsteins.

Installation is easy using the four screws and plugs provided. The unit is detachable into two parts. First the base part is screwed to the wall and then the front-cover is attached, covering the mounting screws. The 1WQ can be easily attached to most types of external brick, timber or concrete walls.

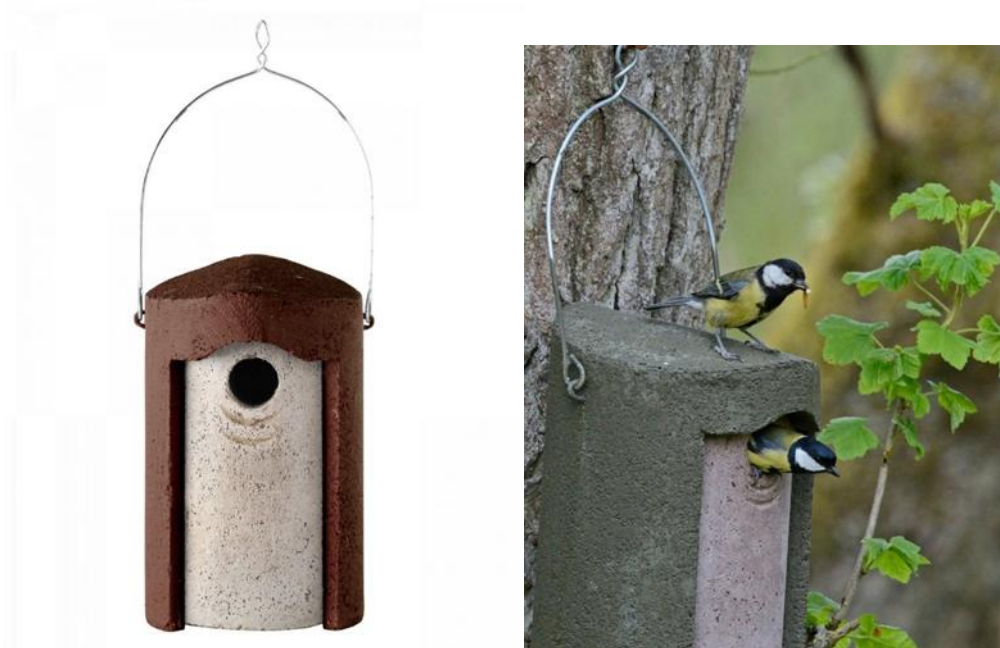
- **32mm entrance hole** will attract great, blue, marsh, coal and crested tit, redstart, nuthatch, collared and pied flycatcher, wryneck, tree and house sparrow and bats.
- **26mm entrance hole** suits blue, marsh, coal and crested tit and possibly wren. All other species are prevented from using the nest box due to the smaller entrance hole.
- **Oval entrance hole** (29 x 55mm) suits redstarts because more light enters the brood chamber. It is also suitable for all other species which nest in the 32mm boxes

The Schwegler 1B general small bird box will be preferably mounted on a stable tree trunk, rather than on branches which will sway. The mounting location will not be heavily shaded. Boxes should be mounted vertically on the tree.

Boxes will be mounted a minimum of 2m, and preferably 3m, above the ground, and as far as possible placed on the SE- or SW-facing surfaces of the tree trunks.
