*Report No. BC/MB/06.19.05/3.*

# **Report on Drilling and Grouting Operation: Land at Plymouth House, Merthyr Tydfil.**

***Mr and Mrs D. Rees***

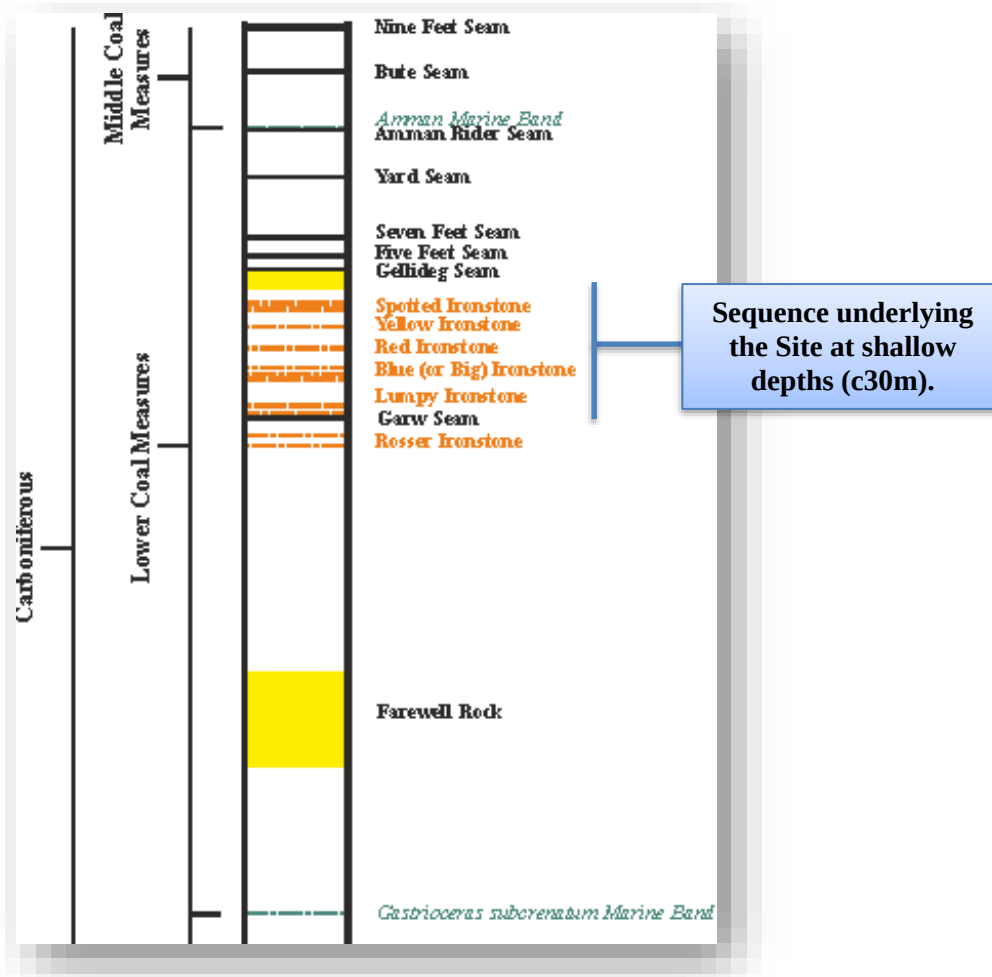
**Figure 2**  
**Part of the Stratigraphic Column.**

The earlier reports identified the Site is underlain at shallow depths with strata assigned to the Lower Coal Measures. The sequence underlying the Site at shallow depths includes a series of five ironstone veins, the Garw Coal Seam and the Rosser Ironstones (see Figure 2, Part of the Stratigraphic Column).

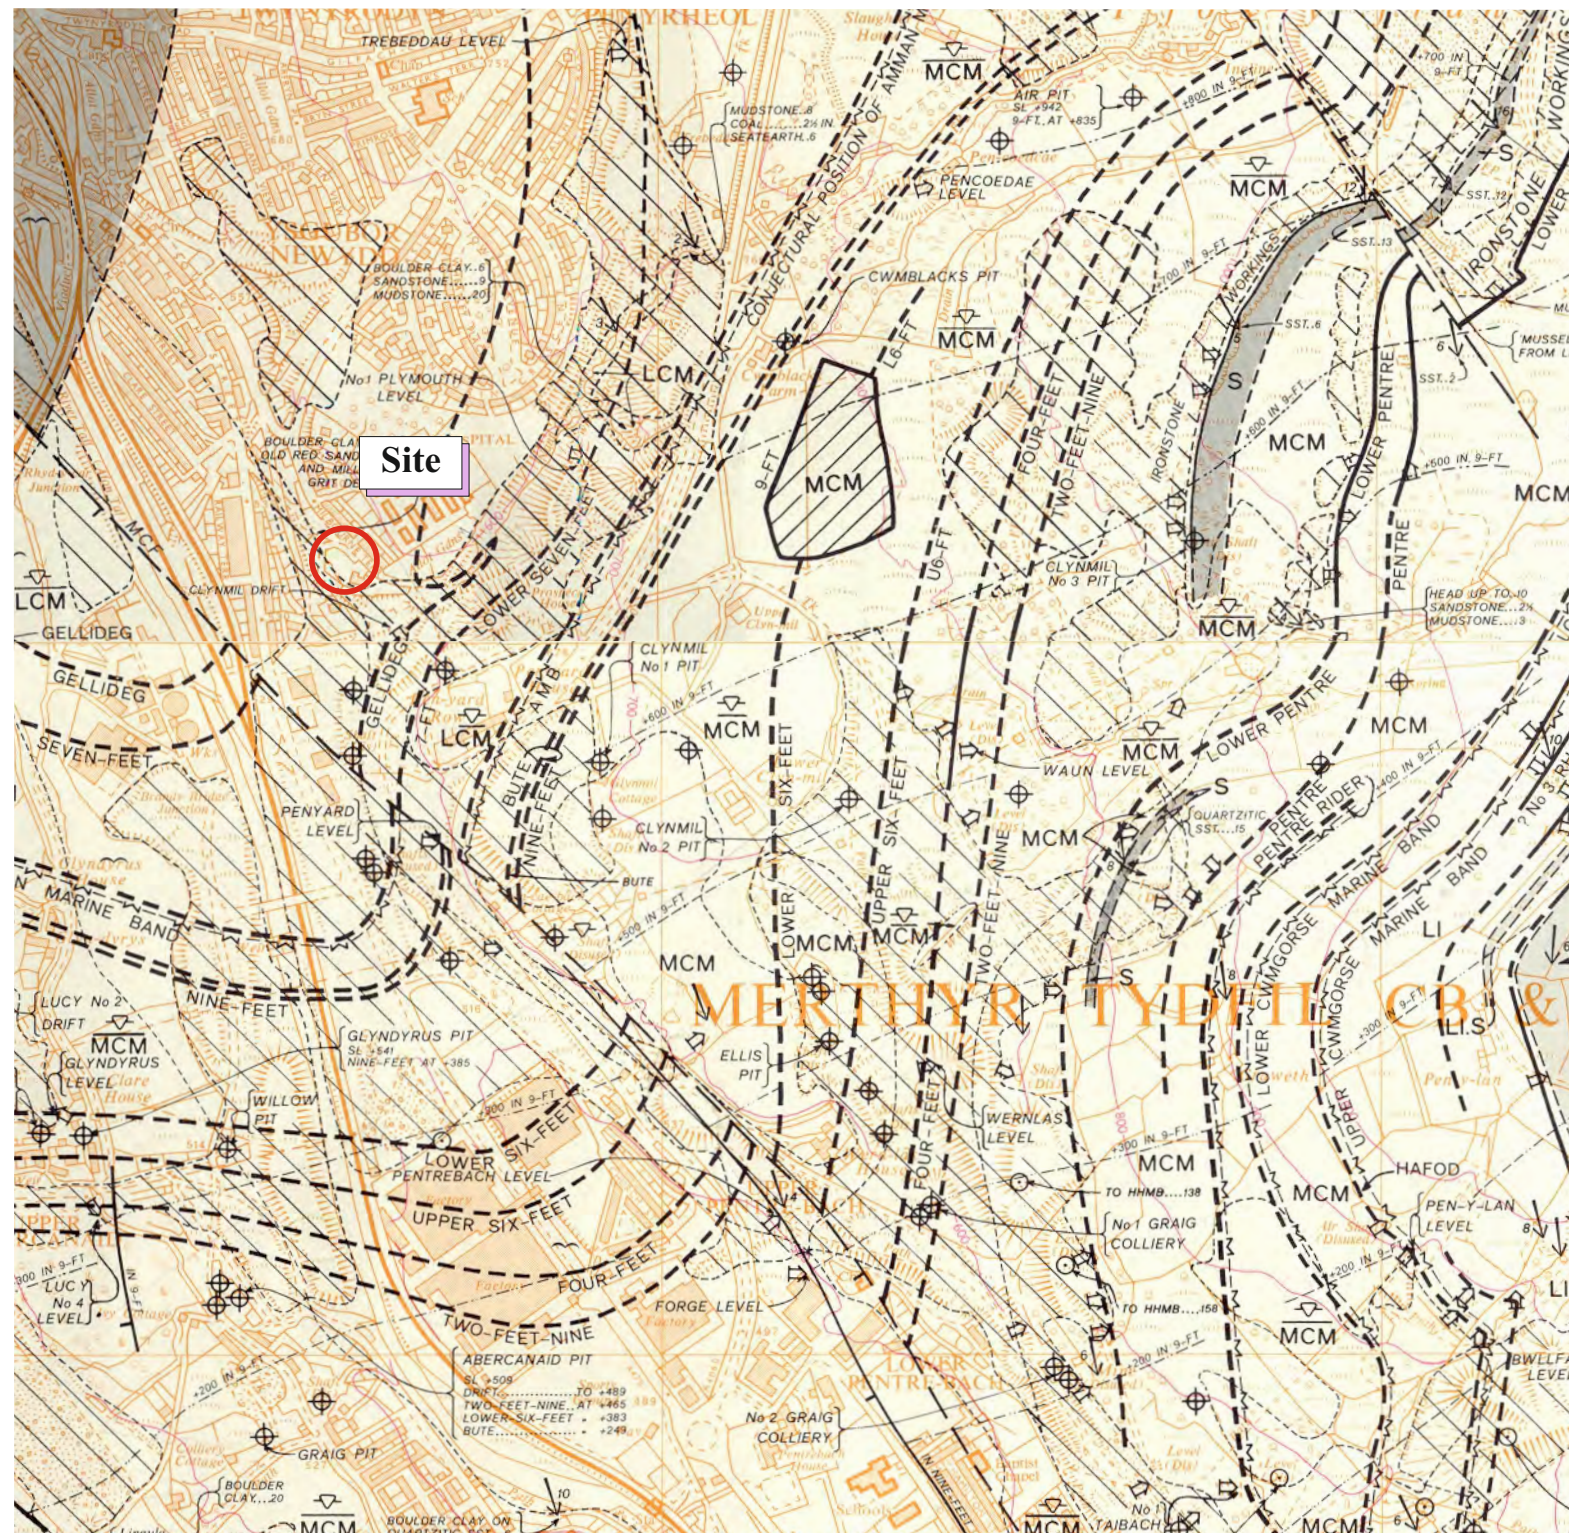
**Drawing No: BC/MB/06.19.05.02.**

*Geology Plan.*

The earlier report also identified that the Site is not affected by large scale faulting and it is not affected by landslip conditions. The report also found that published geological information shows the Site to be covered with glacial deposits of river alluvium and with Made Ground that is almost certainly colliery spoil.

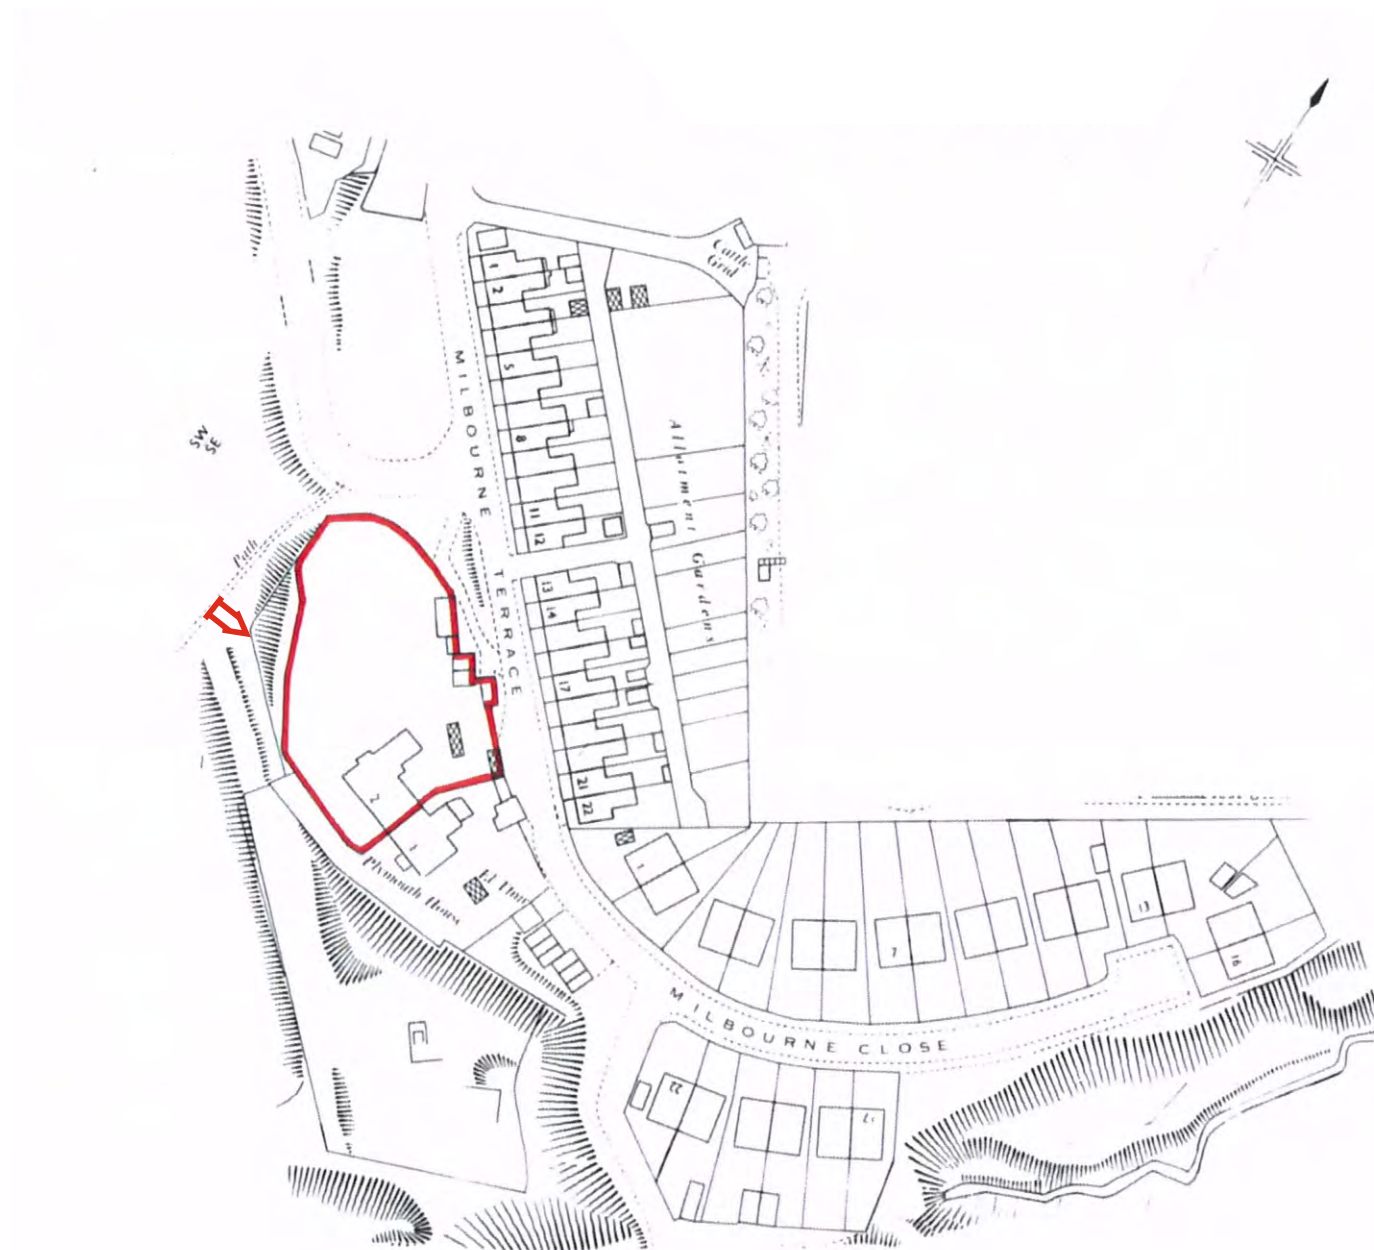
Drawing No: BC/MB/06.19.05.03.

## *Detailed Location Plan.*

➤ Approximate position of disused mine adit.

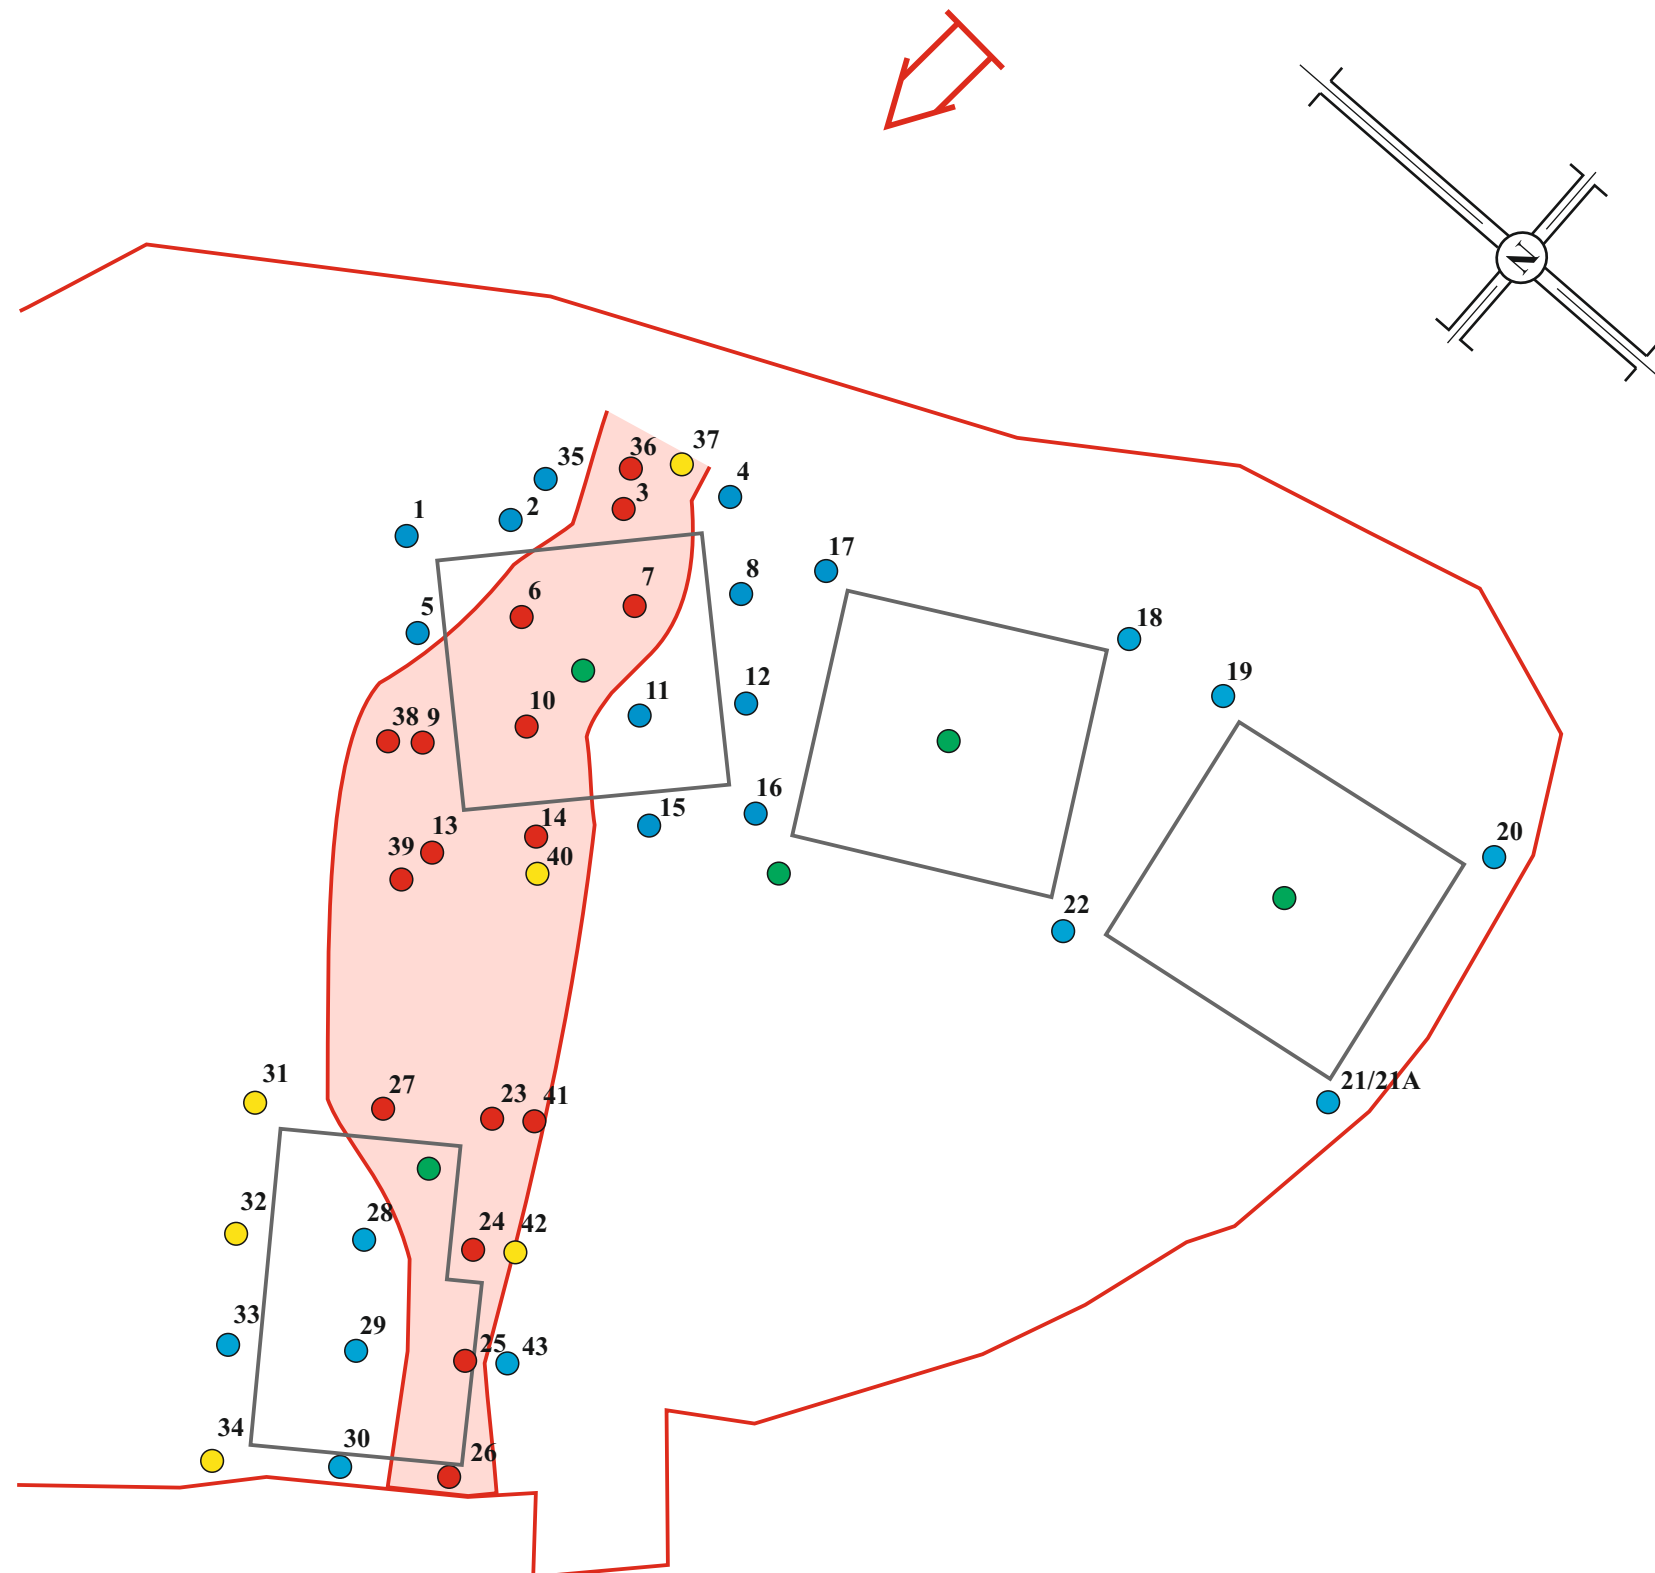
Drawing No: BC/MB/06.19.05.08.

The boreholes were drilled to a maximum depth of 22m. The locations of the boreholes are shown on the *Borehole Location Plan 2*, drawing no. BC/MB/06.19.05.08 and the borehole logs are included in Appendix I. The boreholes were supervised by a Chartered Geologist and drilled by Apex Drilling Services using a Beretta T44 rig.

## Borehole Location Plan 2.

A total of thirty-seven boreholes were drilled across the Site, the majority along the line of the adit where it affects Plots 1 and 4; the boreholes positions included a 1m wide perimeter around the two footprints. No old workings were encountered under Plots 2 and 3. The borehole grid was designed to permit an efficient grouting up of the old ironstone adit. A total of 169 tonnes of grout and 135.5 tonnes of chippings were injected into the boreholes. The old workings are considered to have been stabilised and the risk of any remnant voids remaining following the grouting operation being large enough to collapse to the base of the Boulder Clay is considered to be extremely low to negligible. The coal measures are overlain with deposits of glacial till, Boulder Clay, that vary in thickness between 4.40m and 10.6m and with Made Ground (Colliery Spoil) that was found to vary in thickness from 6.30m in Borehole 30 to 15.90m in Borehole 19. The risk of any subsidence that may occur at the base of the Boulder Clay migrating to the surface and adversely affecting the foundations of the proposed dwellings is considered to be negligible.

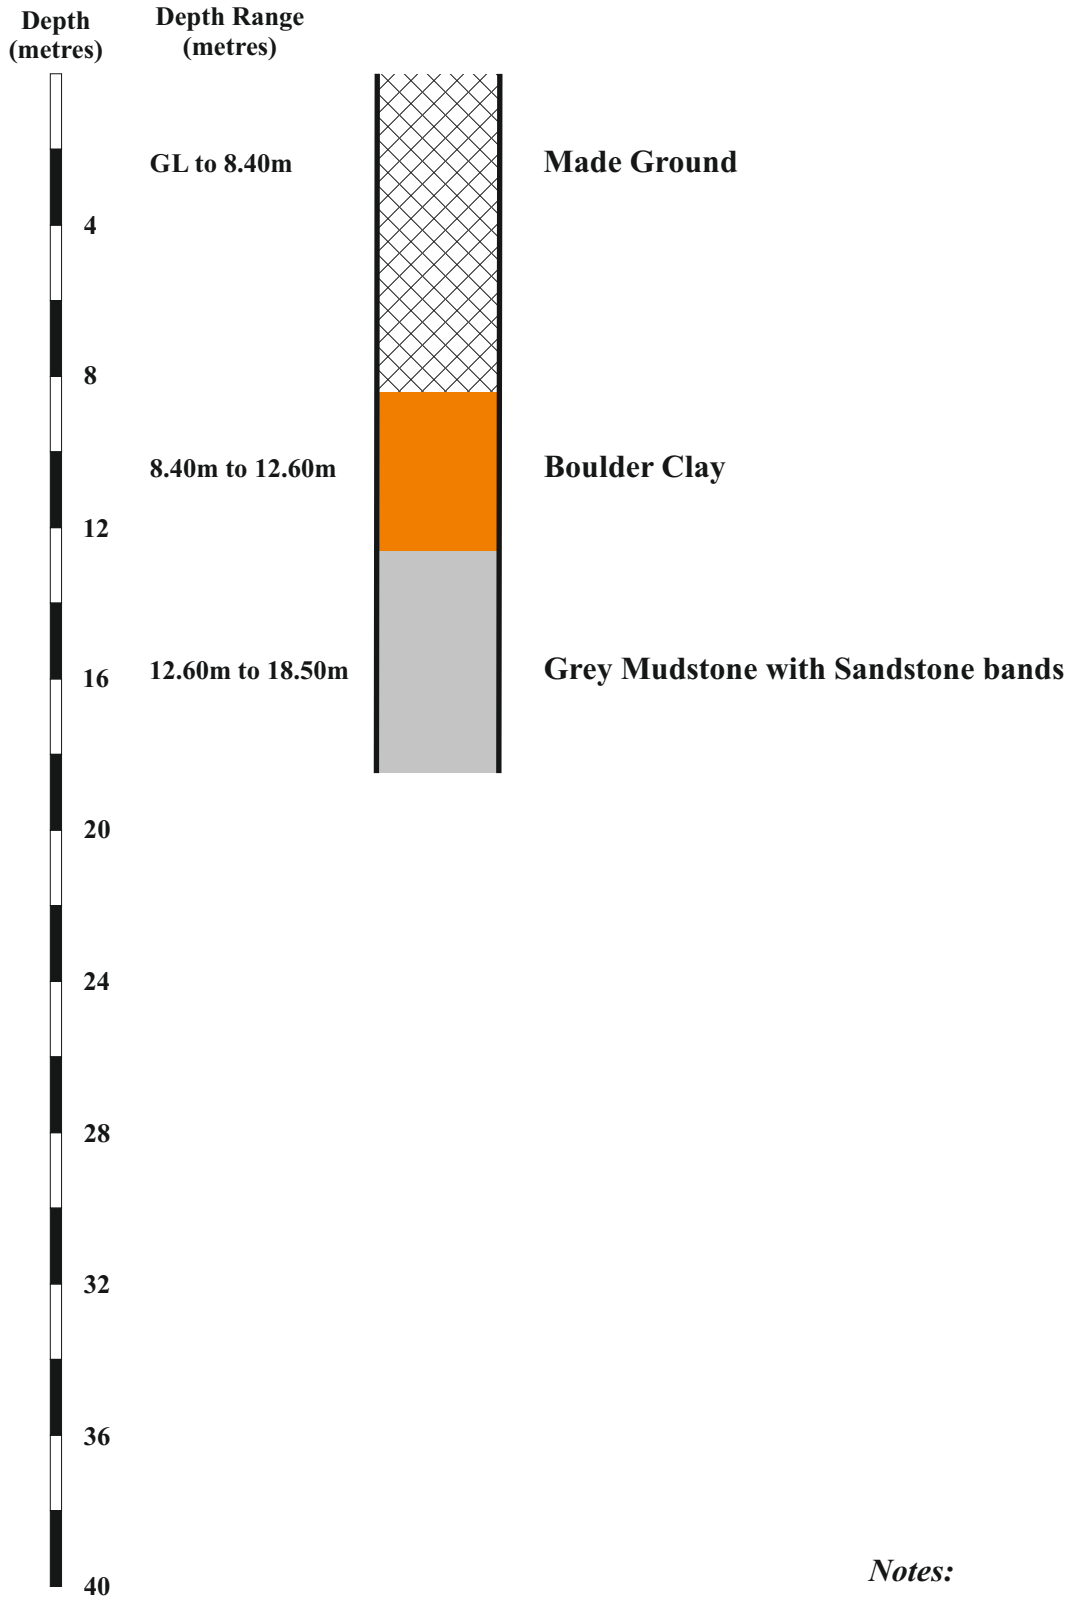
### *Borehole No. 1*

1. *Driller's Descriptions.*
2. *Borehole dry.*
3. *Total depth of borehole, 18.50m.*
4. *Cased 12.40m.*

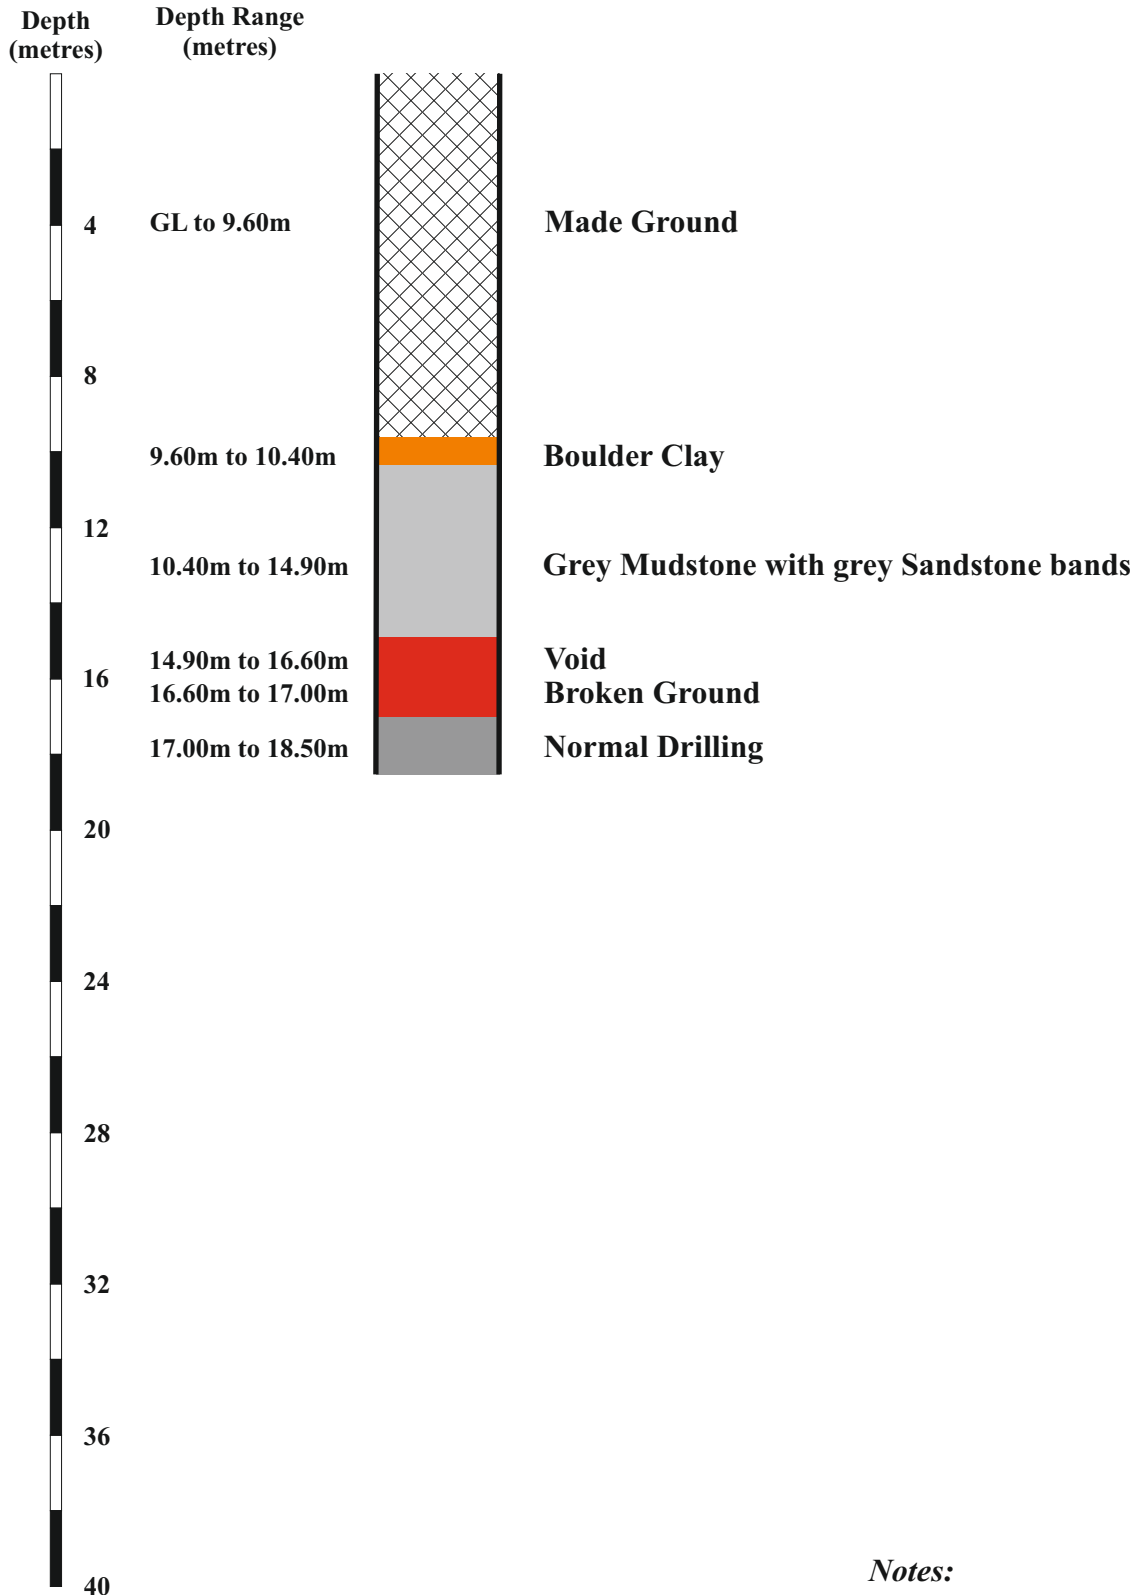
### Borehole No. 6

1. Driller's Descriptions.
2. Borehole dry.
3. Total depth of borehole, 18.50m.
4. Cased 10.00m.

| BH No | Total Depth (m) | Depth to Top of Workings (m) | Thickness of Workings (m) | Total PFA/OPC Injected (t) | Total Chippings Injected (t) | Total tonnage (t) |
|---|---|---|---|---|---|---|
| 6 | 18.5 | 14.9 | 1.7 | 36.00 | 32.00 | 68.00 |

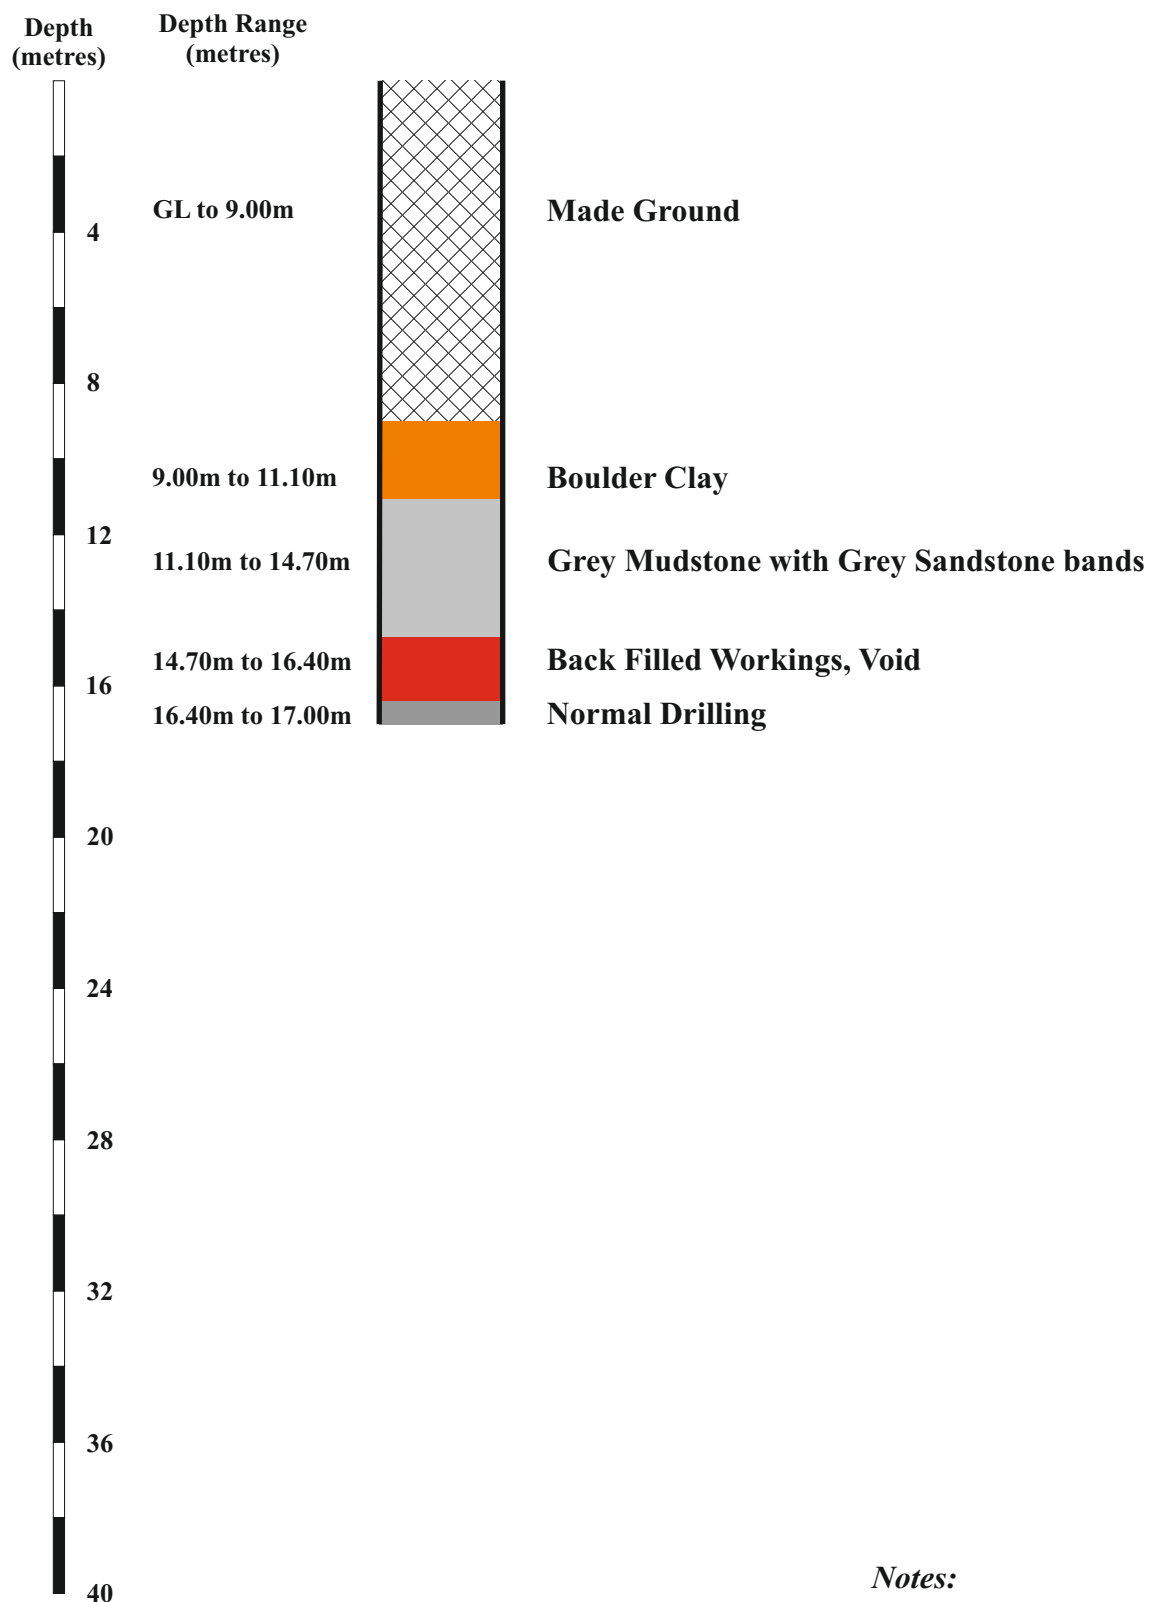
### *Borehole No. 36*

1. *Driller's Descriptions.*
2. *Borehole dry.*
3. *Total depth of borehole, 17.00m.*
4. *Cased 10.00m.*

| BH No | Total Depth (m) | Depth to Top of Workings (m) | Thickness of Workings (m) | Total PFA/OPC Injected (t) | Total Chippings Injected (t) | Total tonnage (t) |
|---|---|---|---|---|---|---|
| 36 | 17.0 | 14.7 | 1.7 | 43.00 | 47.00 | 9.00 |

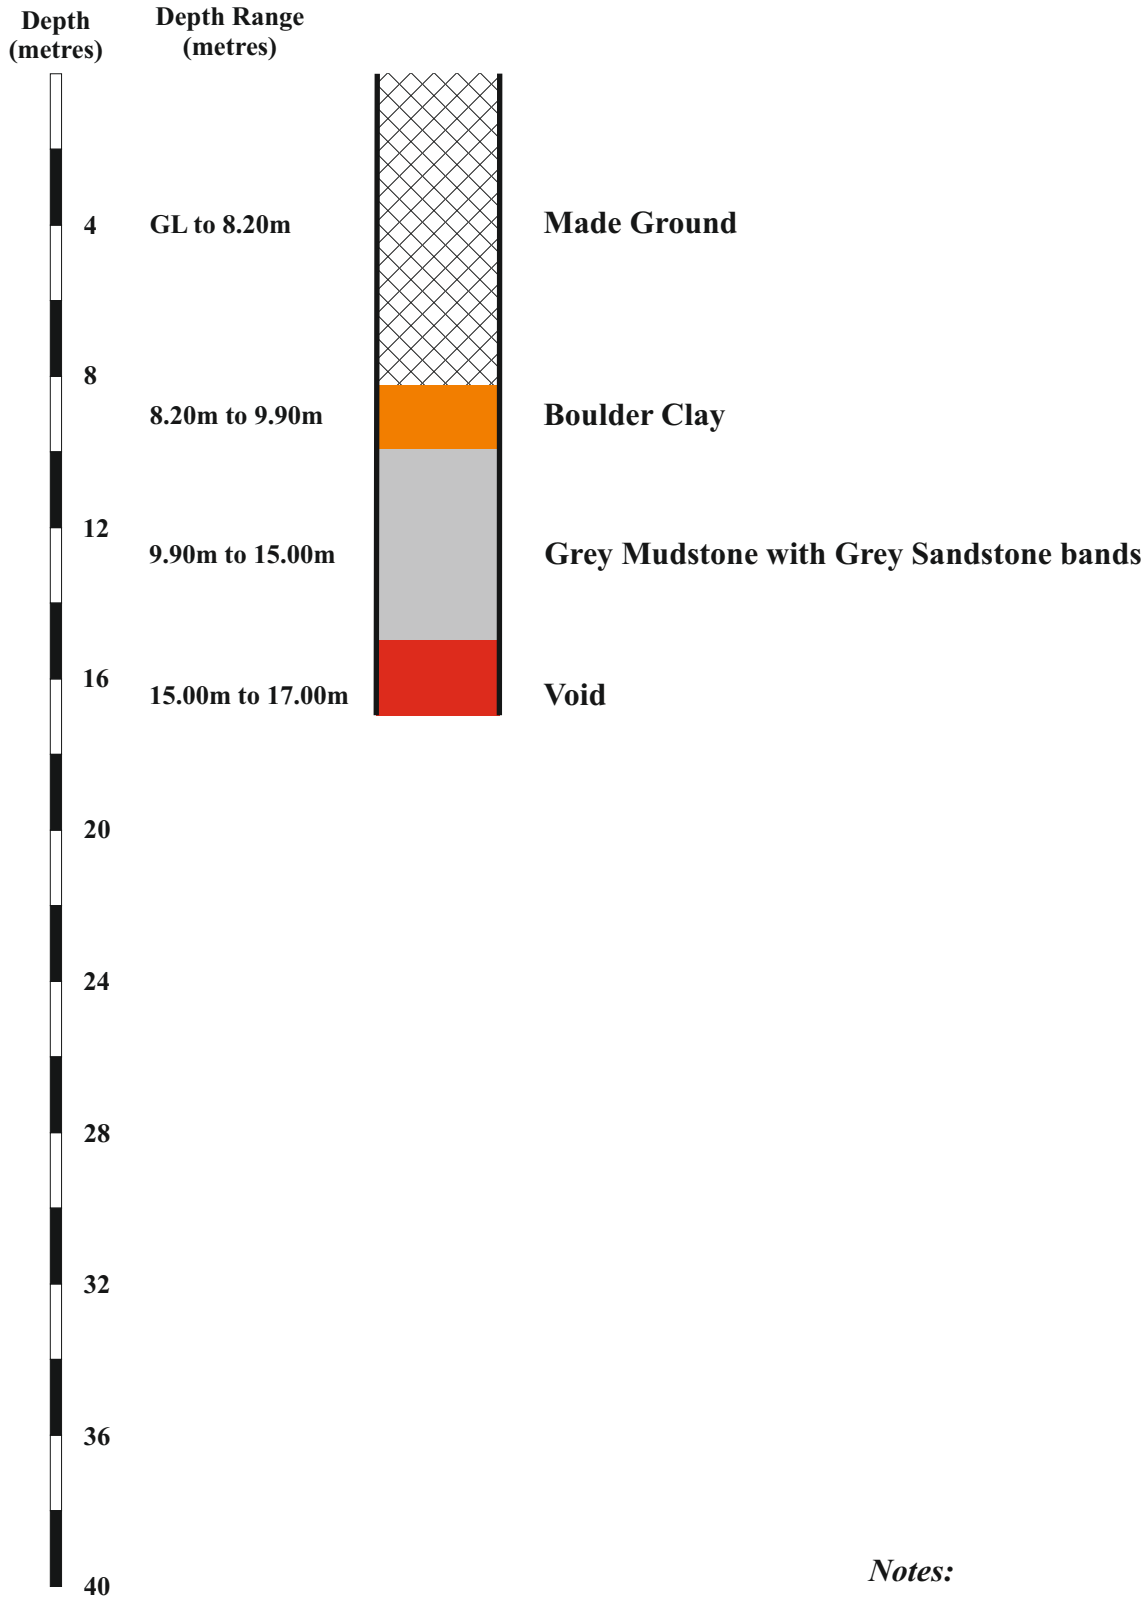
### *Borehole No. 38*

1. *Driller's Descriptions.*
2. *Borehole dry.*
3. *Total depth of borehole, 17.00m.*
4. *Cased 8.50m.*

| BH No | Total Depth (m) | Depth to Top of Workings (m) | Thickness of Workings (m) | Total PFA/OPC Injected (t) | Total Chippings Injected (t) | Total tonnage (t) |
|---|---|---|---|---|---|---|
| 38 | 17.0 | 15.0 | 2.0 | 19.00 | 14.00 | 33.00 |
