Our Reference: LT065-PRA

**Re: Preliminary Roost Assessment (PRA) of 14 Lower High Street, Merthyr Tydfil, CF47 8EB**

Table 2: Preliminary Roost Assessment

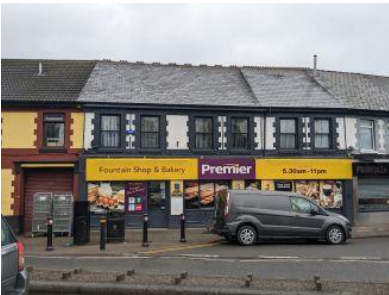
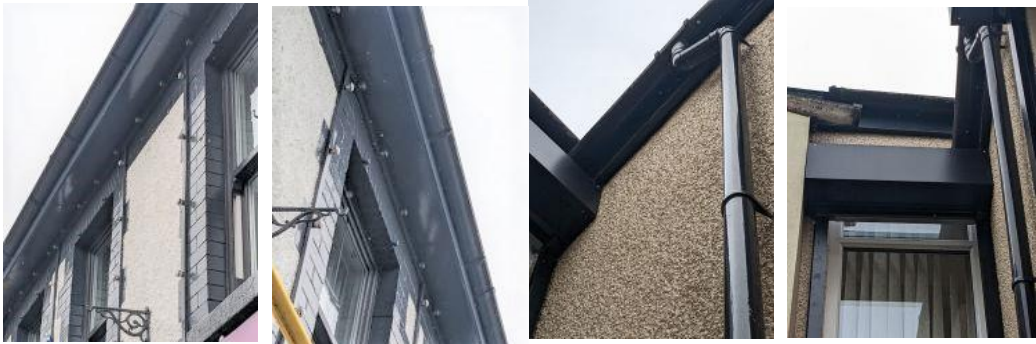
| Description | Potential Nest and Roost Assessment | Evidence | Assessment | Photographic Evidence |
|---|---|---|---|---|
| <p><b><u>Building A:</u></b></p> <p><b><u>14 Lower High Street</u></b></p> <p>An occupied Structure – mixed residential/ commercial.</p> <p>A two-storey stone and brick built Victorian structure with a cement render, and traditional slate roof.</p> | <p><b><u>External Inspection: Soffits and Fascias</u></b></p> <p>No significant gaps were recorded on the exterior of the western or eastern elevation of the main building.</p> <p>All exterior fixtures were well sealed and in good order.</p> | <p>No evidence recorded of nesting birds or roosting bats.</p> | <p>Negligible<br/>(Bats)</p> <p>Negligible (birds)</p> | |

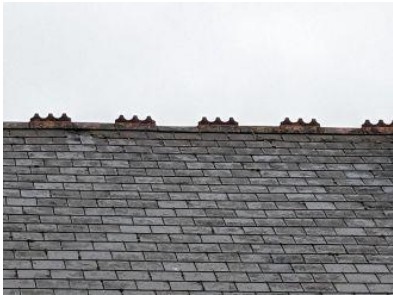
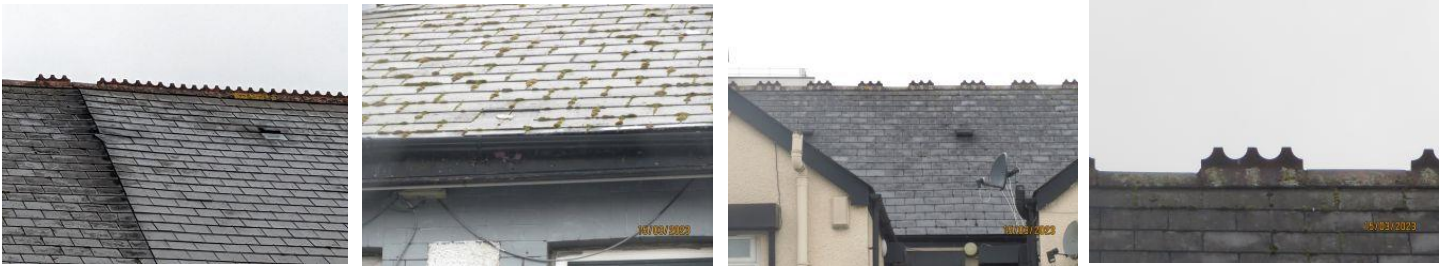
| <p><b><u>Building A:</u></b><br/><b><u>14 Lower High Street</u></b></p> <p>An occupied Structure – mixed residential/ commercial.</p> <p>A two-storey stone and brick built Victorian structure with a cement render, and traditional slate roof.</p> | <p><b><u>External Inspection: Roofing Materials</u></b></p> <p>No raised tiles were recorded. The slates and ridge tiles were well-maintained and in good order.</p> <p>Two slipped slates were identified on the western elevation but these had a low profile and provided no access points suitable for bats.</p> <p>Roof vents are present on the western and eastern elevation but these are fitted with a grill to deter wildlife.</p> | <p>No evidence recorded of nesting birds or roosting bats.</p> | <p>Negligible</p> <p>(Bats)</p> <p>Negligible (birds)</p> | |

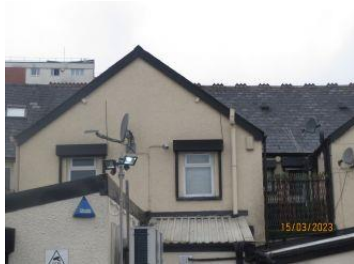
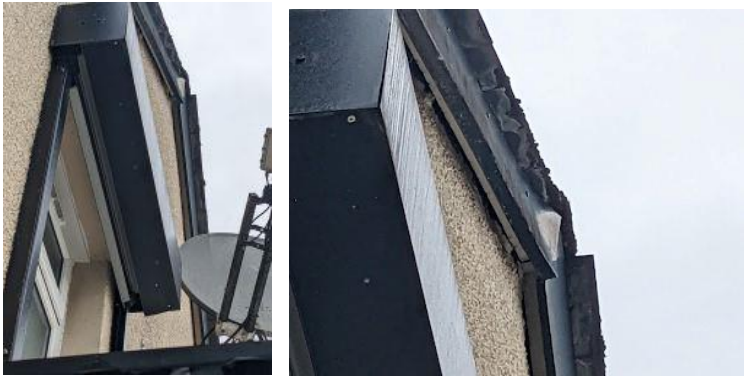
| <p><b><u>Building A:</u></b></p> <p><b><u>14 Lower High Street</u></b></p> <p>An occupied Structure – mixed residential/ commercial.</p> <p>A two-storey stone and brick built Victorian structure with a cement render, and traditional slate roof.</p> | <p><b><u>External Inspection: Rear Gables</u></b></p> <p>A gap was recorded between the barge board and the wall providing access to a void of unknown proportions.</p> <p>This offers a potential access point for bats to enter the roof space of the rear extensions and potentially gain access to the hyper-membrane cavity.</p> | <p>No evidence recorded of nesting birds or roosting bats.</p> | <p>Moderate</p> <p>(Bats)</p> <p>Negligible (birds)</p> | |

However, despite the main structure being considered to have a low potential, the presence of bat roosts within extensions cannot be entirely ruled out. The roof structures of the rear extensions are considered to offer a moderate potential to support roosting bats. Consequently, if the proposed work was in any way impact the roofs of the extensions, this would require two dusk emergence or dawn re-entry survey with at least one surveyor to be completed between May and September (at least two weeks apart) during the year in which the works are to commence.

As a precaution, and in order to avoid any potential impacts under either of the scenarios outlined above, it is recommended that during works no scaffolding be erected along the eastern gables of the rear extensions.

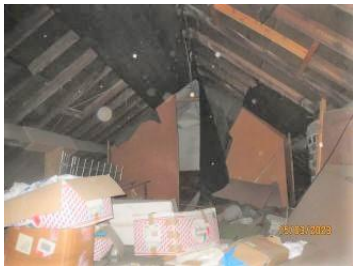
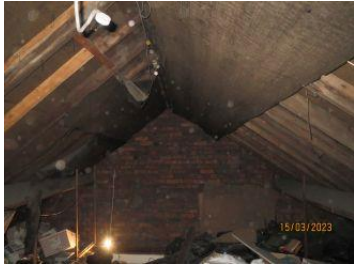
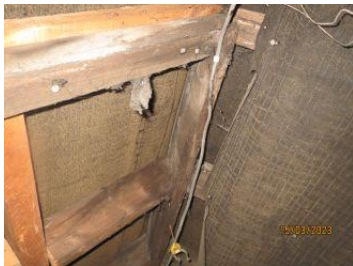
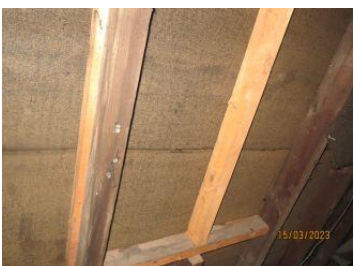
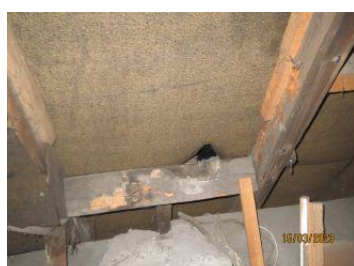
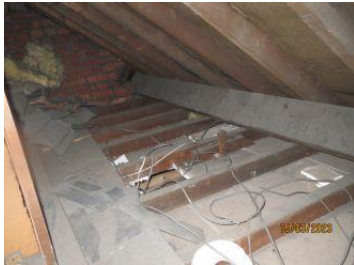
| <p><b><u>Building A:</u></b></p> <p><b><u>14 Lower High Street</u></b></p> <p>An occupied Structure – mixed residential/ commercial.</p> <p>A two-storey stone and brick built Victorian structure with a cement render, and traditional slate roof.</p> | <p><b><u>Internal Inspection: Roof Spaces</u></b></p> <p>The roofing structure consisted a traditional hand-cut roof with ridge-board. An intact bitumen membrane was in place between the rafters and the slate roofing slates.</p> <p>The only light penetration recorded into the roof space was at the uPVC vents below each of which a slit had been made in the roofing membrane. These vents are fitted with a grill to deter wildlife.</p> <p>No access was possible to the interior of the two small rear extensions. No hatches were present and access was not possible from the main roof space.</p> <p>The main roof space is divided into a northern and southern section by a partly wall. A full and complete inspection was made of the northern roof space but access was limited to the main southern roof space. This</p> | <p>No evidence recorded of nesting birds or roosting bats.</p> | <p>Negligible</p> <p>(Bats)</p> <p>Negligible (birds)</p> | <p>Northern roof space</p> |

| <p>was due to a suspended ceiling which was fitted below the access hatch. The frame of this suspended ceiling allowed the hatch to be partially opened to the extent that, while it was possible to view the roof space from the entrance it was not possible to enter.</p> <p>However, the roof void was surveyed as far as possible from the loft hatch using high power-torches.</p> | | | |
