**Willow Works, Merthyr Tydfil**

**Factual Site Investigation Report**

**R1538/12/4337**

**January 2013**

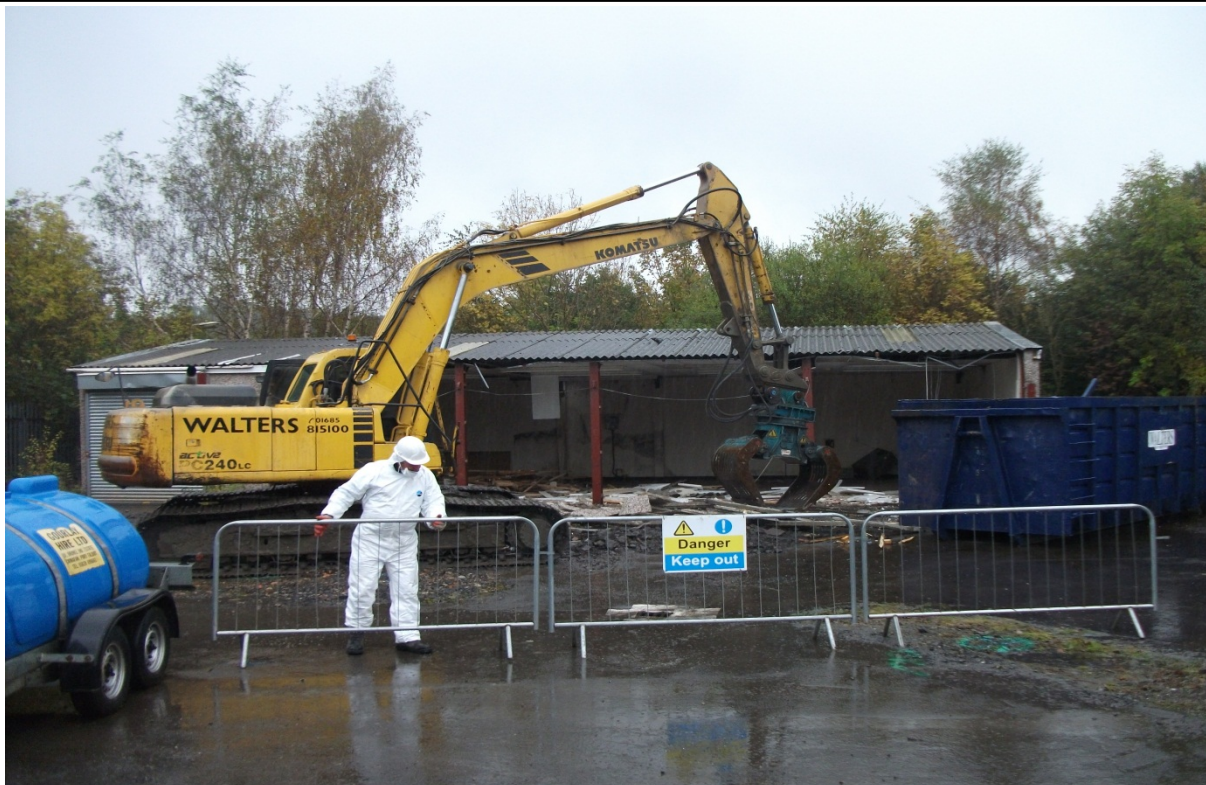
Plate No.: 1

Title: Demolition works undertaken on the pre-fabricated building.

Prior to the site investigation works, enabling works were carried out. This comprised the demolition of a single storey prefabricated building in the north east of the site. The building was demolished between the 8<sup>th</sup> and 10<sup>th</sup> of October 2012 by Walters Environmental. The building was demolished to its ground floor slab and all materials resulting from the demolition were removed from site by Waters Environmental. Consignment notes for the materials removed from site are included in Appendix H. Photographs of the works are included in Appendix B.

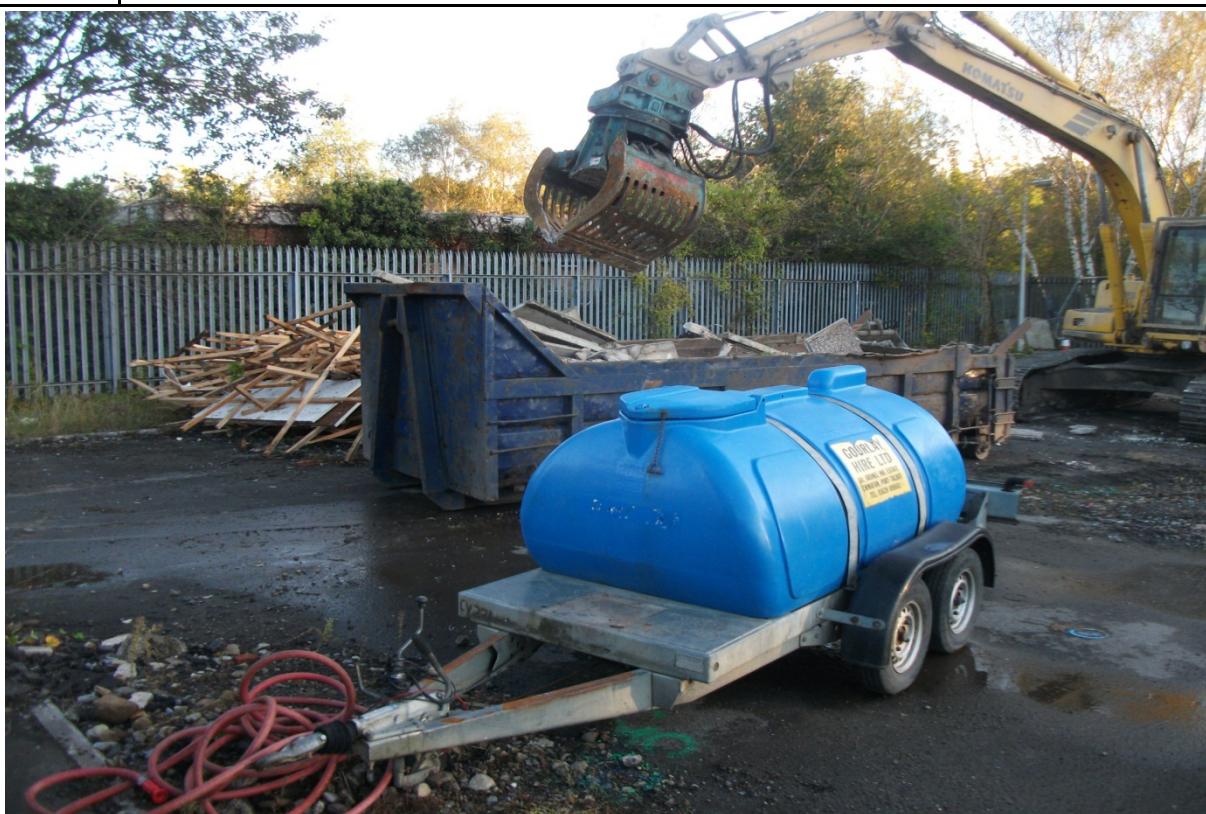
Plate No.: 2

Title: Waste materials from the demolition were segregated and sent for offsite disposal or recycling.

Materials arising from the demolition, including asbestos, metal and brick/concrete were disposed of off-site under appropriate Duty of Care. Water and non-aqueous phase liquid (NAPL) recovered from boreholes during the works was stored in a bunded IBC container during the works. On completion of the works, the contents were removed from site under appropriate Duty of Care. All other waste generated by the works was disposed of under appropriate Duty of Care.

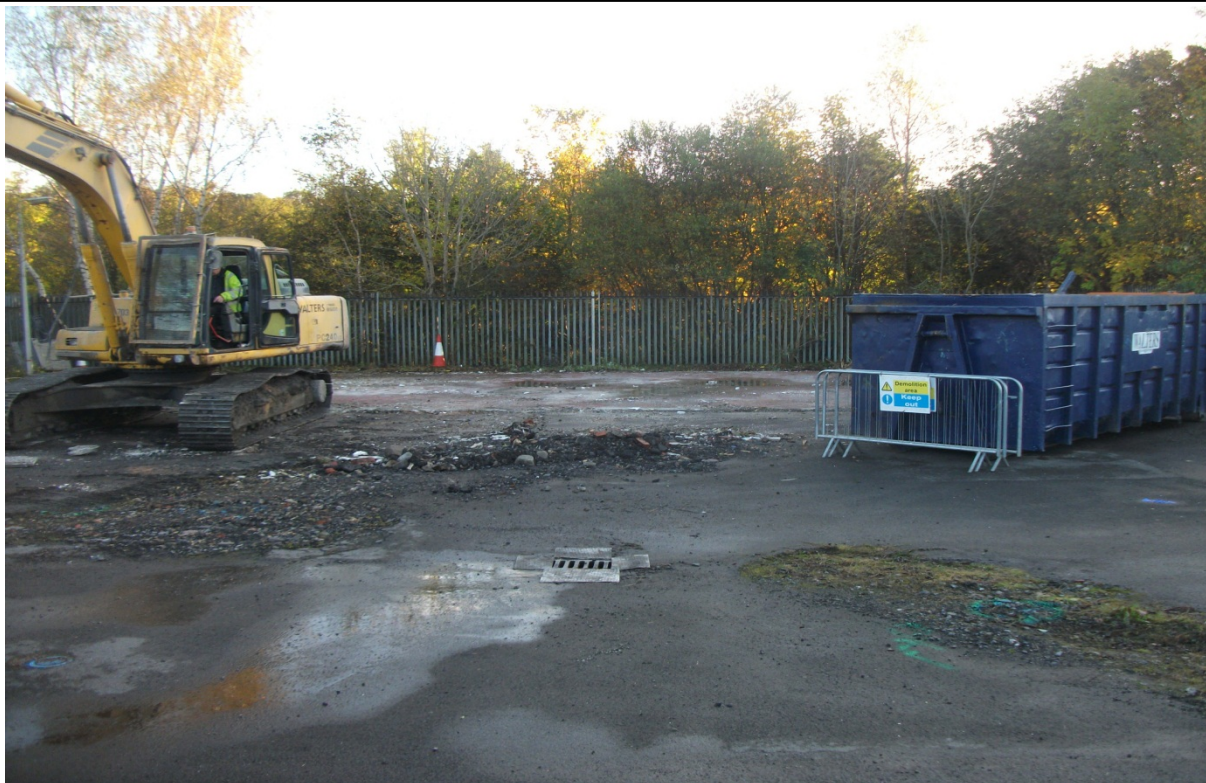
Plate No.: 3

Title: The building was demolished to slab level with all associated waste removed from site.

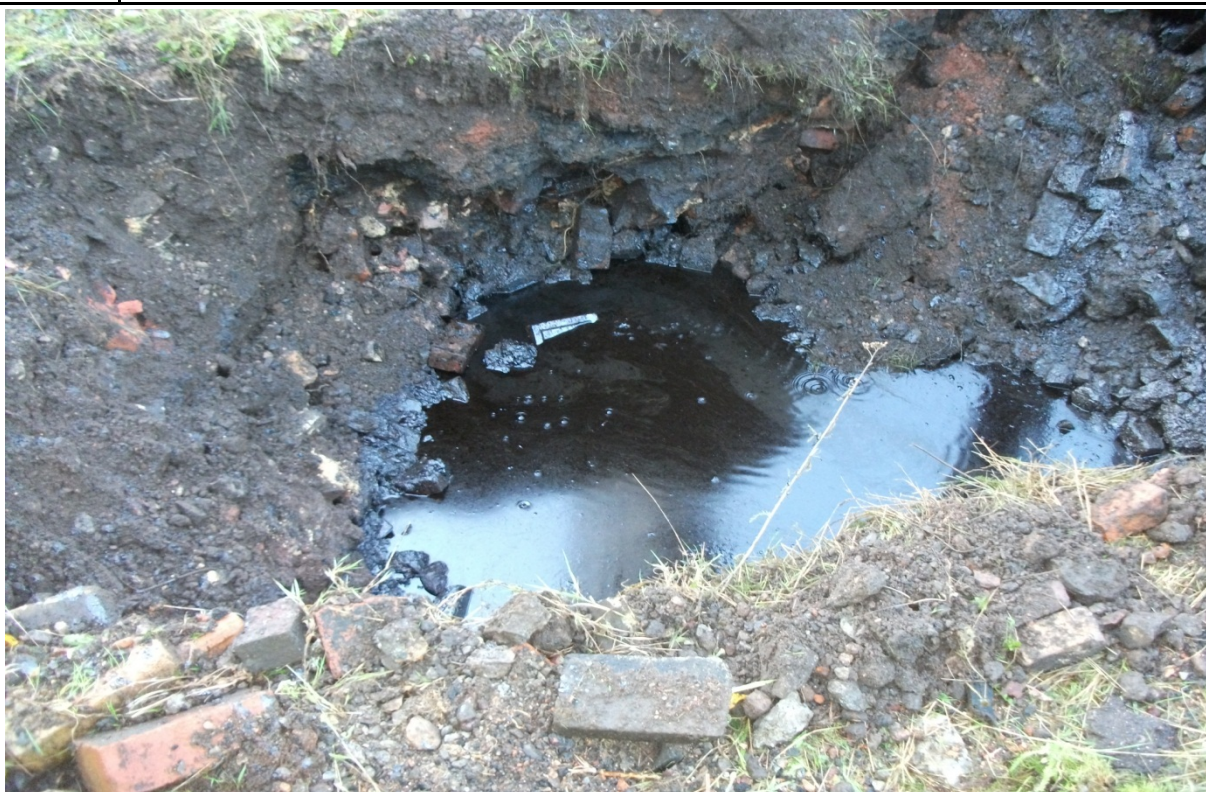
Plate No.: 4

Title: Trial pits within the Relief Holder Base exposed heavily contaminated waters. The majority of the tank was backfilled with brick and rubble fill.

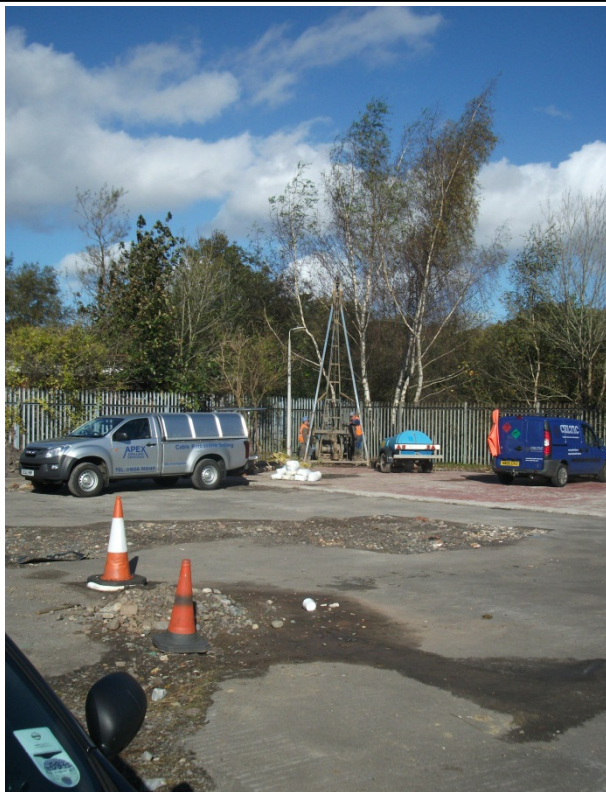
Plate No.: 5

Title: Boreholes were drilled using cable percussion methods.

A total of 11 boreholes were drilled using cable percussive methods between the 15<sup>th</sup> and 26<sup>th</sup> of October 2012. The boreholes were drilled by Apex Drilling Services. At each location, a hand dug trial pit was excavated to 1.2 m to check for services. The boreholes were sunk to a maximum depth of 8.0 m. Four of the other boreholes (CBH4/4a, 7 and 8) had to be aborted due to obstructions generally associated with slag deposits at the base of the made ground. Where completed to depth, standpipe installations were installed in the boreholes. The locations of the boreholes are shown on Drawing D1538/4337/A3 in Appendix A. Engineers logs for the boreholes are presented in Appendix C.

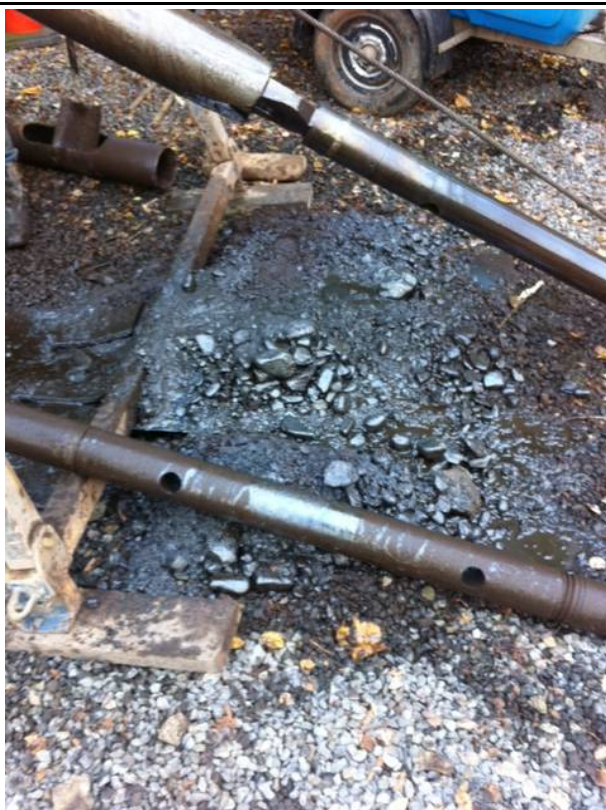
Plate No.: 6

Title: A number of the boreholes encountered grossly contaminated strata at the groundwater level.

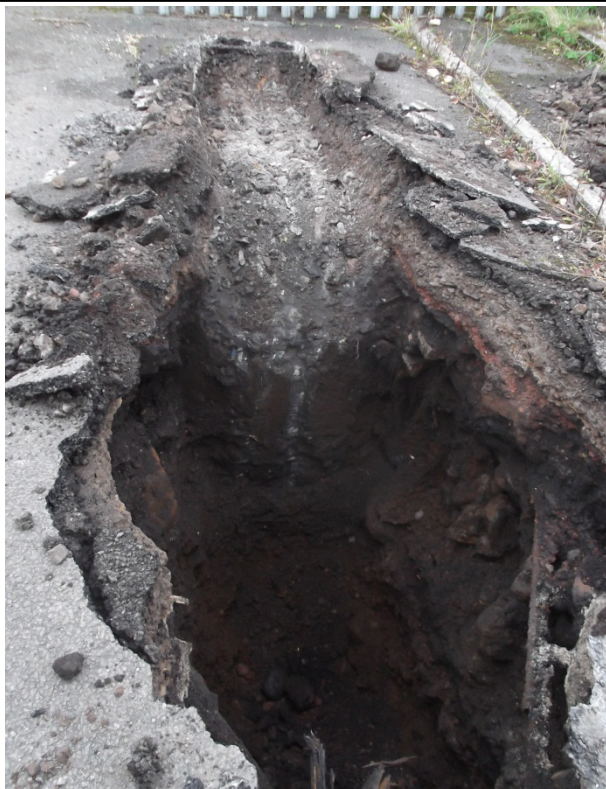
Plate No.: 7

Title: Within CTP3, a cylindrical concrete structure was uncovered which is situated in the same location as the historical air scrubber stack.

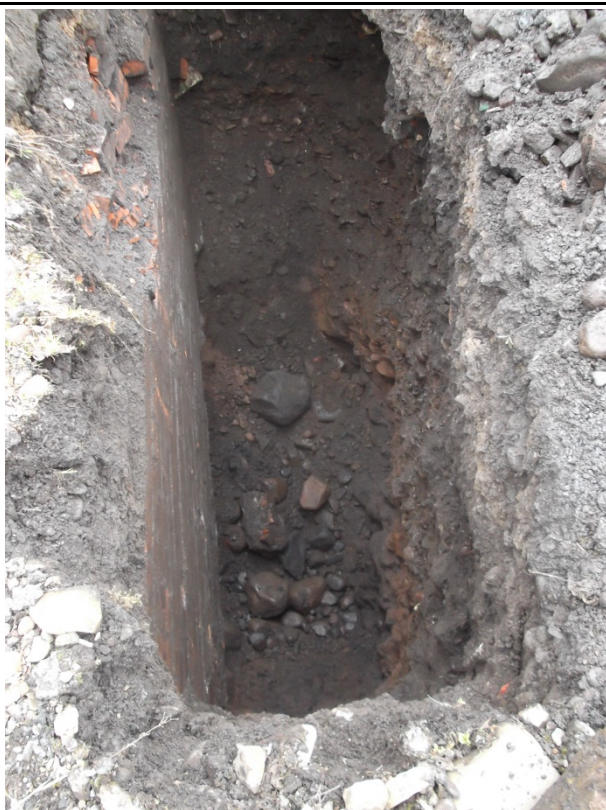
Plate No.: 8

Title: Within CTP4, a red brick wall was encountered which is possibly the western wall of the historical CWG plant.

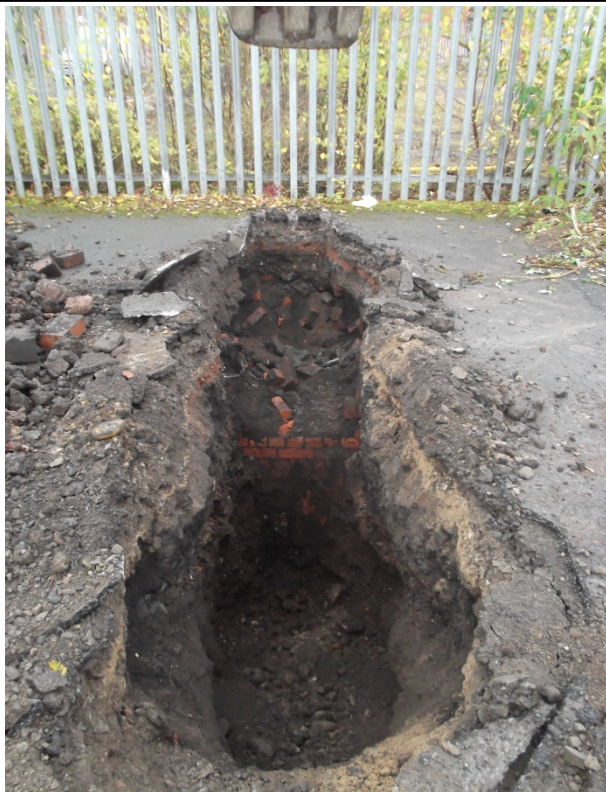
Plate No.: 9

- A tank of approximate plan dimensions 4 x 8 m was encountered at the location of trial pit CTP7. The tank was approximately 2.6 m deep and was an open top type structure. The structure was infilled with ashy brick fill and the perched water level in the structure was approximately 1.5 m below ground level. Water in the tank had brown LNAPL on the surface.
- The bottom of the Relief Holder Base structure was proved at 1.7 m below ground level. No live services were encountered passing over this structure and the structure was found to be approximately 12.5 m in diameter.
- Two separate areas of NAPL are present on the site. An area of brown LNAPL is present in the area of boreholes BH105 and CBH6. An area of grey LNAPL is present in the area of BH103.

Title: Within CTP7, the red brick walls of the rectangular structure were encountered.

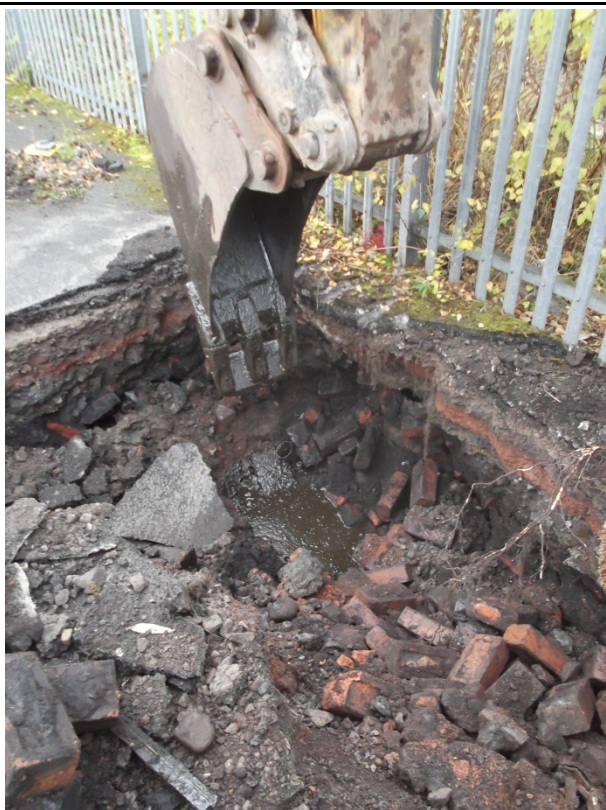
Plate No.:10

Title: Grossly contaminated silty perched waters were encountered within CTP7.
