**Bat Survey:** Wesley Methodist Church, South Street, Dowlais, Merthyr Tydfil,  
CF48 3DS

**Instructed by:** Karl Lewis of LeTrucco Design Limited

**Reported by:** Ecological Services Ltd  
10 Mount Pleasant, Llanelly Hill, Abergavenny, Monmouthshire, NP7 0NT

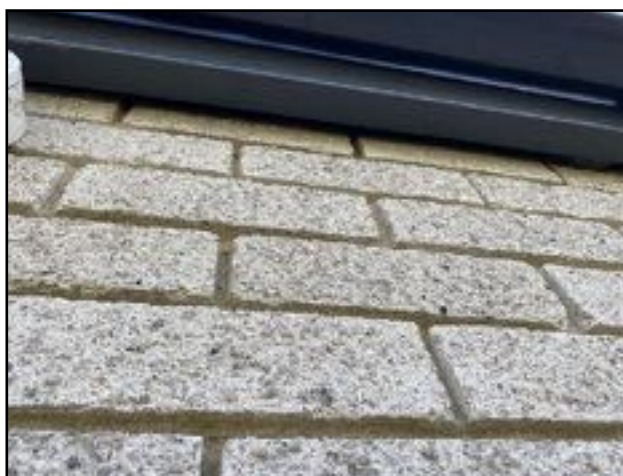
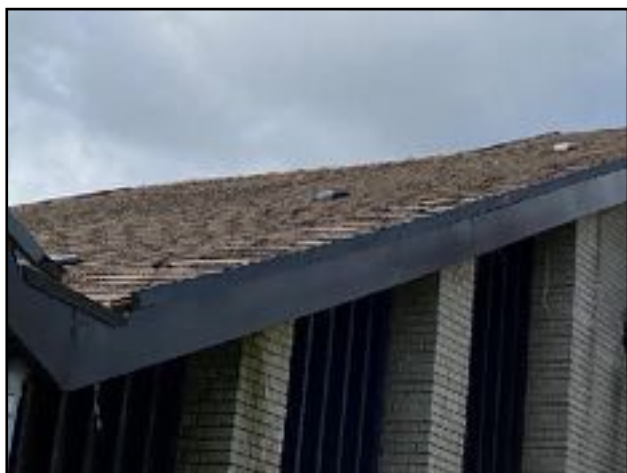
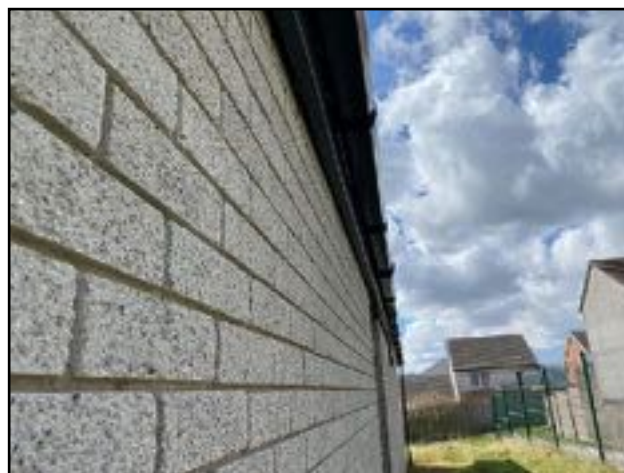
**6.6 Examples of apertures potentially allowing access to cavities in the building:**

**6.3 Due to the condition of the building, there were a small number of opportunities for bats to access and use the building and those that were available were deemed as having at least low to moderate potential for bat use. There were areas of slipped tiles and raised ridge tiles; apertures around the roof line and the roof dormer and an aperture along the entire length of fascia on the northern elevation of the building.**

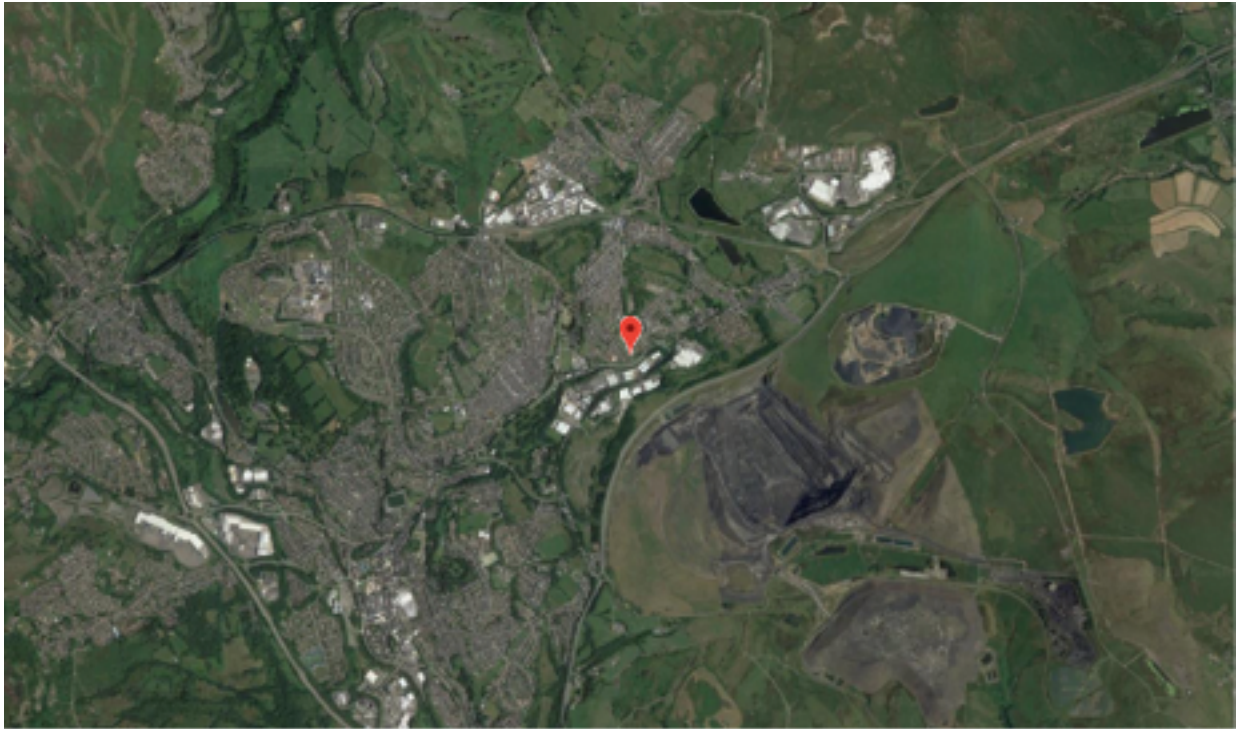
### **11.1 Aerial Site Photo**

**The site in its wider environment offering excellent ecological connectivity to the surrounding habitat.**

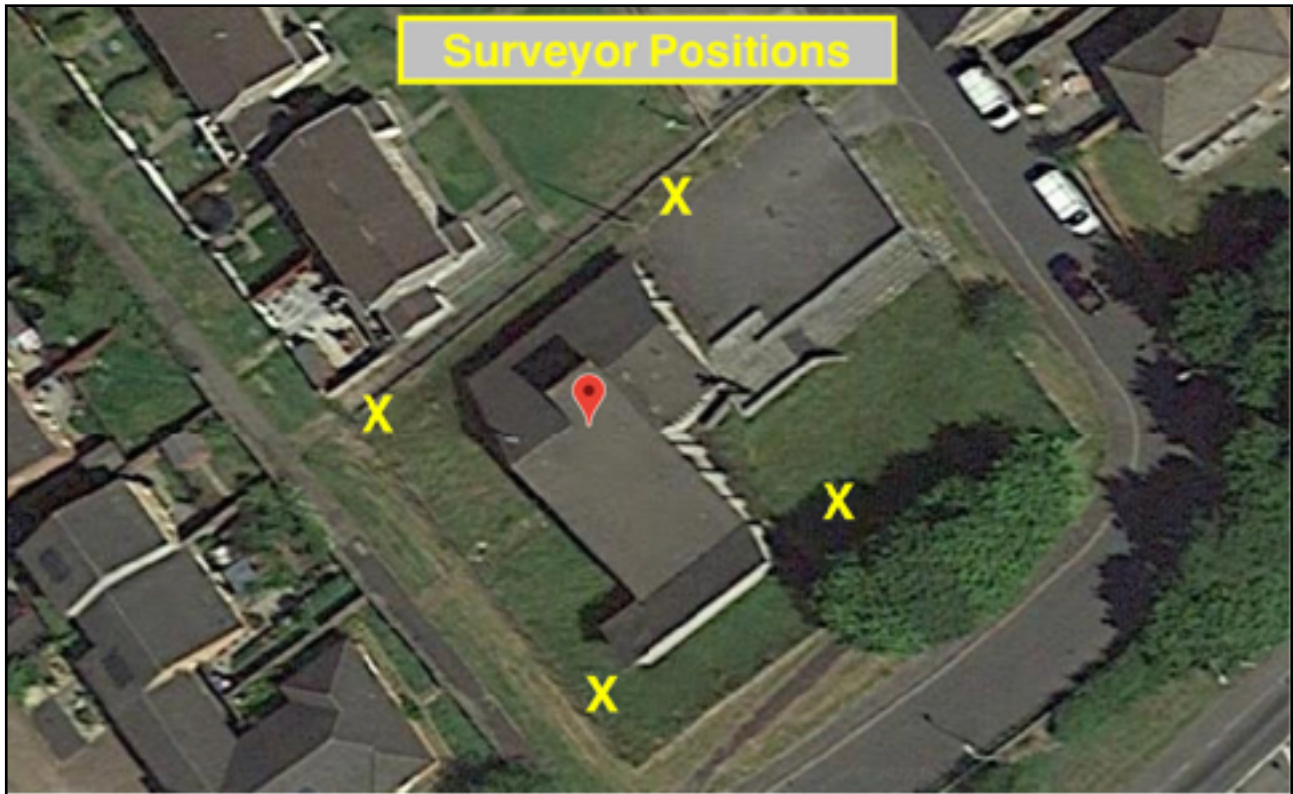
### 11.2 Surveyor Positions

**8.2** The emergence surveys gave extra consideration to the features identified during the external scoping survey which could be utilised by bats.

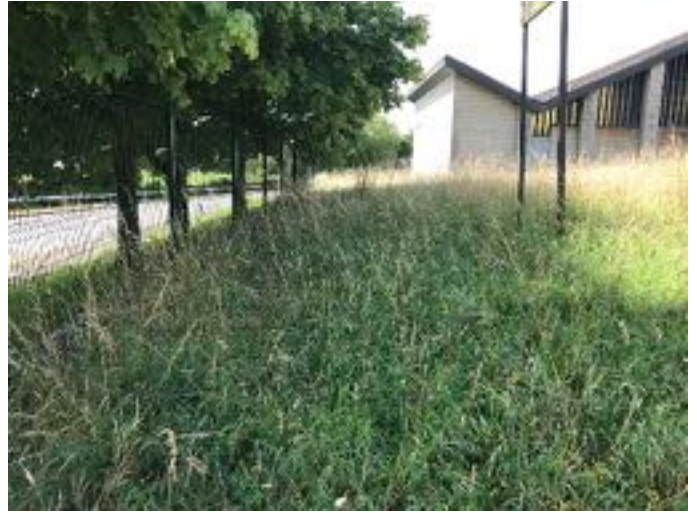
Southern portion of site within fence line

**2.7** Longer grassland which isn't regularly mown is present within the weld mesh fence that is present around the building. Species noted within the longer grassland include birds foot trefoil, cocksfoot, false oat grass, common hogweed, yorkshire fog, Knapweed, a species of bent grass thought to be creeping bent, ragwort and three orchids. The orchids were mostly going to seed making identification difficult but they were thought most likely to be common spotted orchid. The remaining habitat within the site boundary is tarmac car park and the former church building.

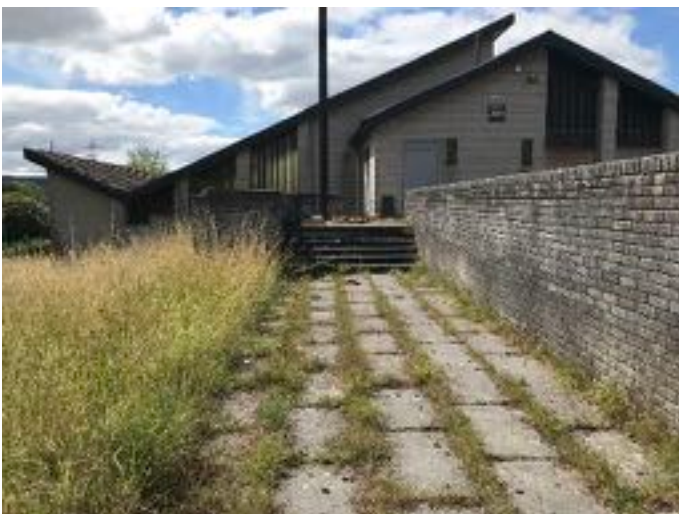
**2.1** Wesley Methodist Church is a detached, single storey, brick building with a multiple tiled apex roof. There is a dry verge and plastic fascia and soffits present and there is likely to be a cavity wall. There is a single brick built roof dormer present with a tiled lean-to roof and plastic fasciae and soffits.

Church building
