*Report No. BC/MB/12.19.04.*

**Coal Mining Risk Assessment:  
Land to the Rear of Brackendale,  
Heolgerrig, Merthyr Tydfil.**

The report reviews the geology and mining history of the property and the immediately surrounding area as they may affect a proposal to develop an office and a garage on the land. Recommendations are made for exploratory boreholes to determine the details of shallow mine workings in the Six Feet Seam in order to assess the risk in greater detail.

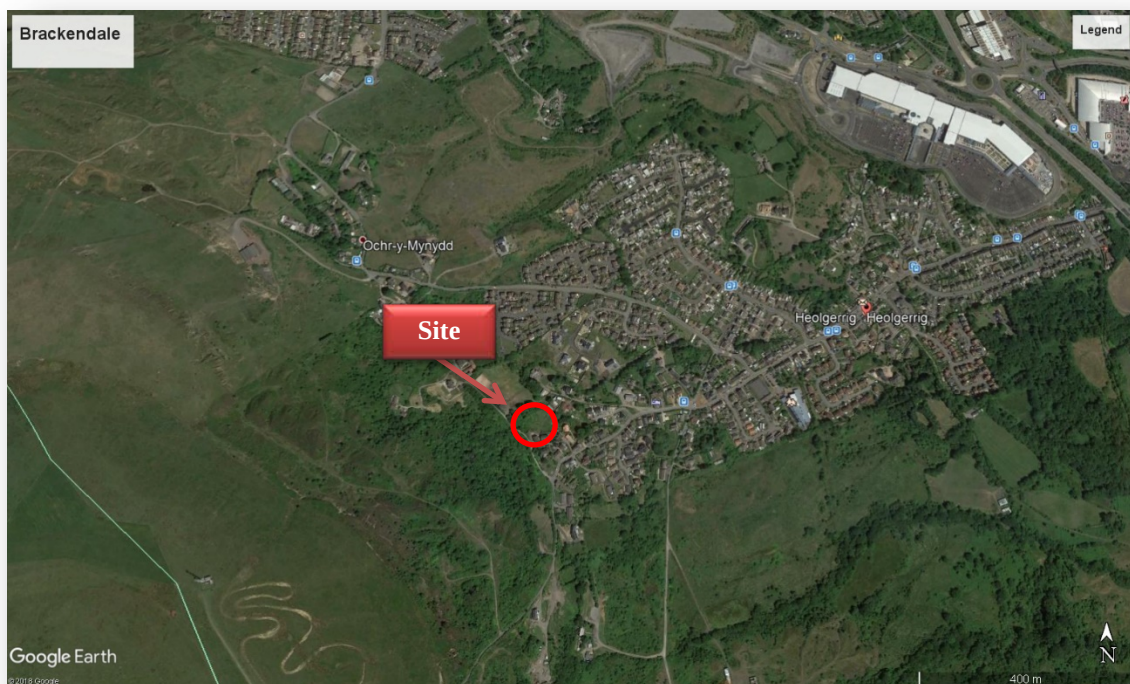
**Figure 1**  
**Aerial View of Property**

The parcel of land which is the subject of this report ('the Site') is situated on the upper slopes of Mynydd Aberdâr, approximately 2km west of the centre of the town of Merthyr Tydfil (see Figure 1 and *General Location Plan, drawing no. BC/MB/12.19.04.01*). The Site is on the south-western fringes of Heolgerrig and is located within a semi-rural landscape bounded on the east and south by detached dwellings and on the north and west by agricultural enclosures and open hillside. The Site is irregular in outline and has approximate maximum dimensions of 44m by 27m; it slopes eastwards at elevations of between 320m and 314m above ordnance datum.

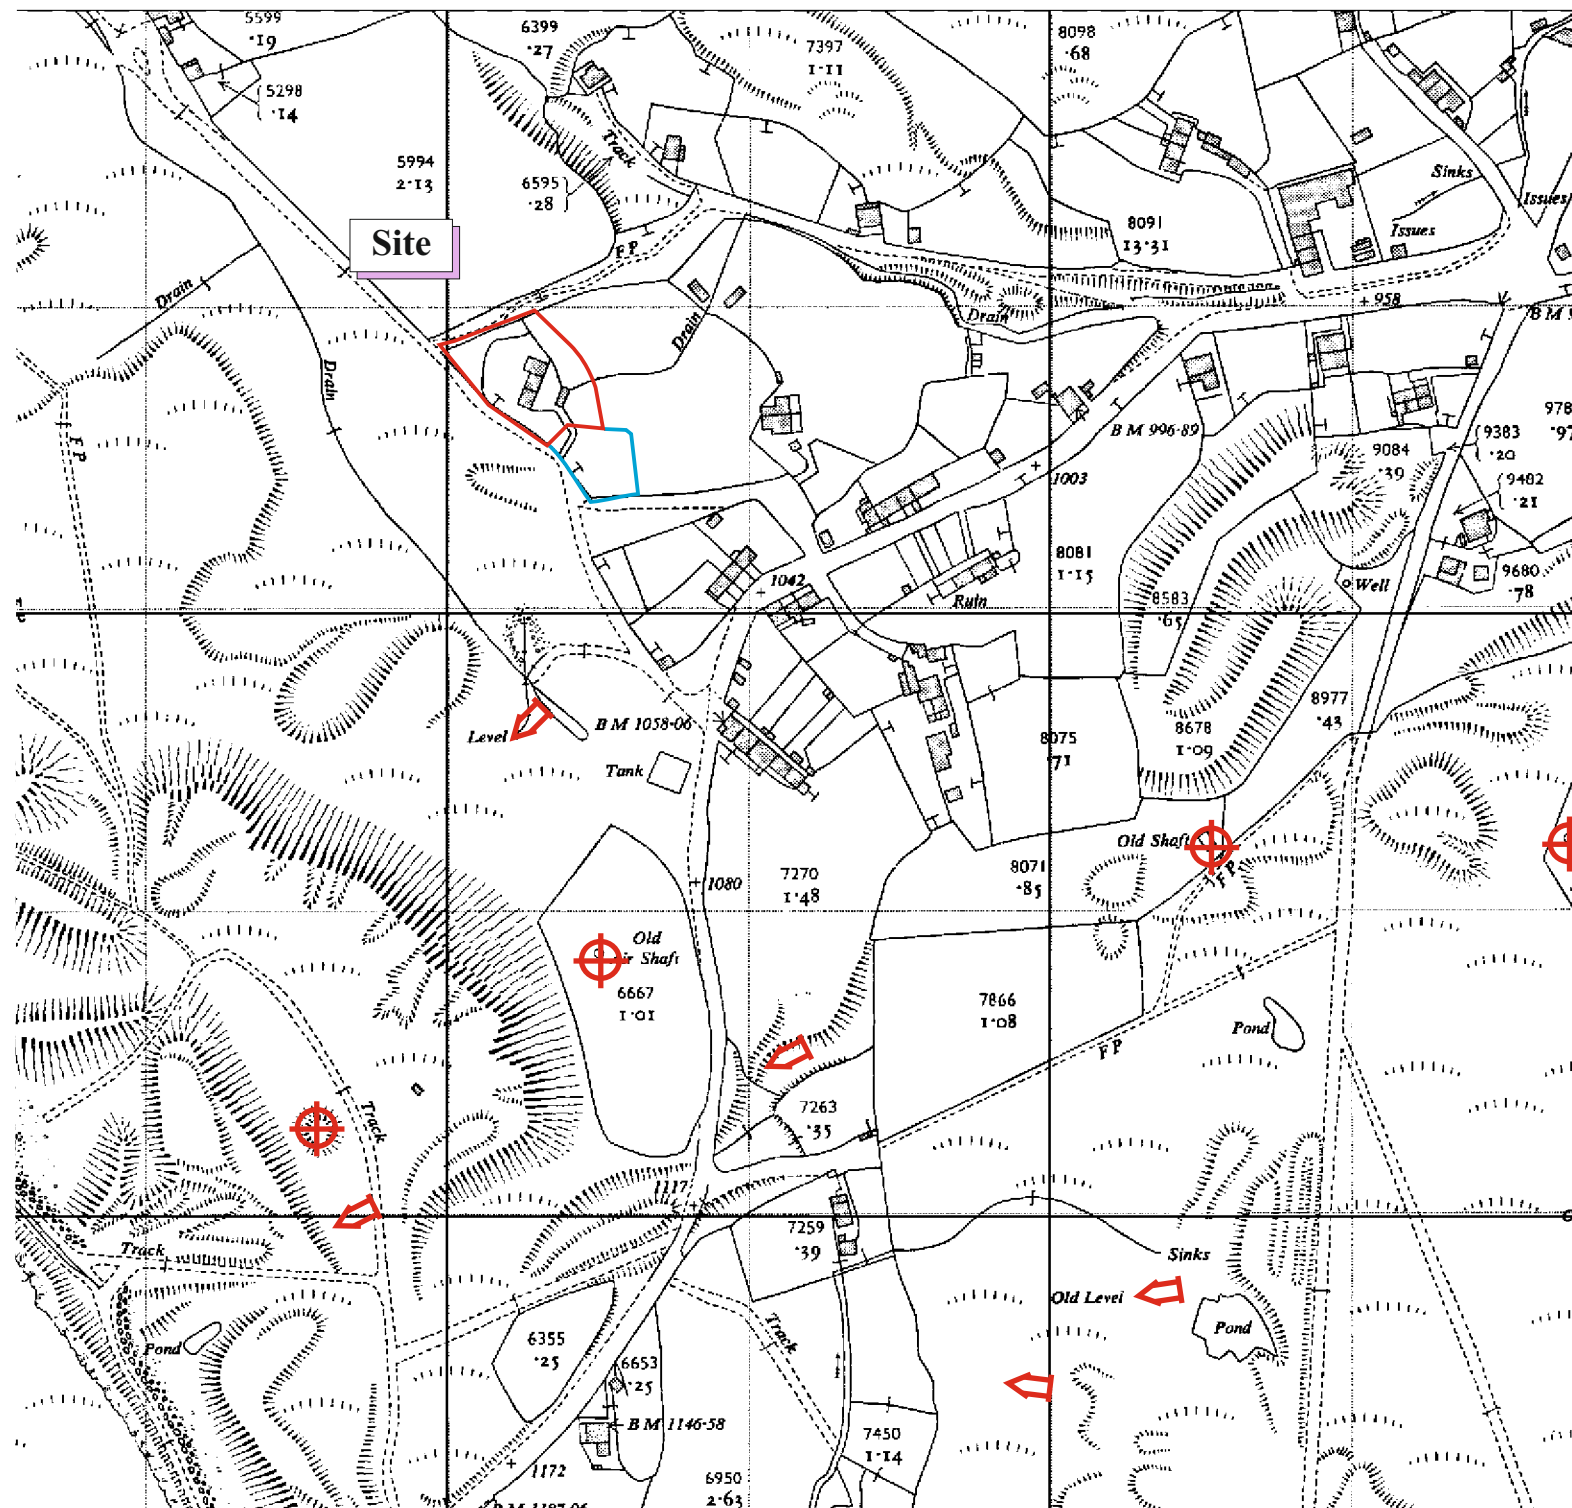
Drawing No: BC/MB/12.19.04.07.

There are several disused shafts and adits in the vicinity of the Site; their locations have been derived from the several editions of the Ordnance Survey Sheets and shown on the Extracts from the Ordnance Survey Sheets, drawing nos. BC/MB/12.19.04.04 to BC/MB/12.19.04.07. The nearest disused mine entry to the Site is a disused adit approximately 80m south of the Site.

## *Extract from Ordnance Survey Sheet 1958 - 1964.*
