# **PRELIMINARY ROOST ASSESSMENT, 74, PONTMARLAIS, MERTHYR TYDFIL.**

**On behalf of**

**MERTHYR TYDFIL COUNTY BOROUGH  
COUNCIL**

**December 2020**

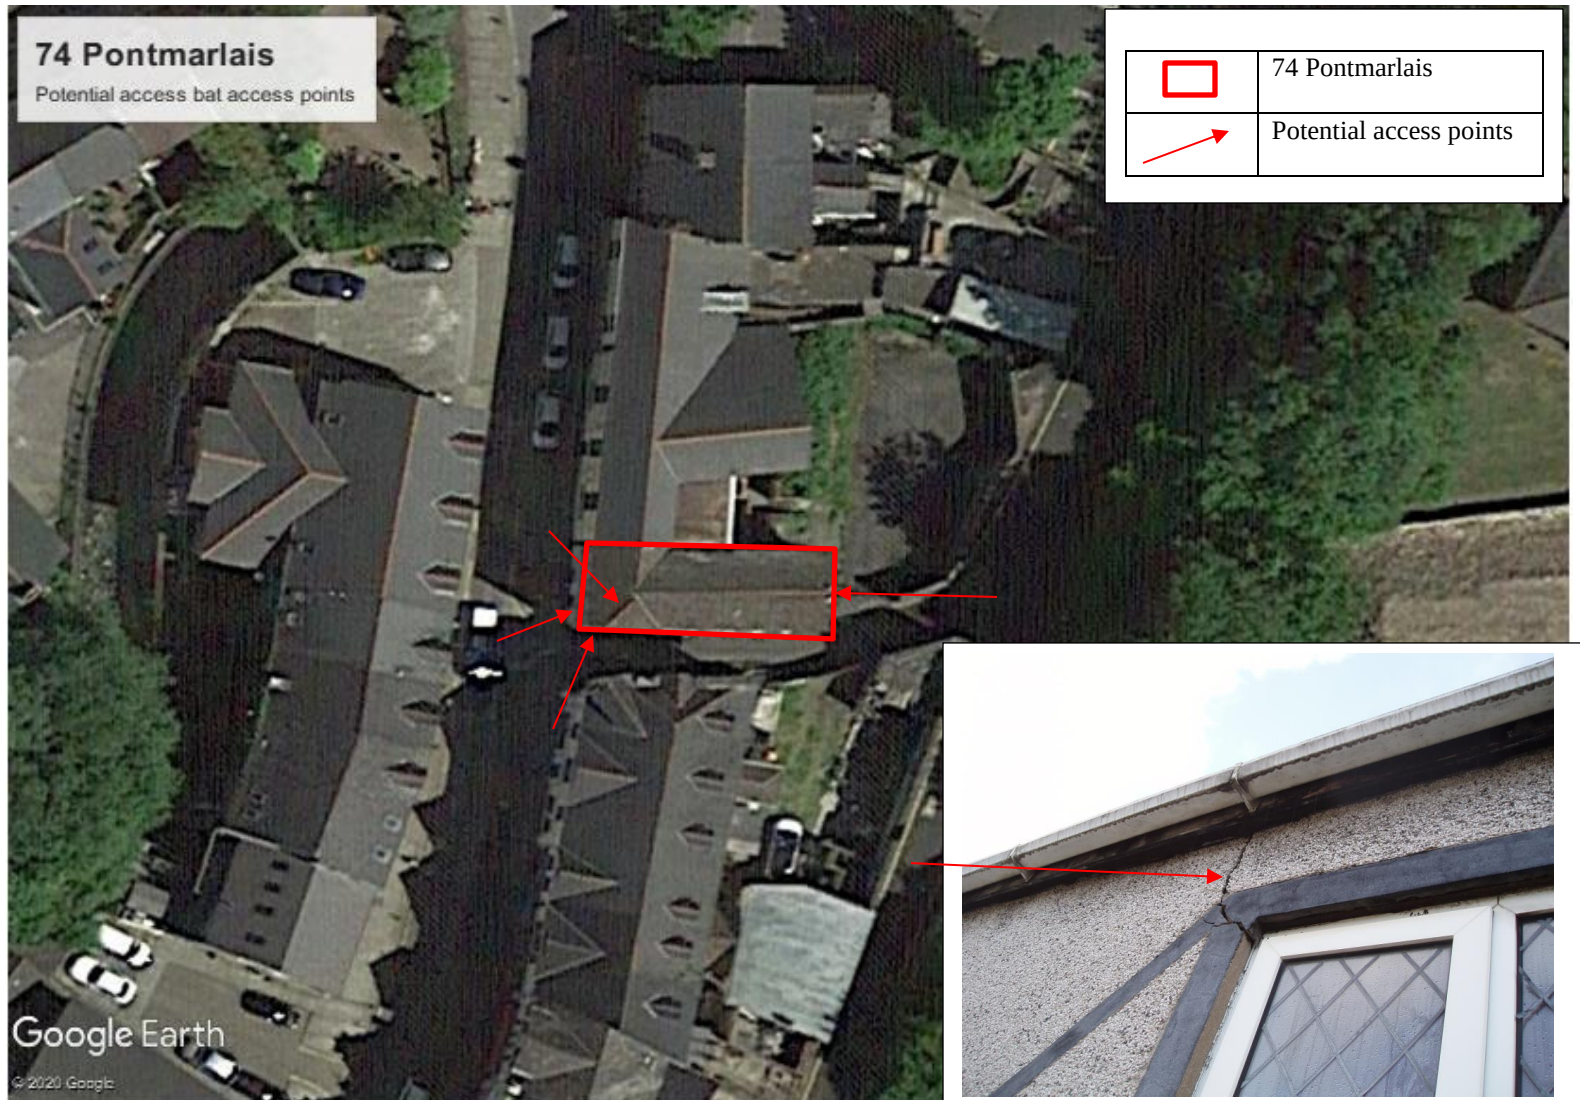
**FIGURE 1**  
**LOCATION OF 74 PONTMARLAIS AND POTENTIAL BAT ACCESS POINTS**

- 5.1 74 Pontmarlais fronts onto the High Street, Merthyr Tydfil and is an end of terrace building with an 'L' shaped configuration. It is a three storey building which is used for holiday and longer term letting. Photographs of the building are given in Appendix 1; potential access points are highlighted in Figure 1.

- 7.1 The daytime inspection of the building found no direct evidence of bats using the building for roosting purposes but limited potential for them to access the wall tops via cracks at the front of the building and gaps at the front corner of the building and at the rear gable under the fascia boards.

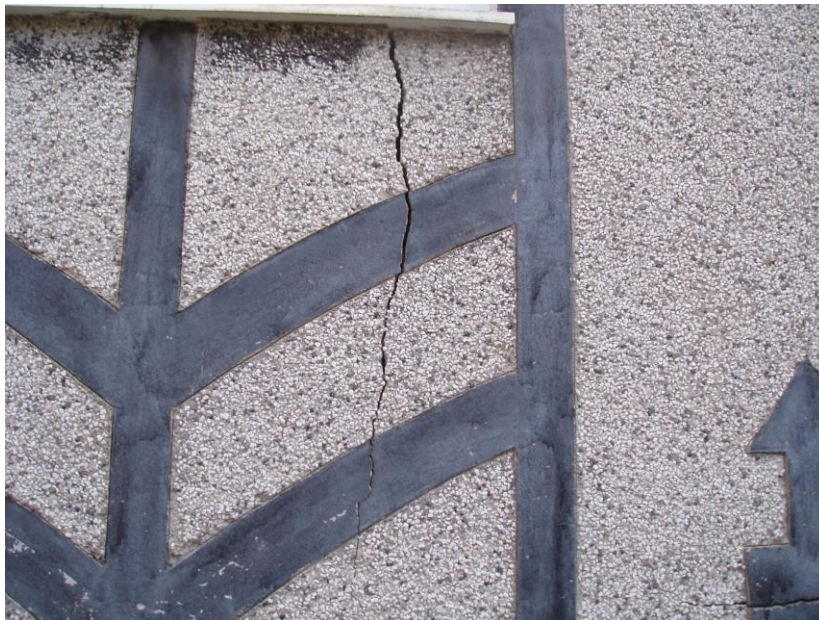
The large crack below the window on the second floor facing the main road

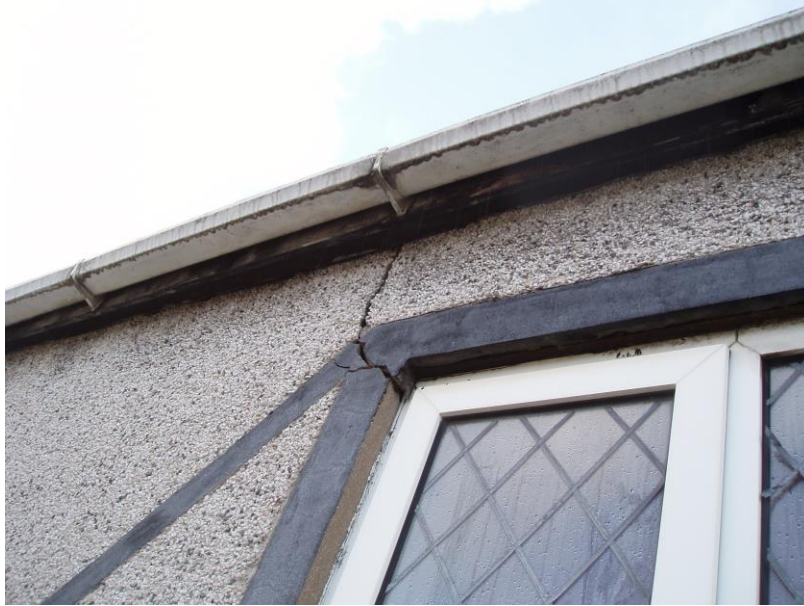
The large crack above the window

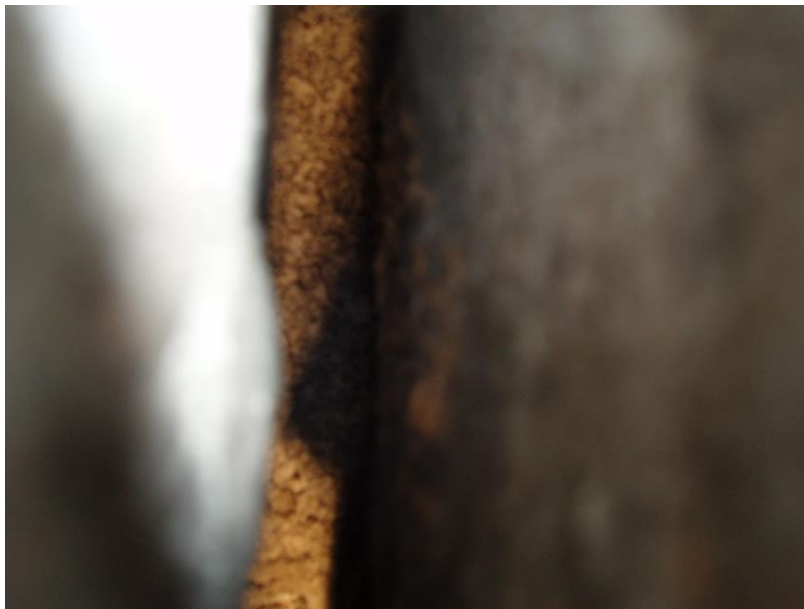
Looking into the main crack with the endoscope, no evidence of bats

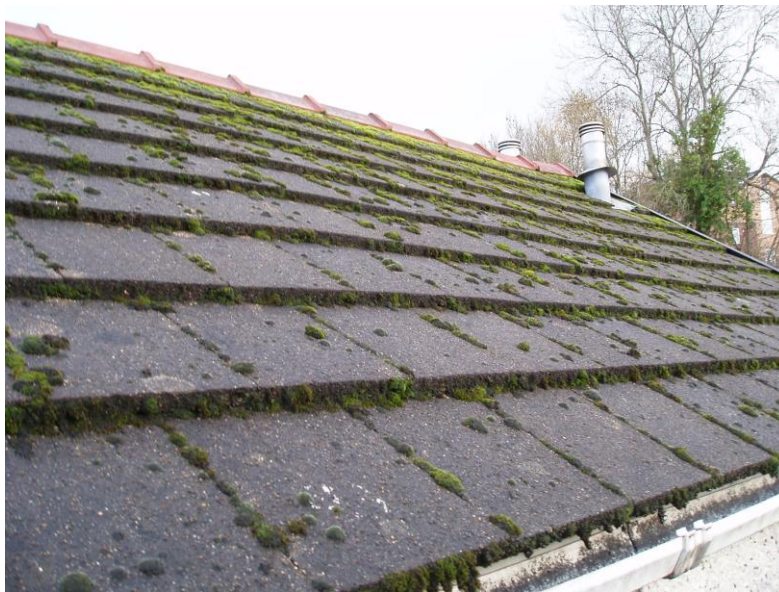
- 5.5 The roof is concrete pan tile covered with clay ridge tiles. There is a hipped gable at the southern elevation, where previous roof alterations have taken place, and a gable at the end of the western facing extension adjacent to Tramroadside North. The roof appears to be in a fair condition with only a few gaps noted in the ridge tiles, potential bat access to the roof via the roof cover was considered unlikely.

Roof condition

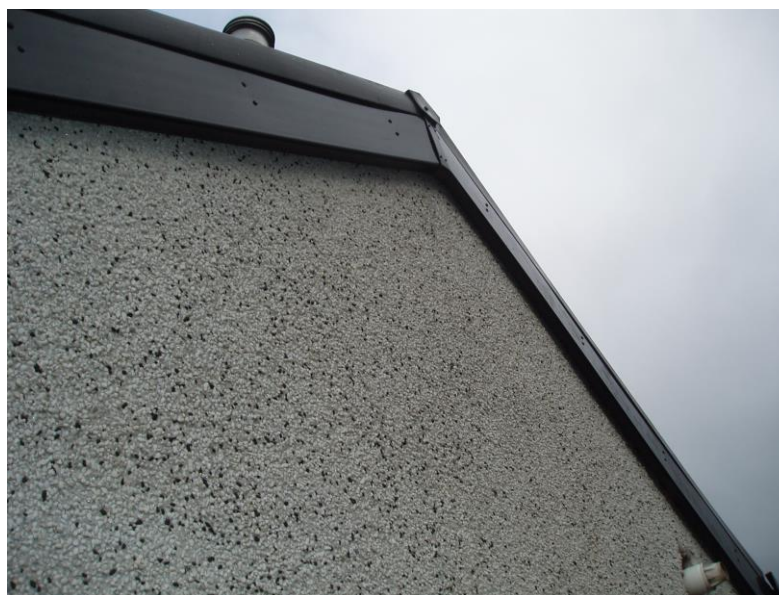
Eastern facing gable, from MUPE

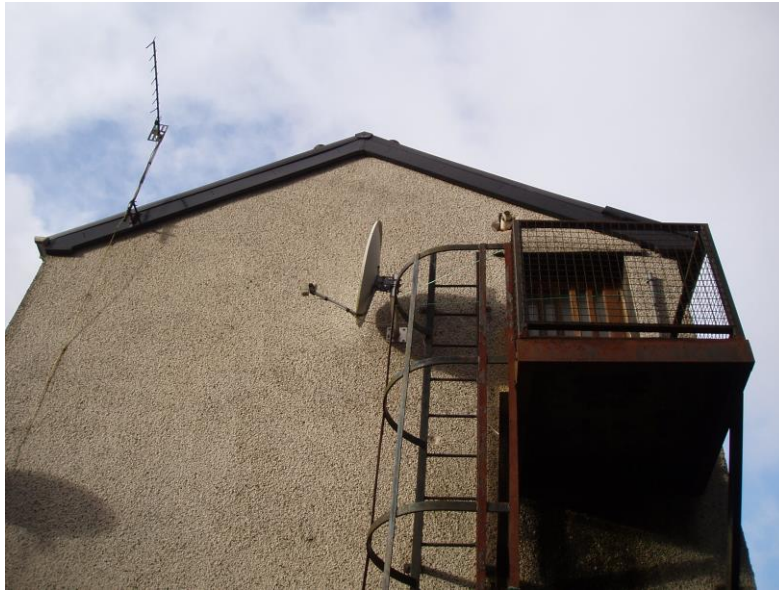
- 5.4 Some gaps were noted under the fascia boards and the front corner of the building where alterations to the property were made in the past and at the rear of the building where new fascia UPVC boards are present. The gaps at the front of the building are limited and immediately adjacent to a lamp standard. At the rear (towards Tramroadside North), the boards potentially allow access to the wall tops. An inspection with the endoscope showed these to be clean with no direct evidence of bats using the building. The gables along the building side elevations were tightly sealed.

Eastern facing gable, gaps beneath UPVC fascia

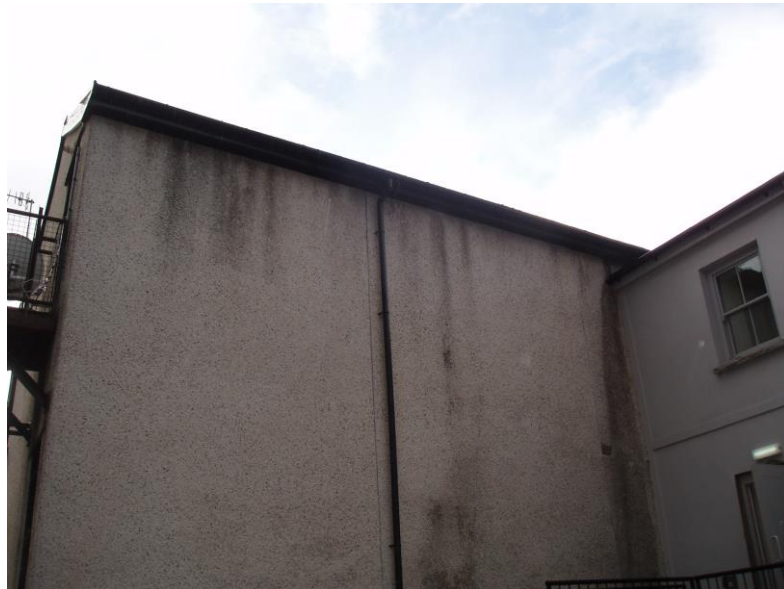
North facing elevation, new soffit, tightly sealed
