## **Arboricultural Method Statement**

### **Premier Inn Hotels**

**Premier Inn,  
Duffryn,  
Pentrebacj,  
Merthyr Tydfil,  
CF48 4BB**

**30 April 2024**

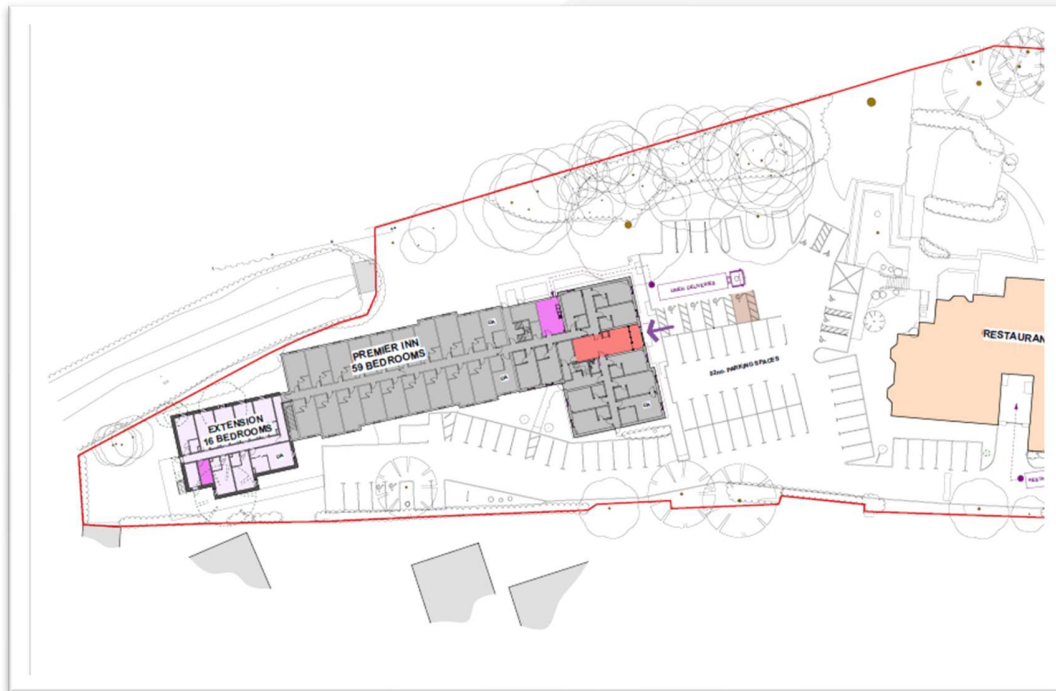
**Figure 3:** Proposed scheme, drawings “proposed site plan - option 3”, drawing No 6153-F-PROP (Axiom Architects)

The proposed scheme for the site is to extend the existing hotel, adding 16 new bedrooms.
