Merthyr Branch  
Wales & Borders

Trees with Bat Roost Potential

## Appendix B: Dusk Emergence / Dawn Re-entry Survey Results

## Appendix C: Bat Tree Photographs

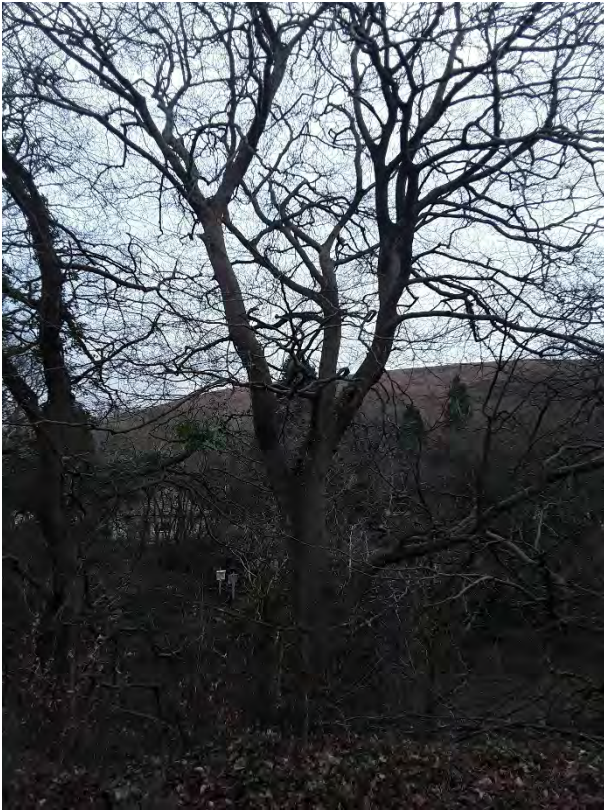
Photo 1: MER 1 Beech with moderate bat roost potential.

| Tree Number | Location (Grid Reference) | Location (ELR Mileage and Chain) | Survey 1 | | Survey 2 | | Notes |
|---|---|---|---|---|---|---|---|
| MER 1 | ST 08378 94927 | CAM 16m 46ch | 13/06/2021 | Dusk Emergence Survey | 18/07/2021 | Dusk Emergence Survey | No emergences recorded. Mainly P.pyg and P.pip foraging and commuting activity along rail corridor and adjacent woodland. |

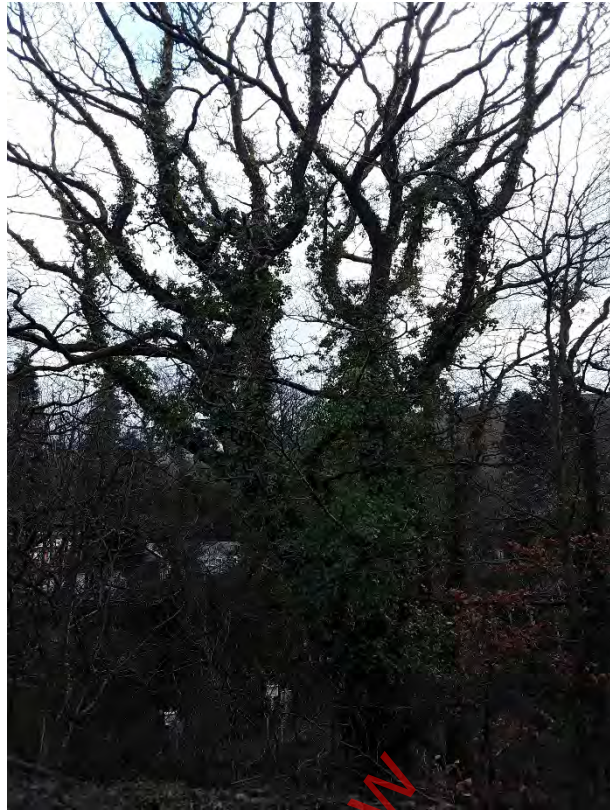
Photo 2: MER 2 Oak sp. with moderate bat roost potential.

| Tree Number | Location (Grid Reference) | Location (ELR Mileage and Chain) | Survey 1 | | Survey 2 | | Notes |
|---|---|---|---|---|---|---|---|
| MER 2 | ST 08386 94940 | CAM 16m 47ch | 13/06/2021 | Dusk Emergence Survey | 18/07/2021 | Dusk Emergence Survey | No emergences recorded. Mainly P.pyg activity with occasional P.pip, noctule and BLE. |

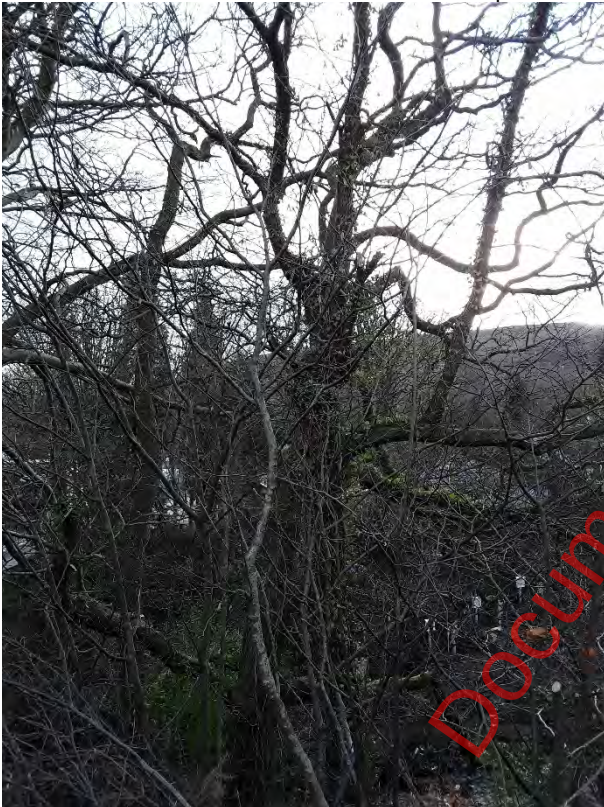
Photo 3: MER 3 Oak sp. with moderate bat roost potential.

| Tree Number | Location (Grid Reference) | Location (ELR Mileage and Chain) | Survey 1 | | Survey 2 | | Notes |
|---|---|---|---|---|---|---|---|
| MER 3 | ST 08391 94948 | CAM 16m 48ch | 13/06/2021 | Dusk Emergence Survey | 18/07/2021 | Dusk Emergence Survey | No emergences recorded. High P.pyg foraging activity within the understory surrounding the tree, with occasional P.pip and myotis activity. |

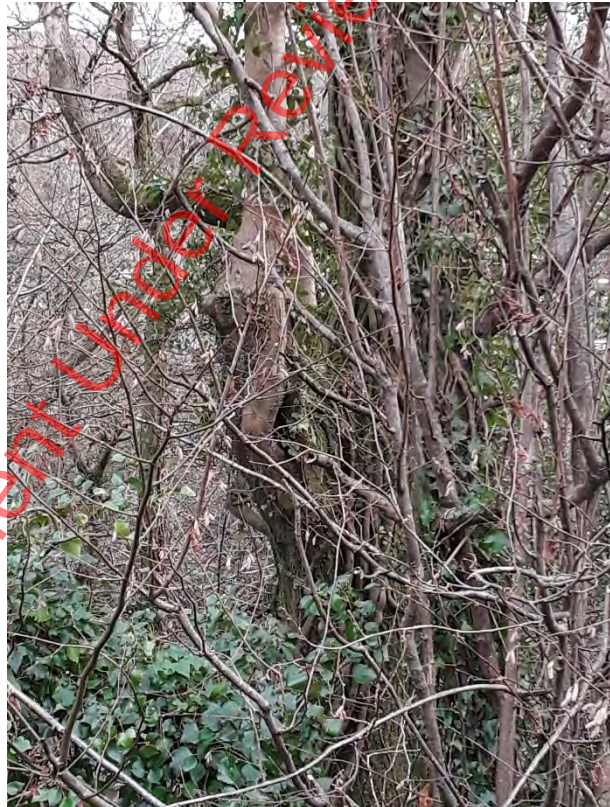
Picture 4: MER 4 ash with moderate bat roost potential.

| Tree Number | Location (Grid Reference) | Location (ELR Mileage and Chain) | Survey 1 | | Survey 2 | | Notes |
|---|---|---|---|---|---|---|---|
| MER 4 | ST 08465 95023 | CAM 16m 52ch | 19/07/2021 | Dusk Emergence Survey | N/A | N/A | No emergences recorded. High P.pyg and noctule foraging and commuting activity, with occasional P.pip and myotis activity. |
