## Tree Survey, Categorisation & Constraints Report

in accordance with  
BS 5837:2012 (Survey Phase 4.4, 4.5 & 4.6)

At  
Quakers Yard Station CVL-MER

Dated: January 2023

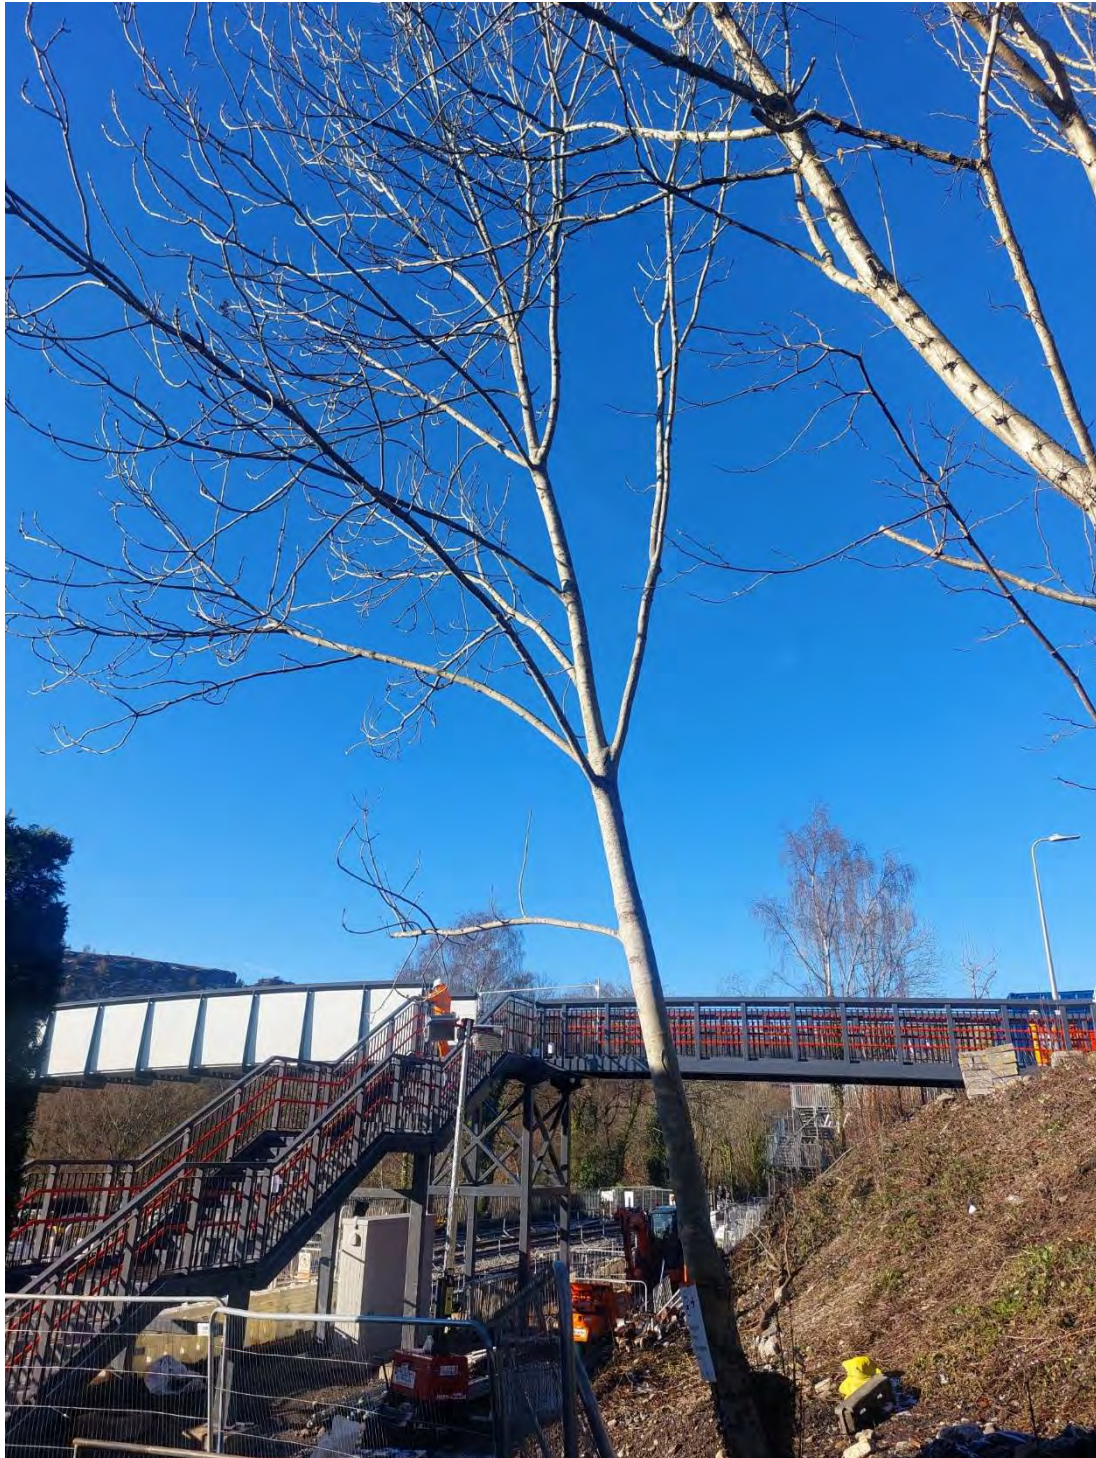
Photograph 1. Tree 2- Lost stem has left an asymmetrical crown.

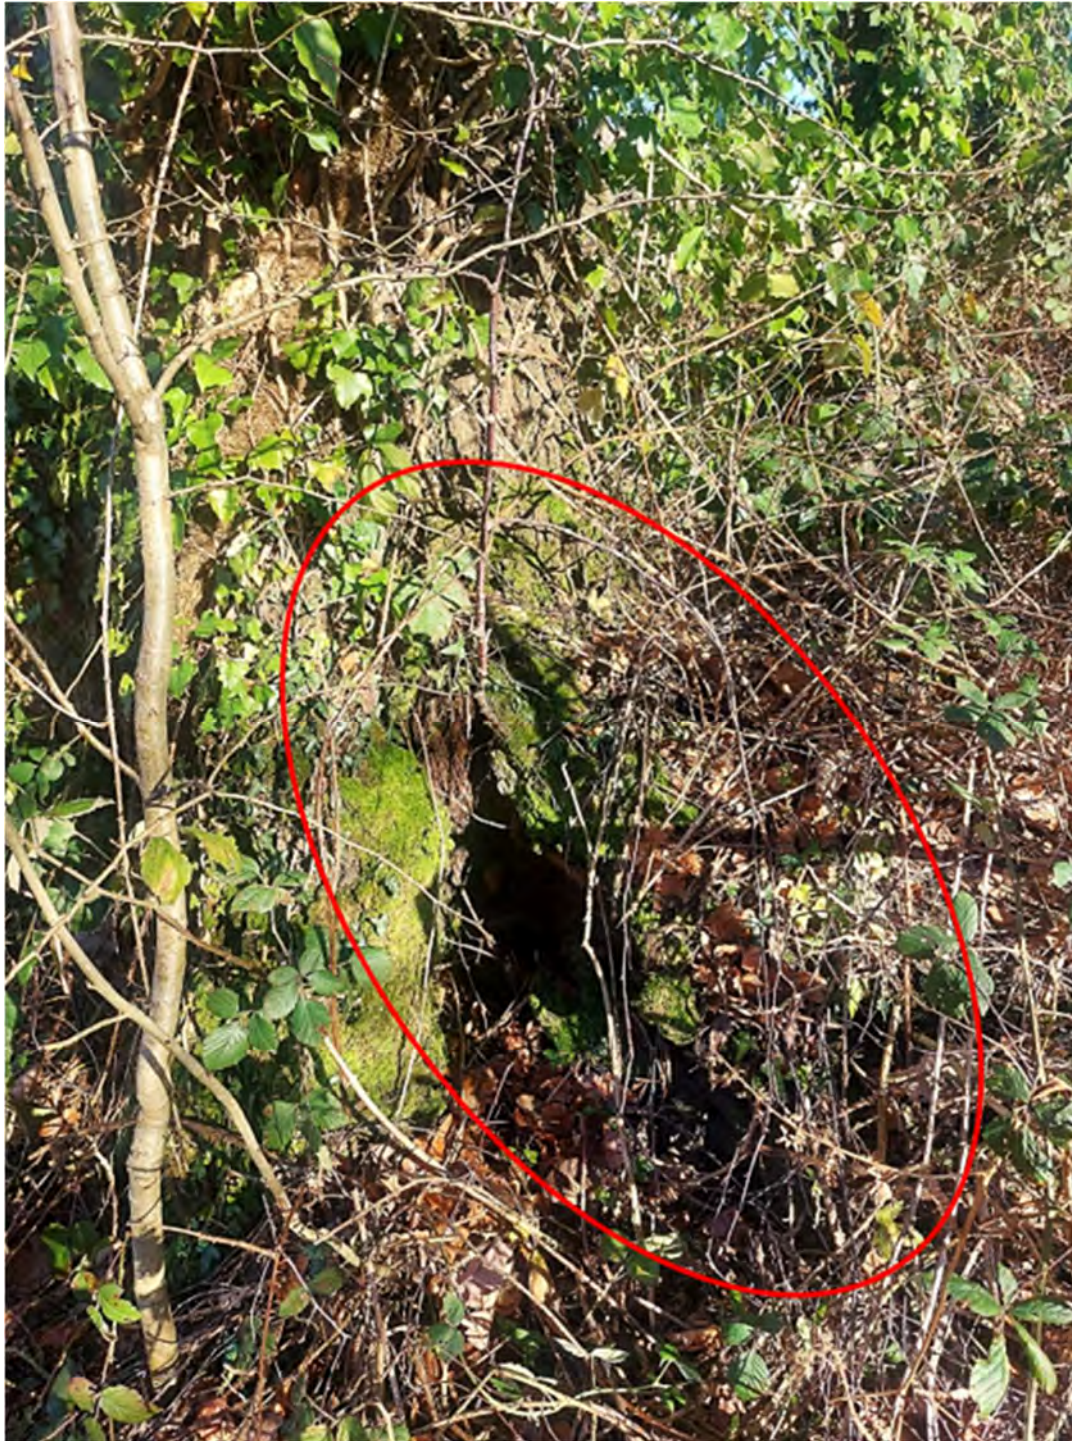
| Ref. | Species | Height (m) | Effectual Diameter (mm) | Crown Spread (m) | | | | Lowest Branch | Canopy Clearance (m) | Life Stage | General Observations | Preliminary Management Recommendations | Remaining Contribution (years) | Retention Category | RPA Area (m3) | RPA Radius (m) | Photos |
|---|---|---|---|---|---|---|---|---|---|---|---|---|---|---|---|---|---|
| T9 | Silver birch | 12.0 | 550 | 5.0 | 5.0 | 5.0 | 5.0 | 4(E) | 4.0 | Mature | Tree situated on neighbouring land. Decay cavity observed on south side of the base with significantly decayed buttresses. 35° stem lean to the north. | Liaise with neighbouring landowner to discuss removal. | <10 | U | 0 | 0.0 | / |

Photograph 2. Tree 9- Decay cavity observed on south side of the base with significantly decayed buttresses. 35° stem lean to the north.

Your attention is drawn to the condition of tree numbers T3, T4, T9, T10, T12. These trees are considered to be in a dangerous condition, and the remedial actions within the management recommendations of the Schedule of Findings must be immediately implemented.
