CONTAMINATED LAND RISK ASSESSMENT

M.T.C.B.C. PLANNING APP. P/25/0247

NEW STORAGE UNIT WITH OFFICE

ABERCANAID INDUSTRIAL ESTATE

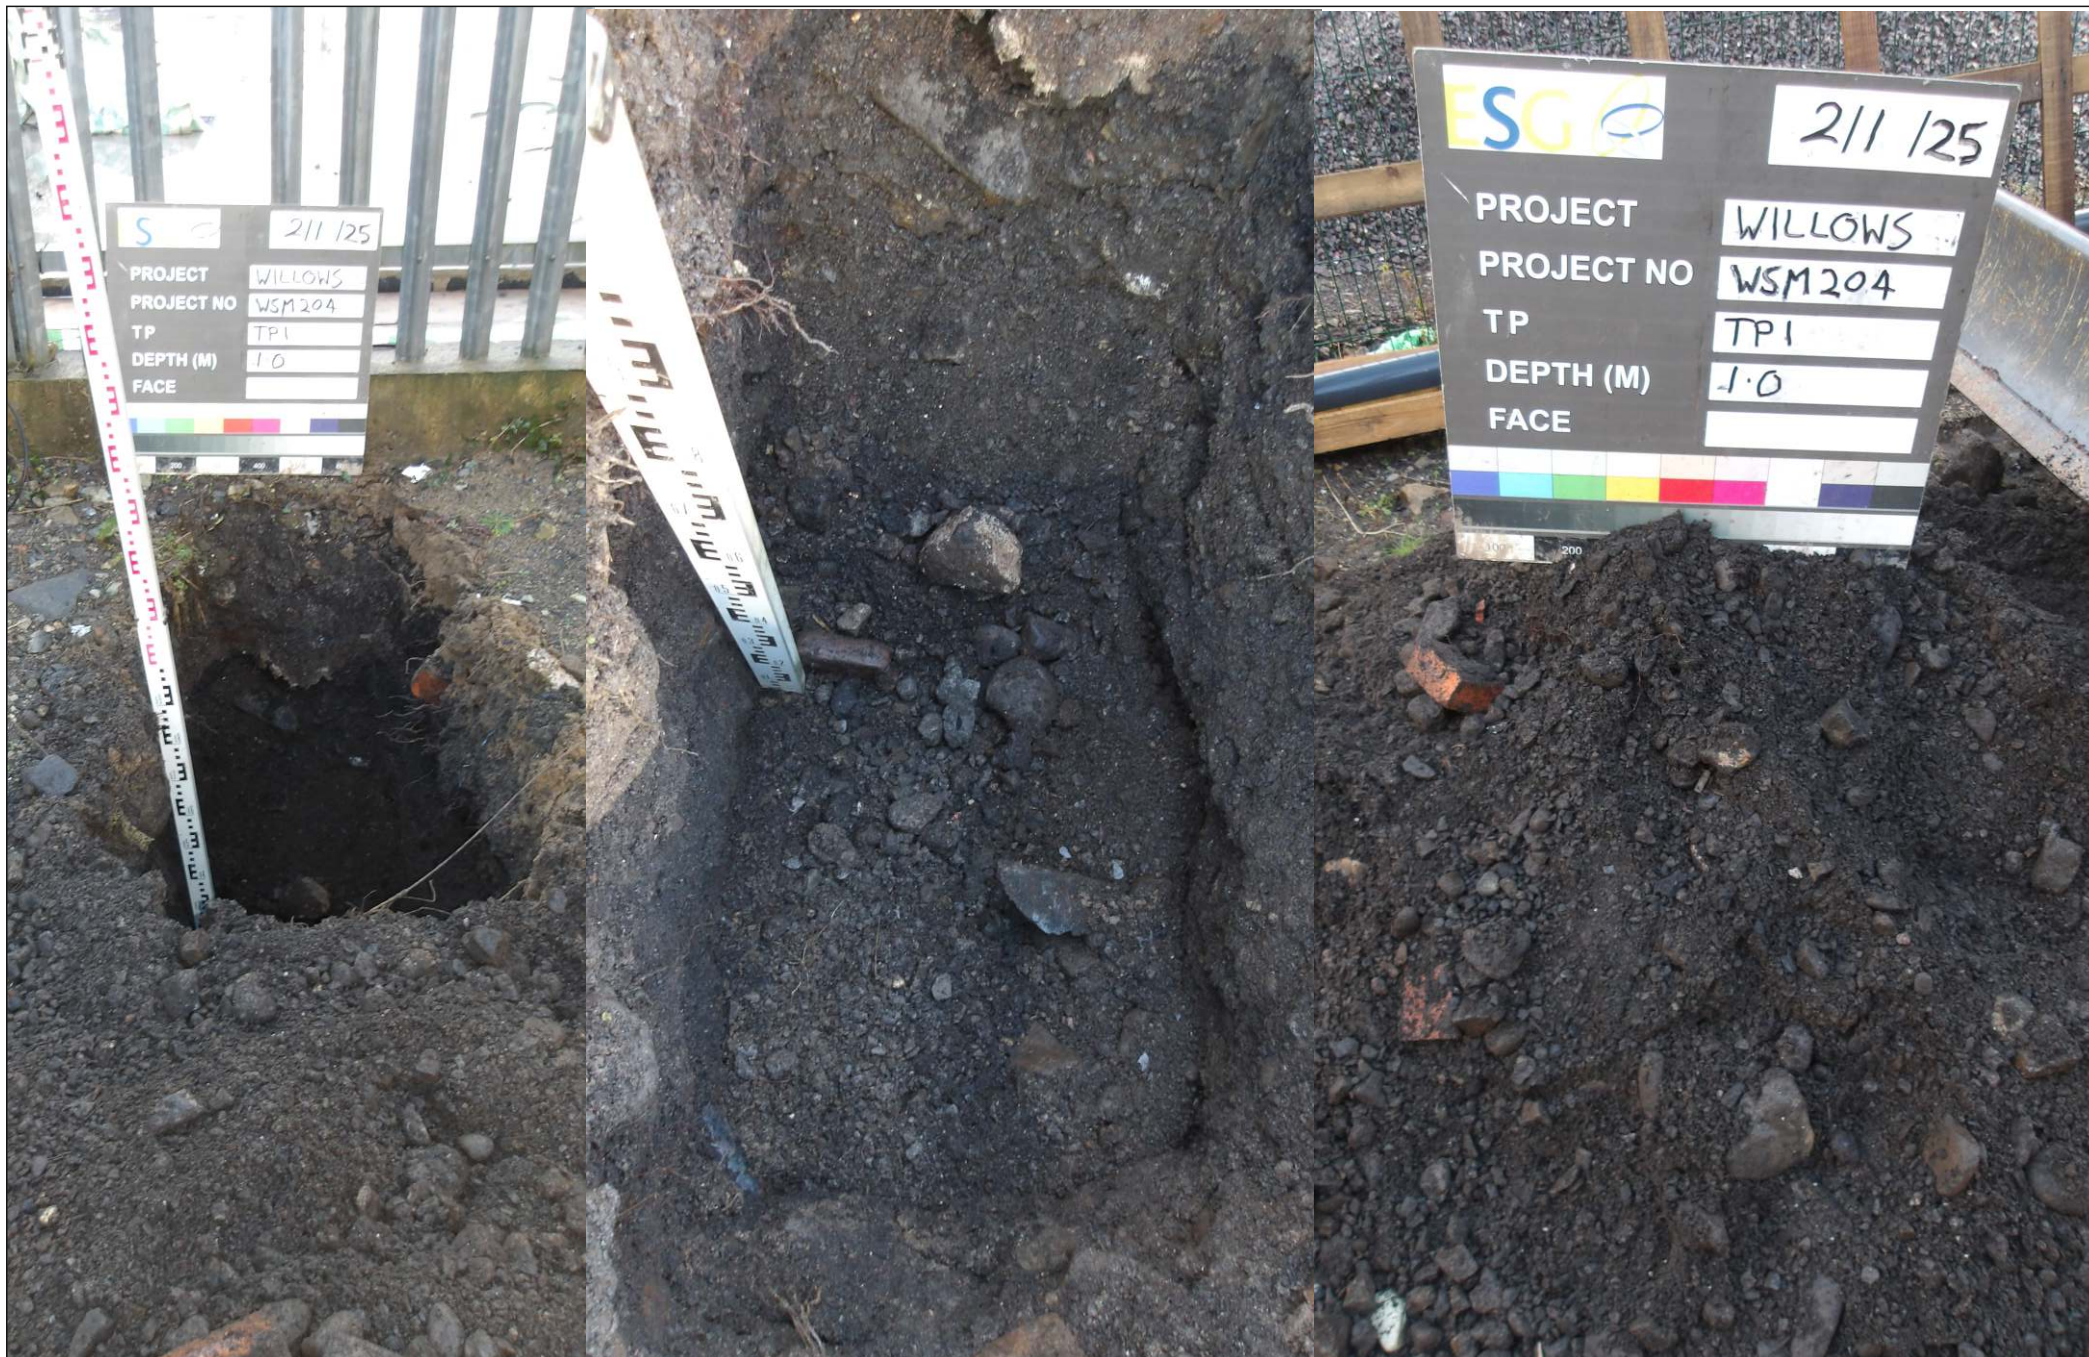
TP 1 THE WILLOWS

| Samples and Tests | | Strata | |
|---|---|---|---|
| | | G.L. | COMPACTED LIMESTONE |
| | | 0.15 | AGGREGATE |
| | | 1.0 | MADE GROUND. Loose to Medium dense black, sandy GRAVEL. Gravel is anular to rounded, fine to coarse of Quartzite (rounded) brick, slag and colliry waste (angular). |

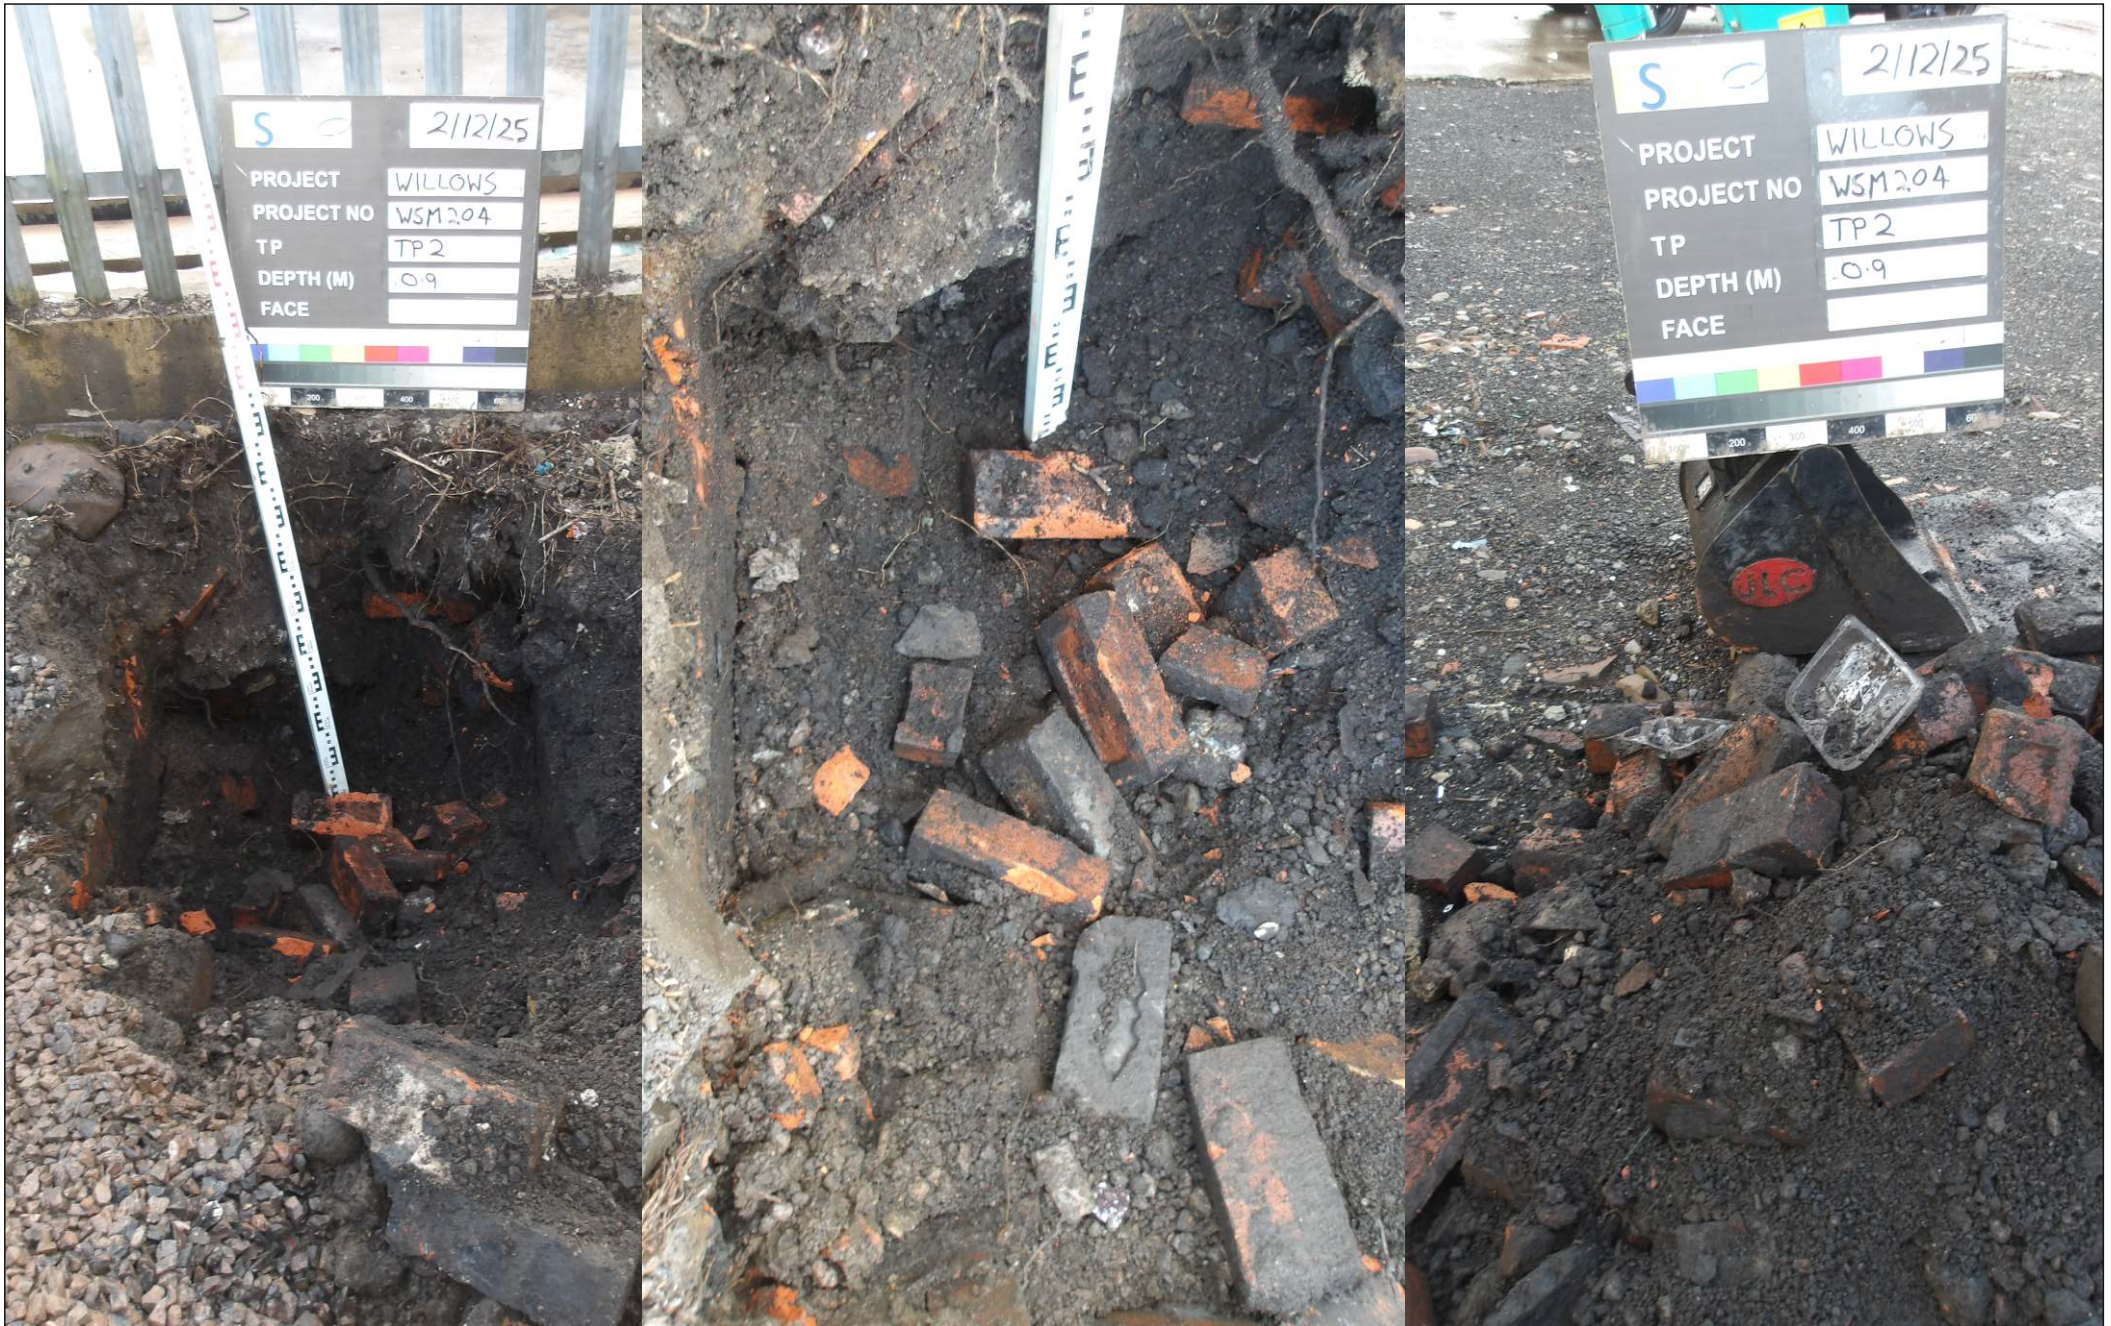
TP 2 THE WILLOWS

| Samples and Tests | | Strata | |
|---|---|---|---|
| | | G.L. | COMPACTED LIMESTONE |
| | | 0.15 | AGGREGATE |
| | | 0.9 | MADE GROUND. Loose to Medium dense black, sandy GRAVEL. Gravel is anular to rounded, fine to coarse of Quartzite (rounded) brick, slag and colliery waste (angular). In-situ brickwork and loose metal pipe |

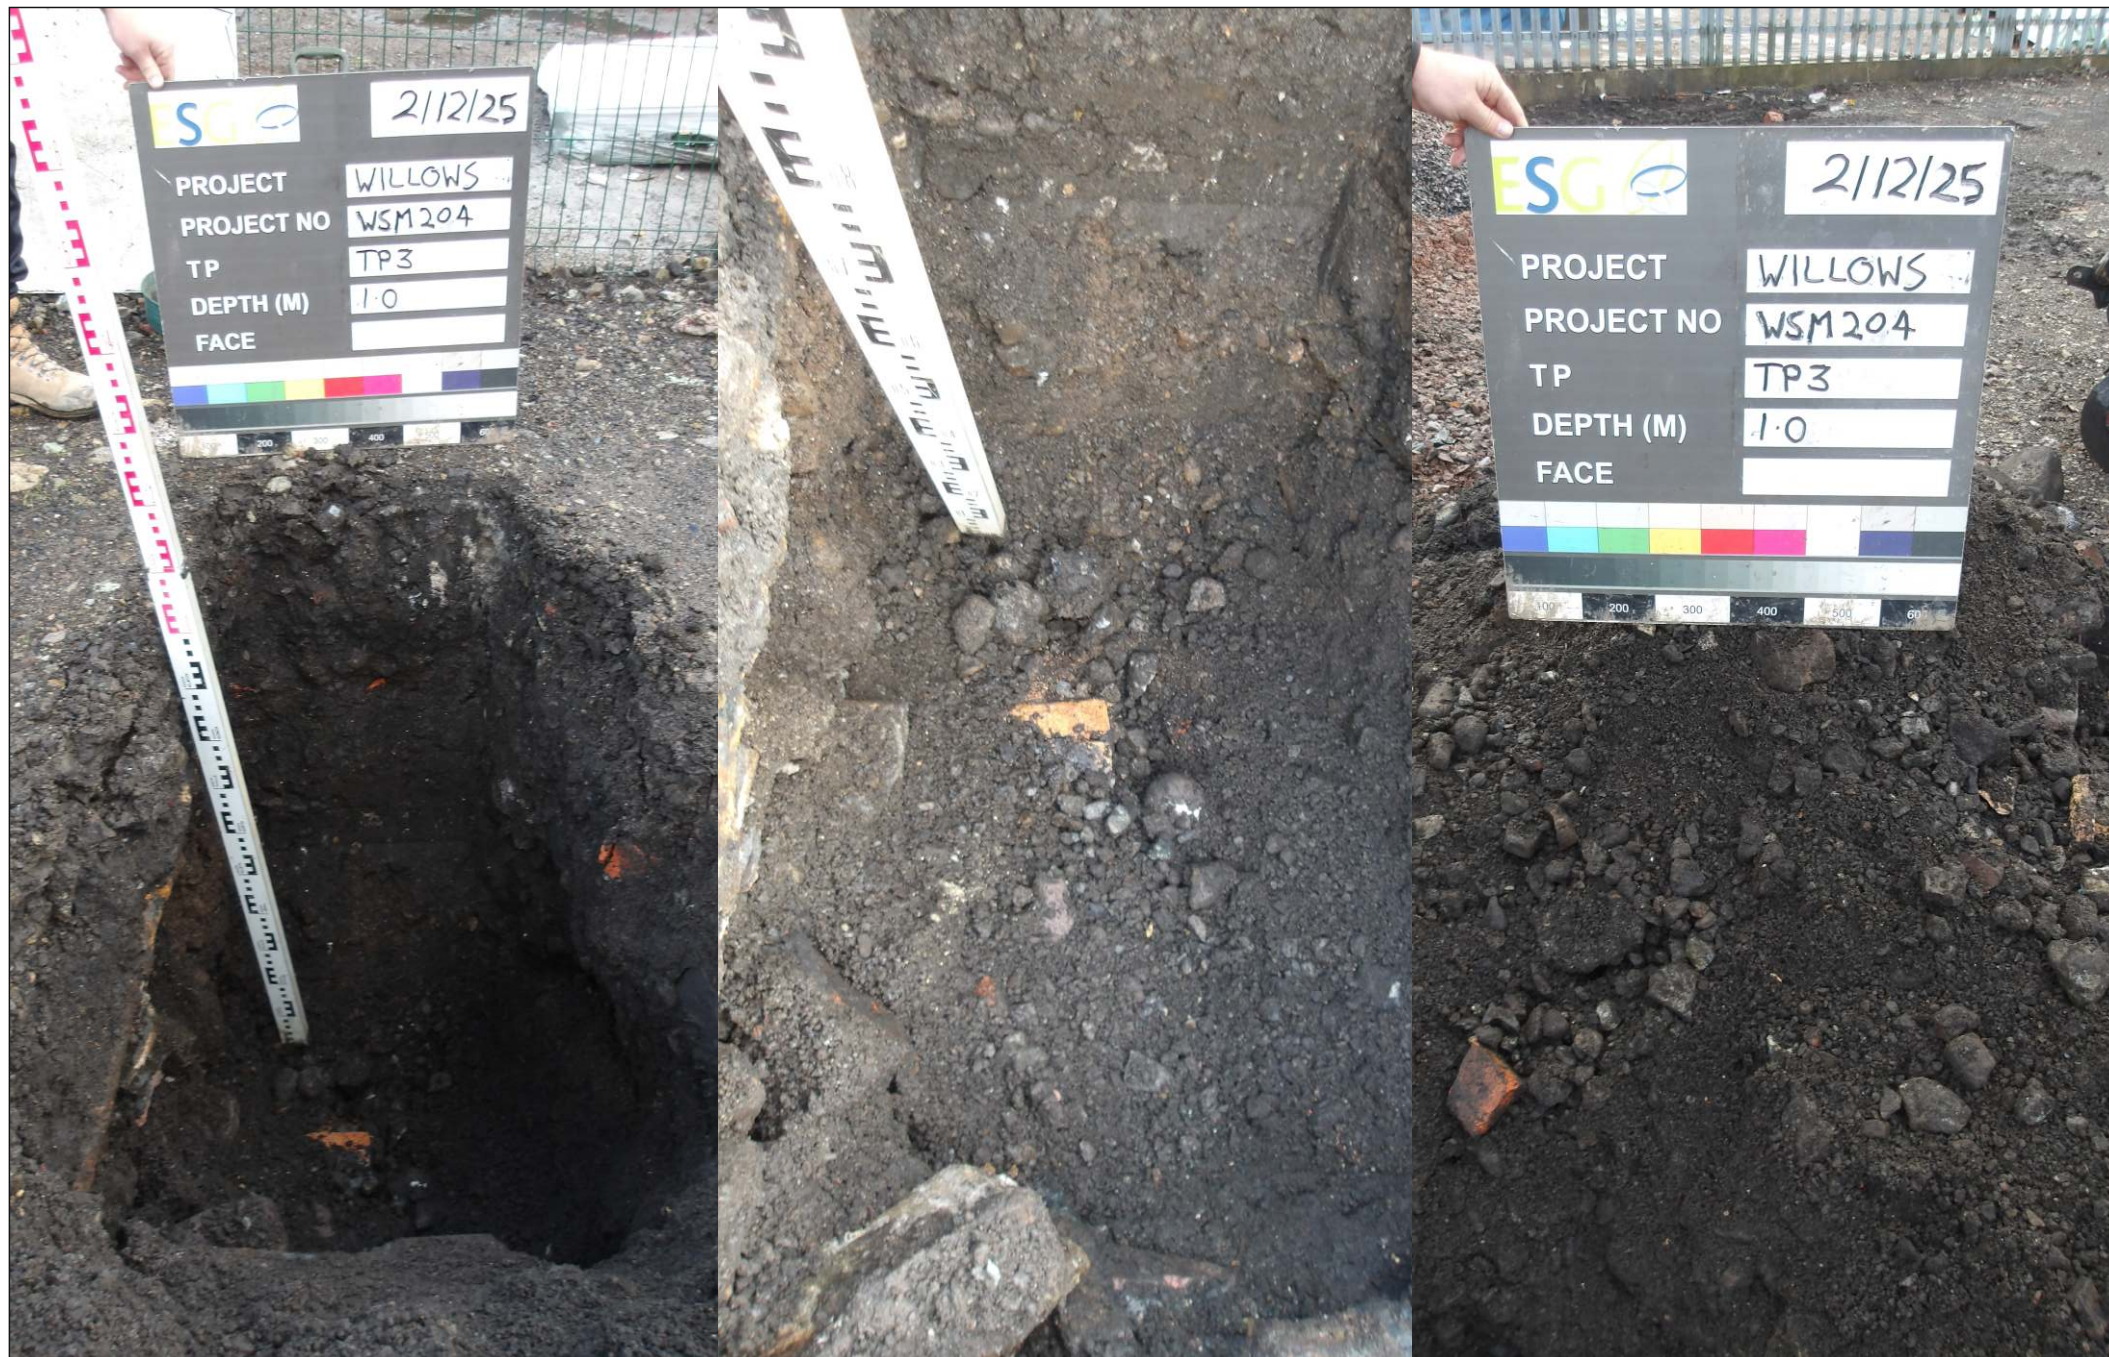
TP 3 THE WILLOWS

| Samples and Tests | | Strata | |
|---|---|---|---|
| | | G.L. | COMPACTED LIMESTONE |
| | | 0.15 | AGGREGATE |
| | | 1.0 | MADE GROUND. Loose to Medium dense black, sandy GRAVEL. Gravel is anular to rounded, fine to coarse of Quartzite (rounded) brick, slag and colliry waste (angular). |

Table 3 shows that there were three S4UL value exceedances for the USEPA16 range of Polycyclic Aromatic Hydrocarbons (P.A.H.s) in the sample from 0.7m in TP3. These are highlighted in red. Unsurprisingly these are the three of the USEPA16 with the lowest S4ULs. In the other two samples all the USEPA16 substances were present in small quantities. These were well below the relevant S4UL for each substance.
