| | JOB<br>TITLE <i>Brynhyfryd Chapel<br/>Thomas Street<br/>Treharris</i> | DRAWING<br>TITLE<br><i>Proposed Elevations</i> | DRAWING No. <i>SD481 06</i> |

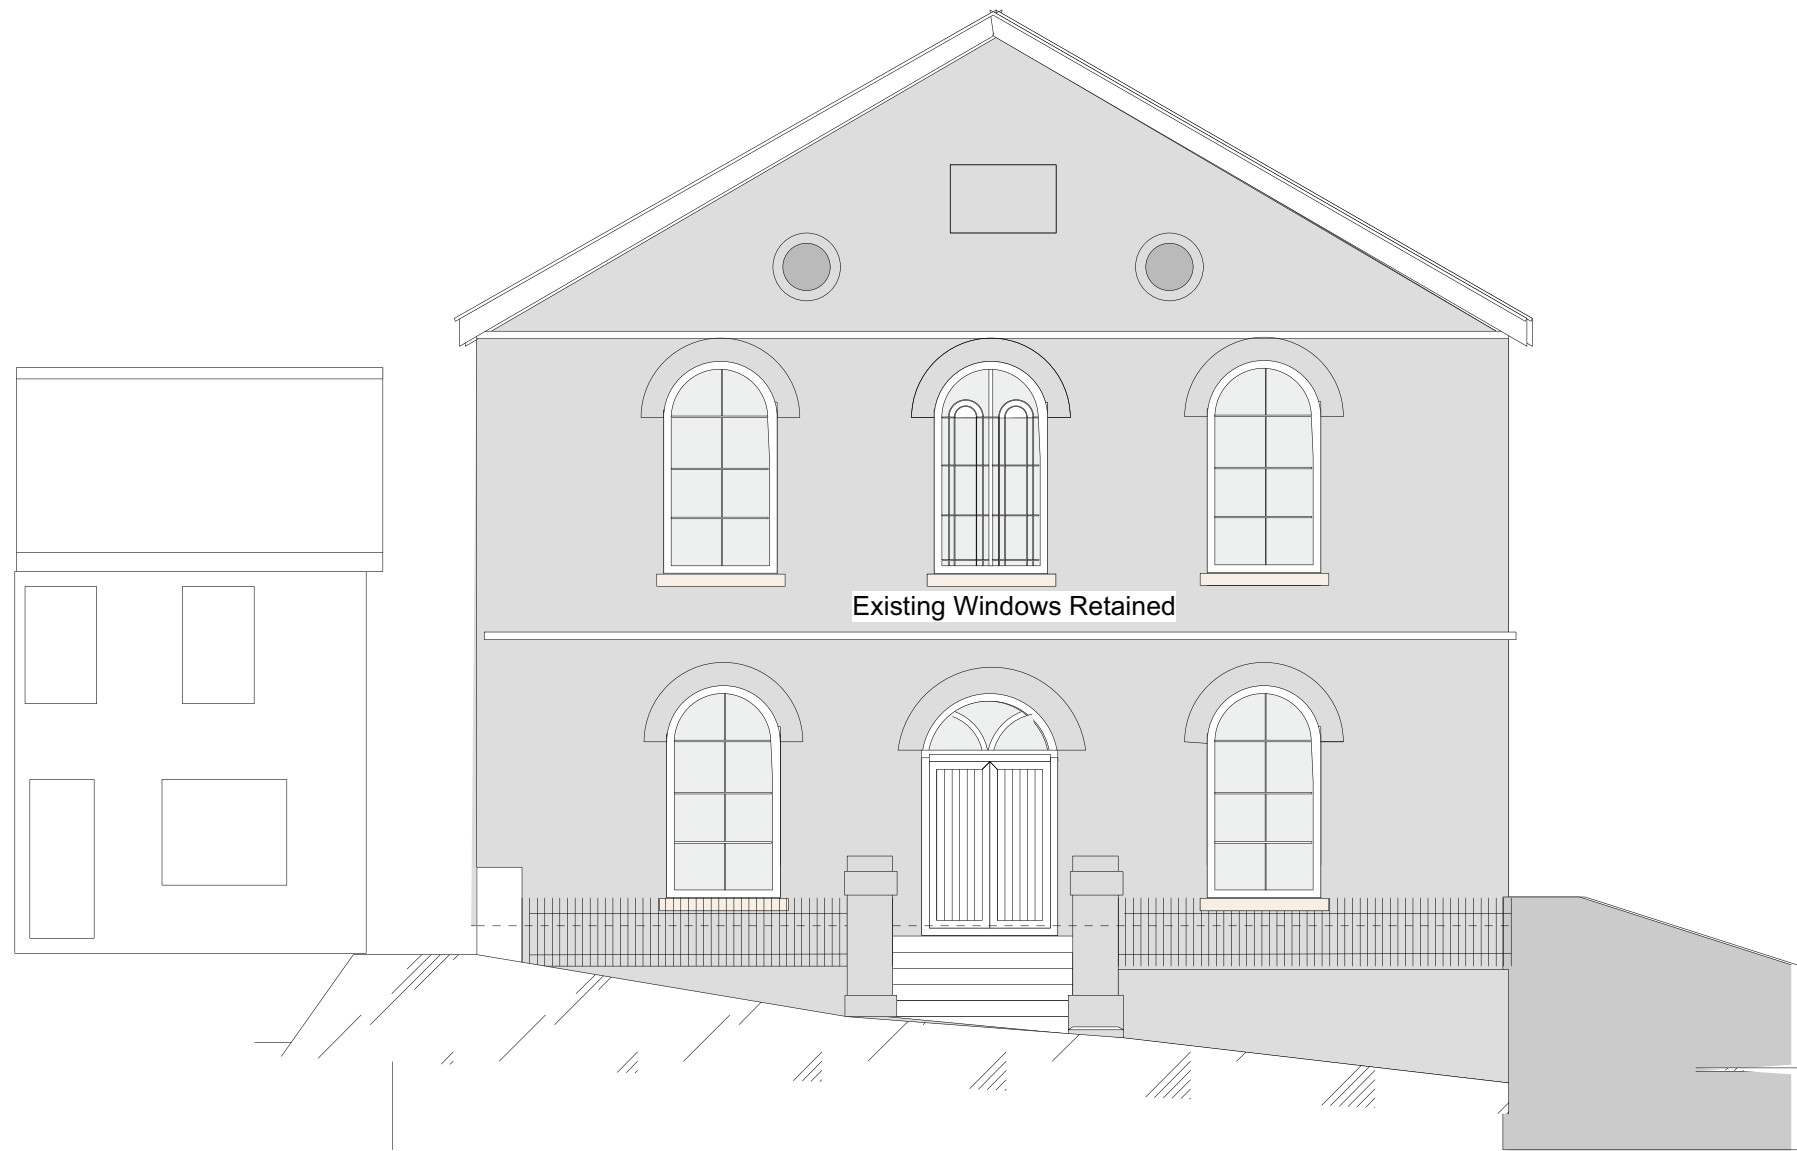
Front Elevation

Windows formed in Hardwood

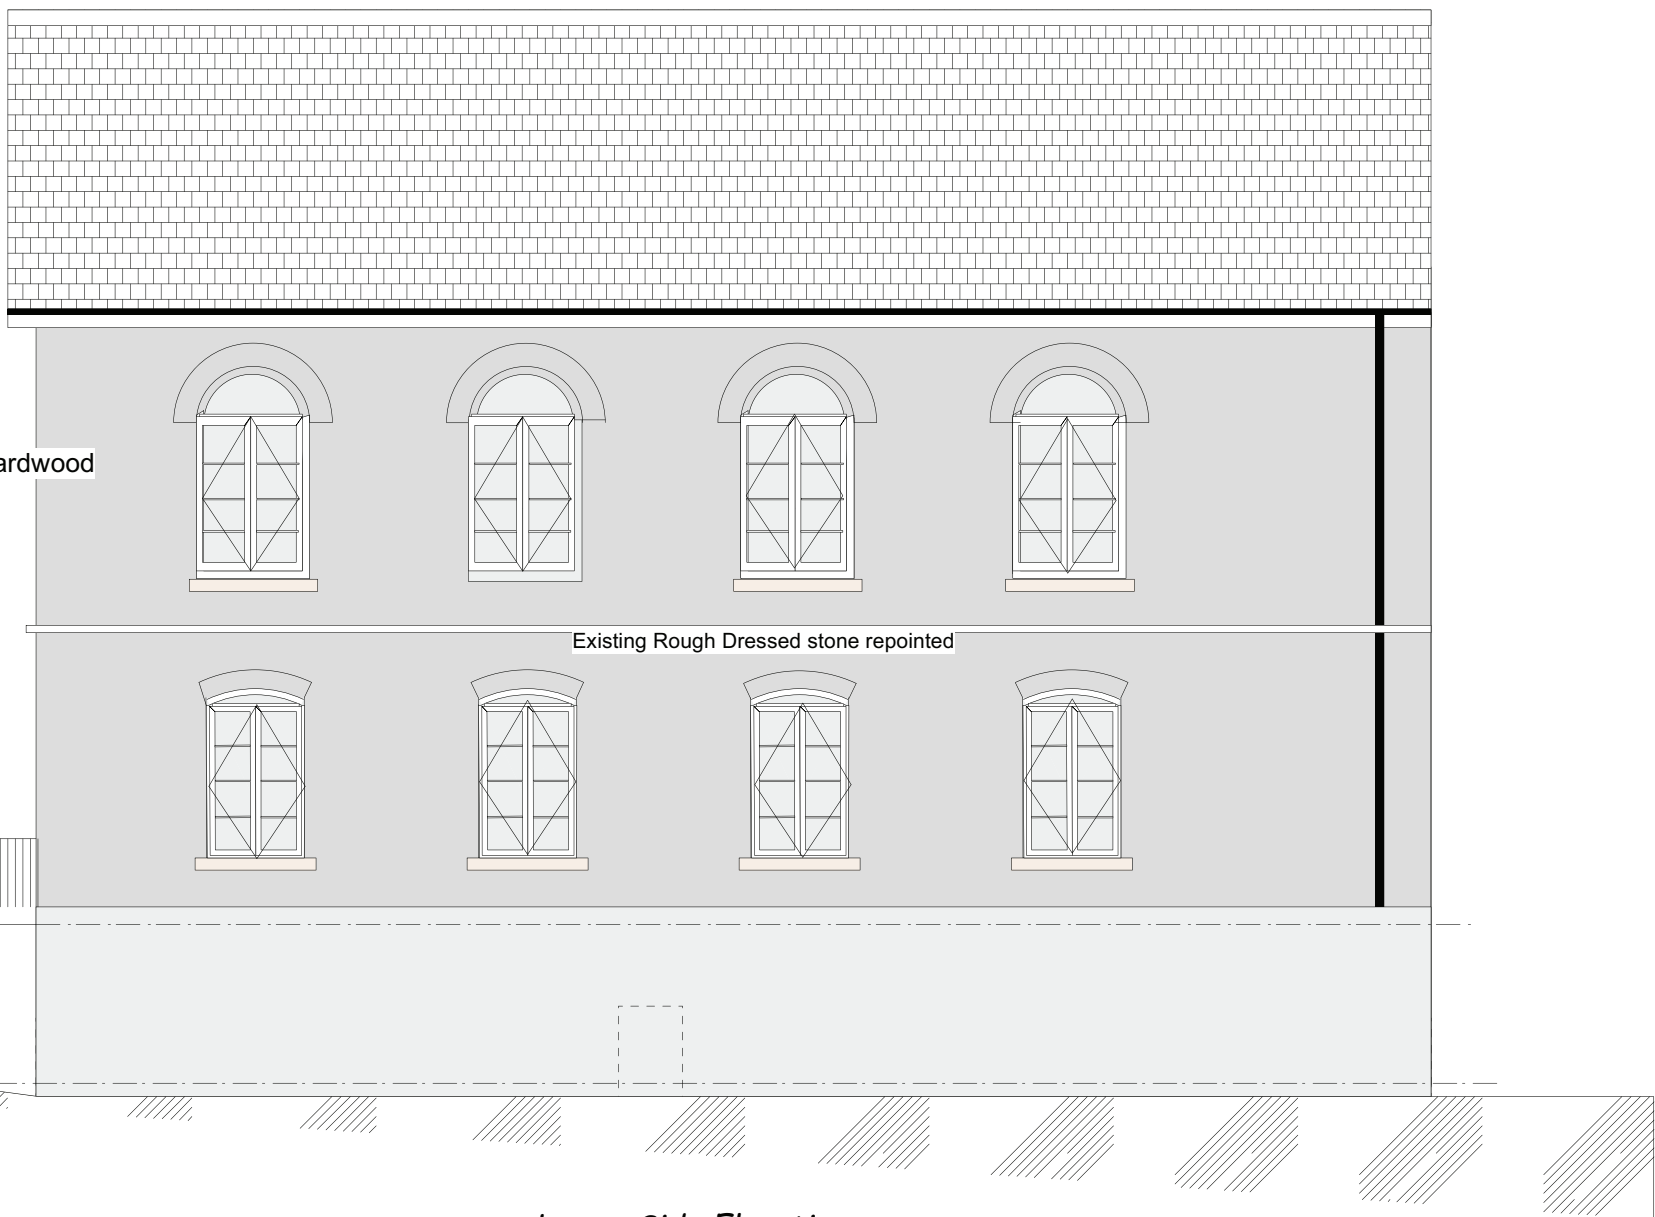
Lower Side Elevation

Works to External Envelope  
Repairs to Slate roof covering,  
Repoint external walls.  
Render rear wall after removal of annex, painted to match sandstone

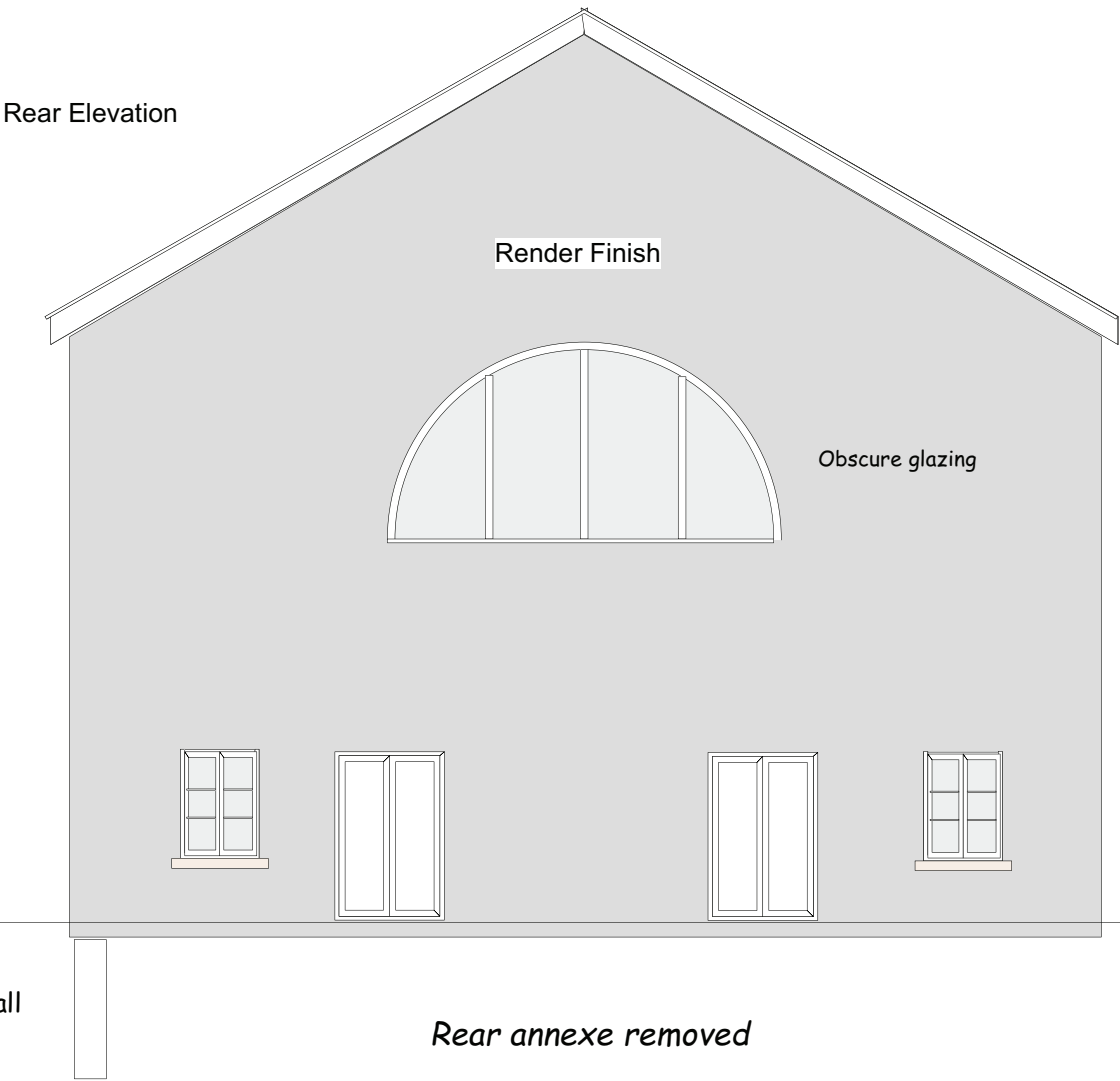
Rear Elevation

Existing wall

Rear annexe removed
