La Bodega
1 Pant Road
Dowlais
Merthyr Tudful
CF48 3SH

A Supplementary Ecological
Survey Report

August 2024

Morgan Ecology

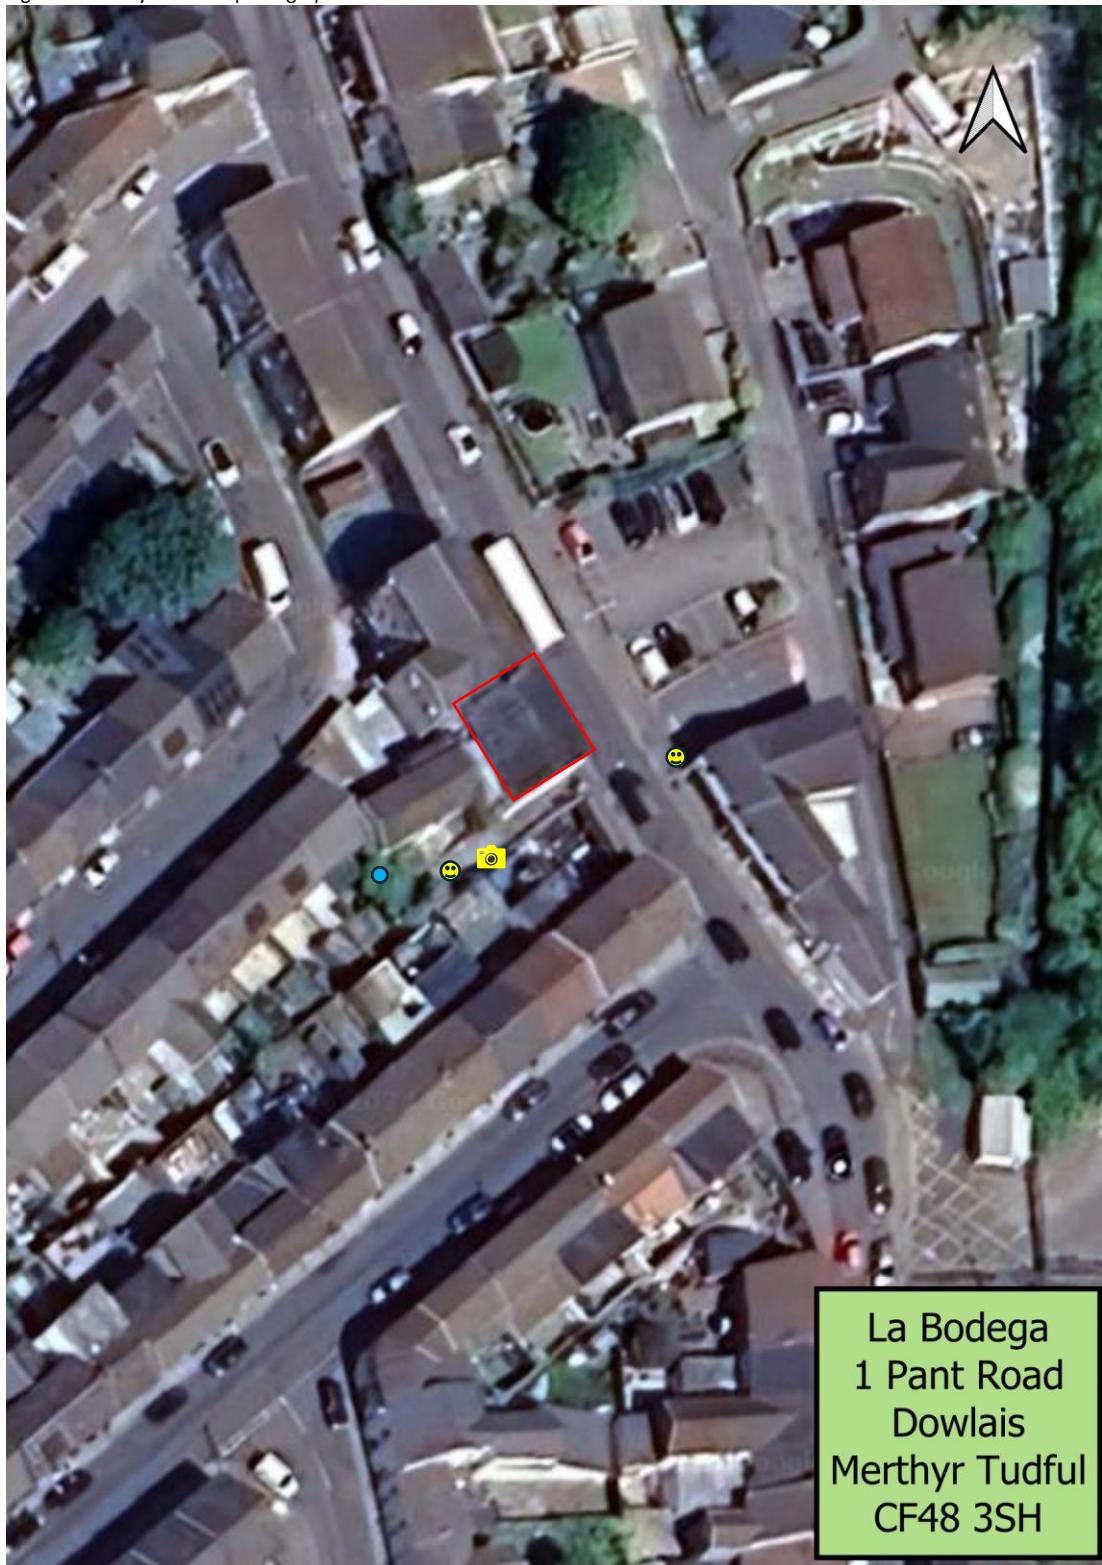
Figure 1: Site layout aerial photograph

Current La Bodega structure shown red

- 🟡 Positions of observers
- 🟡 Positions of video cameras
- 🔵 Japanese knotweed contamination on neighbouring property

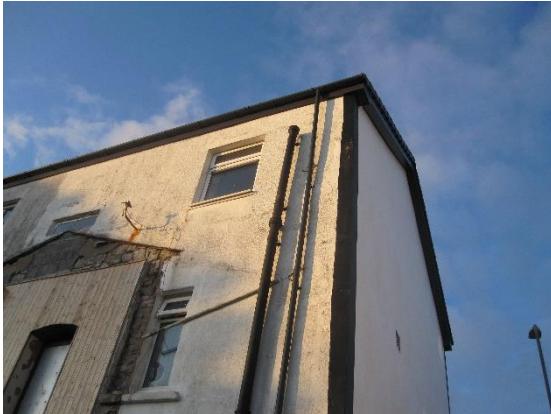
Plate 1: Southern corner of La Bodega (July 2024)

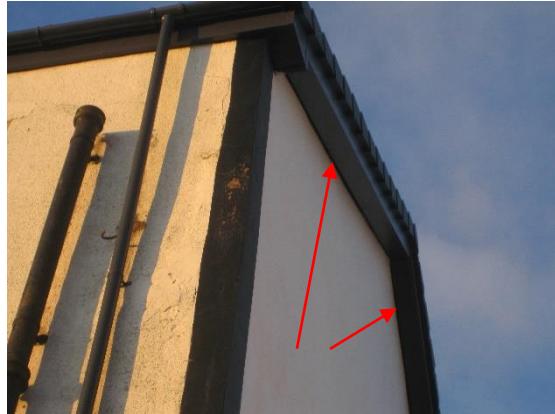
5.2 Prior to undertaking the first observation, on Saturday 27 July 2024, the surveyors inspected the exterior of the building. The re-roofing was apparent, and there were suitable access gaps to bats at the south-eastern gable apex, between the soffit box and exterior walls. No evidence of bats was noted, but photographs were taken.

Plate 2: Gaps between wall and soffit box (arrowed red)

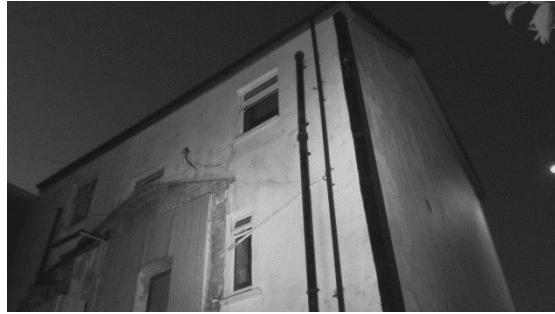
5.3 Observations commenced at 20.38 hours, some 34 minutes before sunset, which on the day was at 21.12 hours. The observation was terminated at 23.07 hours, some 1 hour and 55 minutes after sunset. No bats were seen or heard by either observer during the survey, and no bats were captured by the video camera.

Plate 4: Infra-red camera image (July 2024)

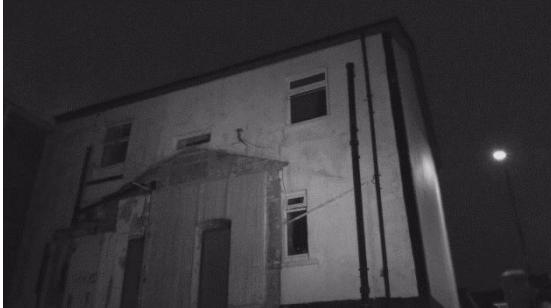
5.4 A second observation was conducted on Sunday the 18th of August 2024 in excellent conditions. No bat or bird activity was noted until 20.58 hours, when four herring gulls (*Larus argentatus*), were noted flying over the site to the west of the building, flying from south-east to north-west. No bat activity was apparent until a single animal was faintly heard, but not seen to the east of the building at 22.08 hours. A recording was made, but unfortunately the call was too faint to obtain a sonogram for analysis. No nesting bird activity was noted during the dusk surveys.

Plate 5: Infra-red camera image (August 2024)

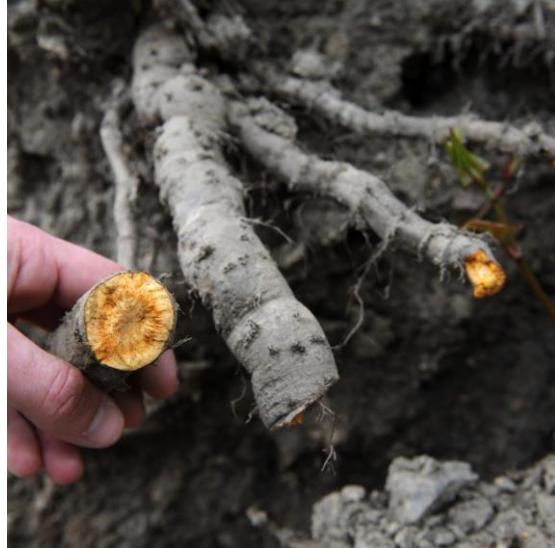
5.5 Prior to undertaking the second observation, an assessment was made of the general site, and it was much the same as when originally surveyed in December 2023. However, what was noted, and was not evident in the winter period, was a stand of Japanese knotweed (*Reynoutria japonica*) in the garden of a neighbouring property – 18 Glendower Street. Although this contamination has not spread to 1 Pant Road, its presence nearby needs to be noted. A decomposed starling (*Sturnus vulgaris*) was also noted behind La Bodega, which appeared to have been dead for some time.

Plate 6: Japanese knotweed roots or rhizomes

7.6 It would be wise for the owner of La Bodega to assess during works if the ground may be contaminated with knotweed rhizomes. Nothing was obviously apparent, but it can remain hidden. If rhizomes (see Plate 6) are found, then the whole of this material, and any soil must be removed to a licenced disposal site. It will also be essential to clean any digging equipment used (e.g. JCB/Bobcat), and any soil washed from the vehicle will also be disposed to the licenced contractor. This is best achieved by engaging a specialist contractor to undertake the necessary work.
