## **Canolfan Soar**

Pontmorlais, Merthyr Tydfil, CF47 8UB

## **Preliminary Roost Assessment (PRA) Report**

**Issue 1, Version A** | July 2026 | Prepared by: Beth Evans BSc MSc, Principal Ecologist

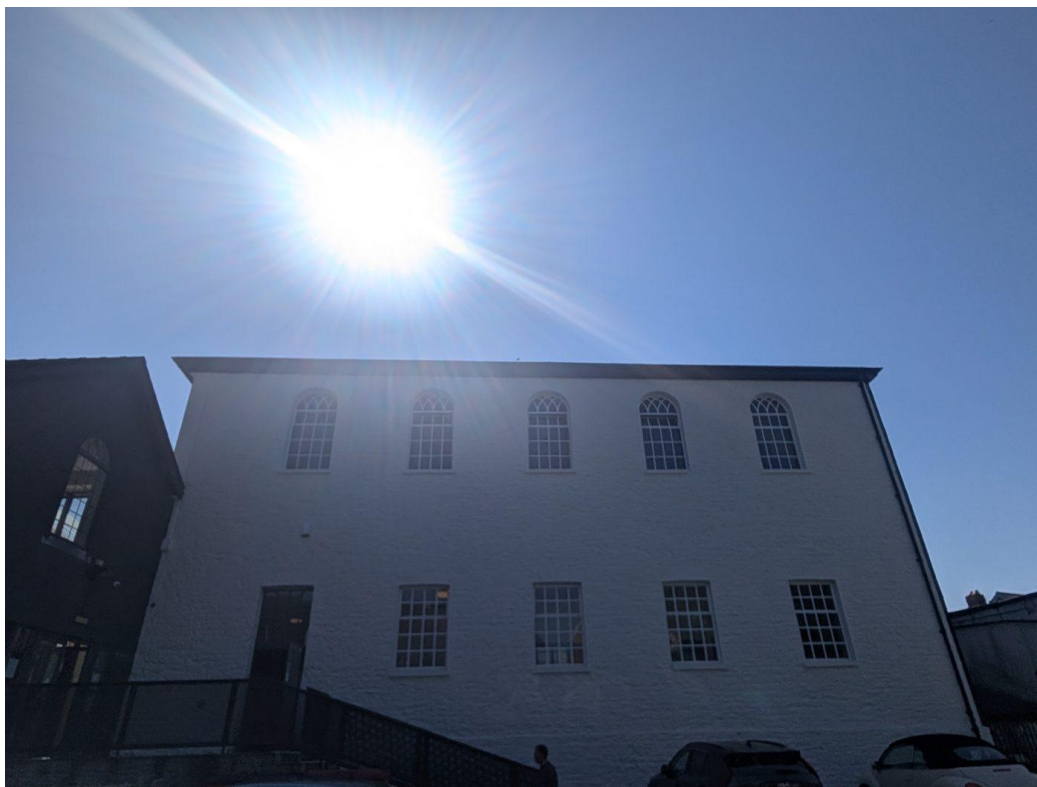
*Plate 1 – Chapel elevation, showing painted render, round-arched first floor windows and closely detailed slate roof with no access points for bats at eaves level*

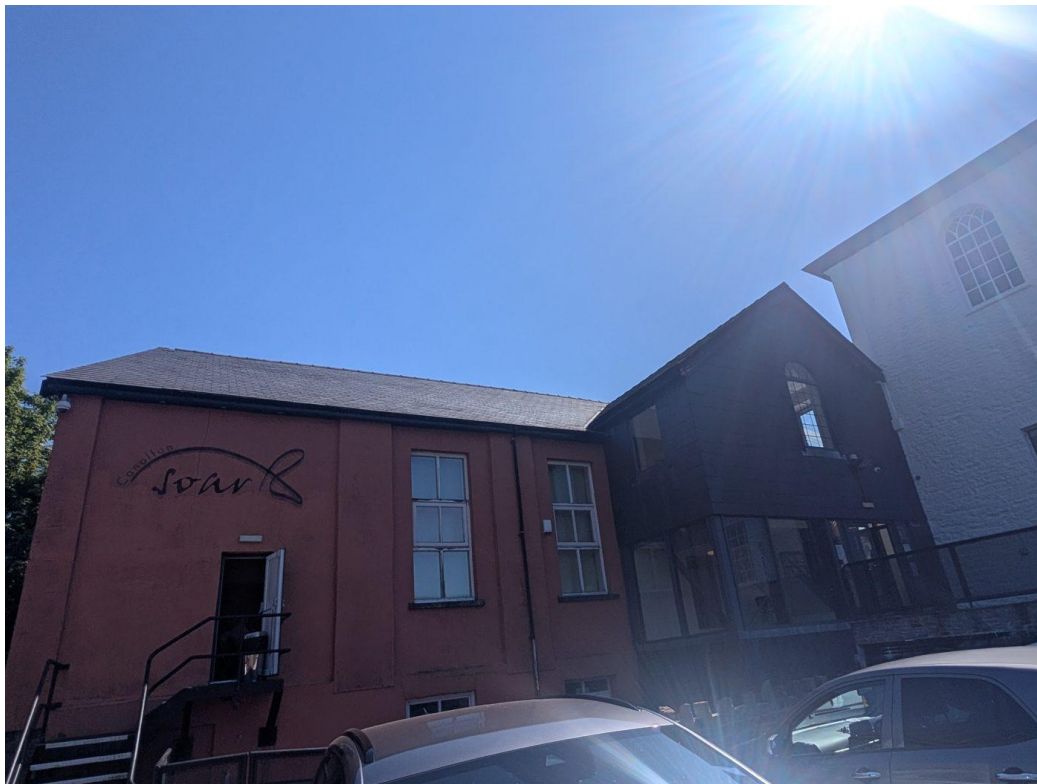
*Plate 2 – Vestry and schoolroom range, showing painted render, timber sash windows, boxed painted eaves and natural slate roof in good condition.*

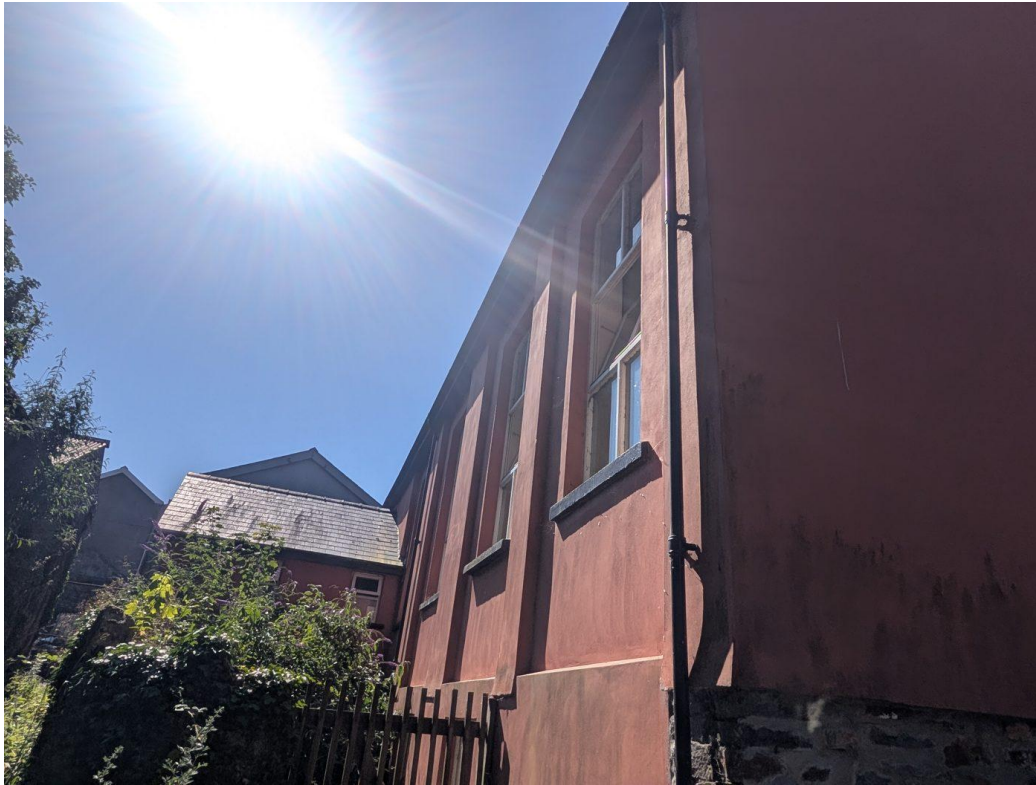
*Plate 3 – Rear elevation of the vestry and schoolroom range, showing sound render, cast iron rainwater goods and closely laid slate roof beyond.*

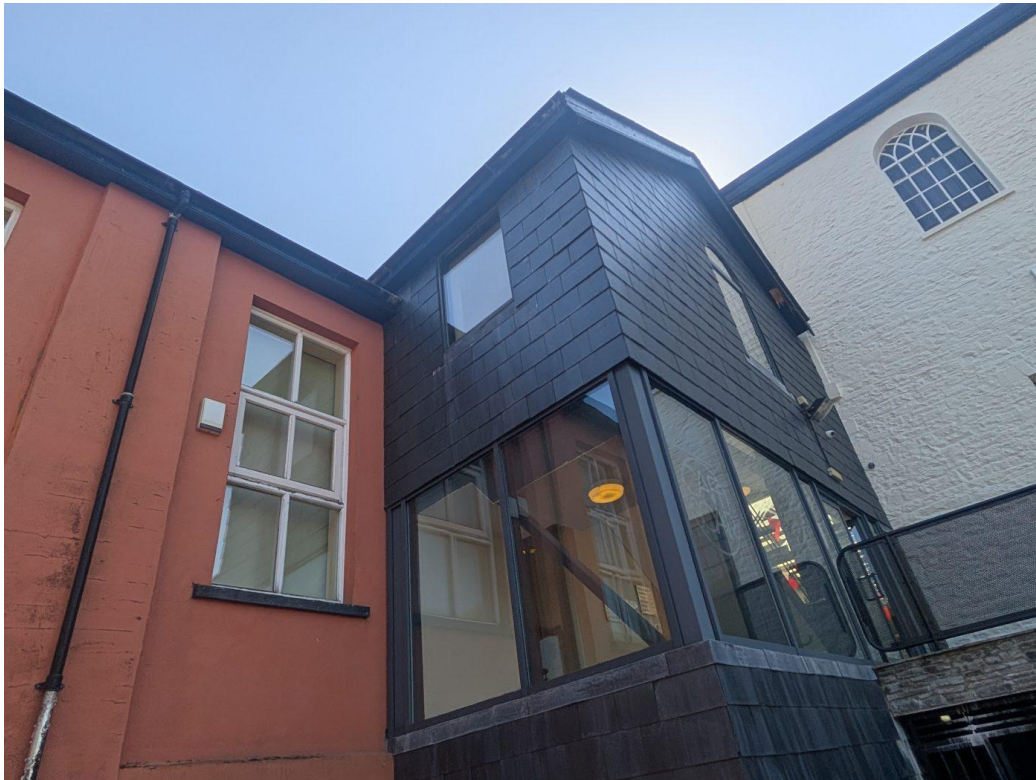
*Plate 4 – Modern link extension between the two ranges*

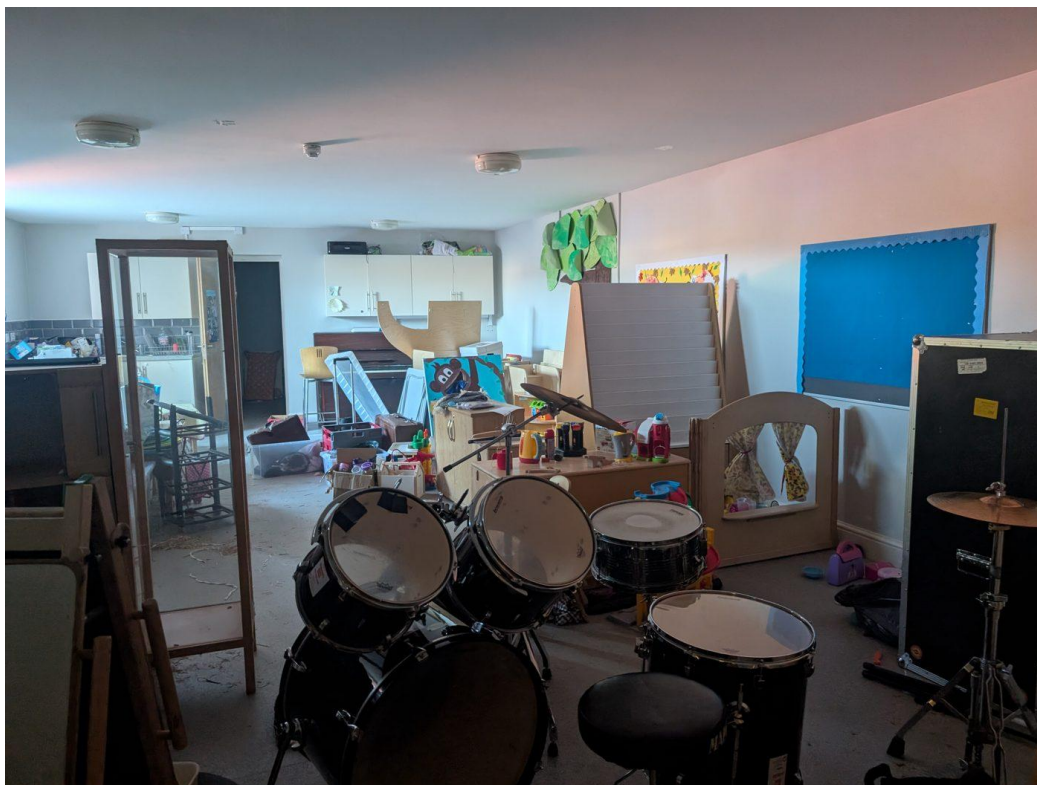
*Plate 5 – Basement level, room retaining existing finishes and in current community use at the time of survey.*

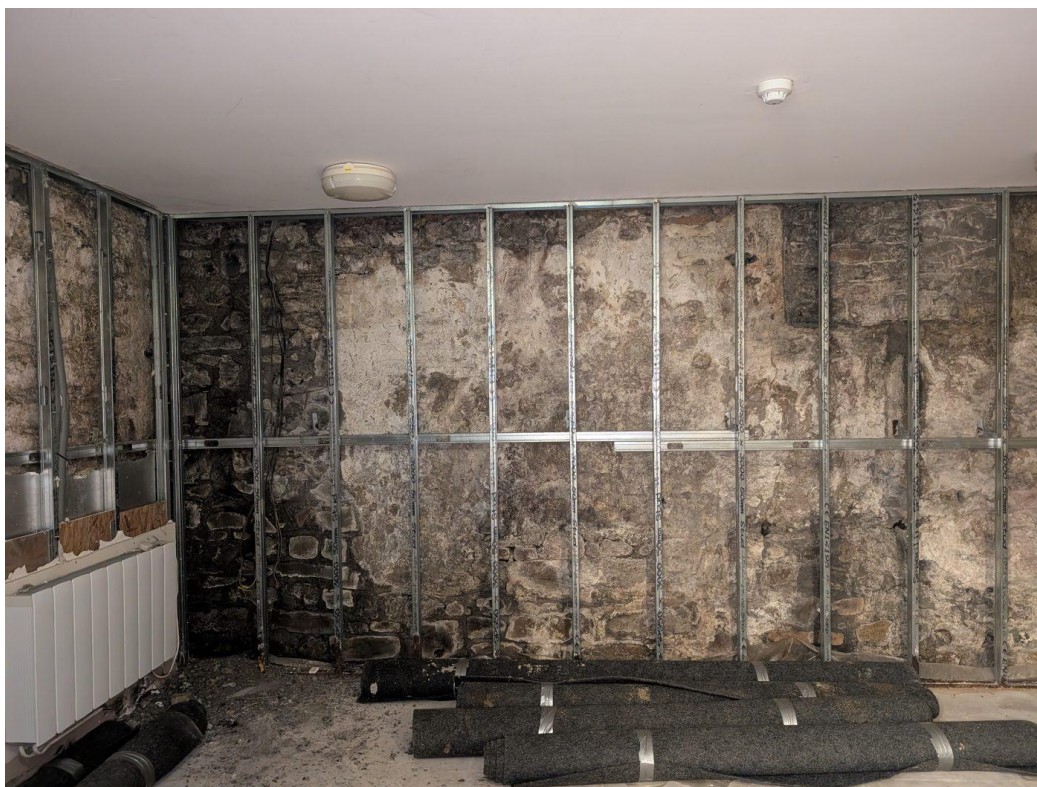
*Plate 6 – Basement level, showing exposed coursed rubble stone perimeter wall, new galvanised metal stud framing and intact plasterboard ceiling. No evidence of bats was recorded.*

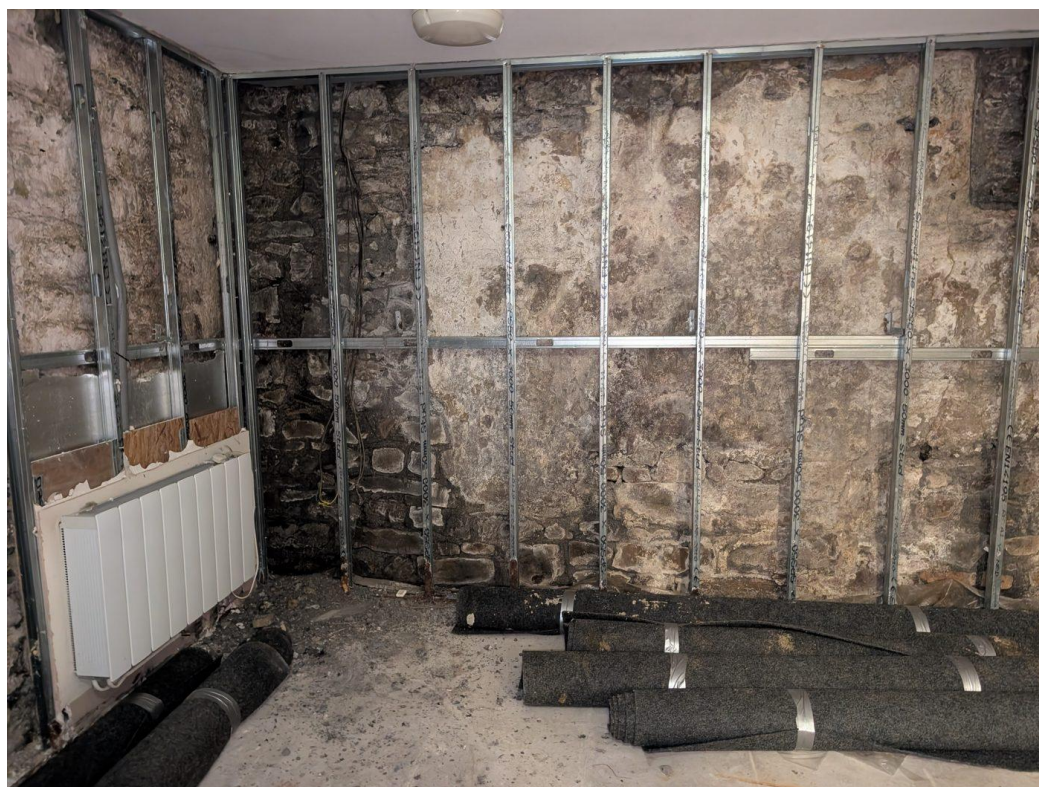
*Plate 7 – Basement level, alternative view of the stripped perimeter wall and stud framing prior to re-lining.*
