# Heritage Statement

Outbuilding to rear of Coop Store, 35 Fox  
Street, Treharris, South Wales, CF46 5HE

BOW-H4054-ZZ-ZZ-RP-A-0001

June 2023

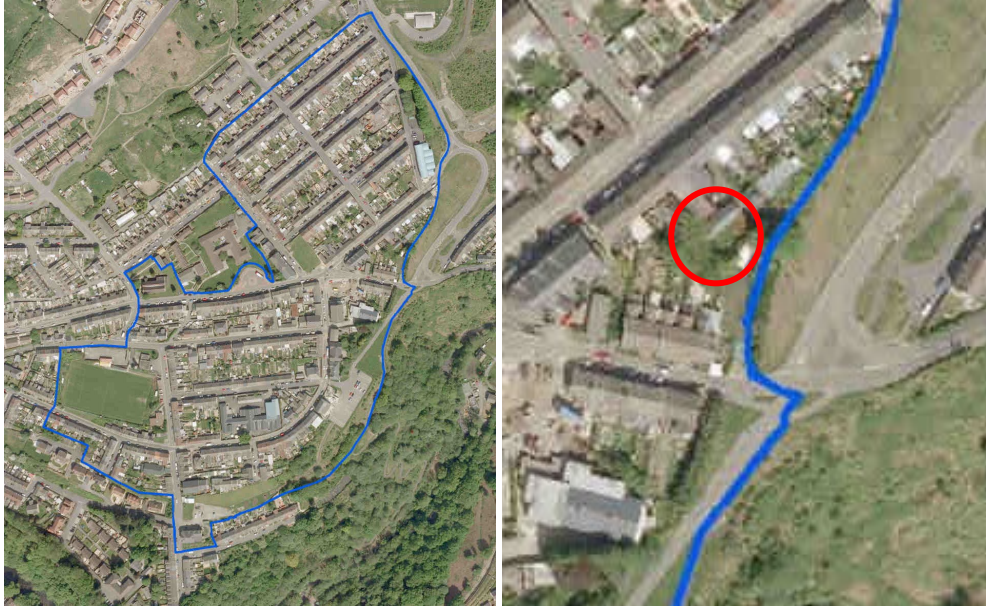
- 5.1 Figure 3 shows the extent of the conservation area (in blue), and the site positioned which is near to the boundary. The existing outbuilding is located to the rear of the cooperative store and runs in parallel to the rows of housing. Access is from the rear of the store and externally from Fox Street. There is a pocket of land adjacent to the outbuilding to the southeast then a terrain sloping to the road below.

Figure 3 Map view showing the Conservation Area boundary. Site indicatively highlighted as a red circle.

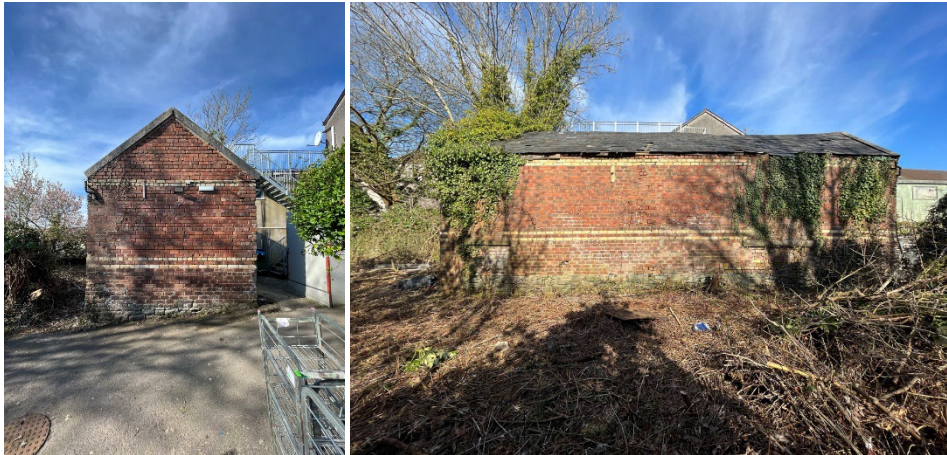
- 5.3 The building is a simple dual pitch uninsulated outbuilding running northeast to southwest, constructed in a mix of stone, brick and contrasting brick walls, timber trusses and a slate roof. Facing the Coop Store, a pair of timber swing doors with an expressed lintel above provides access, three other openings have been blocked up with brick. The building is not being utilised, portions of the roof and rainwater goods are missing and the condition relatively poor with some evidence of later structural support. Externally, the walls have been covered by foliage. Internally, the floor finishes are divided between stone and brick. Refer to photo(s) 1 to 7 below.

Photo 1: Northeast view of the gable end; Photo 2: Southeast view of the side elevation.

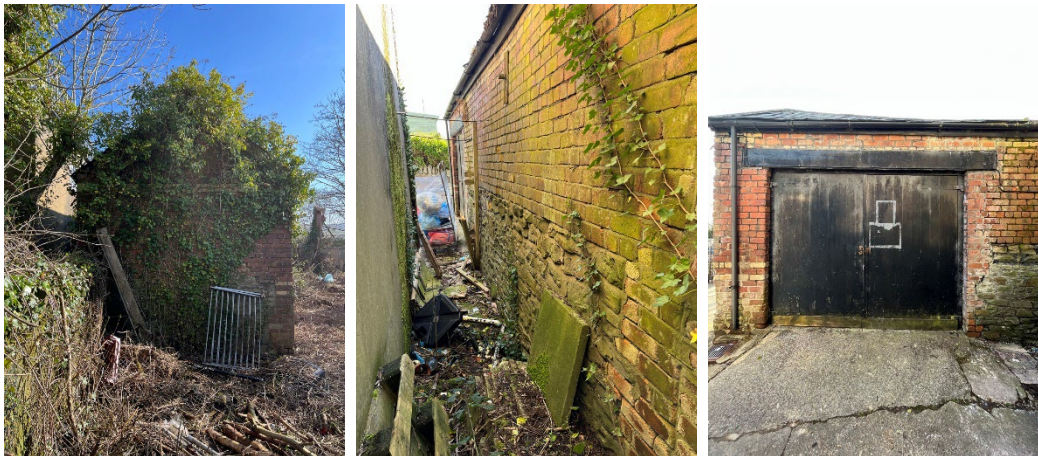
Photo 3: Southwest view of the gable end; Photo 4: Northeast view of the side elevation.  
Photo 5: Facing view of the large double door entrance.

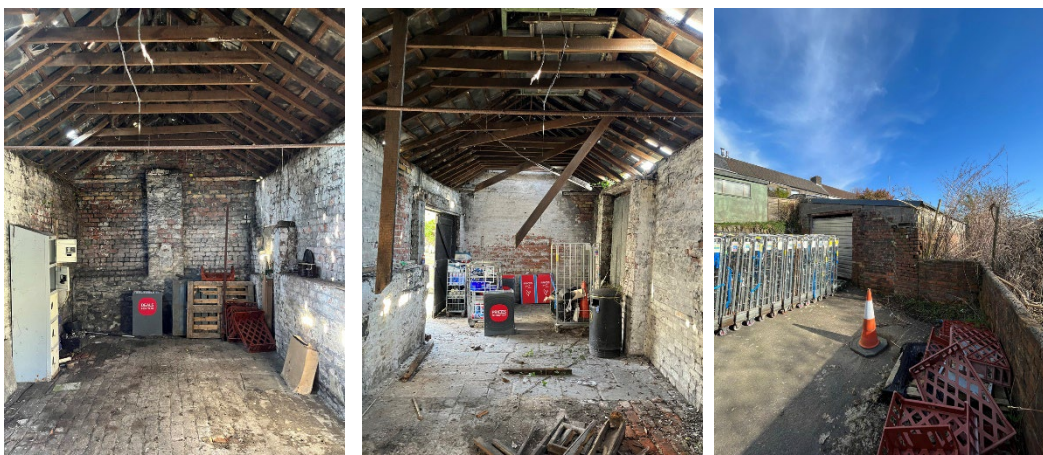
Photo 6: Internal view facing southwest; Photo 7: Internal view facing northeast;  
Photo 8: Further outbuilding which appears on the same OS map.

- 6.6 The timbers used for the raised tie trusses timbers appear to be a later suggesting a replacement roof in the late twentieth century. See photo 6 & 7. The structural tie looks to be added due to the instability of the side elevations and movement of the brickwork.
