## St. Luke's Church, Gellideg

## Bat Activity Survey Report

February 2021

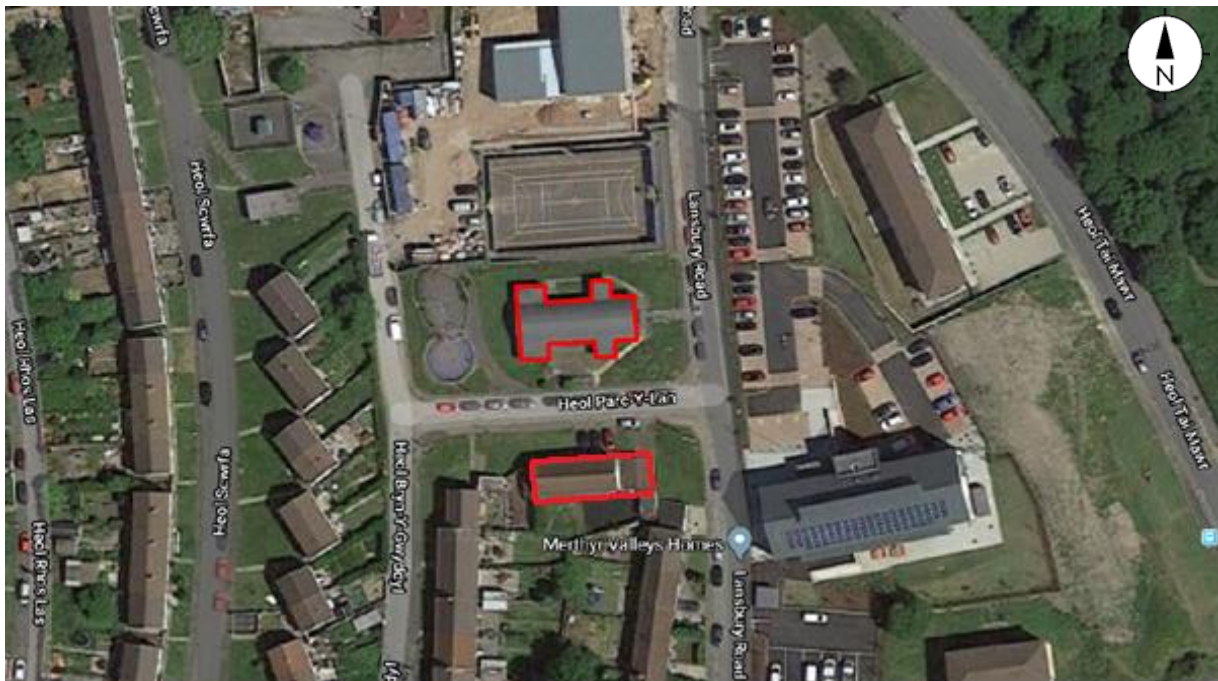
**Figure 1:** An aerial photograph of the surveyed structures at St. Luke's Church, Gellideg (as shown by the red outline).

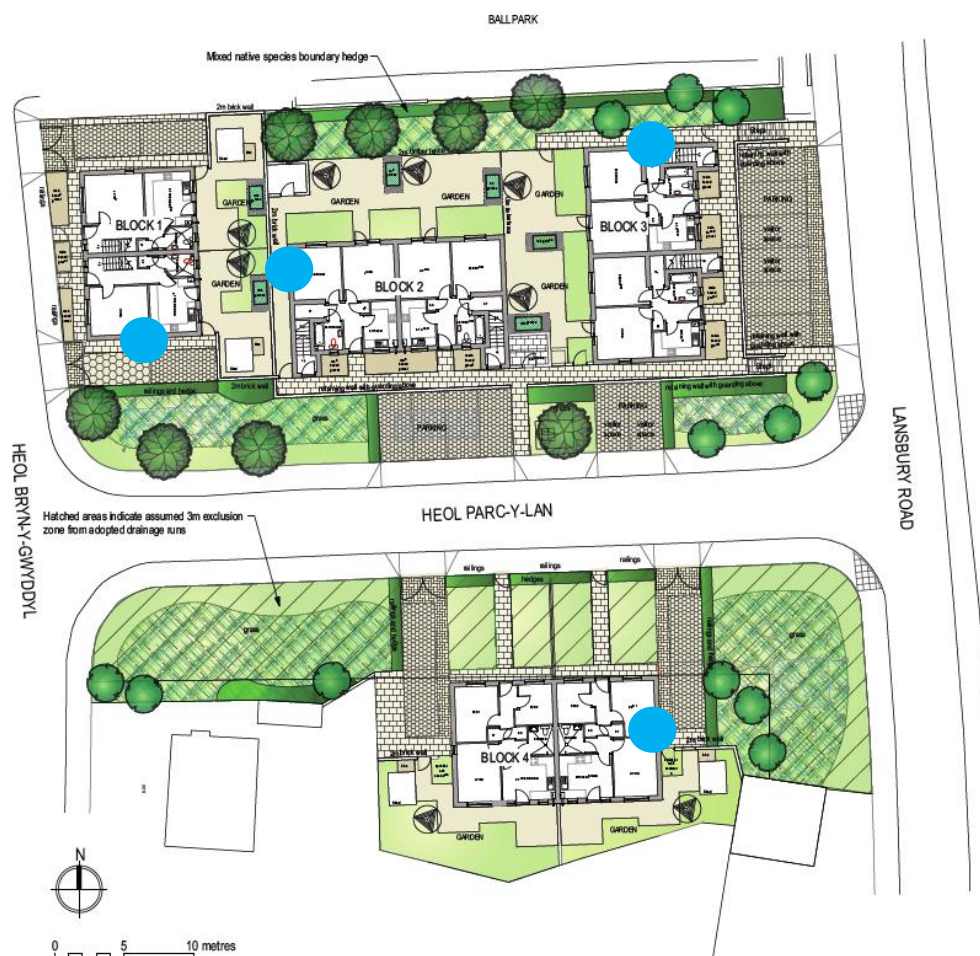
**Figure 5:** An illustration of the integrated eco bat box locations on the proposed landscape plans (as shown by the blue circles).

To increase the number of roosting opportunities for bats, further enhancements can be made by including a number of [Integrated Eco Bat Boxes](#) on the new structures on site. These should avoid any artificial lighting, and are most suitable when facing east, south-east, south-west and/or west. For this site, it is recommended that four boxes should be included.

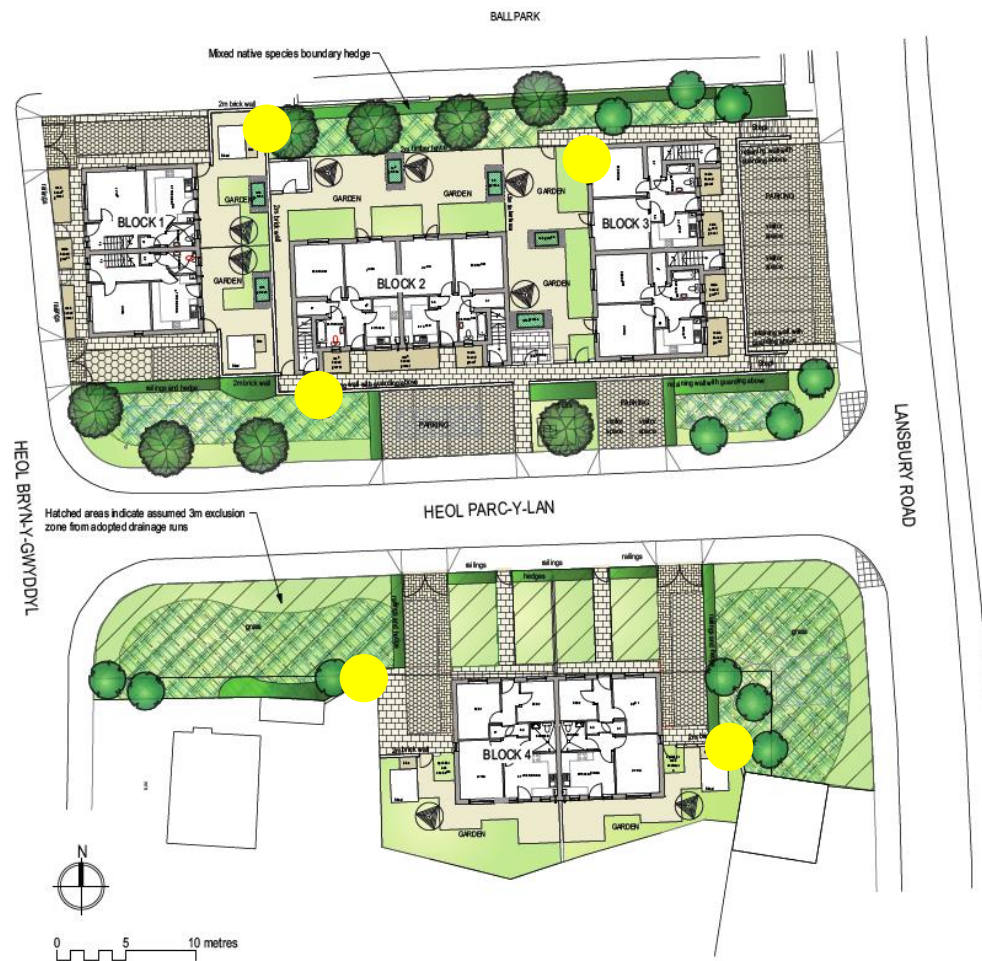
**Figure 7:** An illustration indicating some proposed locations of the eco bird boxes on the proposed landscape plans (indicated by yellow circles).

The site could be enhanced for birds by installing a variety of bird boxes on site. More specifically, it is recommended that five [Eco Bird Boxes](#) are installed on this particular site, due to their outer shell being constructed from precision cut, UV stabilised 100% recycled plastic, making them weatherproof and long-lasting. They can also be constructed with various hole sizes, making them suitable for a range of bird species, and can be installed onto buildings and/or trees.

As the proposed new trees and landscaping on site will not be able to initially support these boxes, it is recommended that the bird boxes are installed on the buildings, walls or fences close to the proposed new habitat, to immediately provide nesting opportunities post-development. See **Figure 7** for example locations of these bird boxes.

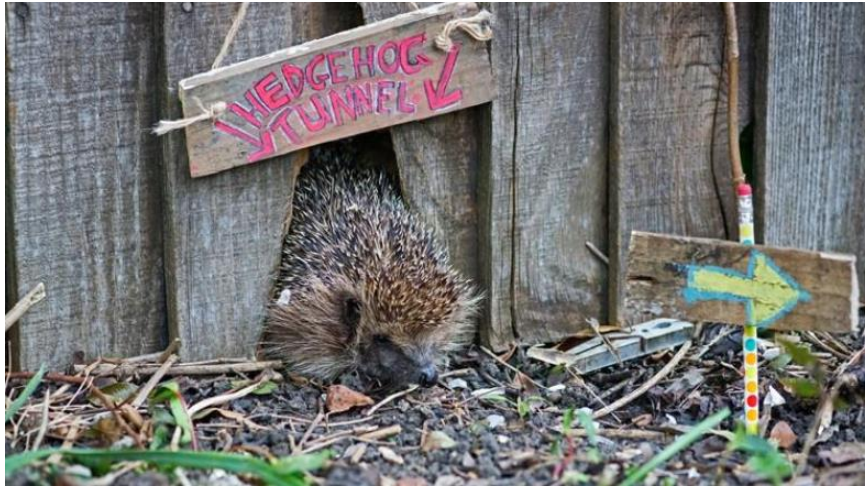
**Figure 8:** An image of an example hedgehog tunnel (obtained from RSPB).

It is also recommended that small gaps (13cm x 13cm) are left within any boundary fencing (if used) to enable the specimens to continue to commute through the area (an example can be found within **Figure 8**). This will ensure that the local hedgehog populations do not become fragmented within the local landscape.

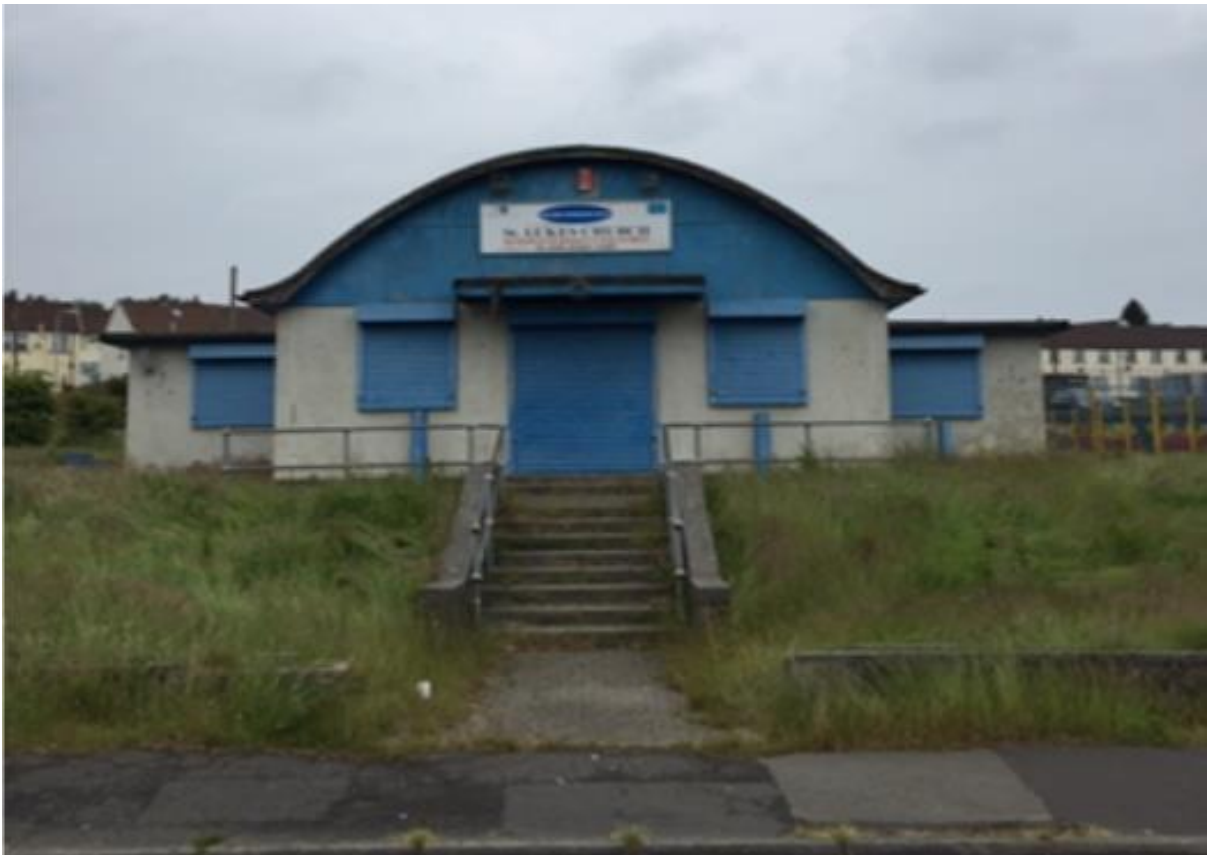
**Plate 1:** Front elevation of the surveyed church.

The church has a unique, dome like roof. The roof is felted and in a good condition. The soffit boards are in poor condition with several large holes. The limited amount of cladding present has some small cracks or has come away from the building. However, the windows are covered with metal rollers, meaning that the lintels are not exposed and as such, do not provide an area for bats to enter. The building itself is not clad in any material and, therefore, presents no opportunity for bats to roost. No evidence of bats or birds was identified externally.

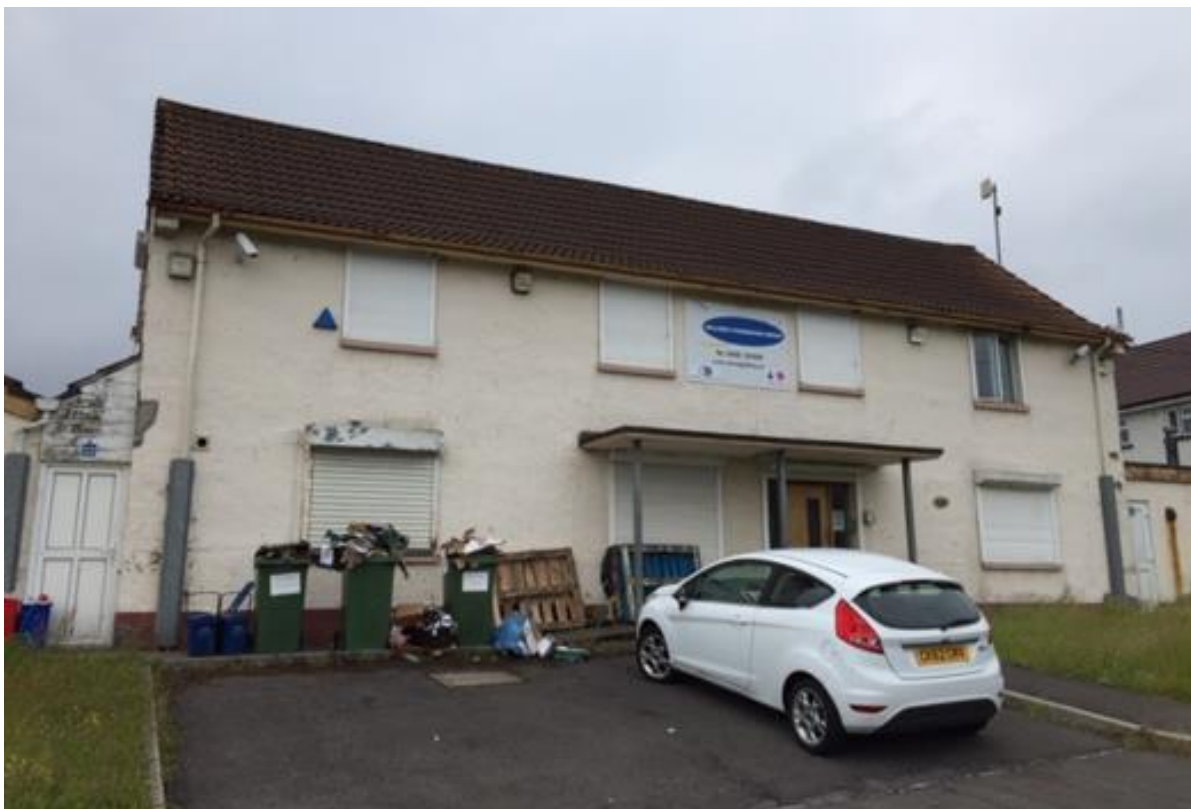
**Plate 4:** Front elevation of the surveyed office building.

This structure has a pitched roof with clay tiles which seems to be in an adequate state. There is, however, room under some of the tiles for access as several small bird species were observed moving in and out of these. Again the lintels were covered by security rollers, however, in two areas these had fallen off and provided an area for bats to enter. Externally, the rest of the building was in good condition and the limited amount of cladding appeared to be good condition. No evidence of bats was identified externally.

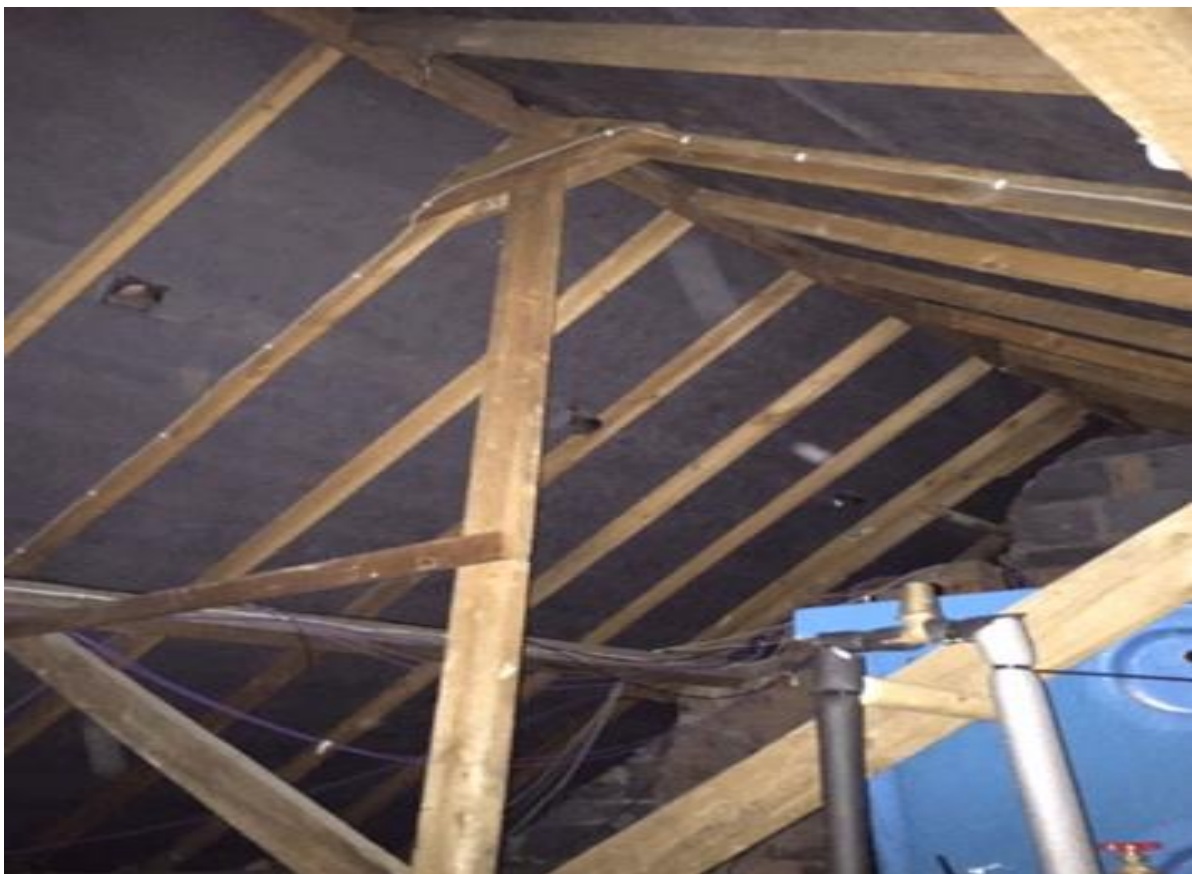
**Plate 6:** Internal view of the office loft space.

Internally there is a small loft space near the front of the building. It is not particularly high and there is limited room to move as it is being used as a storage area. The loft is not lined and is in very good condition. No holes are apparent in the structure itself or in any of the beams. It is located above a corridor and the hatch does not close so it is likely to receive a lot of disturbance despite being dark. No evidence of bats or birds was identified internally.
