**Trefechan**

Addendum to  
Geotechnical Desk Study

November 2007

Job number 123628

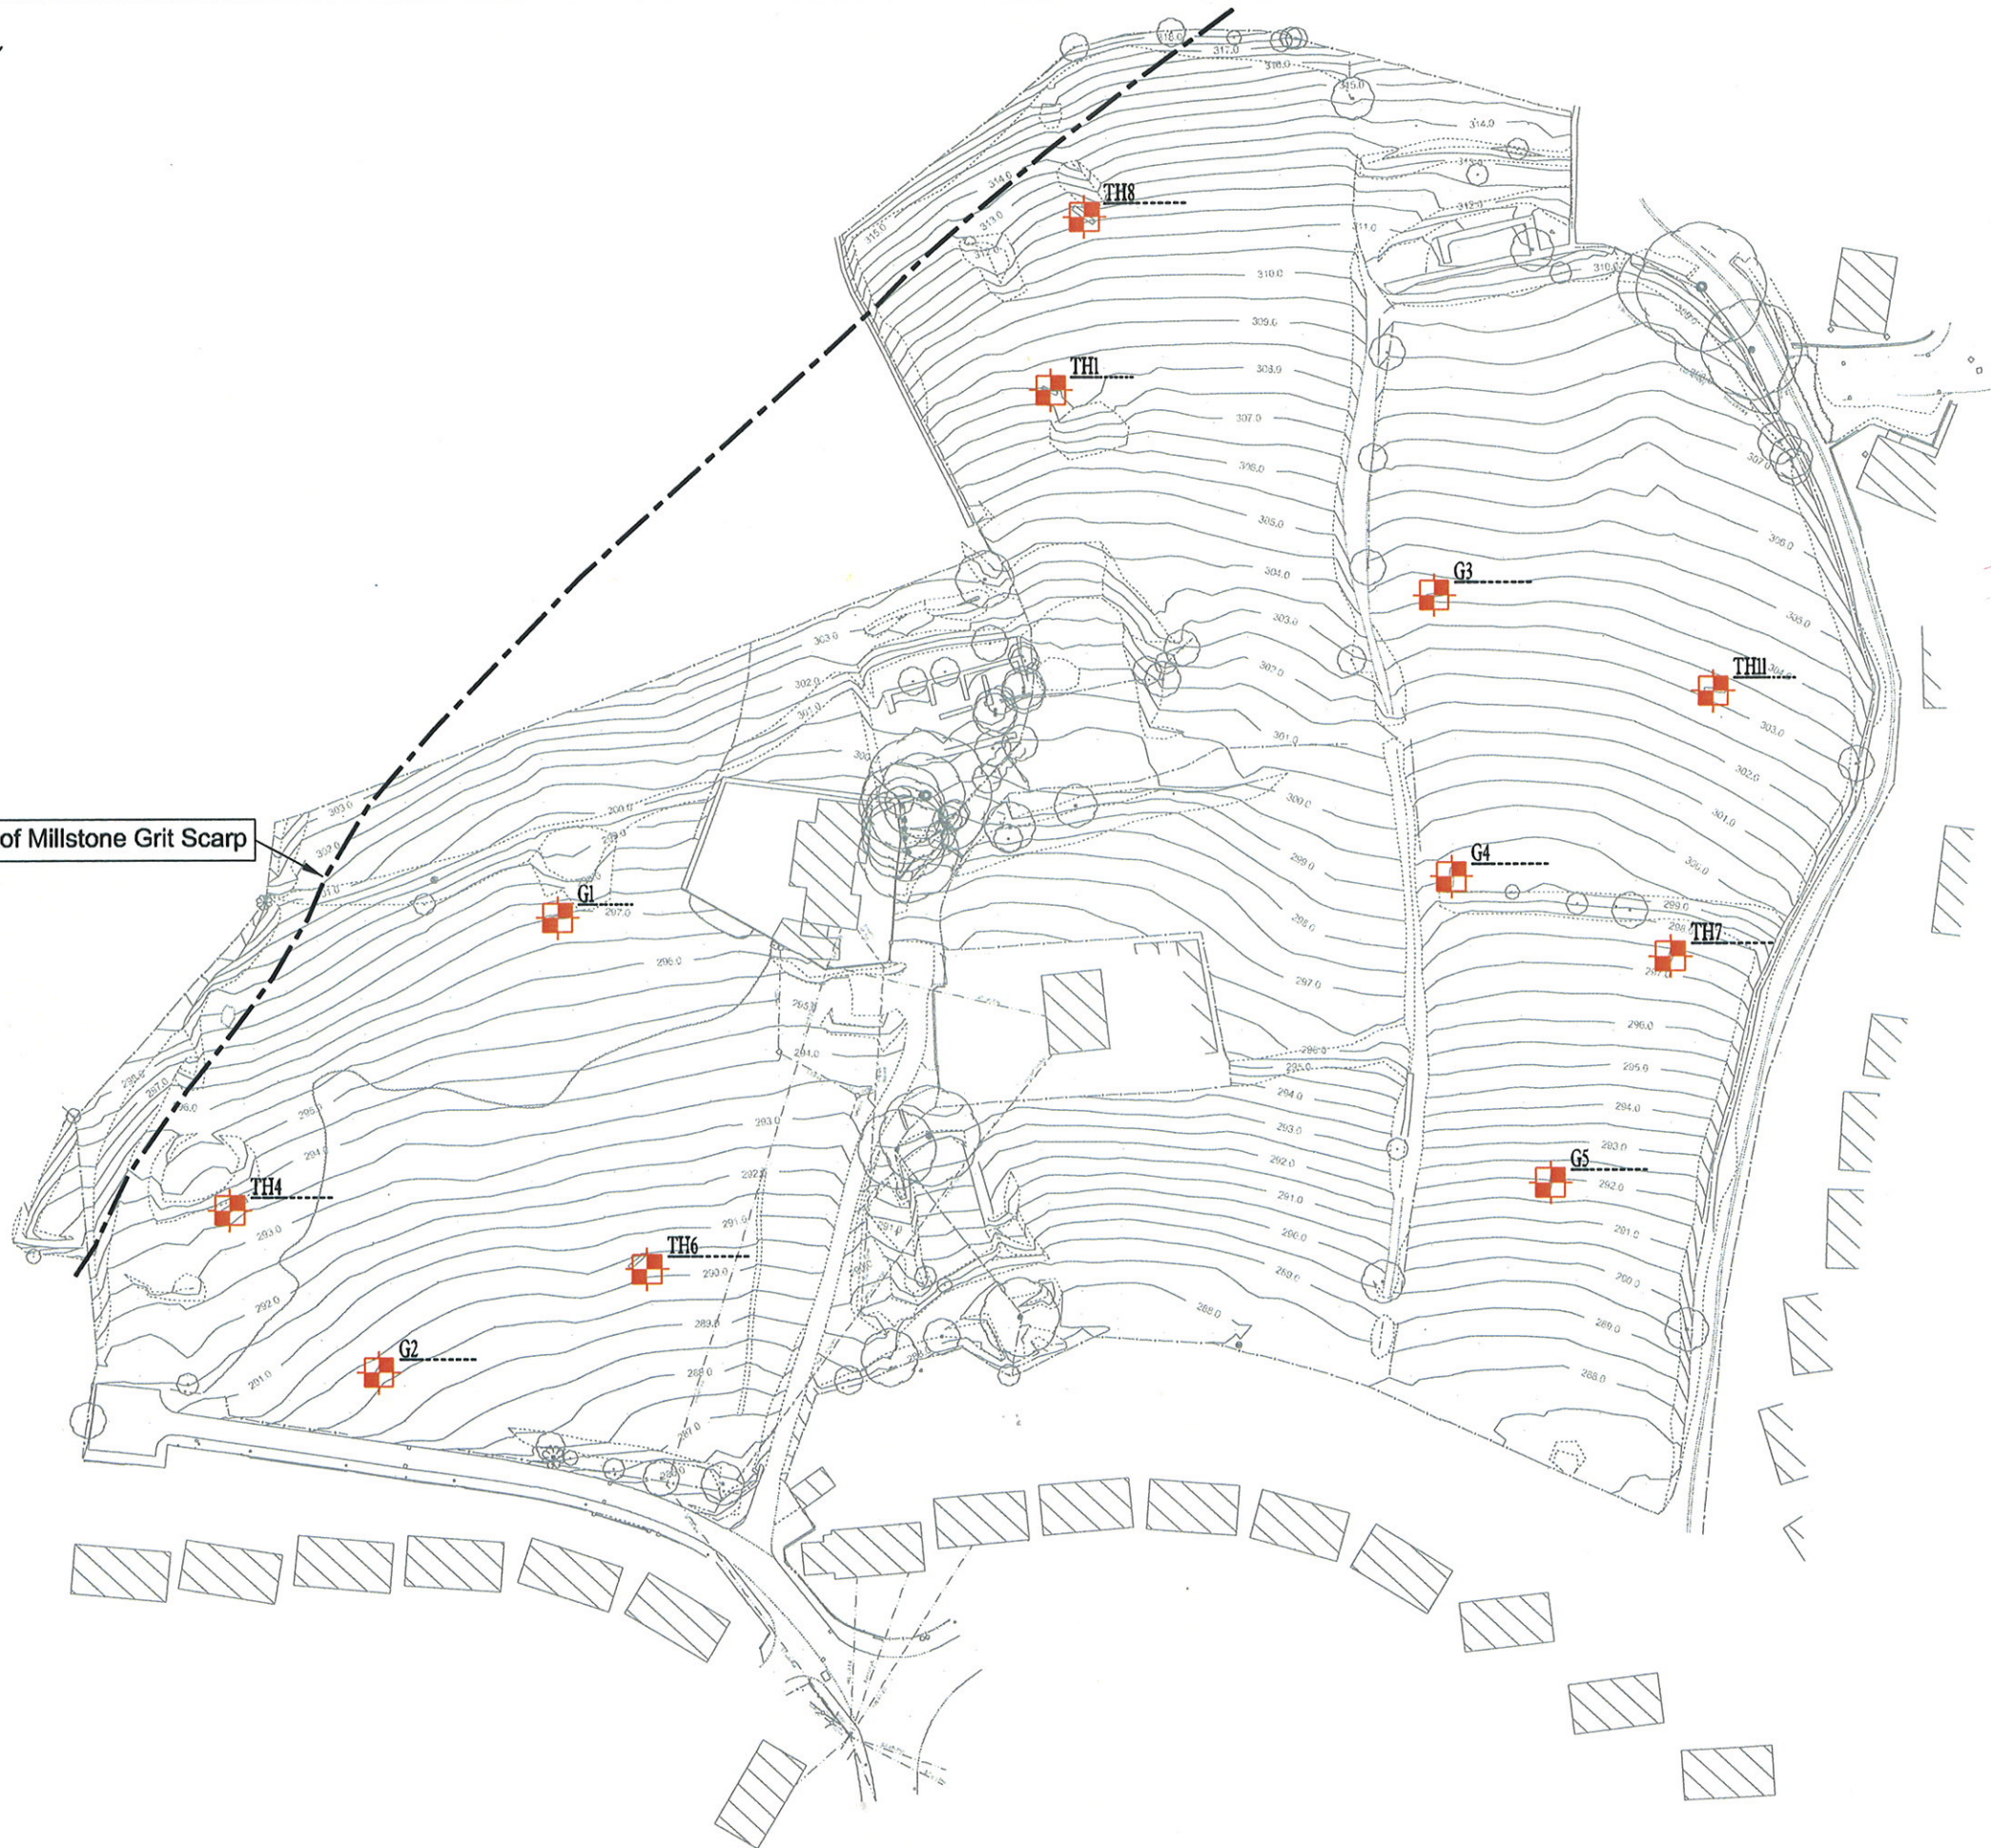
Ground Level  
Survey Results

Foot of Millstone Grit Scarp

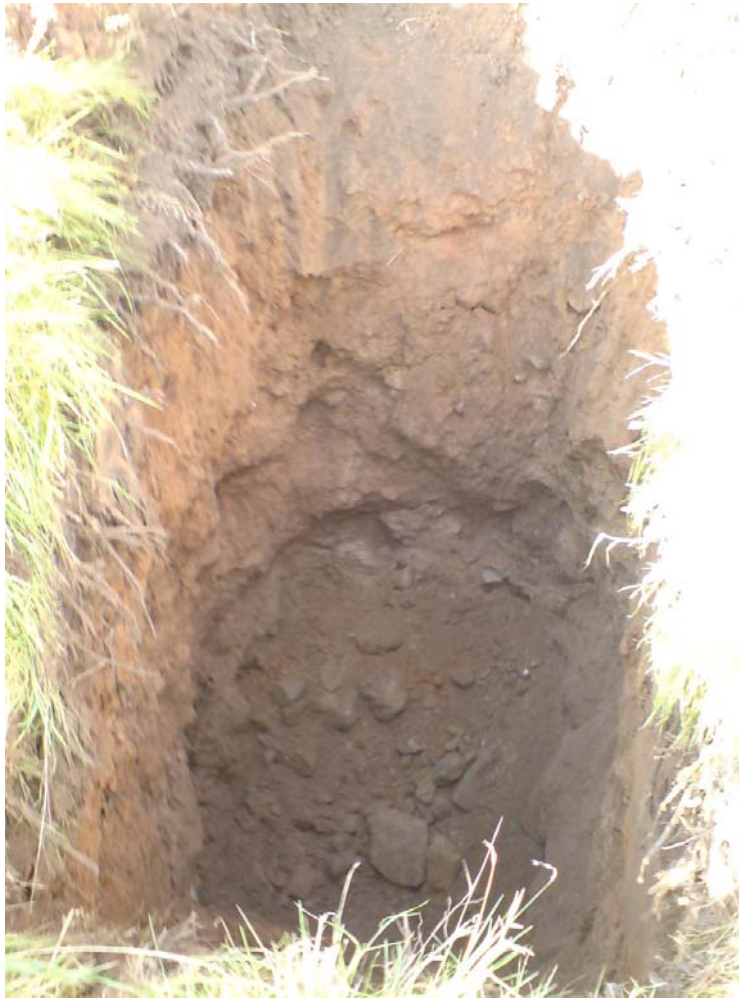
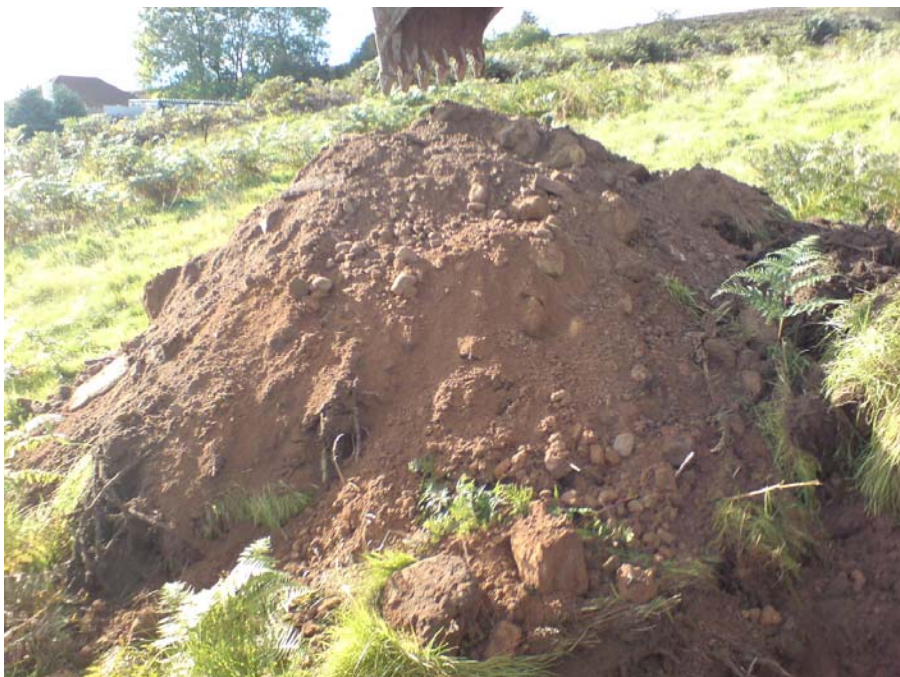
**Trial Pit G5**

Apart from the obvious piles of quartzite cobbles and boulders at the surface in a number of trial pit locations, no evidence of any materials indicative of filling were encountered in the trial pits. One piece of wood was found in TPG5, which appeared to be from an old fence post and probably fell into the pit during excavation. The superficial deposits are therefore interpreted as natural glacial deposits.

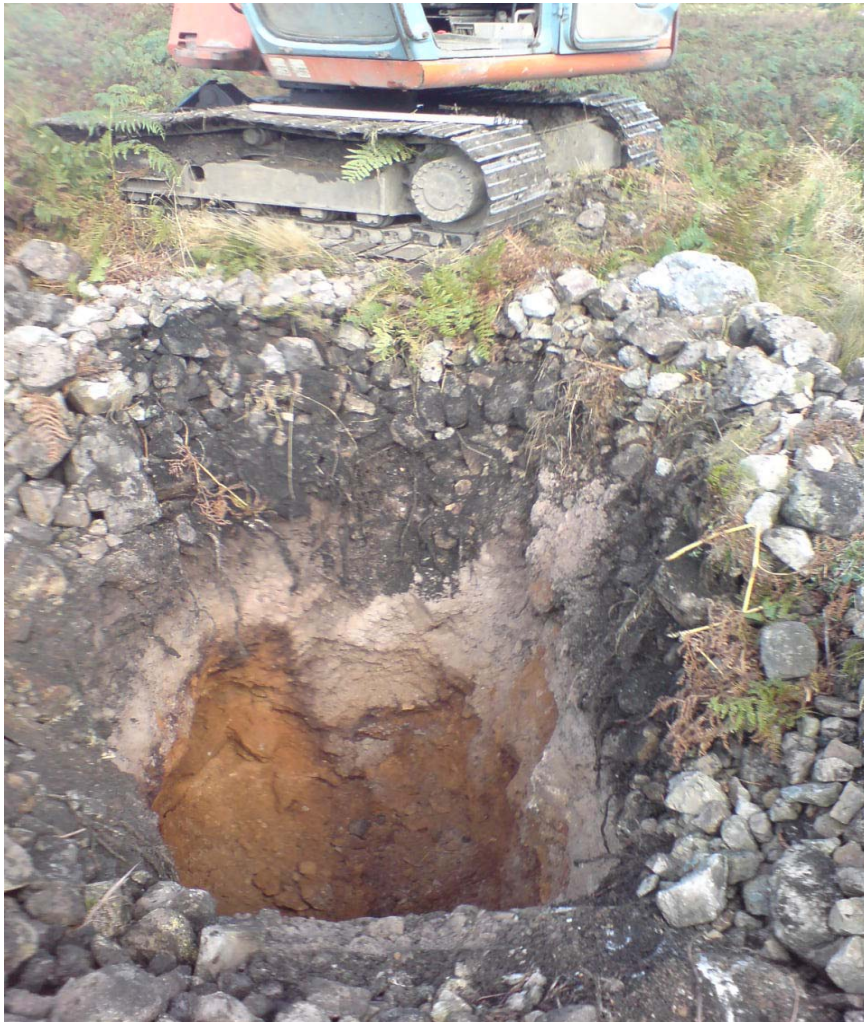
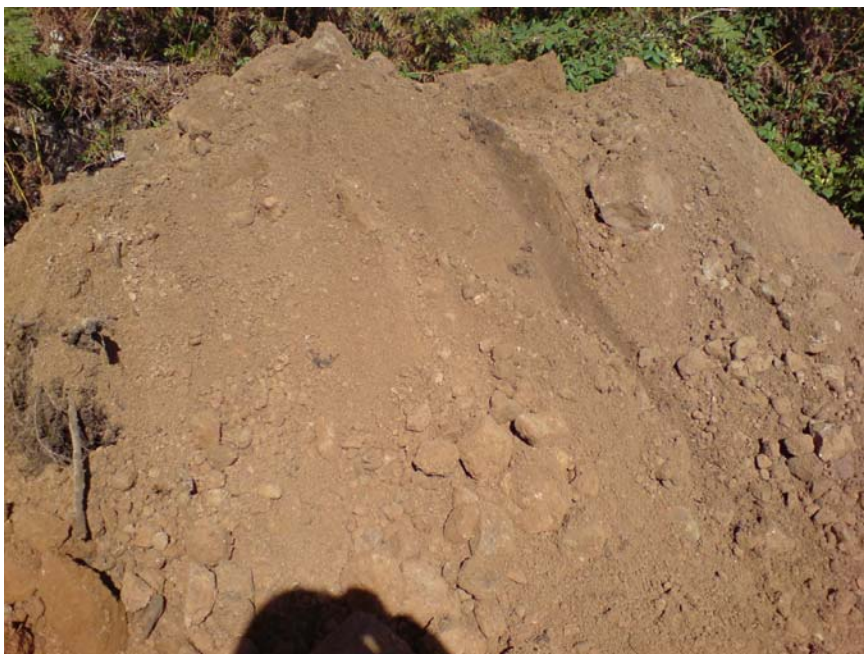
## **Trial Pit TH4**

Loose piles of cobbles existing at surface level were observed during the site walkover and interpreted as possible fill on site. Three locations were excavated where rock piles existed. The only noticeable variation was observed in TH4, which was excavated within the large historic rock pile in the south west of the site. Loose quartzite cobbles were encountered up to 0.8m in thickness (expected due to stockpile size) beneath which a very dark layer of decaying vegetation and roots was observed. Beneath the vegetation a layer (0.7m in thickness) of grey soft sandy clay existed which on initial observation appeared almost ashy. Underlying the light clayey material, slightly clayey gravelly sand was encountered, consistent with the glacial deposits encountered elsewhere across the site, (and beneath the other two rock piles excavated). The glacial deposits are described below.

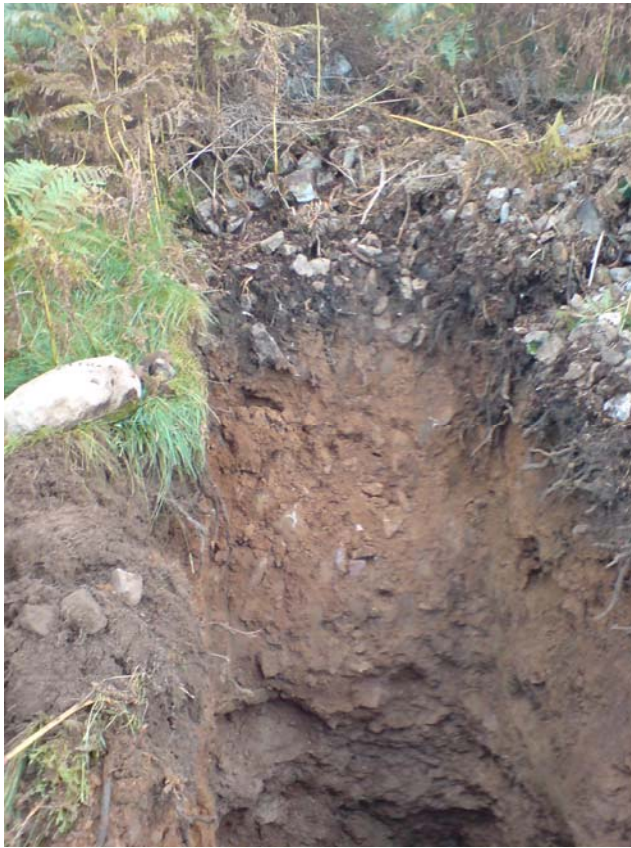
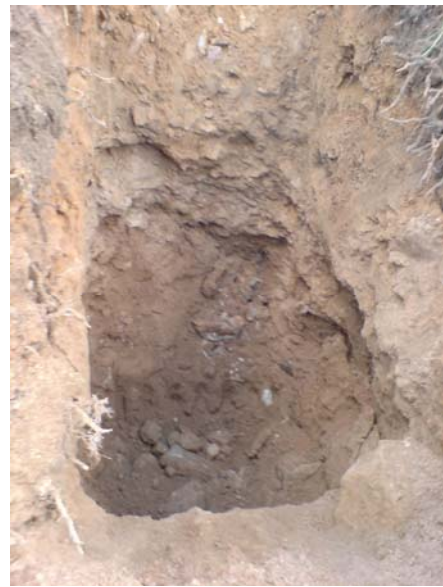
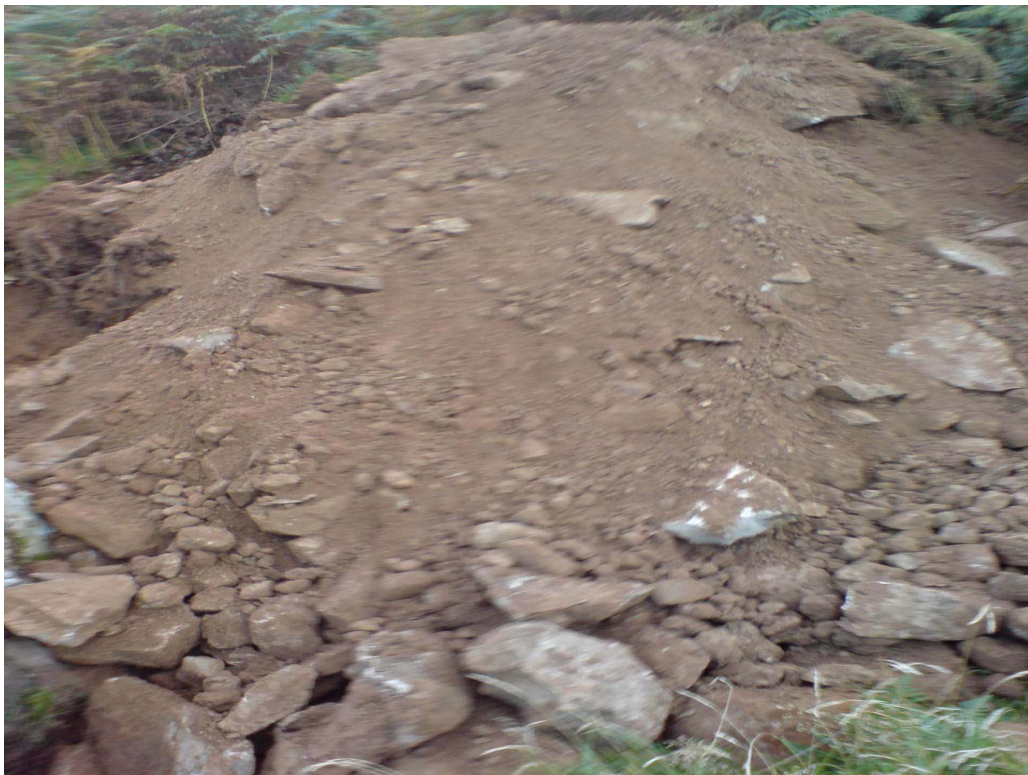
**Trial Pit TH8**

| Strata | Thickness (m) | Description |
|---|---|---|
| Silt and Decaying organic matter | 0.1 | Encountered beneath stockpiles of loose rock (TH8, TH1, and TH4) |
