## Preliminary Ecological Appraisal

Premier Inn Merthyr Tydfil, Duffryn, Pentrebach, Merthyr Tydfil, CF48 4BB

Premier Inn Hotels

The construction of an extension to the hotel for the construction of 16 additional rooms.

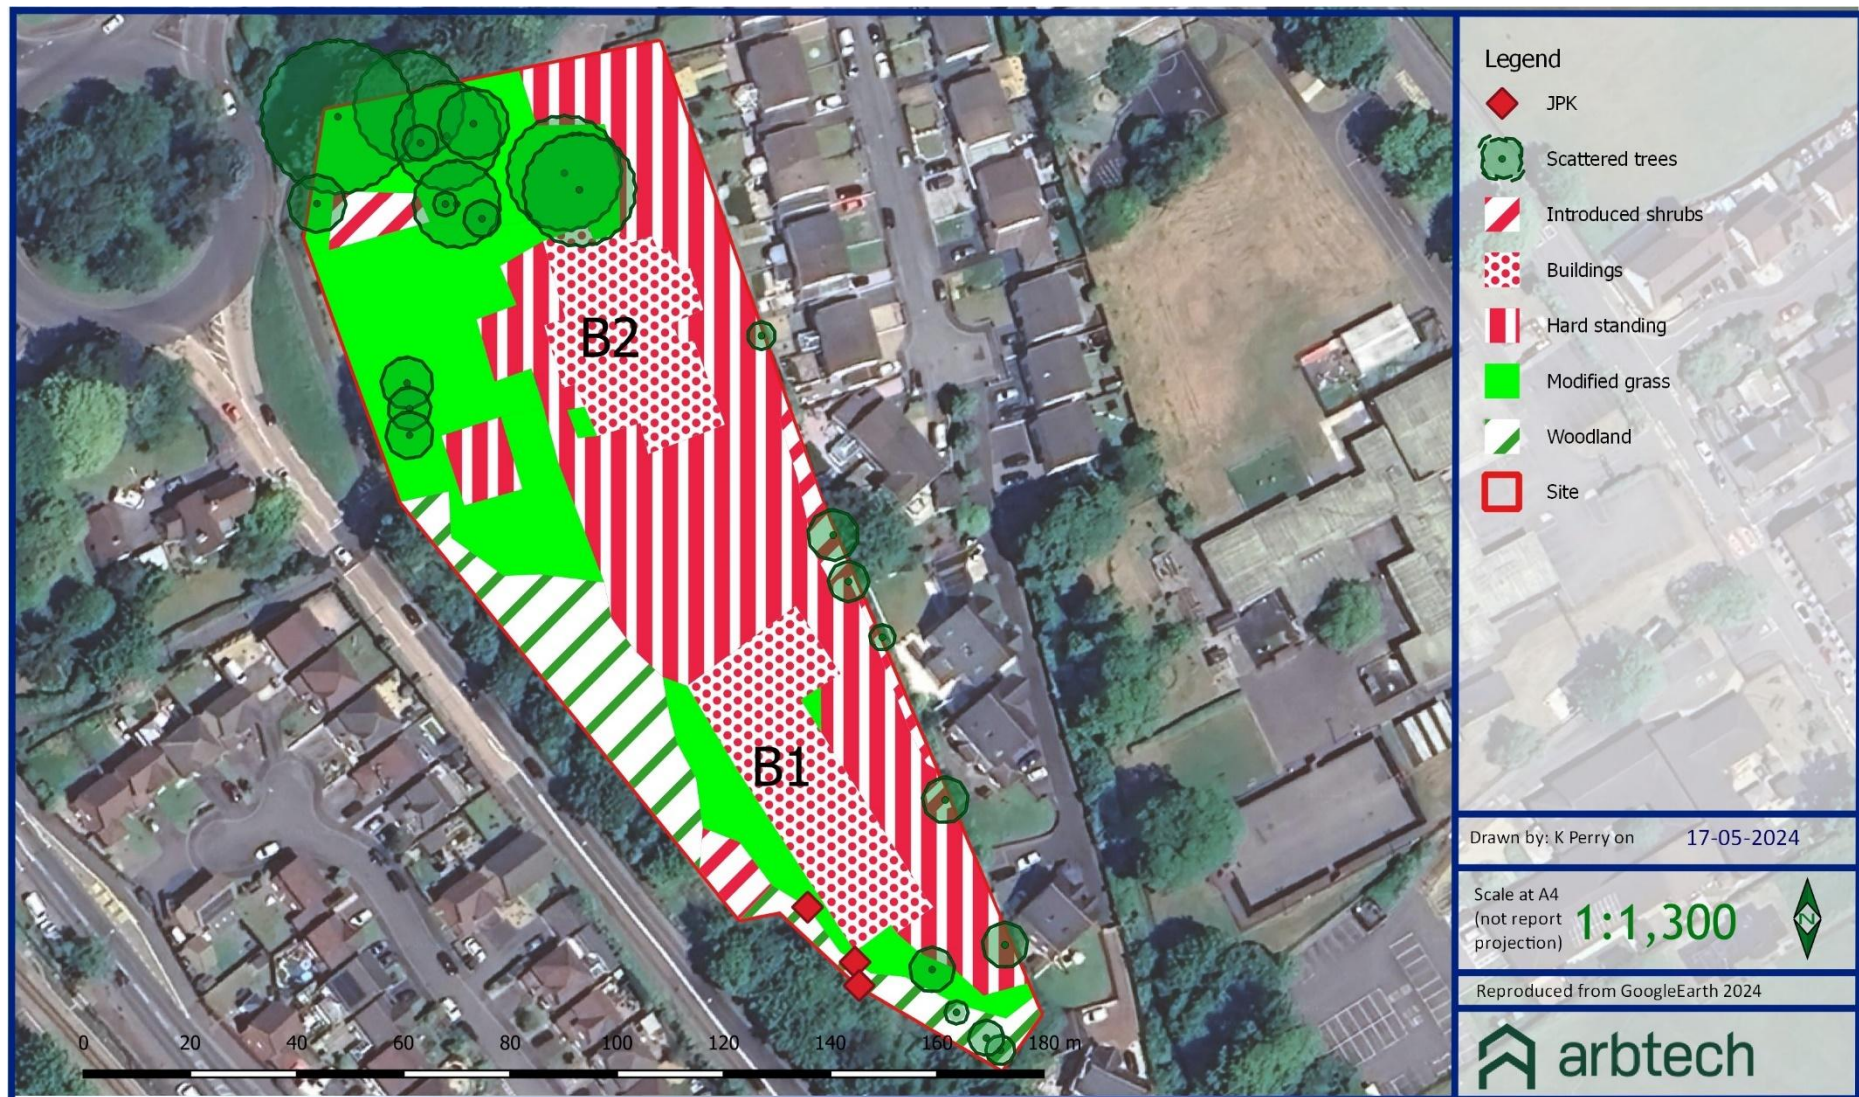
**Appendix 1: Survey/Habitat map**

| Habitats and plants (see habitat map in appendix 1, location plan in appendix 2, photos in appendix 3 and proposal plan in appendix 4). | | | | | |

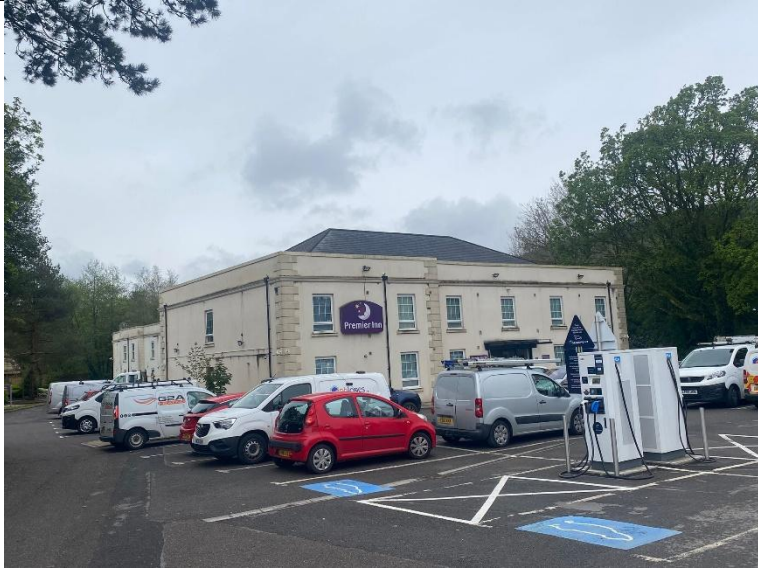
| | <p>&lt; Image 1: North elevation of B1 with rendered brickwork and secure slate roof tiles.</p> | |

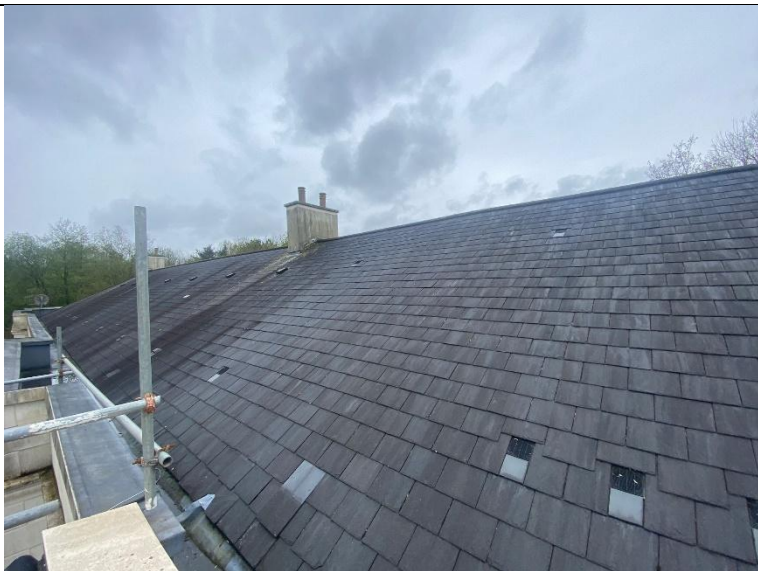
| | <p>&lt; Image 3: A close up of the field tiles on the east elevation of B1. They are in excellent condition.</p> | |

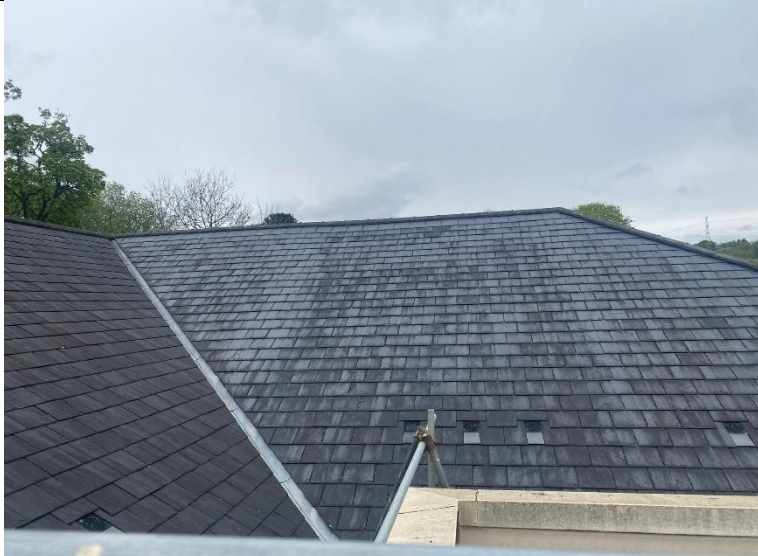
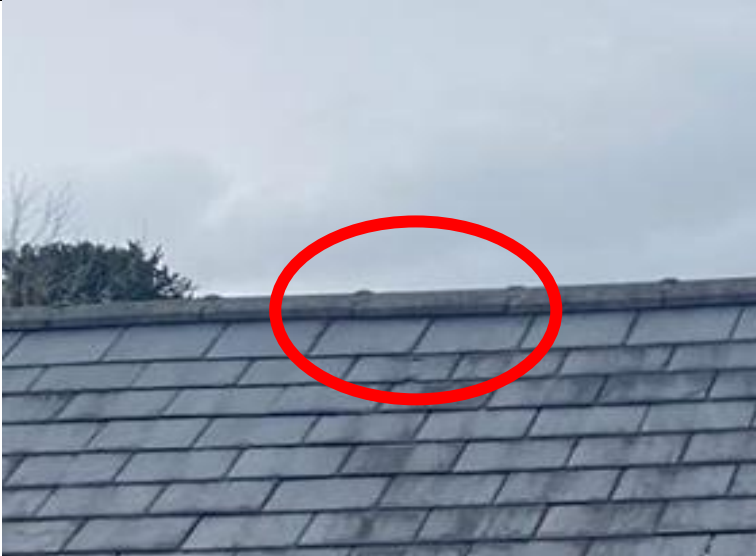
| | <p>&lt; Image 5:<br/>Looking northwest at the field tiles on the L of the building.</p> <p>&gt; Image 6: A close up of the minor, narrow, ridge gap on this northern elevation.</p> | |

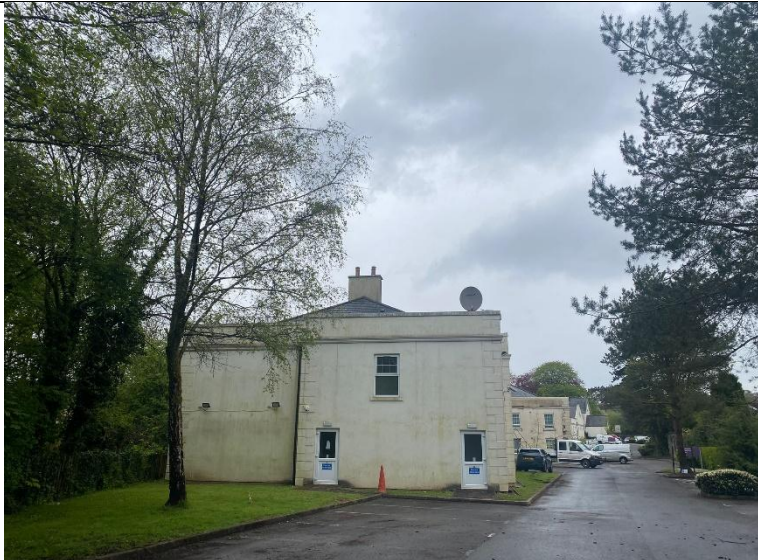
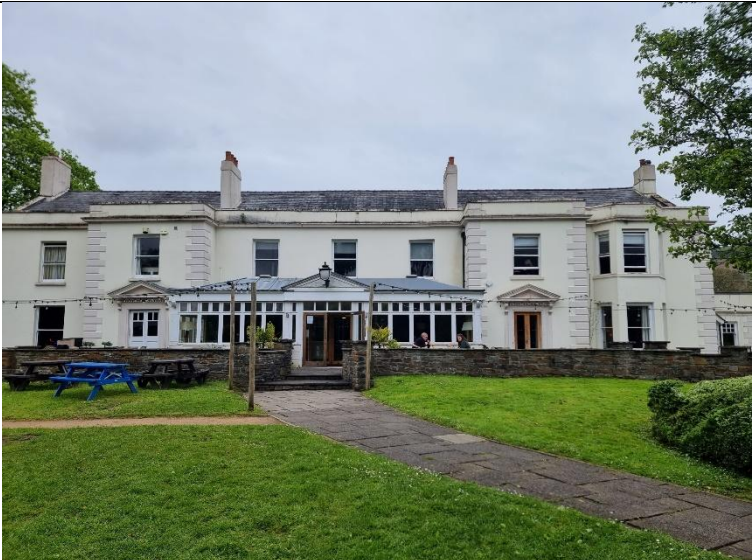
| | <p>&lt; Image 7: South elevation of B1 and T2 in front of it, which has no features present.</p> <p>&gt; Image 8: The exterior of B2. The west facing elevation.</p> | |

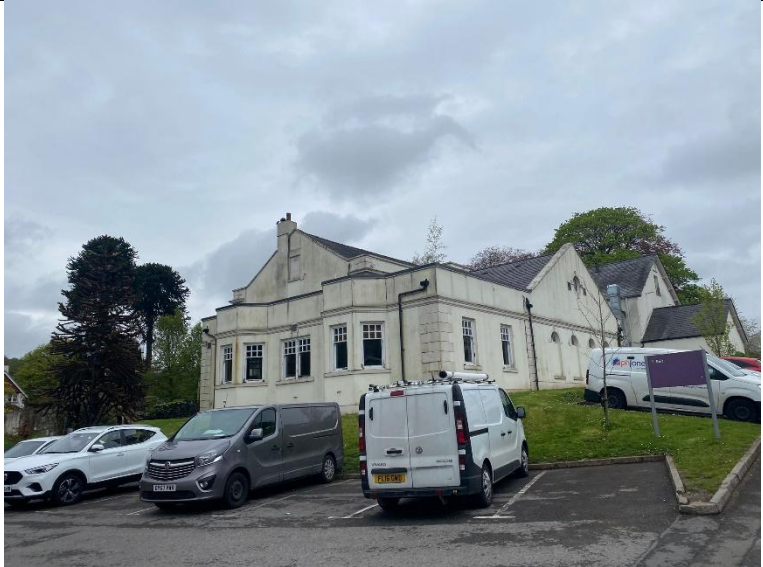
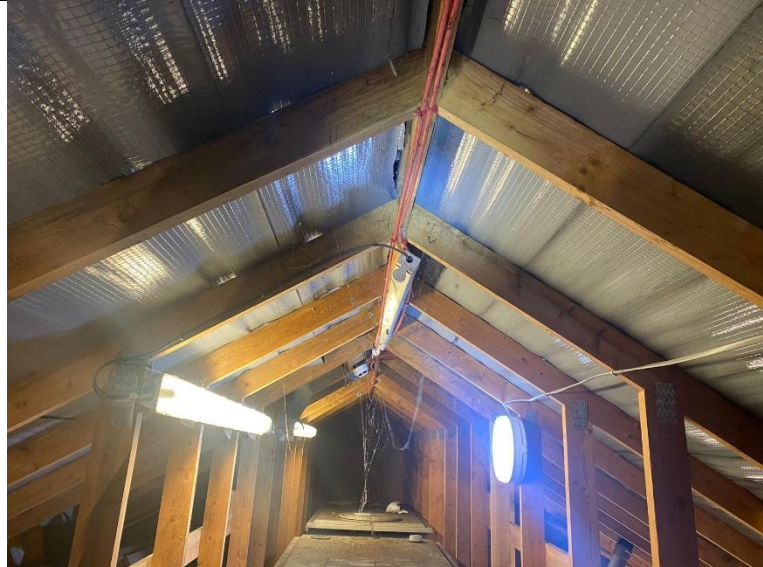
| | <p>&lt; Image 9: South and east elevations of B2.</p> <p>&gt; Image 10: The loft space of B1. There are undisturbed cobwebs along the ridge.</p> | |

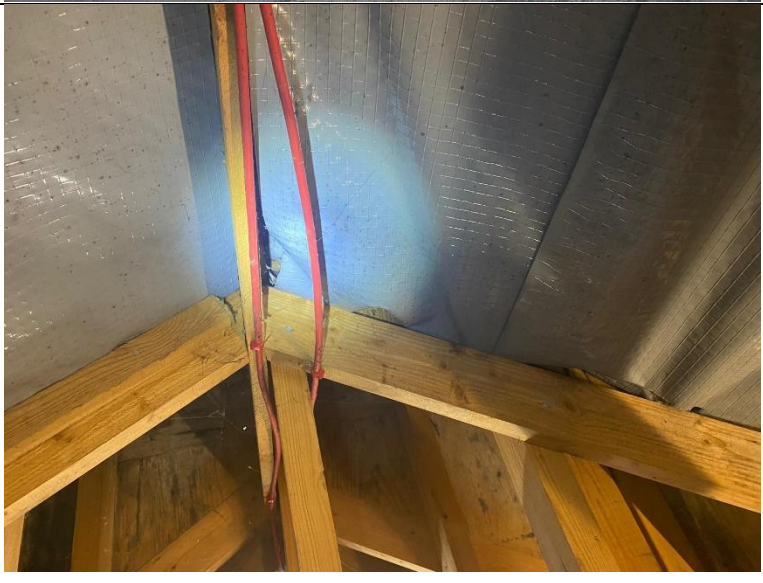
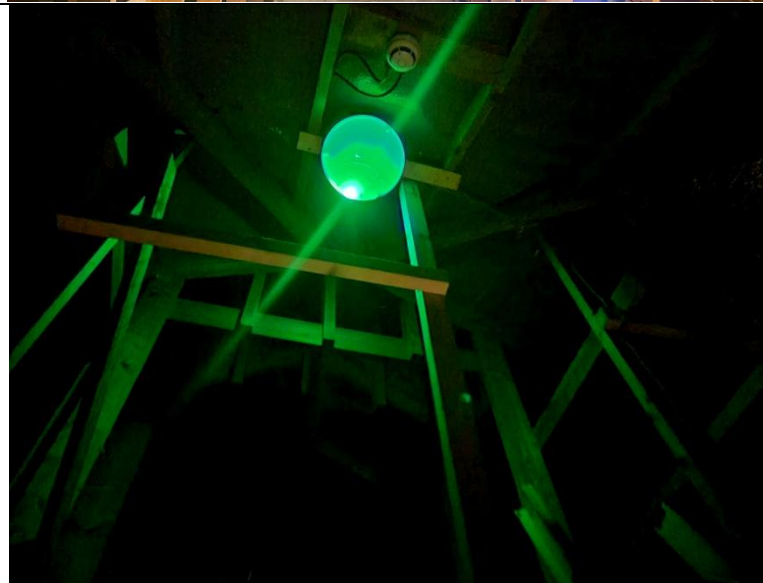
| | <p>&lt; Image 11: Close-up of some gaps along the ridge internally, but with no connection to the exterior of the building.</p> <p>&gt; Image 12: Green fire exit light on permanently within the loft space.</p> | |

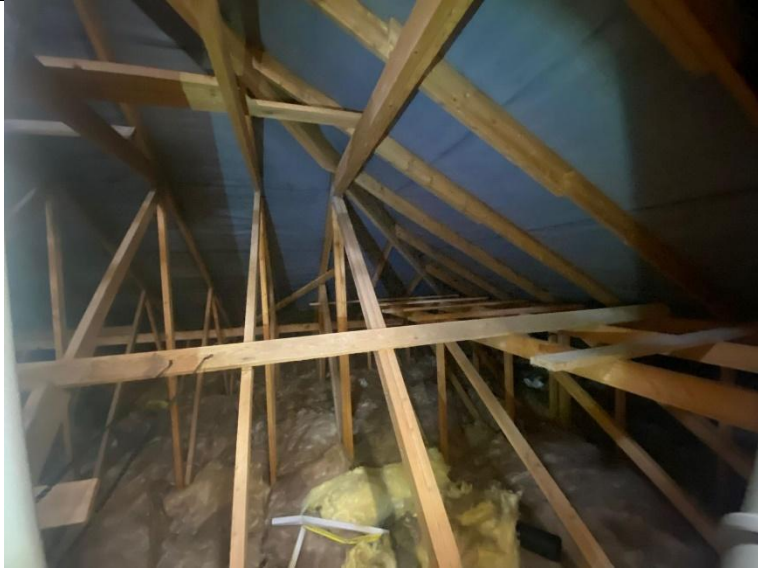
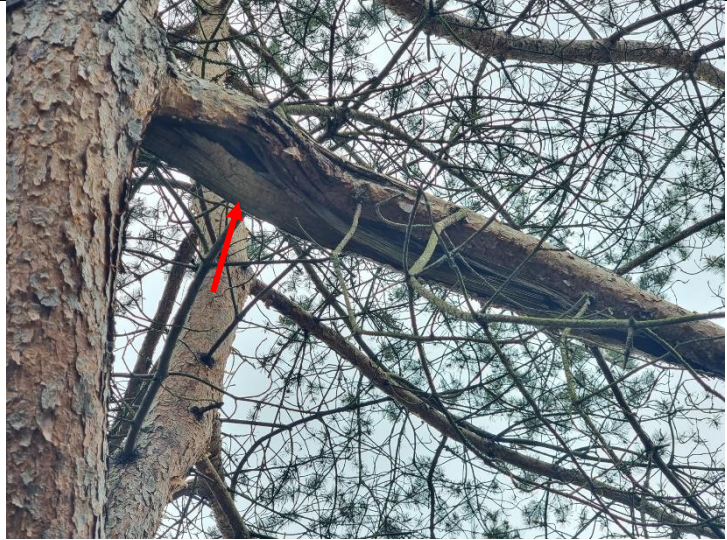
| | <p>&lt; Image 13: internal walls were secure with no external light entering, no evidence of bats or droppings found inside.</p> <p>&gt; Image 14: The limb feature on T8 which can be inspected prior to felling.</p> | |

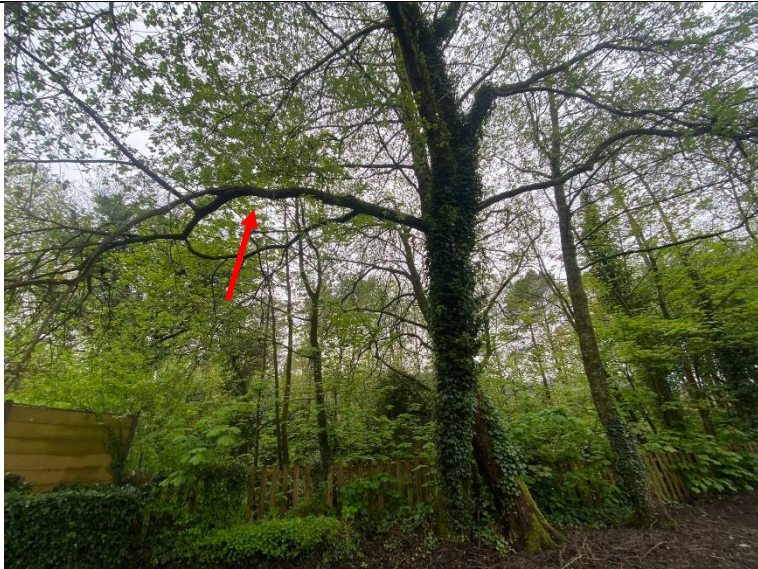
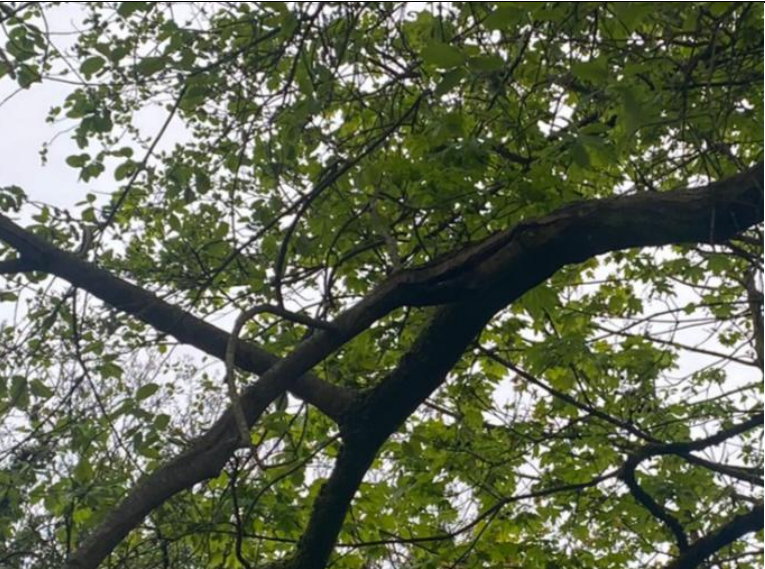
| | <p>&lt; Image 15: T2, an alder, is further south of T1 and T2 and not due to be impacted by the works but has some features present.</p> <p>&gt; Image 16: The limb feature on T2 close-up.</p> | |

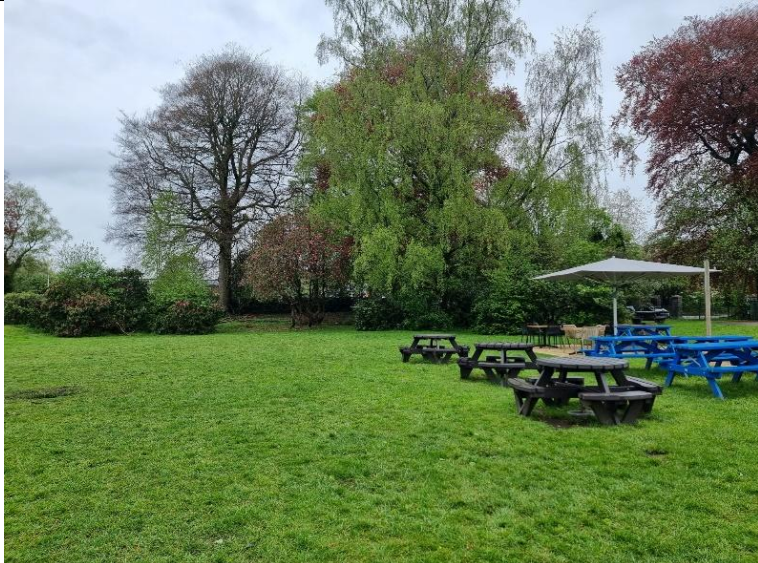
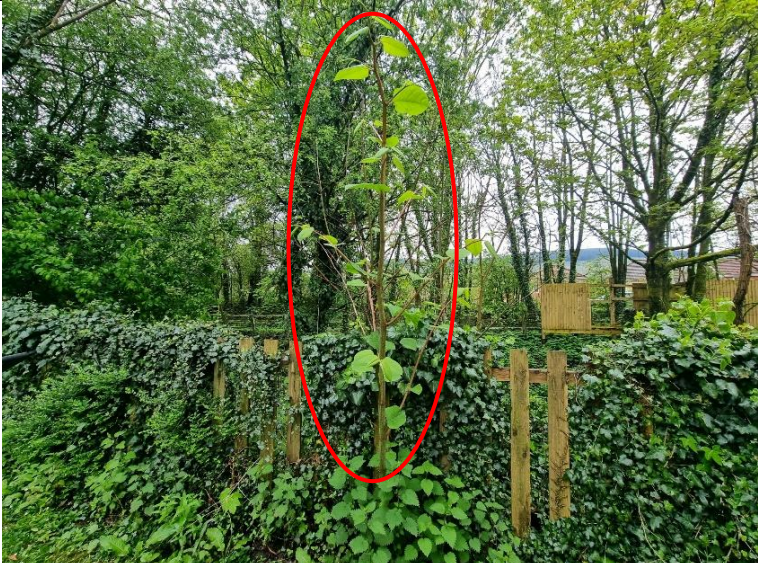
| | <p>&lt; Image 17:<br/>Mature beech trees, willow trees and short modified grass on site.</p> <p>&gt; Image 18: A large stand of JPK adjacent to the south-west corner of the building to be developed.</p> | |

| <i>Recommendations</i> | <p>Visible stands of JPK should have secure fencing installed with a buffer of 7m from the visible stands to prevent machinery, materials or persons entering the zones and to prevent accidental spread.</p> <p>An invasive species management plan will be required to control and/or eradicate Japanese knotweed which will likely include the injection of strong herbicides and will require a waste permit for removal of hazardous waste from site. Specialist contractors should be contacted for treatment and removal of JPK.</p> |

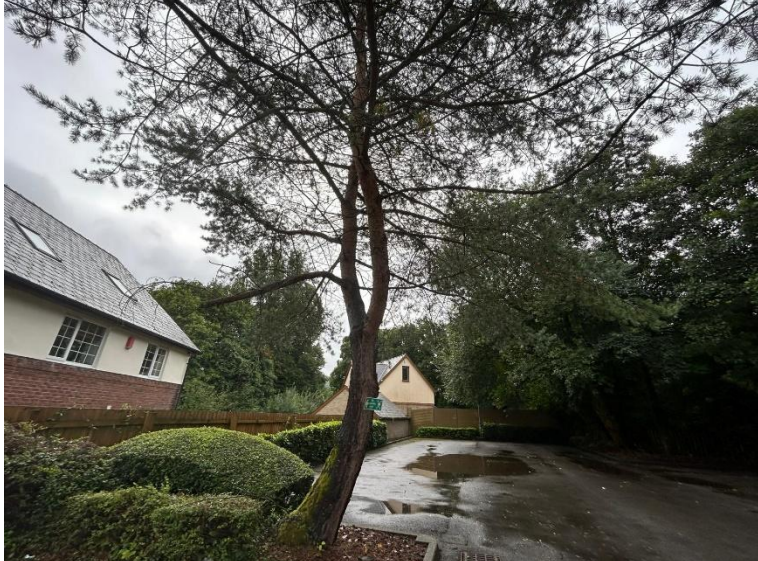
| | <p>T7, is a silver birch with no suitable features on this tree for supporting roosting bat species.</p> <p>T8 and T13 are Scott's pine. T8 has east facing stem approximately 3m up. This crevice is open to the elements making this feature suboptimal. In addition, the feature is easily inspected and therefore can be checked prior to felling. There are no other features present on the tree. This tree is rated PRF-I.</p> <p>T13 has no suitable features on this tree for supporting roosting bat species.</p> <p>T10 and T12 are common holly, with no suitable features on this tree for supporting roosting bat species.</p> <p>T11 is horse chestnut with no suitable features on this tree for supporting roosting bat species</p> <p>Associated images of the buildings and trees surveyed can be found at the end of the report, Appendix 4</p> <p><i>Since completion of the Preliminary Ecological Appraisal, a number of trees have been removed from the site as part of a reactive safety programme (Tree Squadron Ltd, August 2024). This included a group of 11 mature ash trees (Fraxinus excelsior) and one ash sapling, all previously forming part of <b>Group G08</b> in the accompanying Arboricultural Impact Assessment (Arbtech, April 2025). This group represented the <b>woodland habitat described in the original version of this PEA/PRA</b>, and G08 and T32 in the original Arboriculture report. In addition, a single <b>monkey puzzle</b> (Araucaria araucana) tree, referenced as <b>T30</b>, was removed from the southern boundary. These works were undertaken after the initial ecological survey was completed. The trees were not assessed for bat roost potential at the time, and no evidence of protected species was recorded during or following removal.</i></p> <p><b>Foraging and commuting habitat</b></p> |

| | <p>&lt; Image 19: T8</p> <p>&gt; Image 20: T5 and T6</p> | |

| | <p><b>Roosting habitat</b></p> <p>As per Tables 6.3 and 7.1 of the Bat Survey Guidelines (2023) trees with PRF-I's only do not require further survey effort, however compensation for lost features should be installed prior to tree felling works, and works should be carried out under a precautionary working method statement (PWMS). The PWMS includes:</p> <ul style="list-style-type: none"> <li>• Prior to any PRF removal, suitable compensation should be provided onsite (i.e. bat boxes in appropriate locations)</li> <li>• Felling to be done under supervision by an ecologist</li> <li>• An inspection of any features to be carried out by the arborist under supervision of the ground-based ecologist on site</li> <li>• Any identified PRF-I feature(s) will be soft felled in conjunction with an experienced arborist. This will involve sections of the tree with the PRF to be cut away and lowered to the ground and inspected by a licenced ecologist</li> <li>• Any PRFs felled will be left in-situ on the ground within a 10m exclusion zone for 24 hours</li> <li>• In the unlikely event that a bat or evidence of bats is discovered during the development all work must stop and a bat licensed ecologist contacted for further advice.</li> </ul> <p><b>Artificial lighting</b></p> <p>A low impact lighting strategy will be adopted for the site during post-development which outlines the areas of the site that will be retained as dark corridors. Parameters can be found on the Bat Conservation Trust website:<br/> <a href="https://www.bats.org.uk/our-work/buildings-planning-and-development/lighting">https://www.bats.org.uk/our-work/buildings-planning-and-development/lighting</a></p> <p><b>Suggested biodiversity enhancements</b></p> <p>The installation of two bat boxes at the site will provide additional roosting habitat for bats. The bat boxes will be integrated into the new building extension. Bat boxes should be positioned 3-5m above ground level facing in a south or south-westerly direction with a clear flight path to and from the entrance, away from artificial light. The bat box will be a specification suitable for crevice dwelling species such as Vivara pro building bat box, Integrated eco bat box for crevice dwellers, or a similar alternative. To compensate for the loss of tree T8, a woodstone or woodcrete bat box will be added</p> |

| | to a suitable mature tree on site. The bat box should be positioned 3-5m above ground level facing in a south or south-westerly direction with a clear flight path to and from the entrance, away from artificial light |

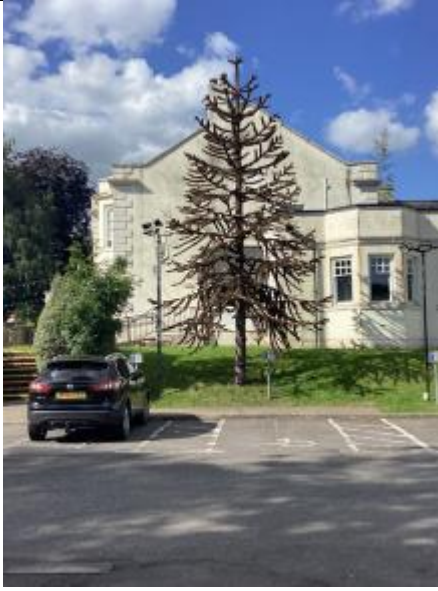
| | <p>&lt;Image 21: T7</p> <p>&gt;image 22: T30 which has now been removed (Tree Squadron Ltd, August 2024)</p> | |

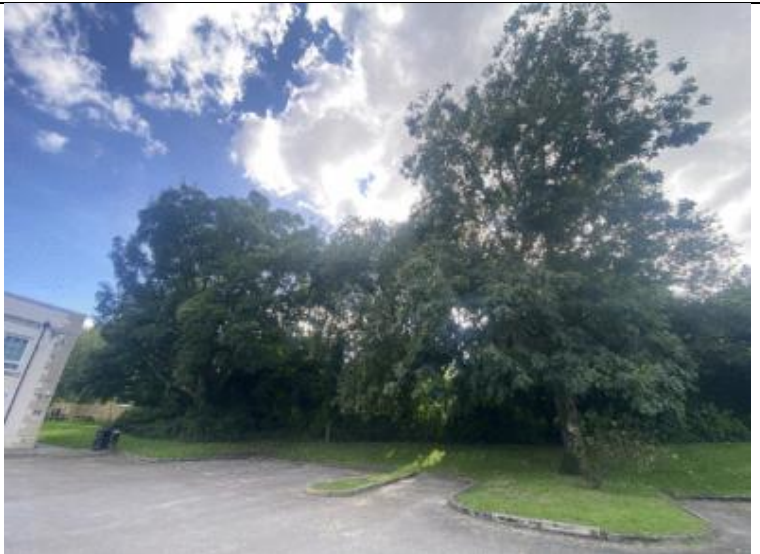
| | <p>&lt; Image 23: Tree group G08 in which some trees have been removed (Tree Squadron Ltd, August 2024)</p> | |
