**GARAGE AT GRAWEN HOUSE, GRAWEN LN, CEFN COED-Y-  
CYMMER, MERTHYR TYDFIL**

**BAT SURVEY  
ISSUE 1, VERSION C**

**MAY 2020**

### **Bat Survey Report**

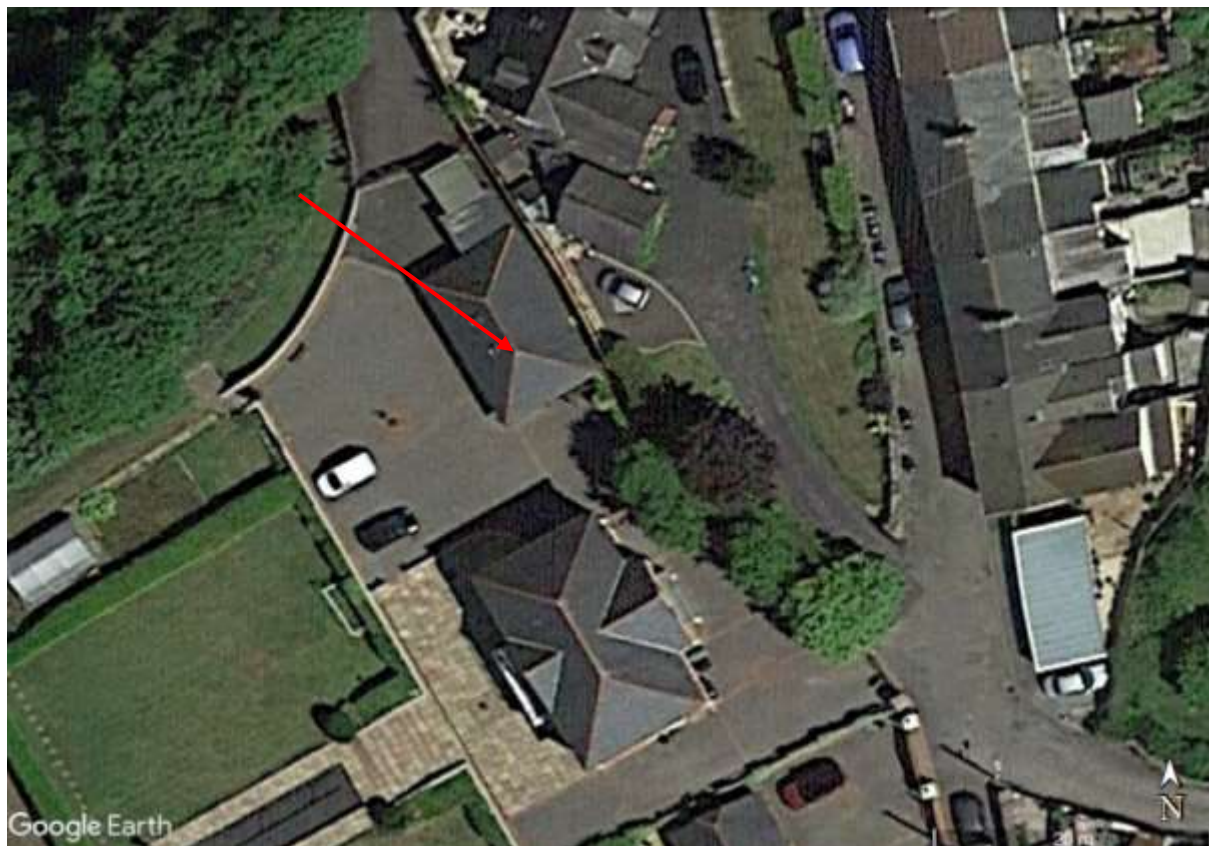
**Figure 1: Detailed view of the garage (arrowed red)**

The garage subject of this survey is located at Grawen House, Cefn-Y-Coed-Y-Cymmer, Merthyr Tydfil (Figures 1 and 2). The property is a two storey brick-built structure under a hipped slate roof, the ridge of which is oriented generally north west to south east. In recent years there has been a shed adjacent to the north western elevation, however, this is no longer present.

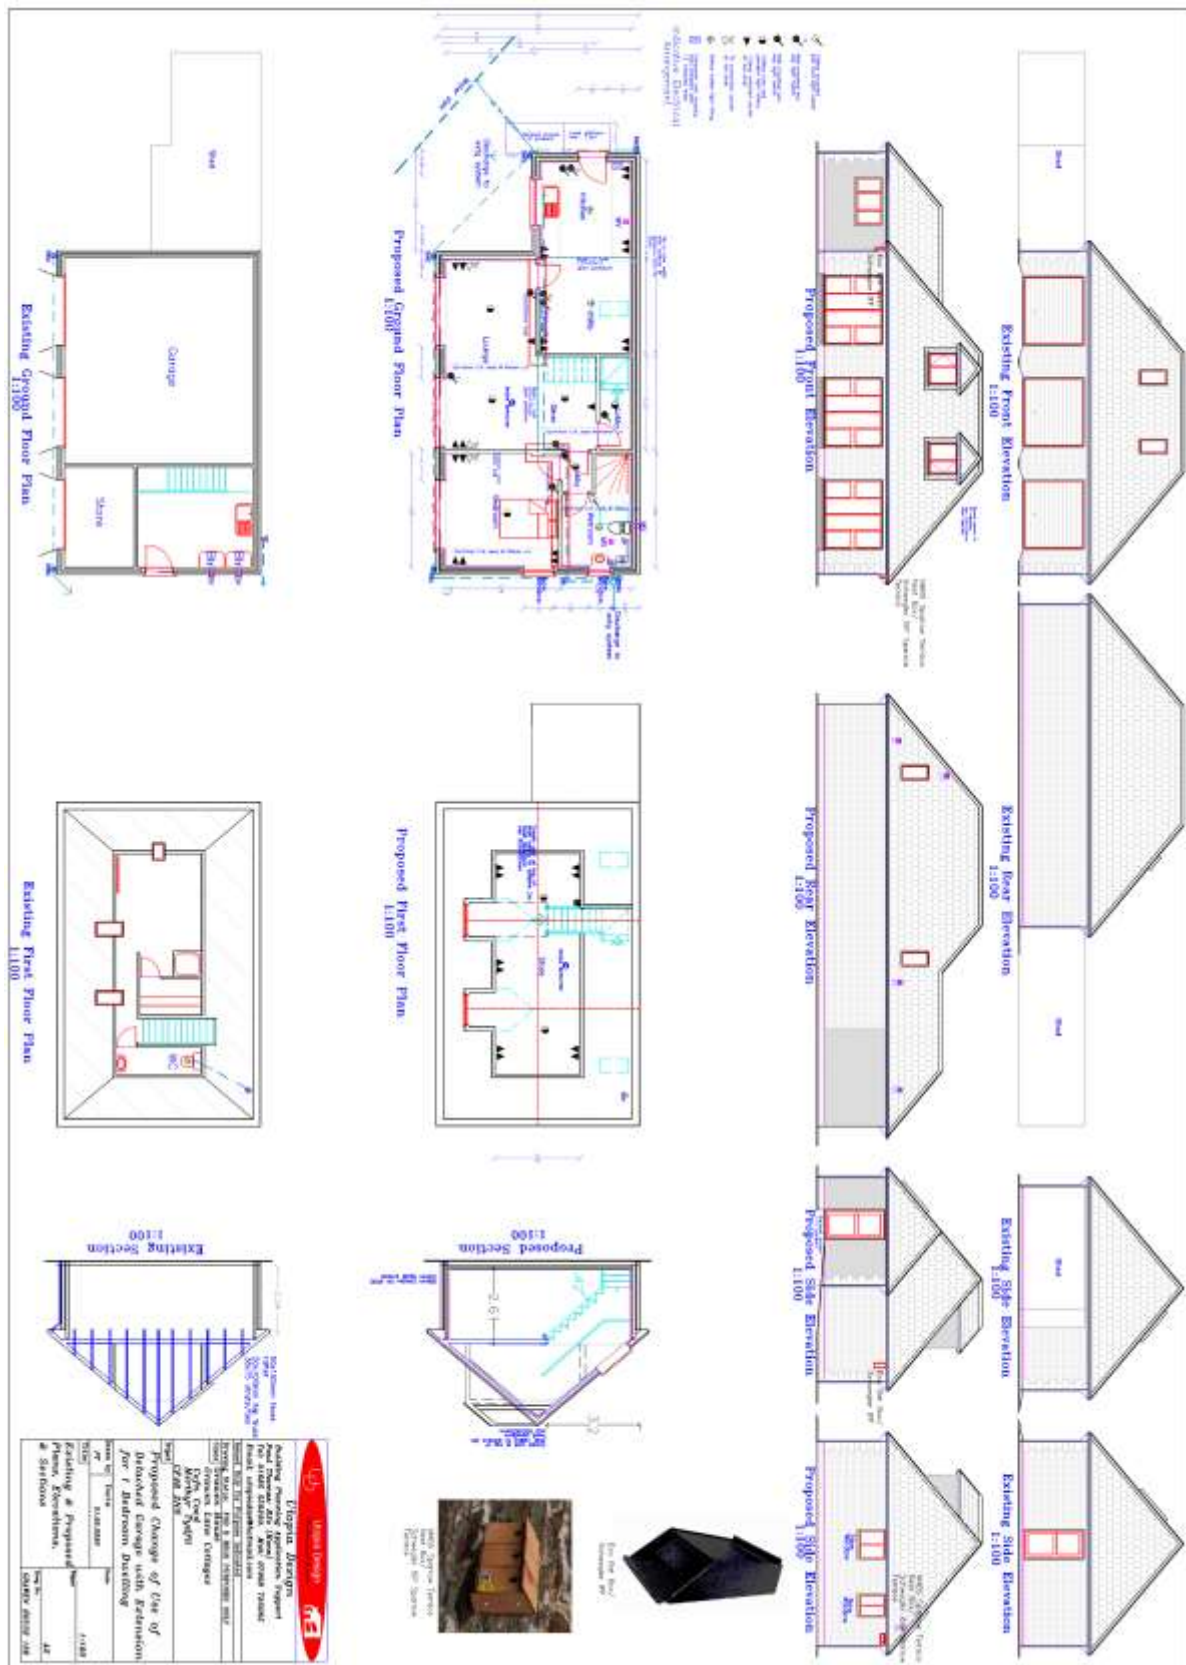
The existing roof lights on the south western elevation are to be converted to dormer windows and the building is to be extended on the north western elevation. The extension will be tied into the existing roof. Please see drawing Grawen House 13 for further details

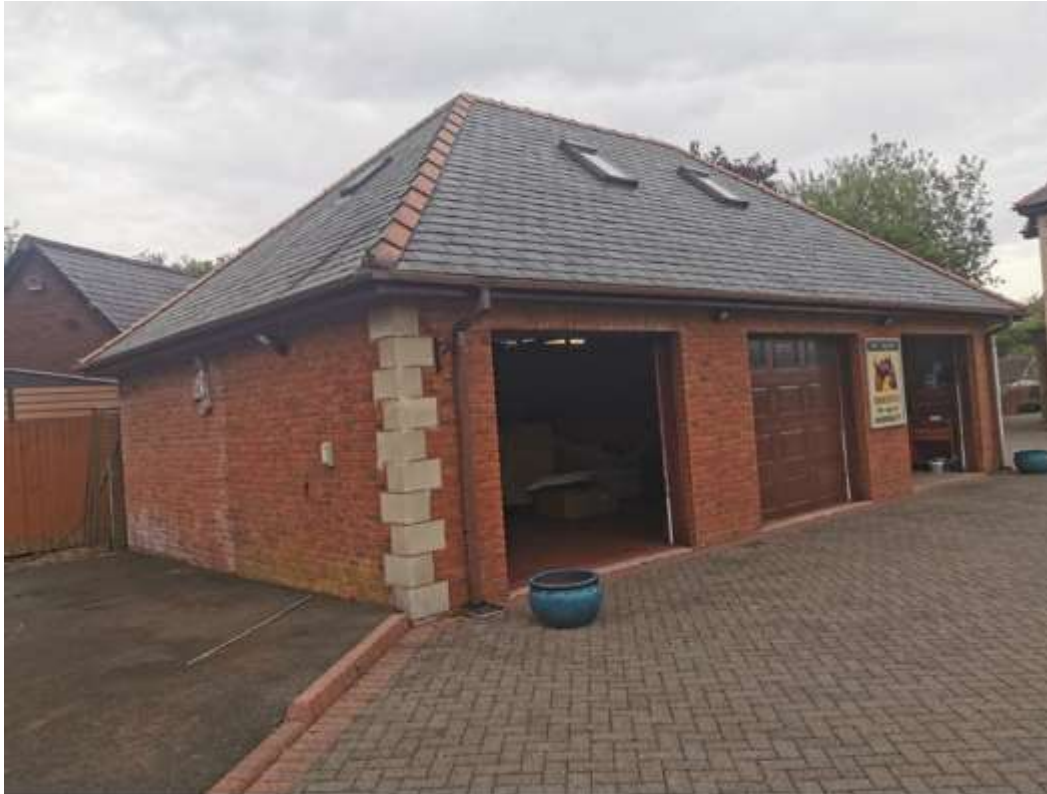
Plate 1- north and south western elevations

The survey carried out by BE Ecological Ltd revealed no droppings or evidence of bats on the exterior of the building, however, access and roosting potential for bats was identified in the form of:

- Small number of potentially lifted ridge/hip tiles

Please see appended plates for photographs of the property exterior. Other than these areas, the building is well sealed with no obvious gaps and no apparent slipped slates on the pitches of the roof.

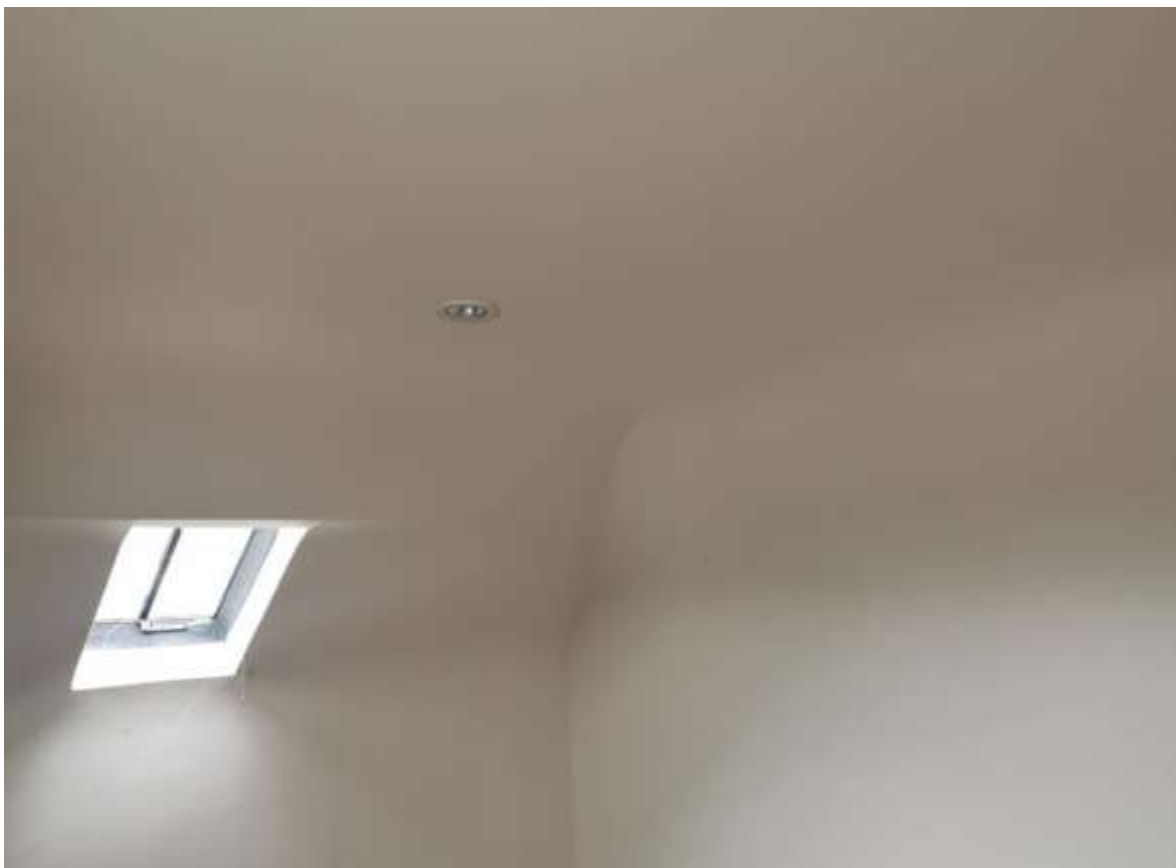
Internally, the property is split into two floors. The first floor only covers half of the ground floor (to the south east). This area is boarded out and has a vaulted ceiling. There is no roof void above this area, only the gap between the internal ceiling and roof covering.

**Plate 4- photograph of vaulted ceiling**

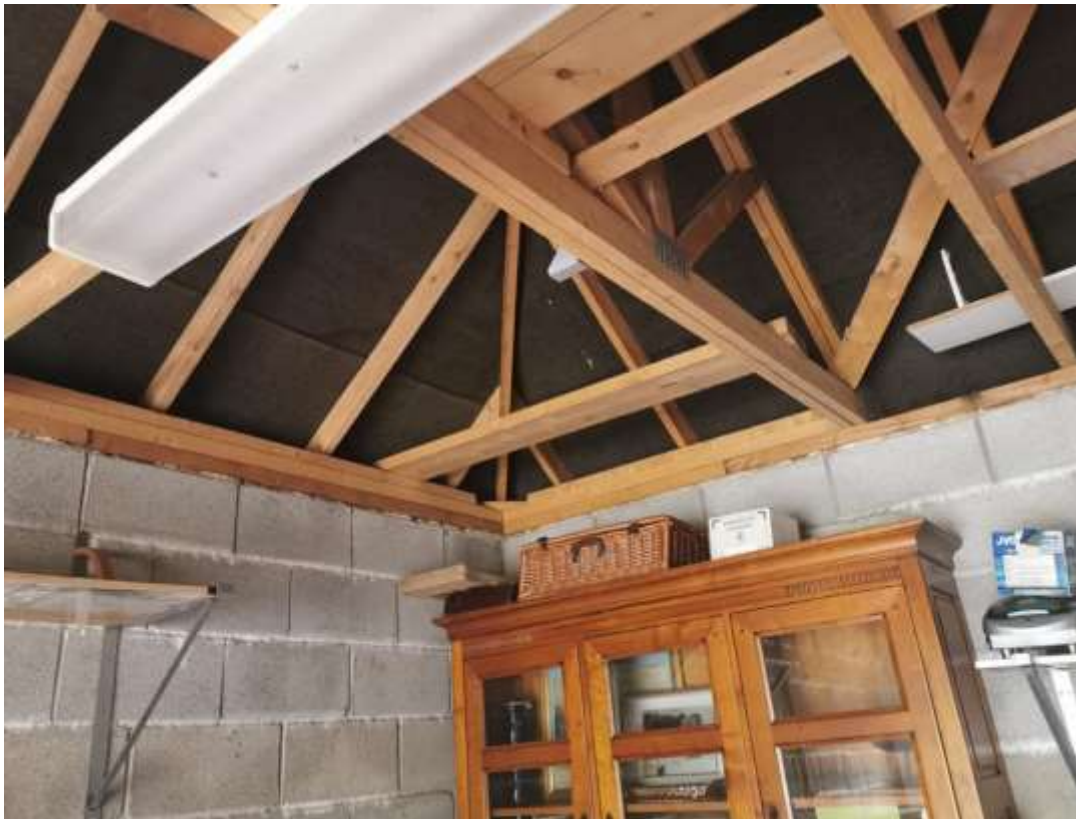
The remainder of the garage is open from floor to ridge and is a typical rafter and purlin style roof. The area is currently used for storage. The timbers are extremely clean, in good order and are lined with bitumen felt. The timbers sit on the wall plates of the garage, sealing the building off from any access via the soffits.

No bats or evidence of bats was found in this location.

**Plate 5- photograph of north western end of garage**

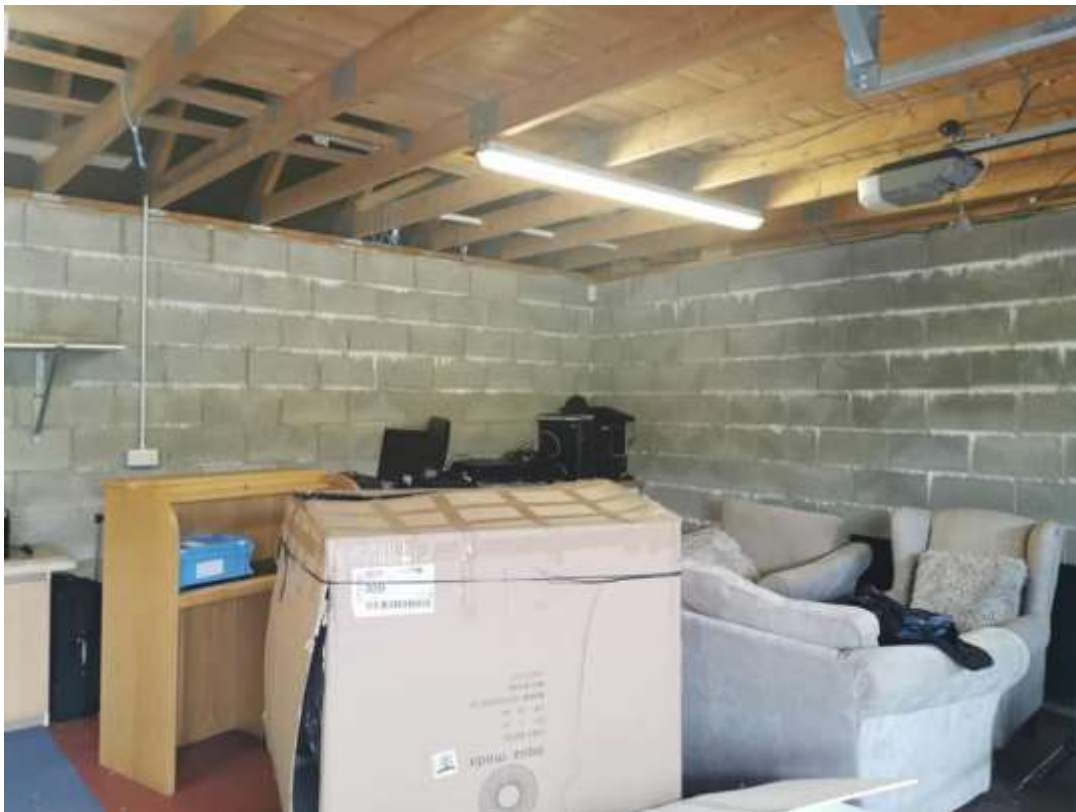
**Plate 6- photograph of south eastern end of garage**

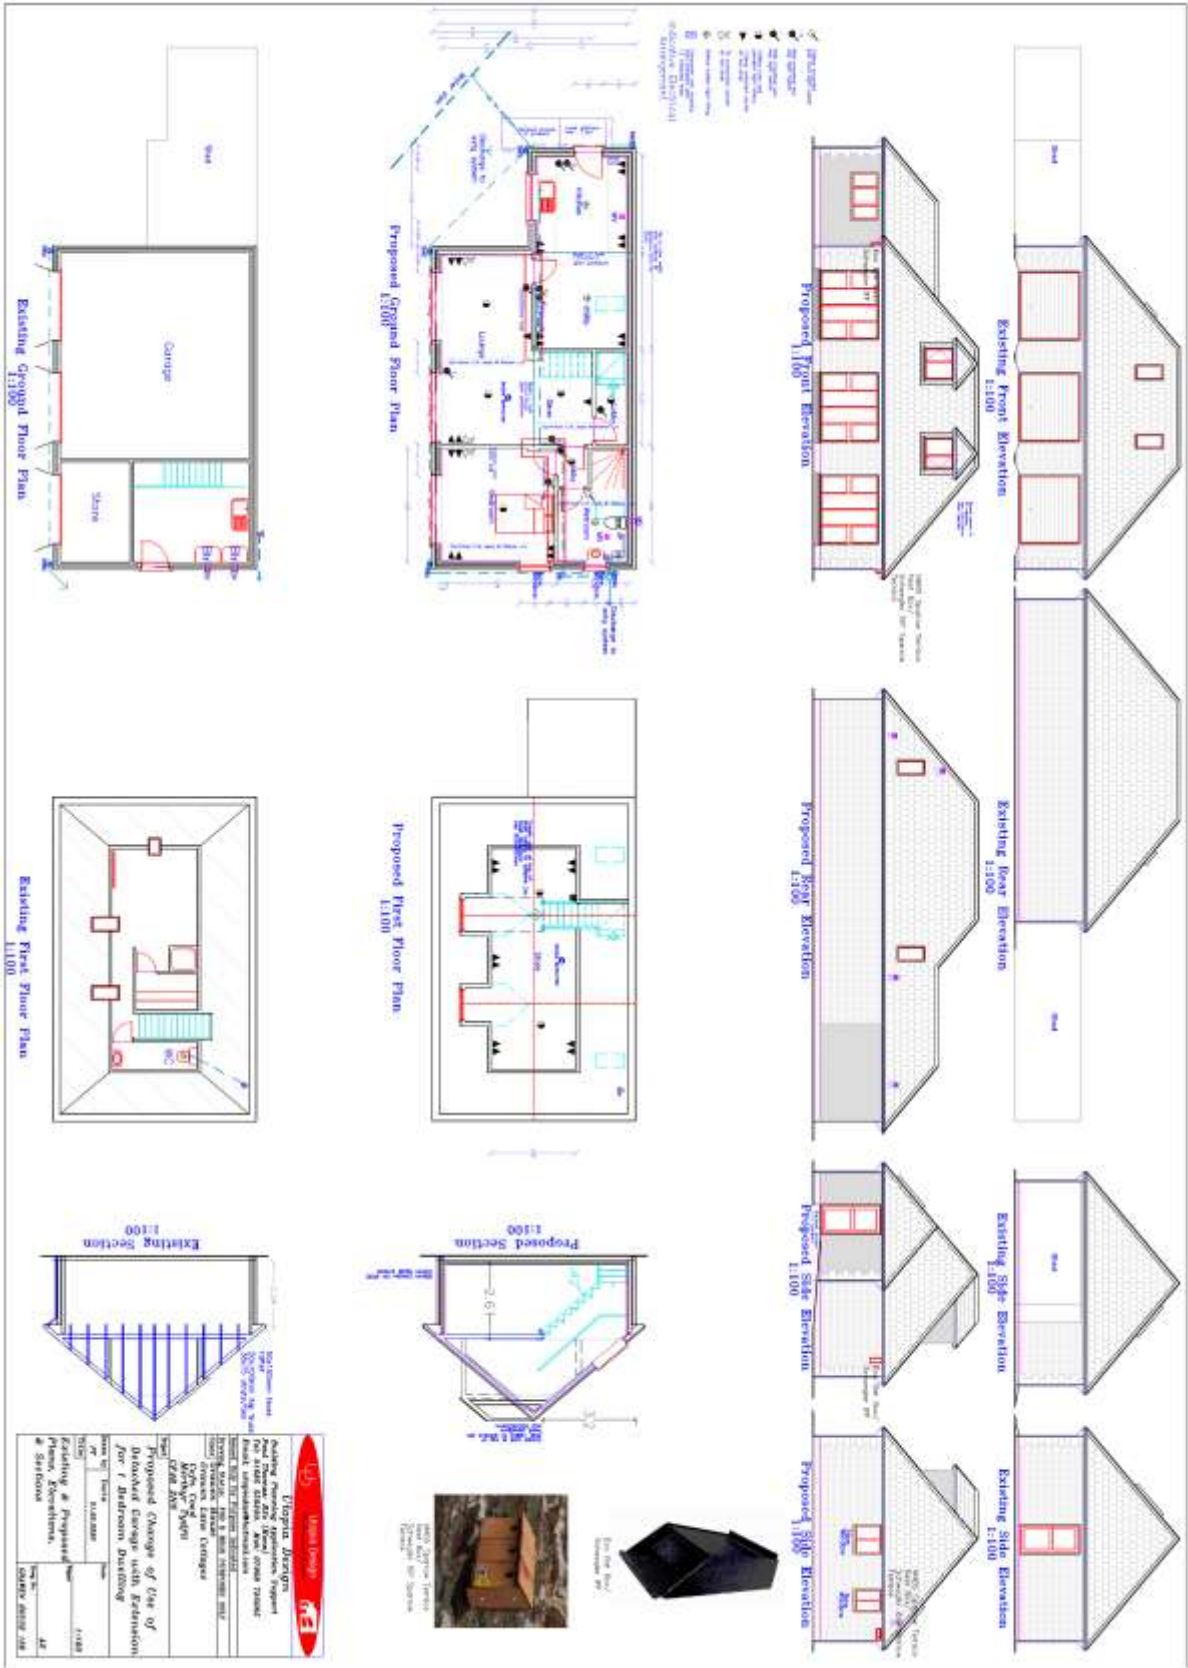
Appendix B- Drawings showing enhancements

A Schwegler 1FF bat box will be attached to the north west elevation of the property. Should the 1FF prove difficult to source, an eco bat box (crevice box) <https://www.nhbs.com/title?slug=eco-bat-box> will be installed in its place.

A Schwegler 1SP Sparrow Terrace or the following <https://www.nhbs.com/sparrow-terrace-nest-box> will be attached to the south eastern elevation of the property.
