**Bat Survey:** 26 Courtland Terrace, Merthyr Tydfil, CF47  
ODT

Reported by: Ecological Services Ltd  
10 Mount Pleasant, Llanelly Hill, Abergavenny, Monmouth NP7 0NT

| Author | Date | Version |
|---|---|---|
| Rich Watkins | October 2020 | V2.0 |

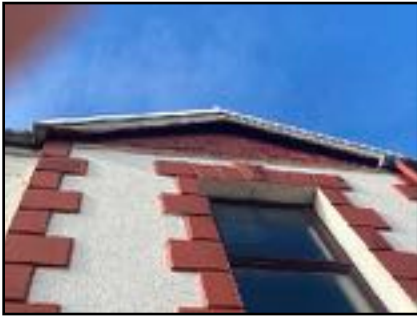
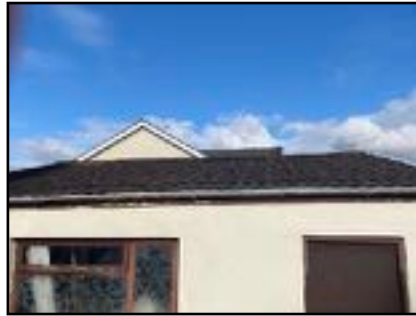
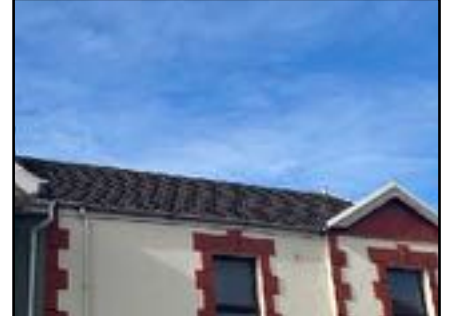
**6.4 Gaps along the roofline and under cement tiles did offer moderate potential for bat access.**

**6.5 No droppings or evidence of bats were discovered on any external features.**

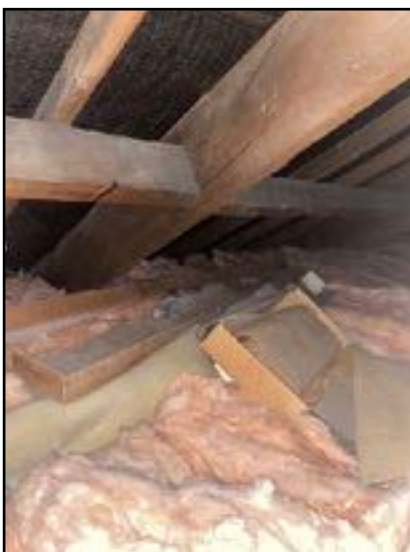
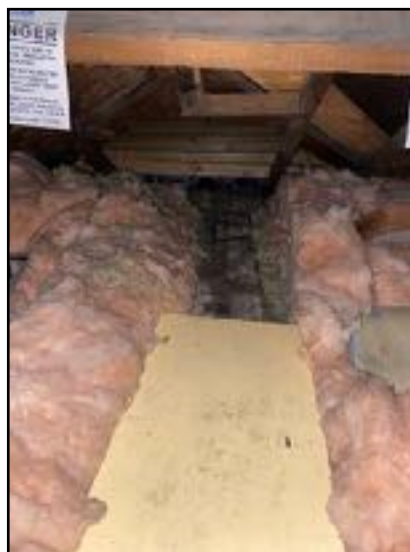
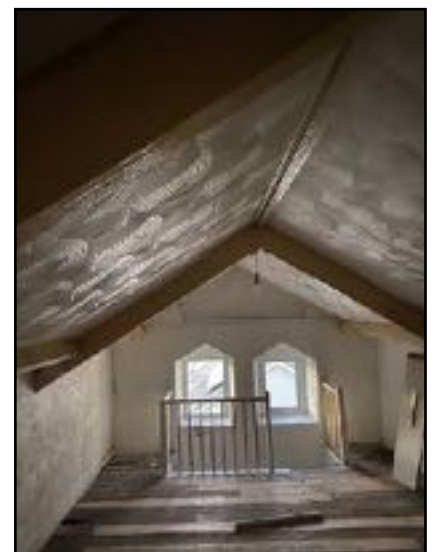
**7.2** The upper floor also occupies the internal roof space.

**7.3** There were limited roof voids.

**7.4** No bat droppings were discovered during the search of the attic space.

**7.8** There was no external light visible from the internal attic space.

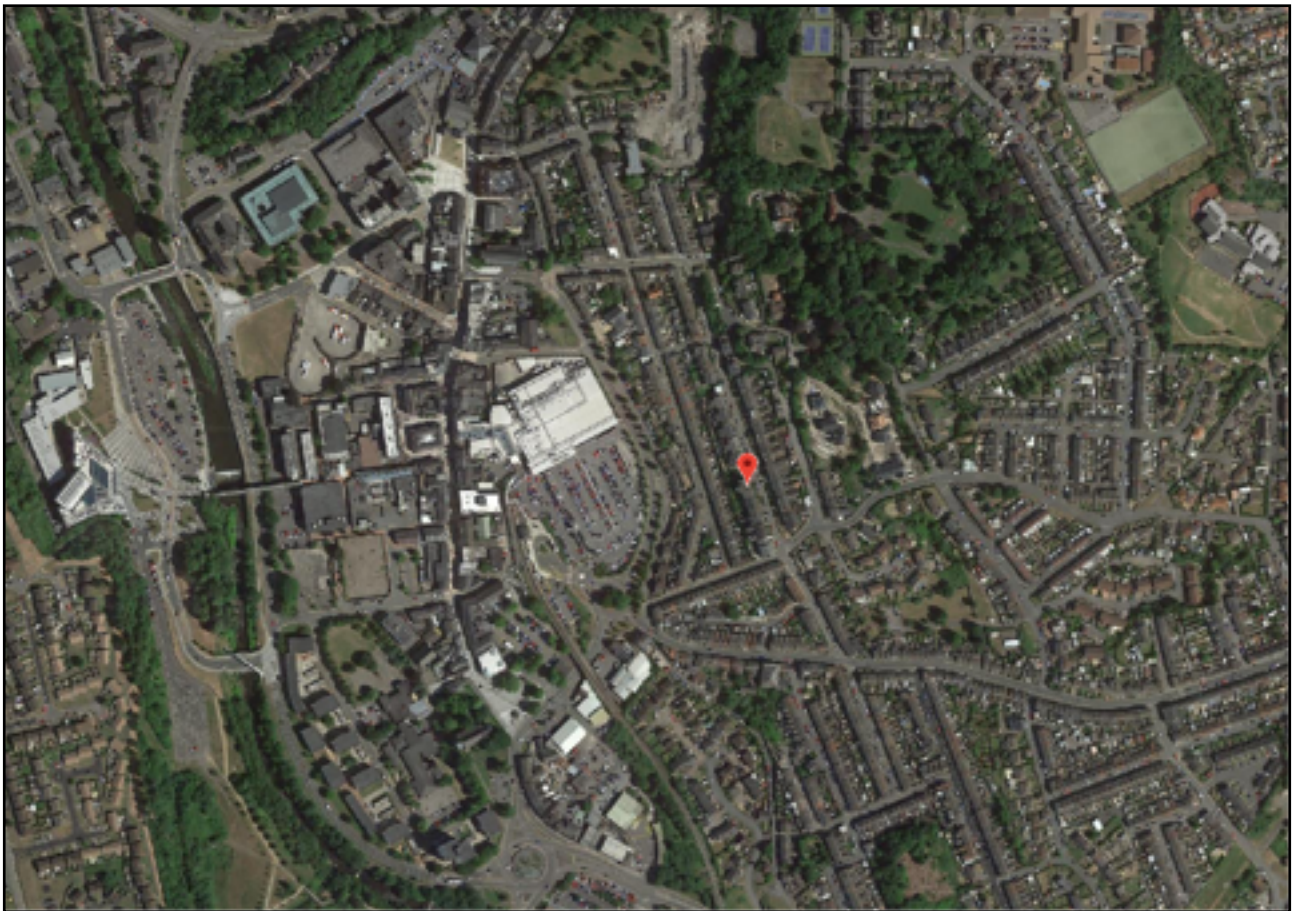
### **Appendix 1 - Aerial Photos**

**The site in its wider environment showing relatively good connectivity to surrounding habitat.**
