**THE RAILWAY INN, HIGH STREET, BEDLINOG, TREHARRIS**

**INITIAL BAT INSPECTION SURVEY**

**Bat Survey Report**

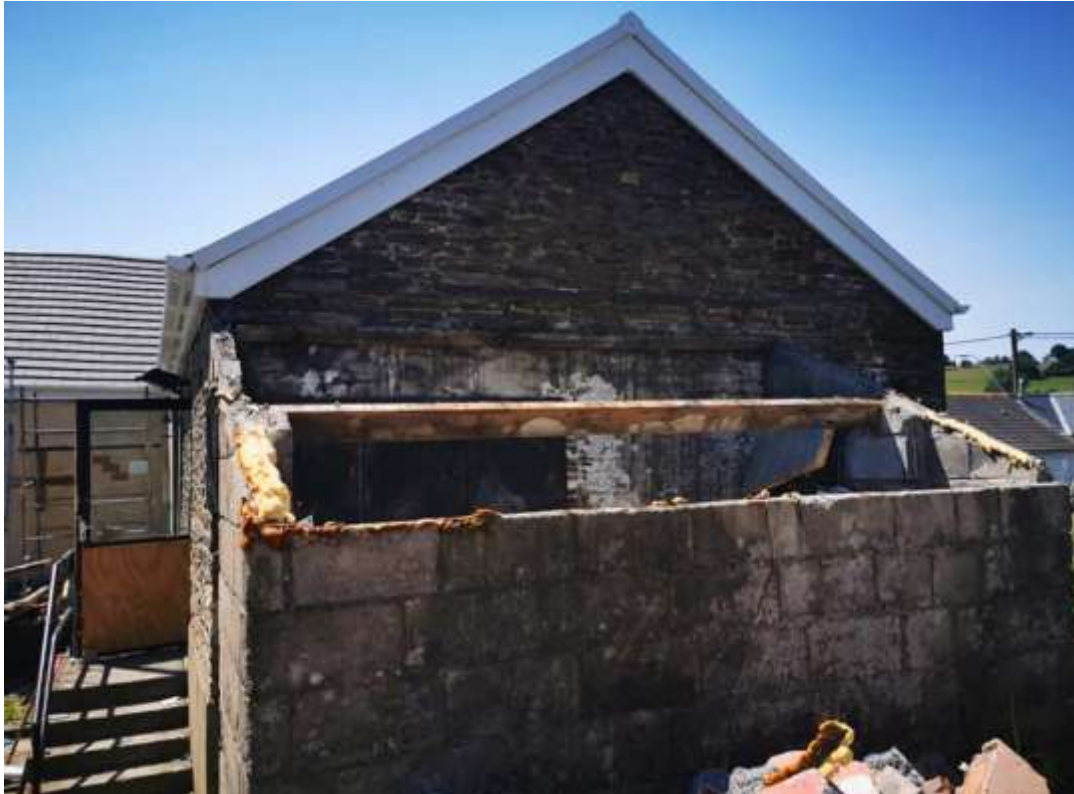
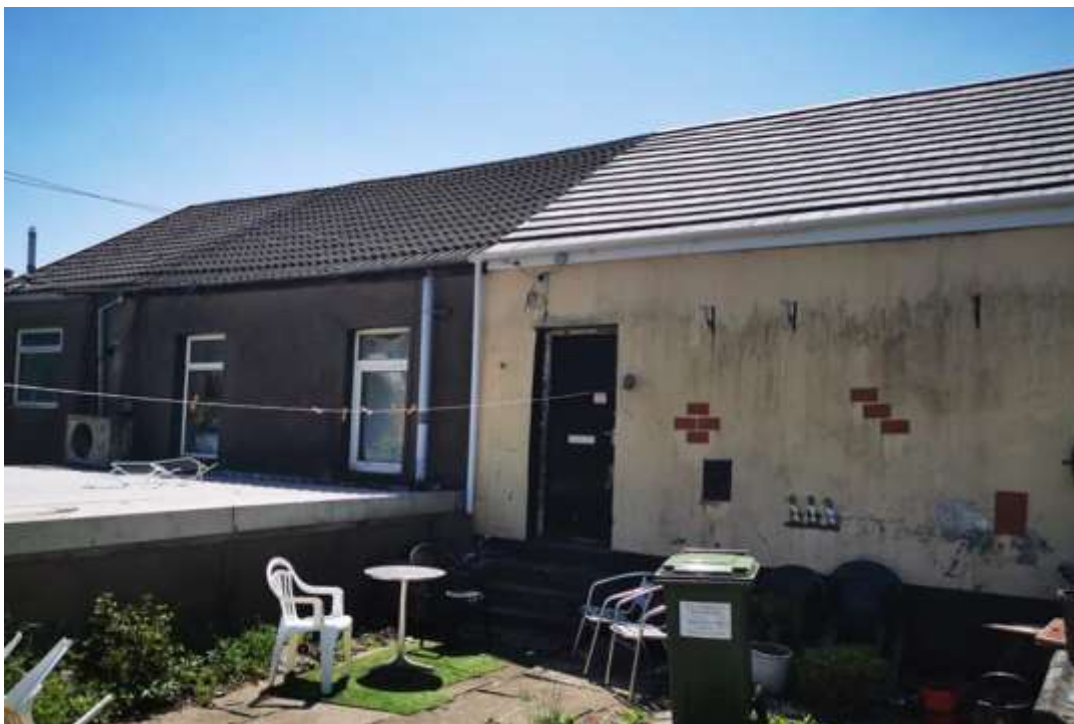
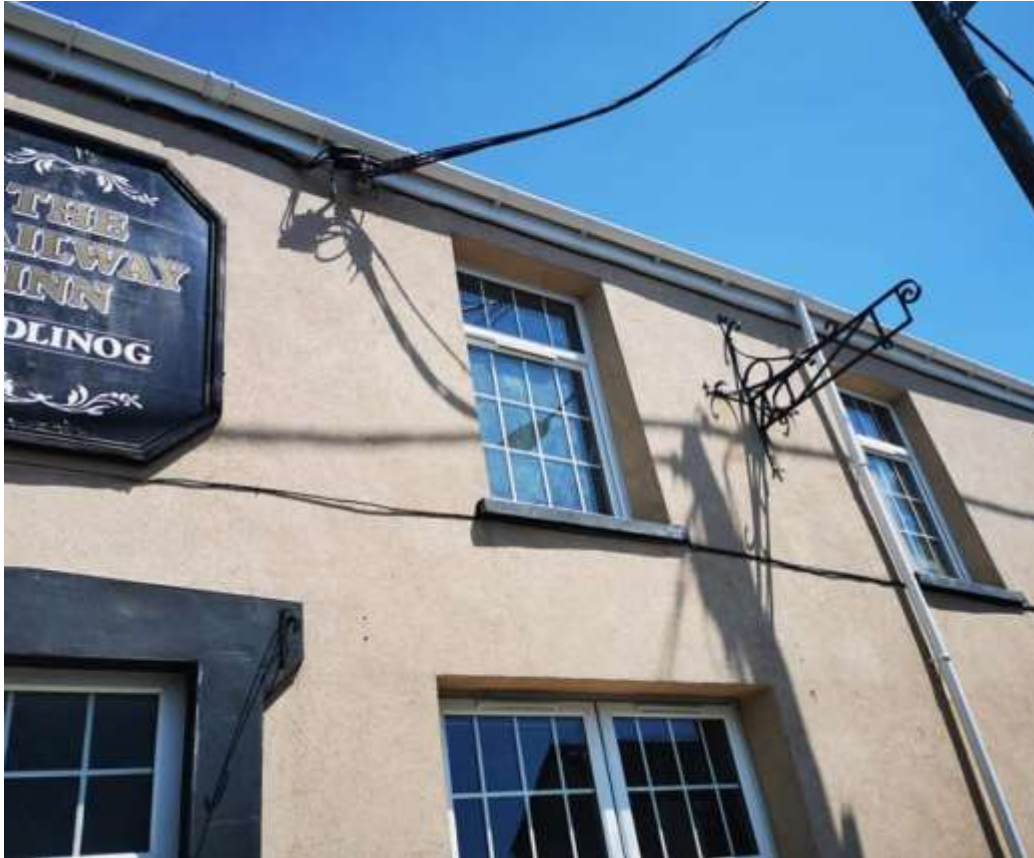
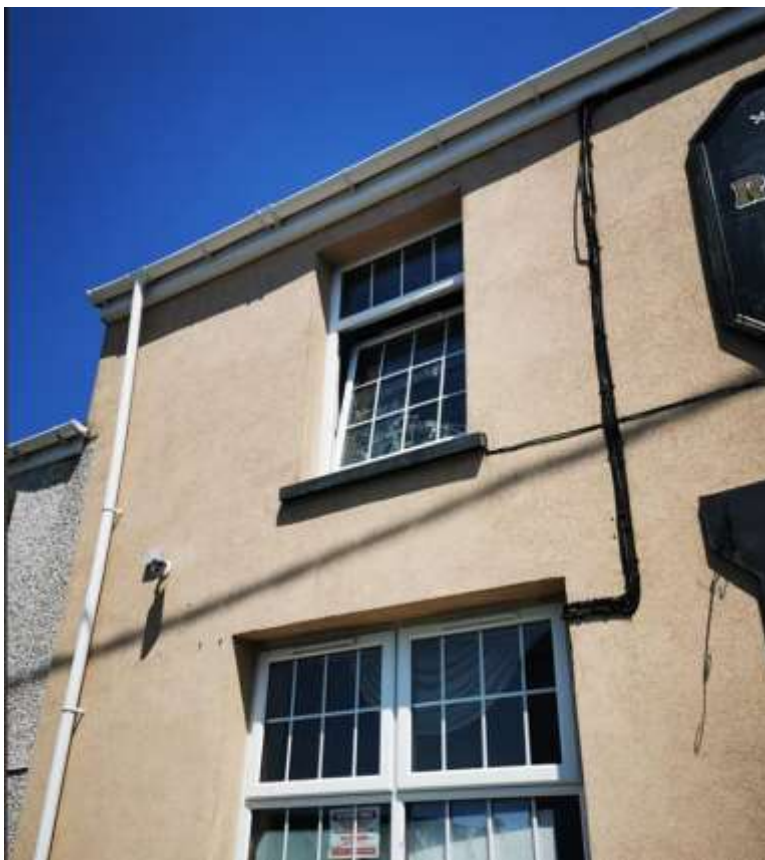
## APPENDIX A- PHOTOGRAPHS

The survey carried out by BE Ecological Ltd revealed no droppings or evidence of bats on the exterior of the buildings. However, a number of potential access points were noted including:

- Gaps beneath newly fitted fascias and barge boards
- Gaps beneath newly fitted ridge tiles

No evidence of nesting birds was seen on the exterior. No birds were seen or heard on the site during the time of survey.
