**Geotechnical &  
Geo-environmental Report:**  
Proposed Temporary Accommodation Structures,  
Glasier Road, Merthyr Tydfil

**Job No: 14545**

**REPORT TITLE**                      **Geotechnical and Geo-environmental Report:**  
**Proposed Temporary Accommodation Structures,**  
**Glasier Road, Merthyr Tydfil**

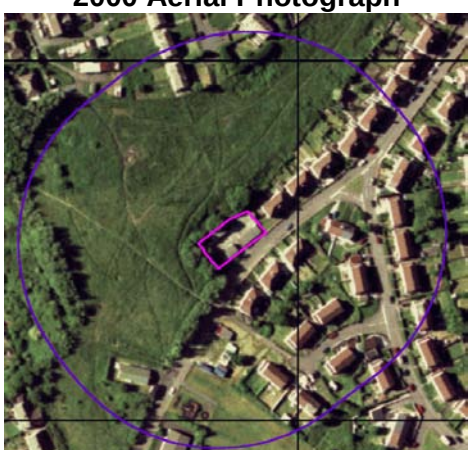
| <b>Map Edition and Scale</b> | <b>Key Features on Site</b> | <b>Key Features off Site</b> |
|---|---|---|
| <b>2000 Aerial Photograph</b><br> | <p>No change since 1969.</p> | <p>No significant change within the immediate surrounding area change since 1981/1989.</p> |
