## Heritage Impact Assessment: Cyfarthfa Castle, Merthyr Tydfil, Boiler Replacement

Report No. 2129

Project Title:  
Merthyr Tydfil County Borough  
Council Cyfarthfa Castle  
Boiler Replacement

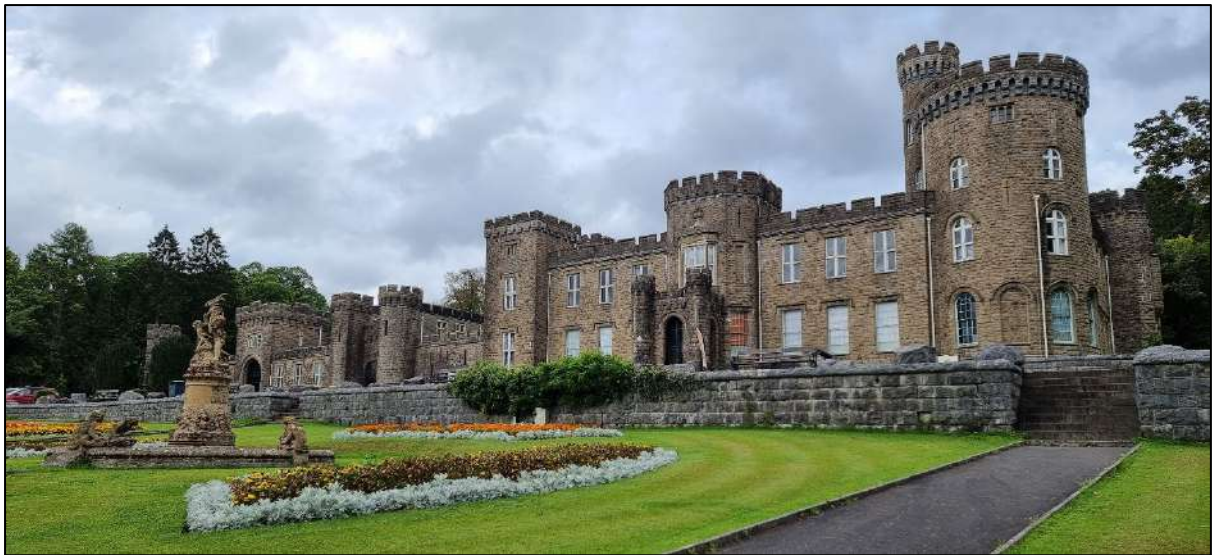
*Plate 1. Cyfarthfa Castle, looking north.*

stone in a castle-like style (Plate 1). Window and door surrounds are of Bath stone. The house is two-storey with a basement storey to the rear. All windows are mullion and/or transom except for the circular tower, the windows being round headed.

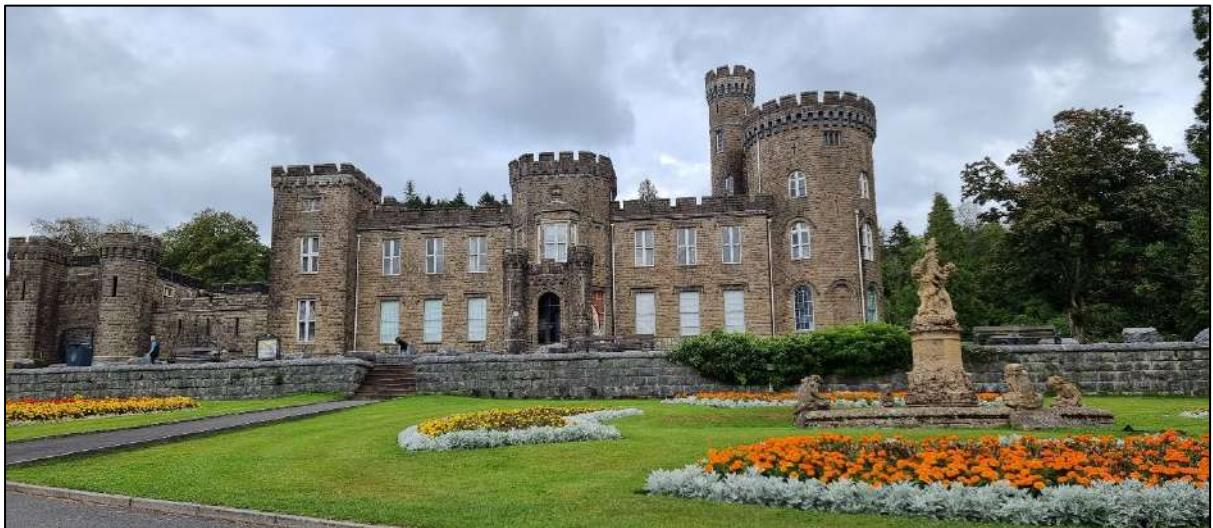
*Plate 2. Front (south-west) facing elevation of Cyfarthfa Castle, looking north-east.*

- 4.3.2. The front of the building faces south-west and has nine bays (Plate 2). The north-westernmost bay is a three-storey square tower and the south-easternmost is a three-storey circular tower. The central projecting bay is an octagonal tower with a single-storey entrance porch flanked by crenelated towers. To the north-west is the attached stable block. The front elevation is single storey with a two-storey square carriage entrance. There is a second smaller entrance to a courtyard area to the south-east, between the house and stables, flanked by a circular tower to the south-east and square tower to the north-west. The east corner of the building has an octagonal tower.

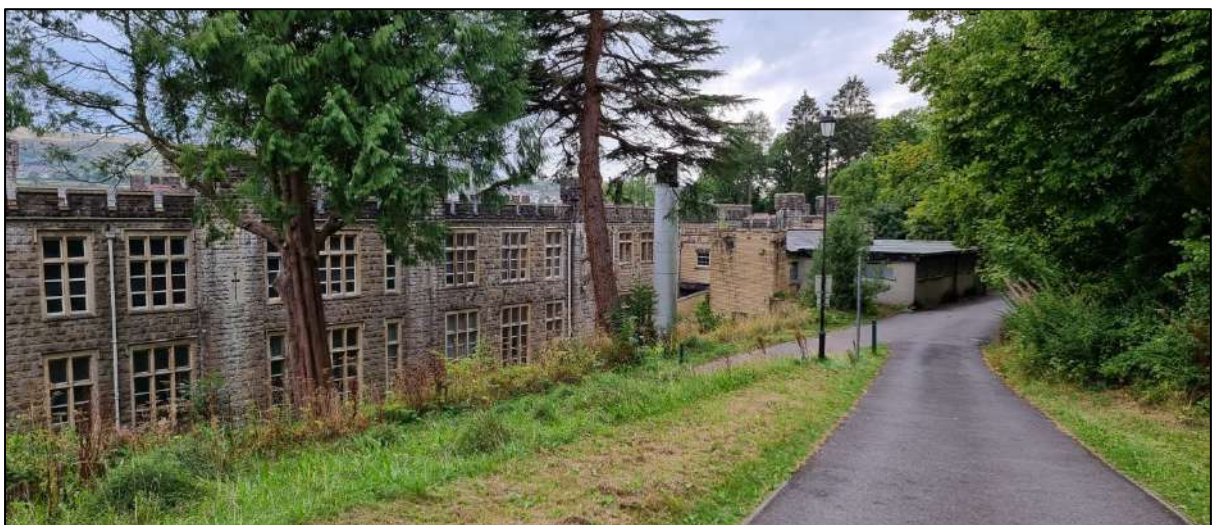
*Plate 3. Rear of Cyfarthfa Castle, looking west.*

- 4.3.5. The rear of the building is two-storey and has 15 bays (Plate 3). The seventh bay projects forward slightly and is flanked by two tower-like pilasters. The rear of the building is dug into the hillside, and there is a tarmacked path between the rear of the building and a low, rubble stone retaining wall (Plate 4). A covered walkway extended from the second storey towards the north-western end of the elevation (Plate 5). The walkway is supported on joists by iron columns on stone plinths. It is of yellow brick in stretcher bond and has crenelations with coping stones.

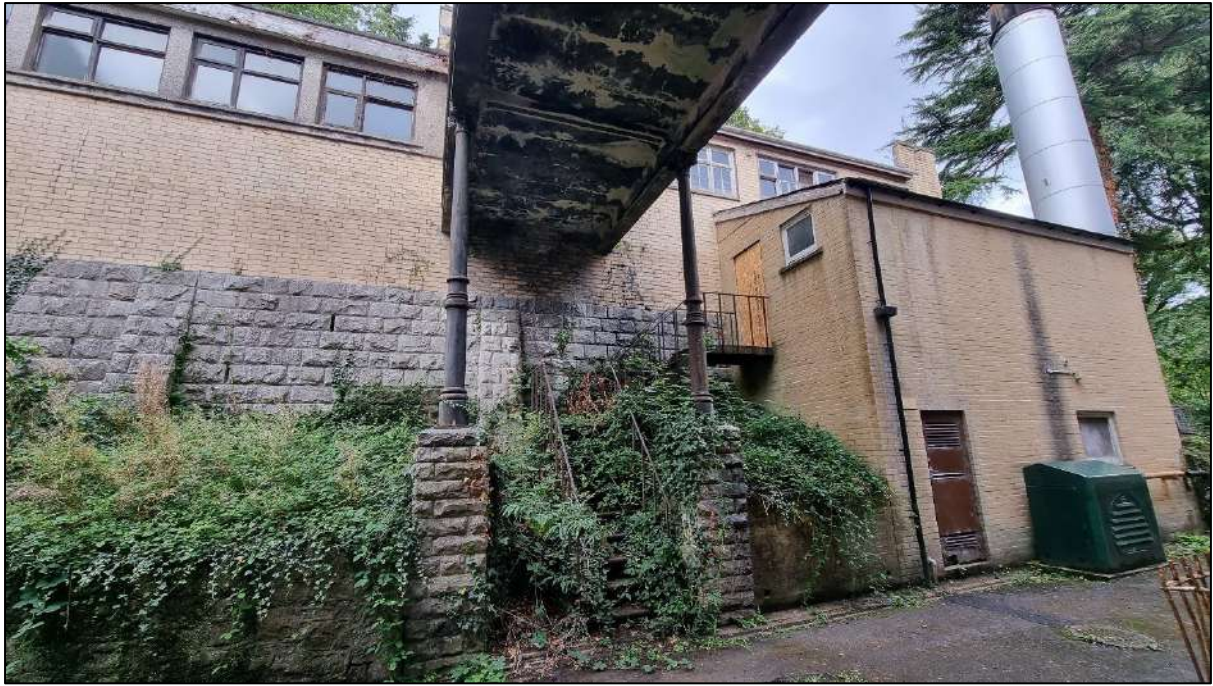
- 4.3.6. The walkway leads to a separate, single storey building built into the hillslope at a higher level (Plate 6). The lower wall of the south-west elevation of the building is in the same rusticated stone as the castle while the upper is yellow brick like the walkway. It has a band of cement render with wooden framed windows. There is a small lean-to projecting element to the south-east also in yellow brick (Plate 7). It has a door on the north-west facing elevation accessed by a metal staircase. It also has a door at ground/basement level, which accesses the boiler room. The south-east facing elevation has a rectangular tower in yellow brick with crenelations. In the southern corner is the metal flue of the existing boiler. There is a single storey projecting element to the rear which is entirely rough cement rendered and has windows with cement sills that have been covered with security grills and a modern door. It is the same level as a road around the rear of the building.

*Plate 6. Attached building to the rear of the Castle, including Boiler Room to the righthand side. Looking north-east.*

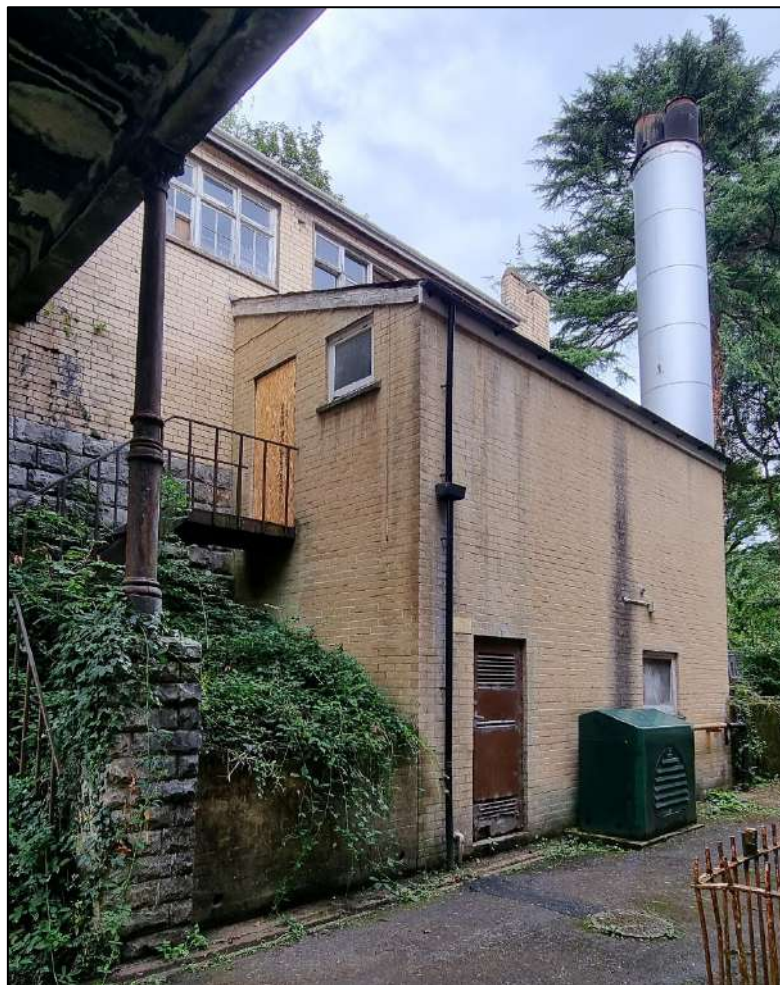
*Plate 7: Boiler Room to basement level of lean-to section, looking east.*

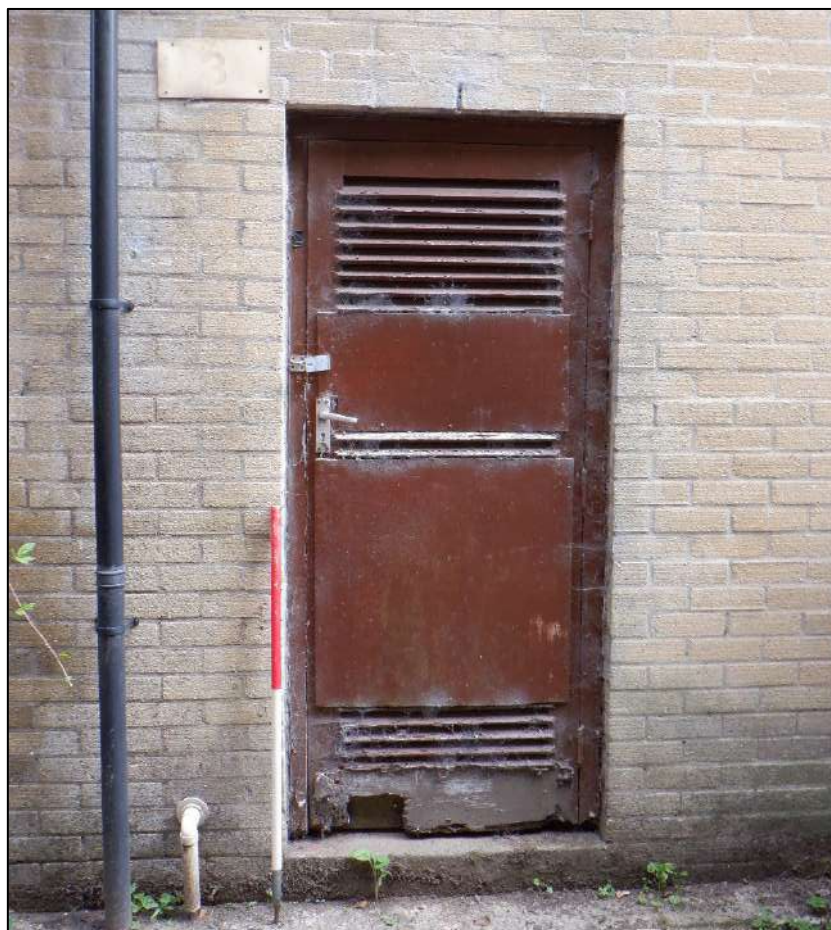
- 4.3.8. The boiler room is located in the separate rear building. It has a wooden vented door in poor condition (Plate 8). The interior has a poured cement floor. The south-west and south-east walls are of red brick (Plate 9), the north-east wall is of aerated blocks, and the north-west of rubble stone (Plate 10). The ceiling is of concrete beams supported by two central brick columns and two steel H-beams. The door and a blocked window on the south-west wall have concrete lintels (Plate 11). The existing boiler and pump frames are set into the floor (Plates 10 and 12). Pipes run around the north-west wall at high level (Plate 10).

*Plate 8. Boiler Room door, in poor condition. Looking north-east, 1m scale.*

- 5.3.6. The existing Boiler Room door is in a poor condition and will be replaced. The door is of mid/late 20<sup>th</sup> century date and considered of no historic significance. The new

| Proposed Work | Objective | Significance of affected fabric | Assessing beneficial impact | Assessing harmful impact | Proposed Solution |
|---|---|---|---|---|---|
| The removal of the plant room door. | Part of new boiler system installation to allow future use of the building and its maintenance. | <ul style="list-style-type: none"> <li>Modern door in poor condition. Of no historic value and poor condition currently detracts from the</li> </ul> | New door will enhance the appearance of the boiler room to the rear of the | None | None |

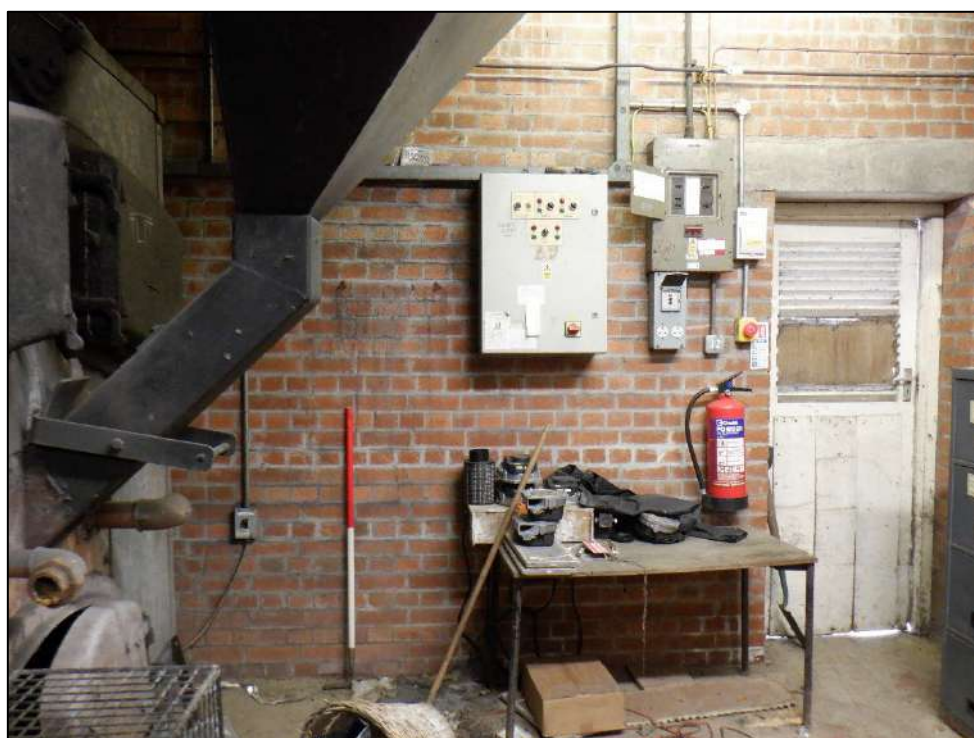
*Plate 9. South-west wall of Boiler Room, looking south-west. 1m scale.*

- 5.3.4. The installation of the new boiler flues to replace the existing will involve creating new holes in the fabric of the structure. The proposed exit point for the flues is the south-west elevation. This wall is of mid/late 20<sup>th</sup> century date and of no historic significance. The flues will not extend above the height of the building, therefore visual impact on the main Castle building will be limited to views along the rear path between the Castle and the Boiler Room. The metal flue of the existing boiler is to be retained.

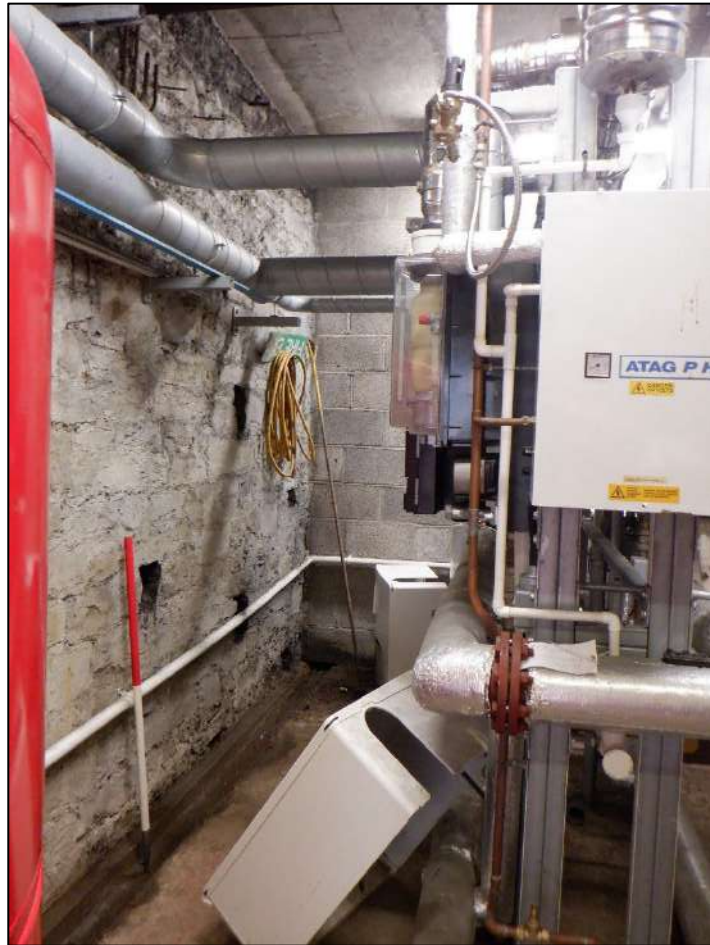
*Plate 10. Rubble stone north-west wall and aerated block north-east wall, looking north-east. 1m scale.*

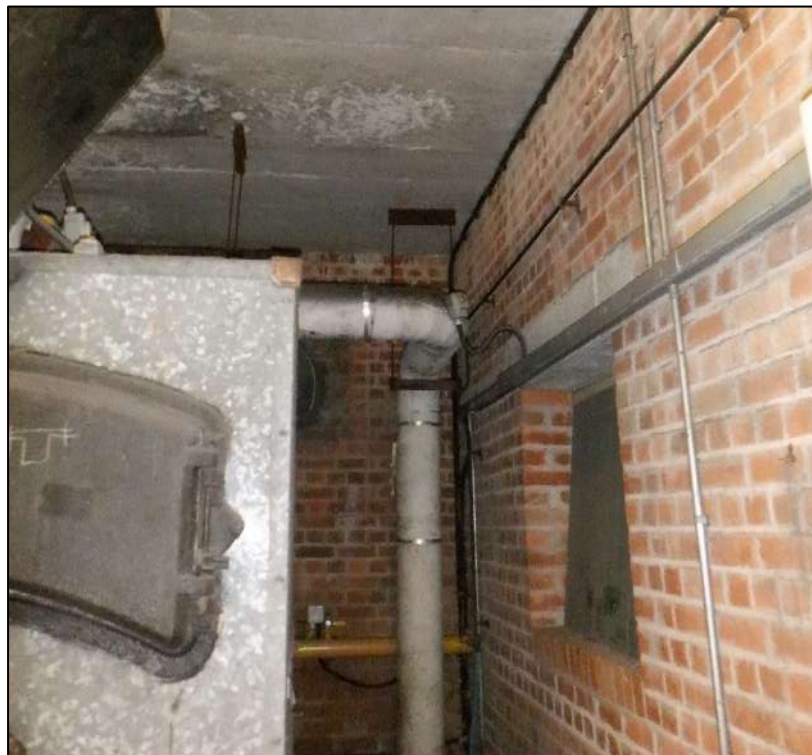
*Plate 11. Blocked window with cement lintel on south-west wall to righthand side, looking south-east.*

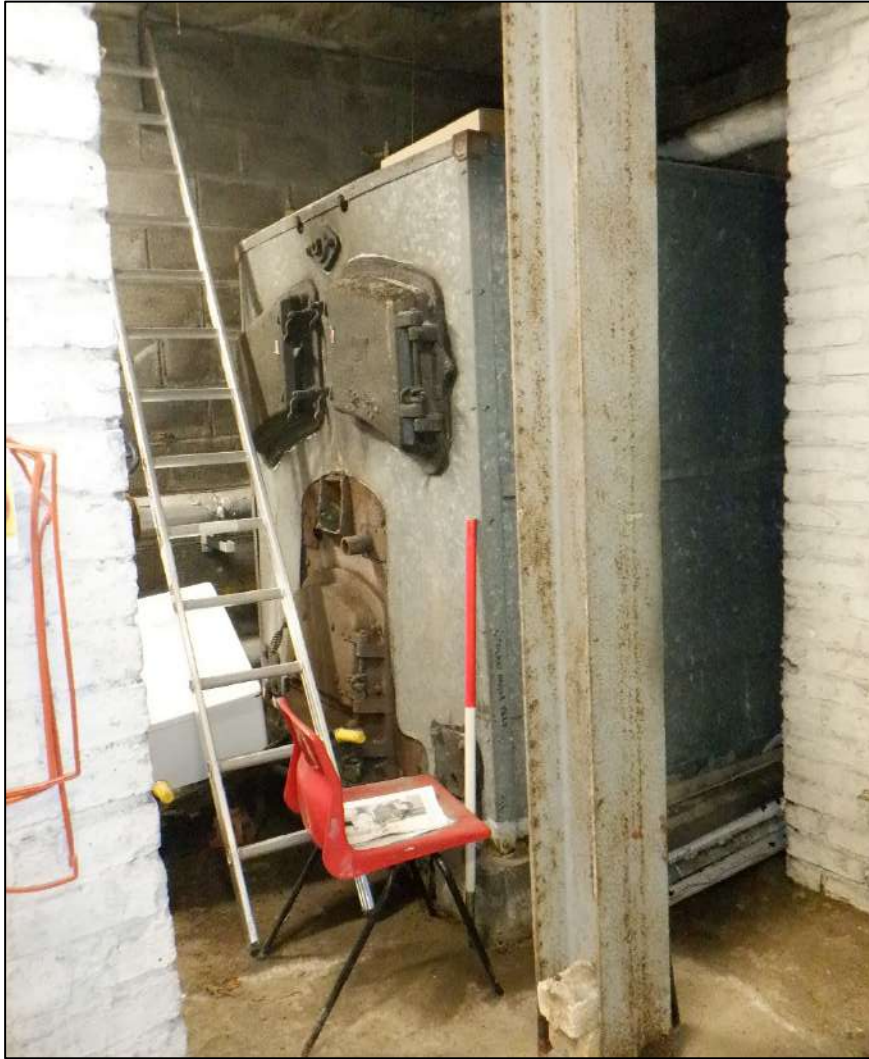
*Plate 12: Existing boiler, looking east. 1m scale.*

| Proposed Work | Objective | Significance of affected fabric | Assessing beneficial impact | Assessing harmful impact | Proposed Solution |
|---|---|---|---|---|---|
| The removal of existing gas fired boilers and frames and replacement with new rig/framed mounted gas fired condensing boilers. | Part of new boiler system installation to allow future use of the building and its maintenance. | <ul style="list-style-type: none"> <li>• Mid/late 20<sup>th</sup> century boilers and frames, of no historic significance.</li> <li>• Frames attached to mid/late 20<sup>th</sup> century fabric, of no historic significance.</li> </ul> | None | None | None |

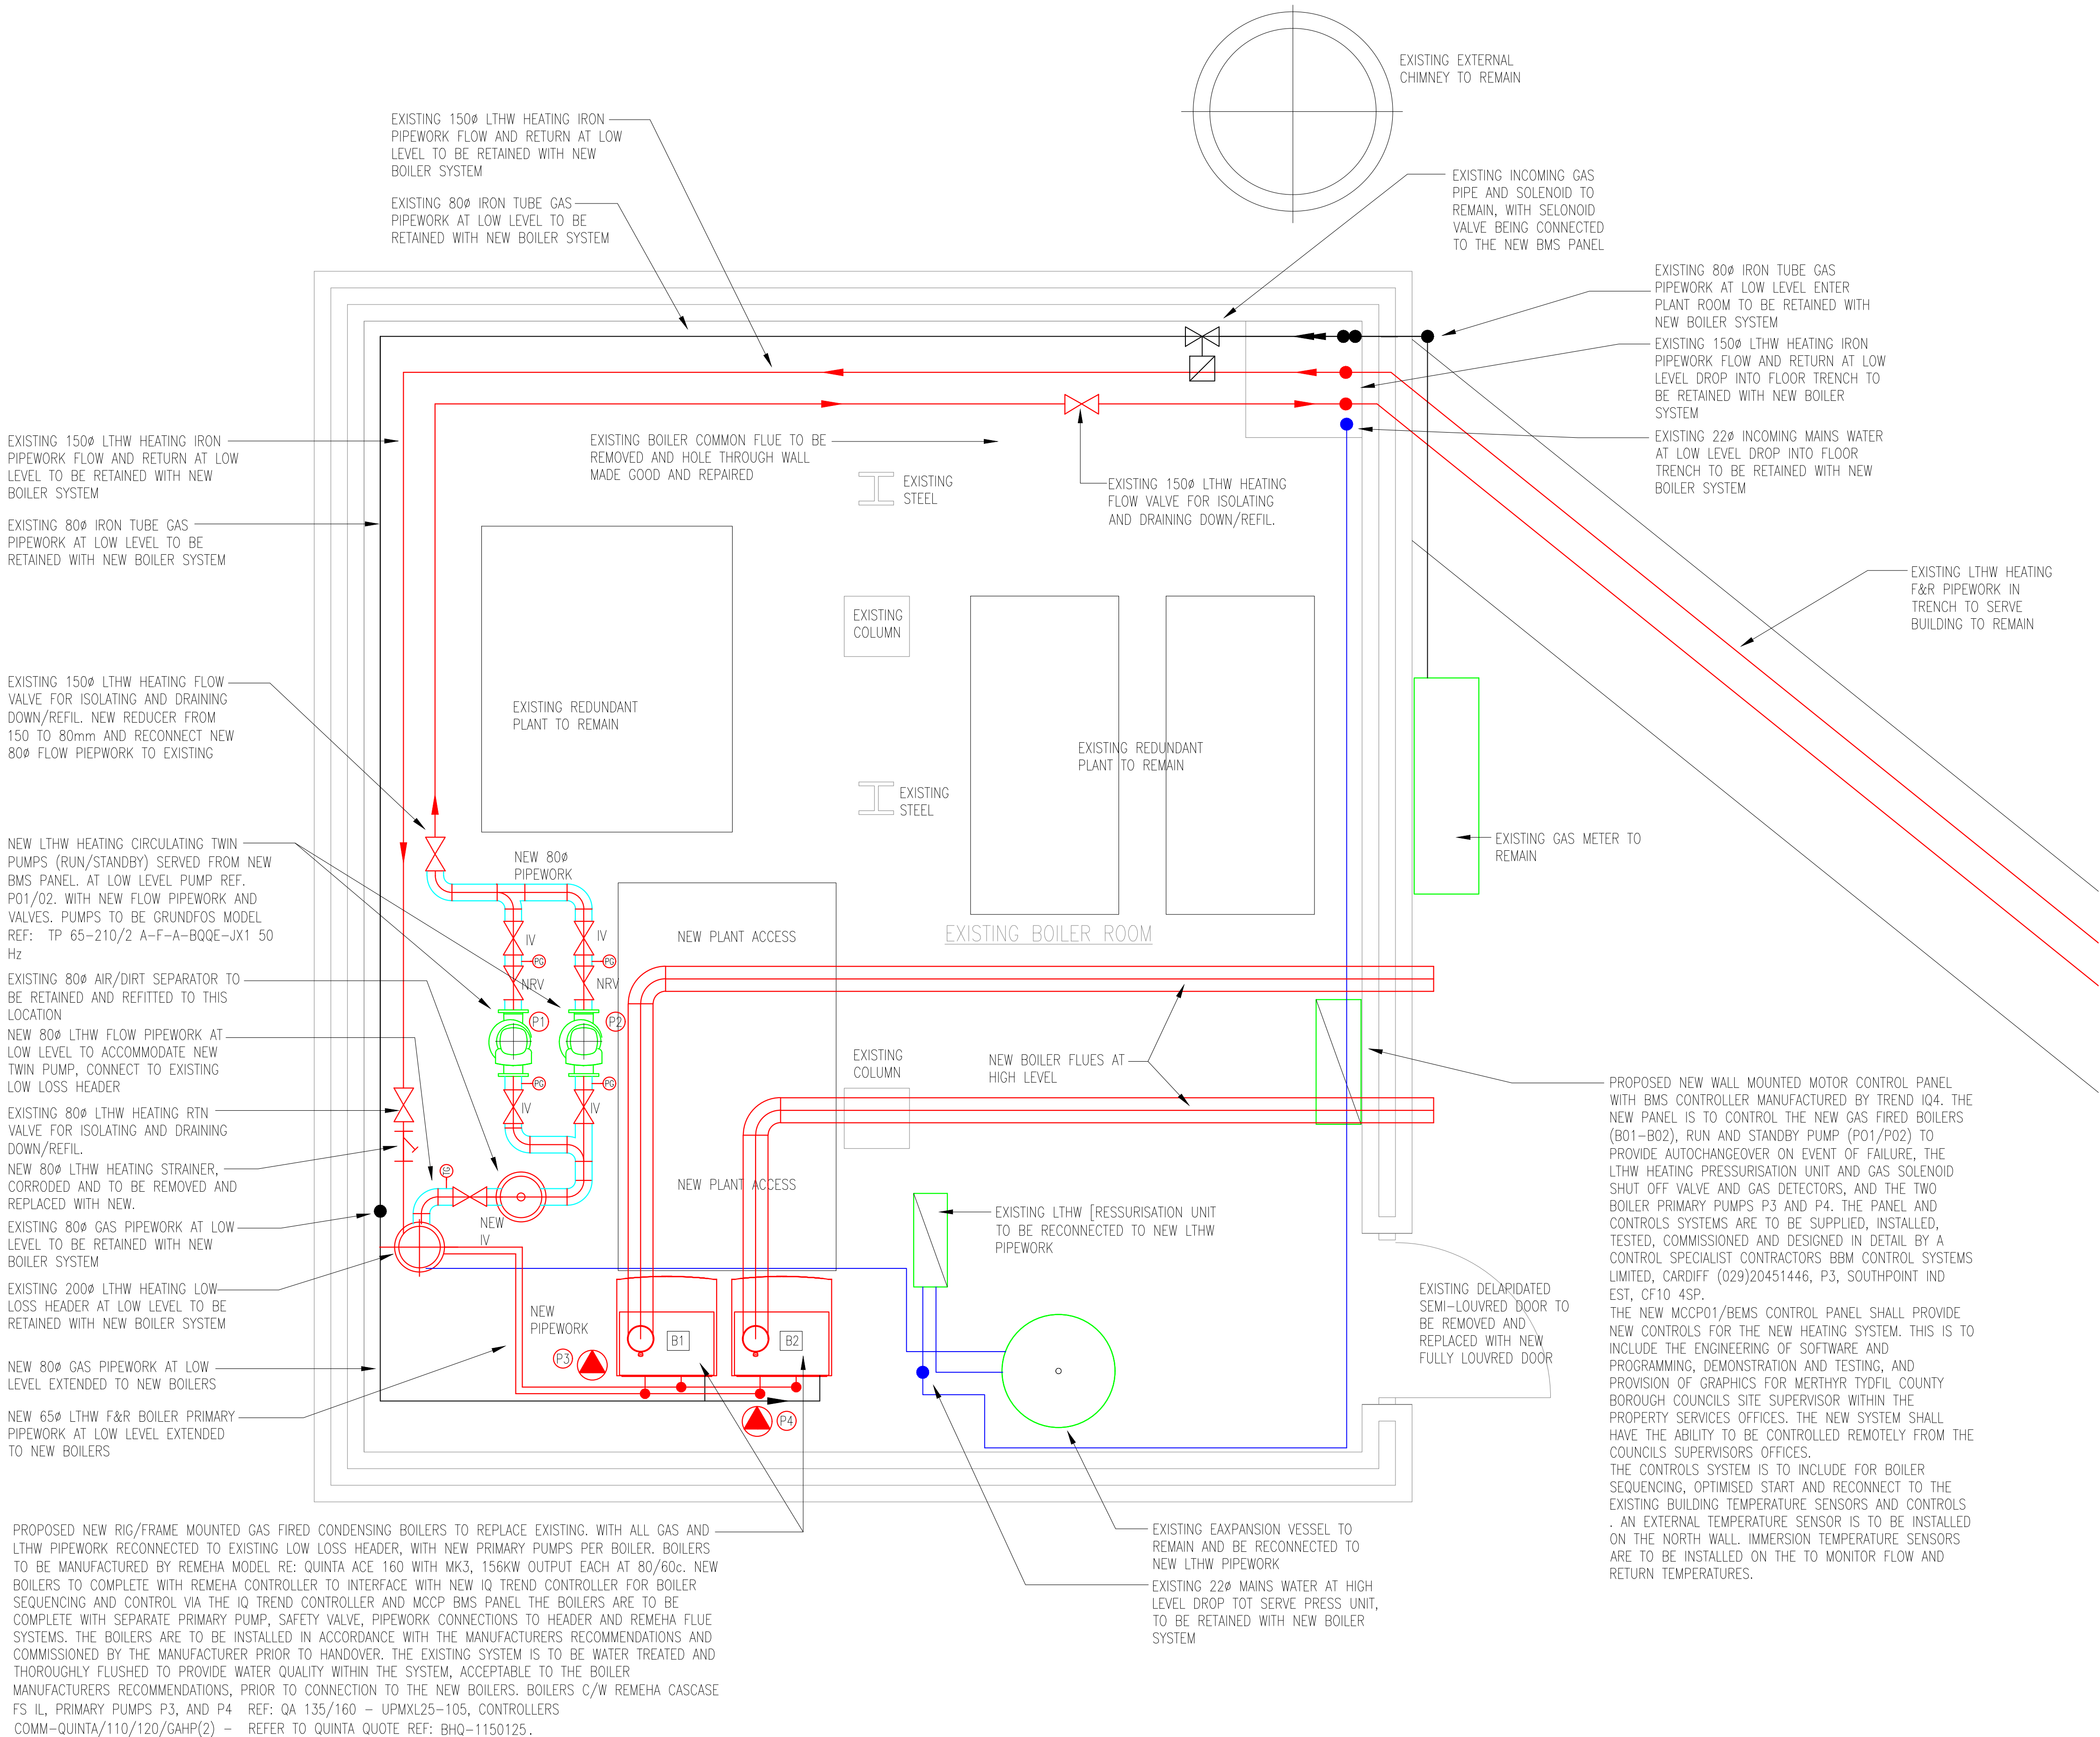
DRAWING NO.  
HTP-3218  
M101

PROPOSED MECHANICAL SERVICES LAYOUT

- The removal of existing crane pump sets and replacement with new LTHW circulating pumps.
- The removal of existing air inlet ducts and flues and replacement with new stainless steel boiler flues.
- The removal of the plant room door.
- The removal of existing heating and water services pipe work, pumps, valves, and fittings. The pipework is generally to be retained and renewed unless replacements are needed.
- The removal of existing gas fired boilers and frames and replacement with new rig/framed mounted gas fired condensing boilers.
- The removal of existing control panel. Existing controls are to be removed and replaced with BEMS Trend controls system, alongside new sensors, and field wiring.
