# PROTECTED SPP REPORT

BRYNTAF GARAGE

| Project: BRYNTAF GARAGE | | |
|---|---|---|
| Title | PROTECTED SPP REPORT | |
| Document Number | M050- Eco Report-V1.1 | |

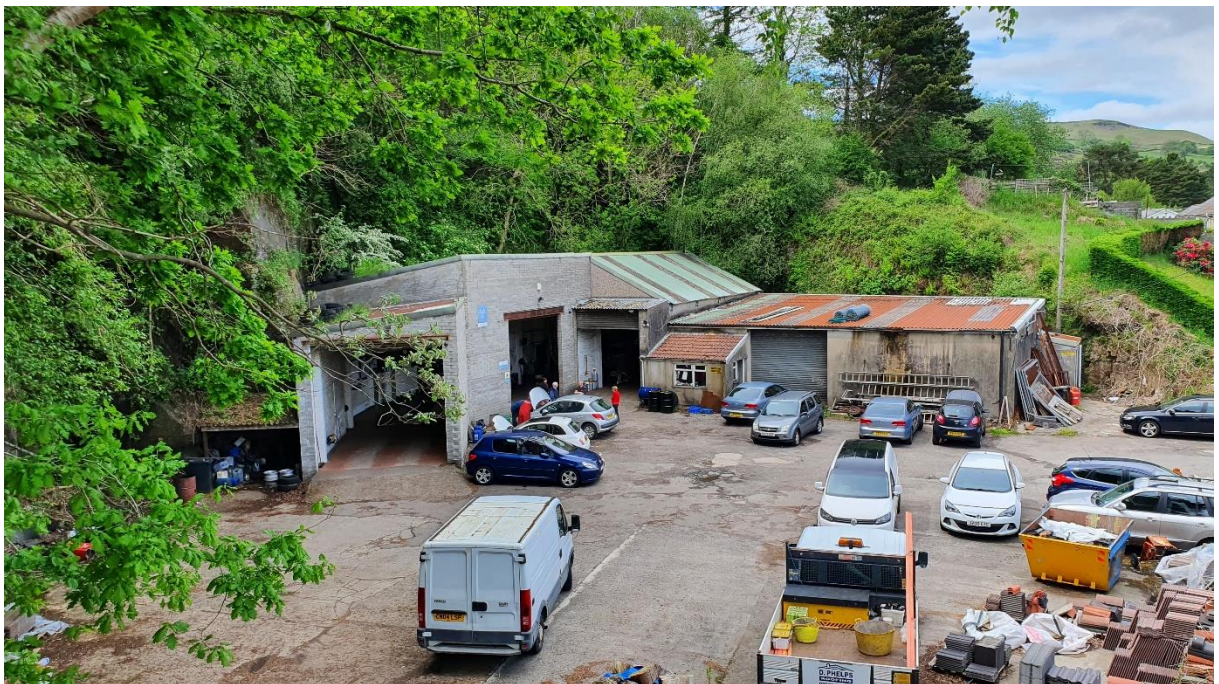
*Photo 1: Shows an overview of the buildings.*

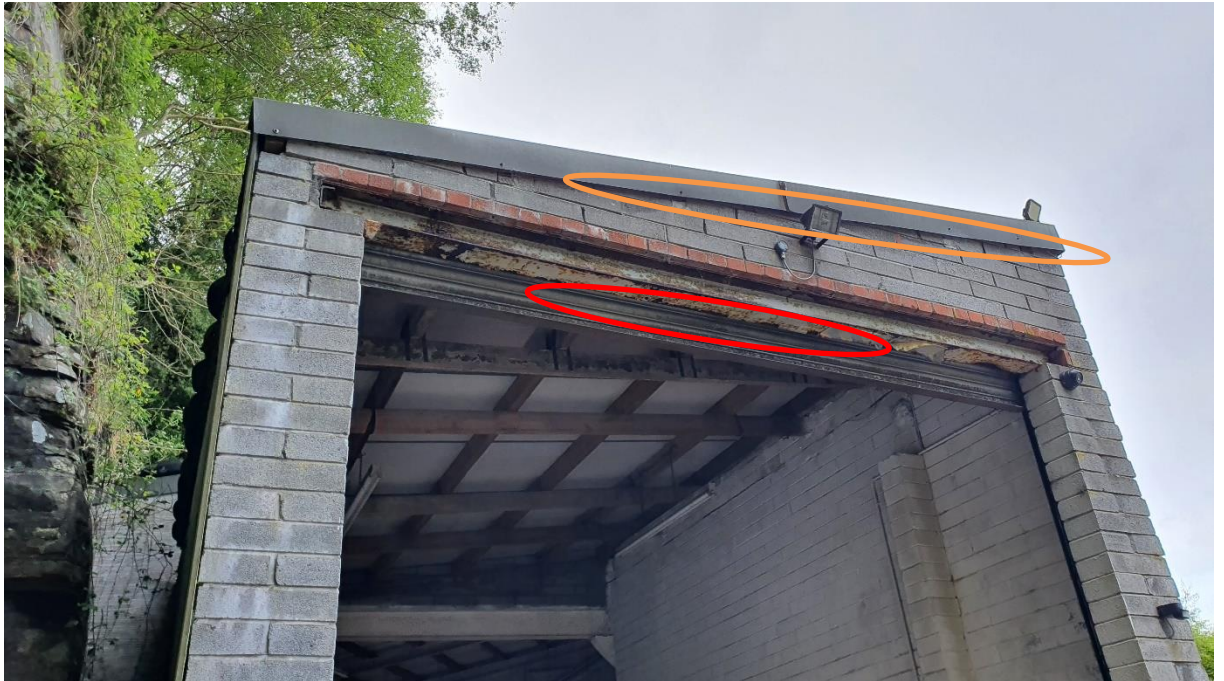
*Photo 2: Shows part of the southern aspect of the workshop, the orange circles highlight some roosting potential beneath the edge of the corrugated steel roof. The red circle highlights a gap along the top of the steel shutter.*

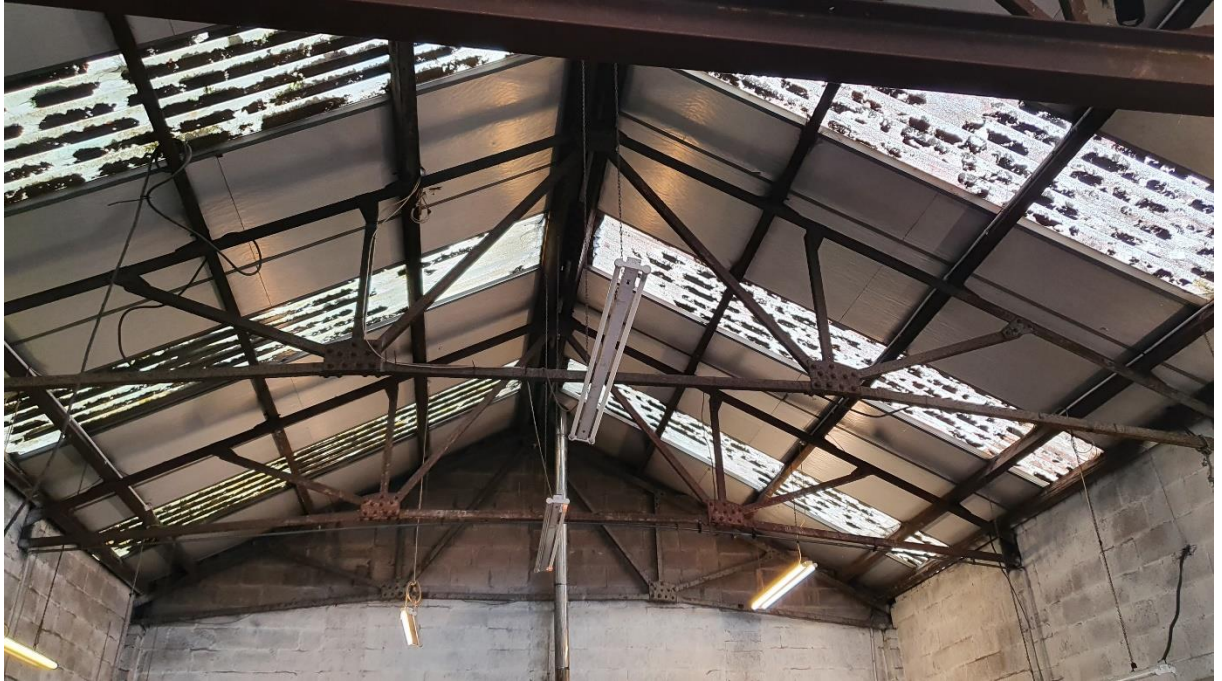
*Photo 4: Shows the internal structure of workshop 2. The roof is partially lined with (likely) asbestos boards. The area is very light and busy during the day, making roosting suboptimal. No evidence of bats was found within this space.*

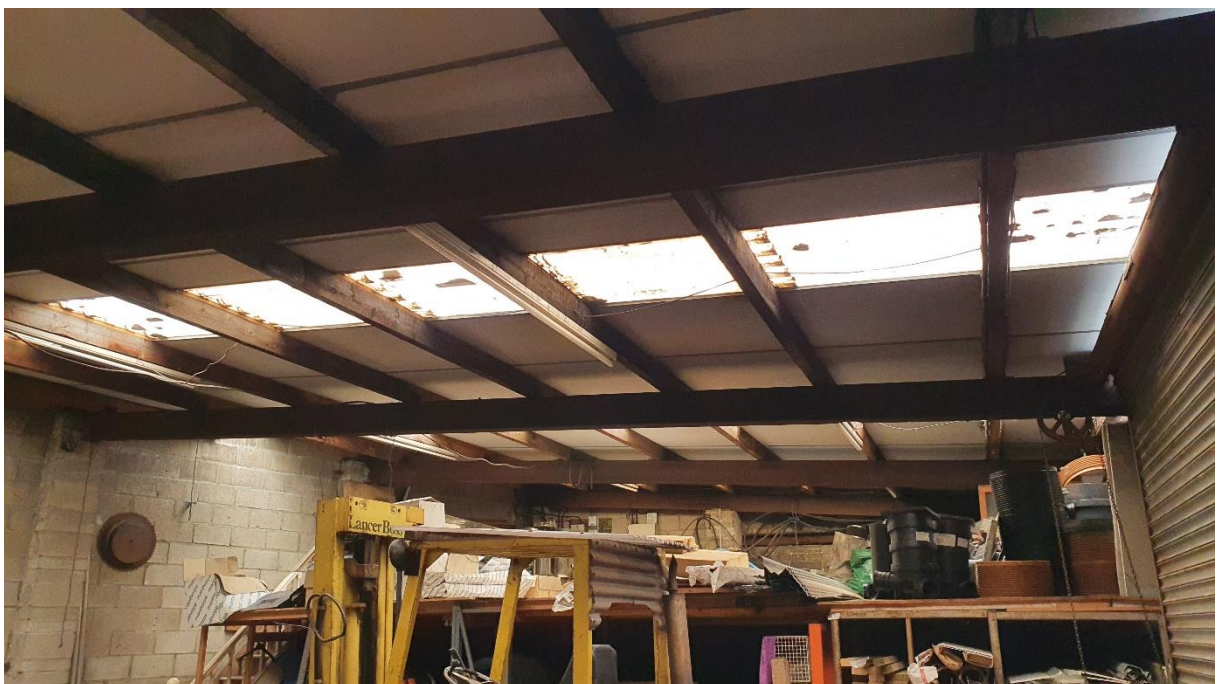
*Photo 5: Shows the internal structure of the storeroom. The roof is partially lined with (likely) asbestos boards. The area is very light and busy during the day, making roosting suboptimal. No evidence of bats was found within this space.*

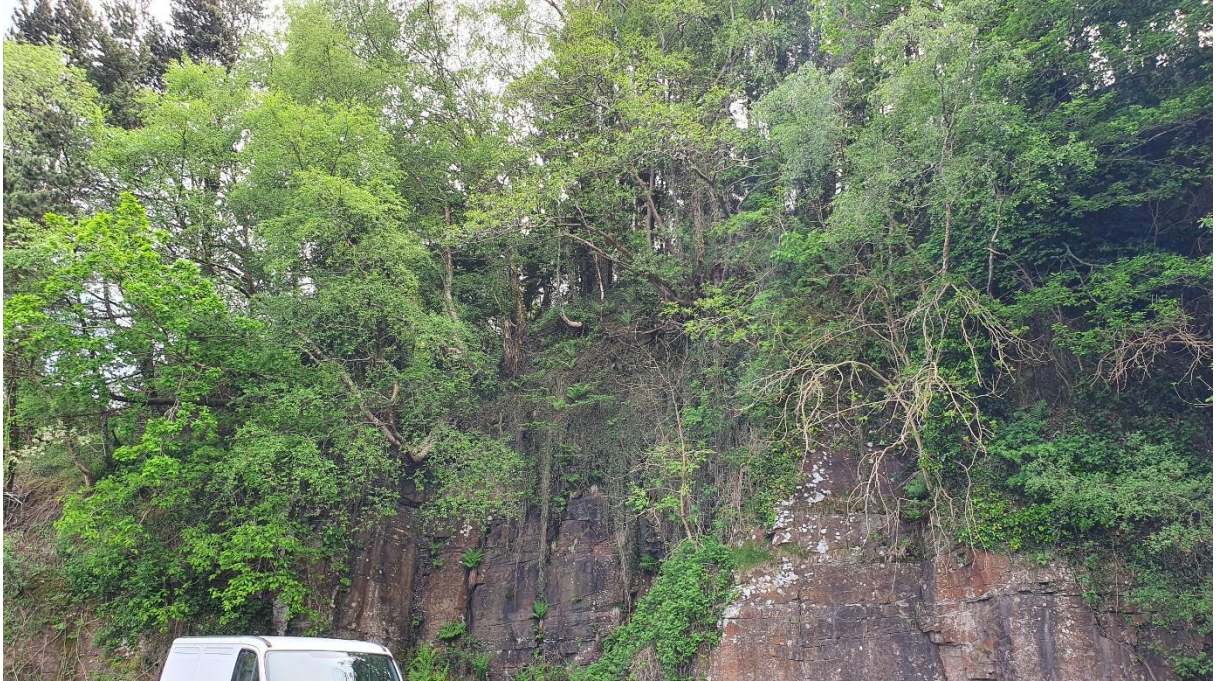
*Photo 6: The old quarry face with woodland above. There is water percolating through many gaps in the quarry face and large parts of it are partially vegetated. As a result the quarry face is considered to have low to moderate potential for roosting bats.*

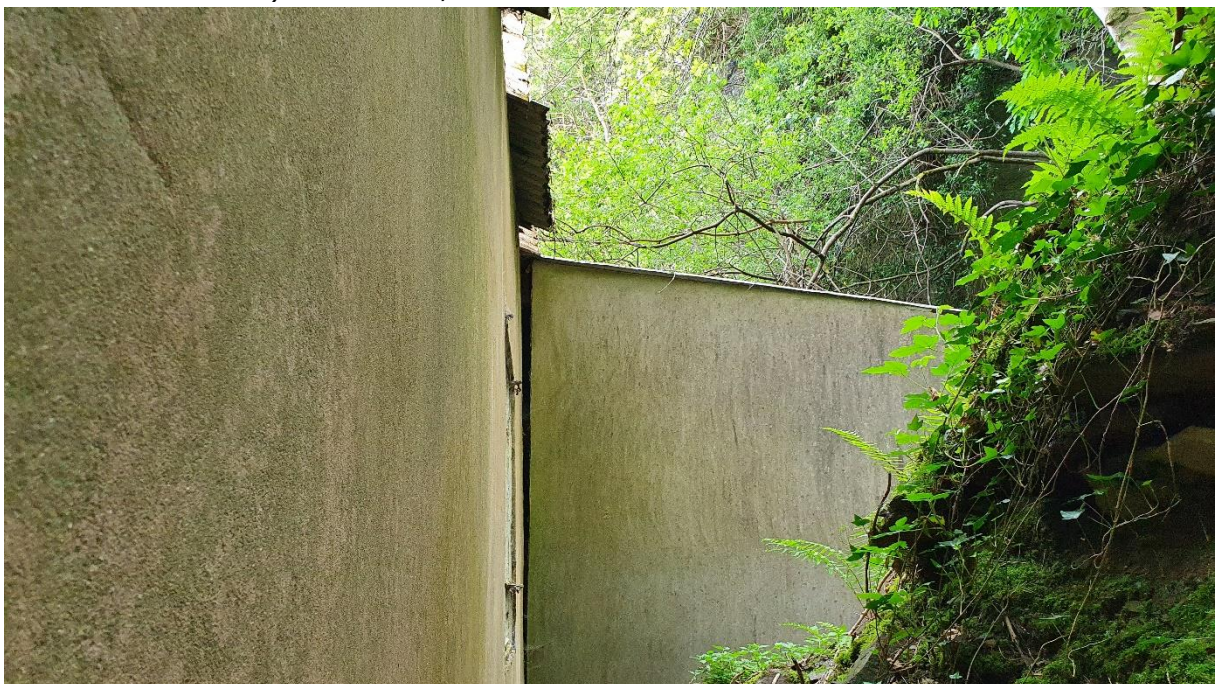
*Photo 7: There is a small lean-to storage room along the western aspect. The mortar along the joint is severely damaged and part of the building has pulled away from the wall. Light is clearly visible on the other side of the crack. The crack offers limited roosting potential for crevice dwelling bats. The space between the two walls was simple to inspect, it was heavily cobwebbed, and no bats or evidence of bats was found.*

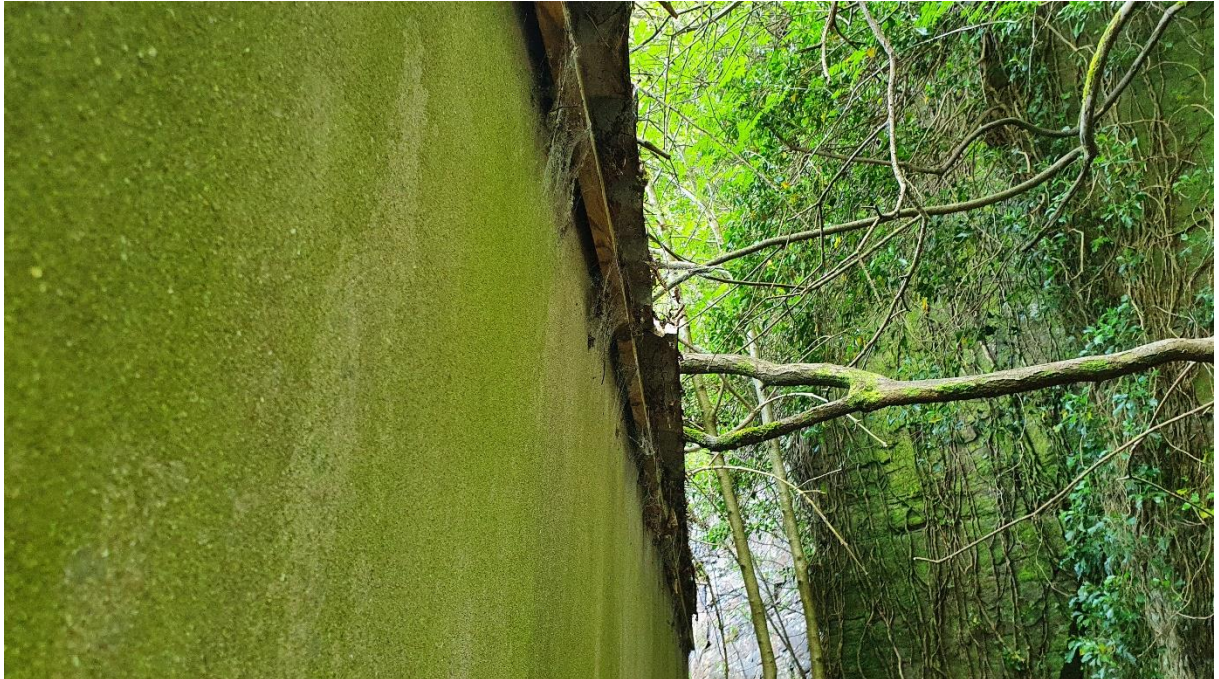
*Photo 8: There is a small wooden bargeboard around the building, the potential roosting feature is shallow and heavily cobwebbed with no evidence of bats.*

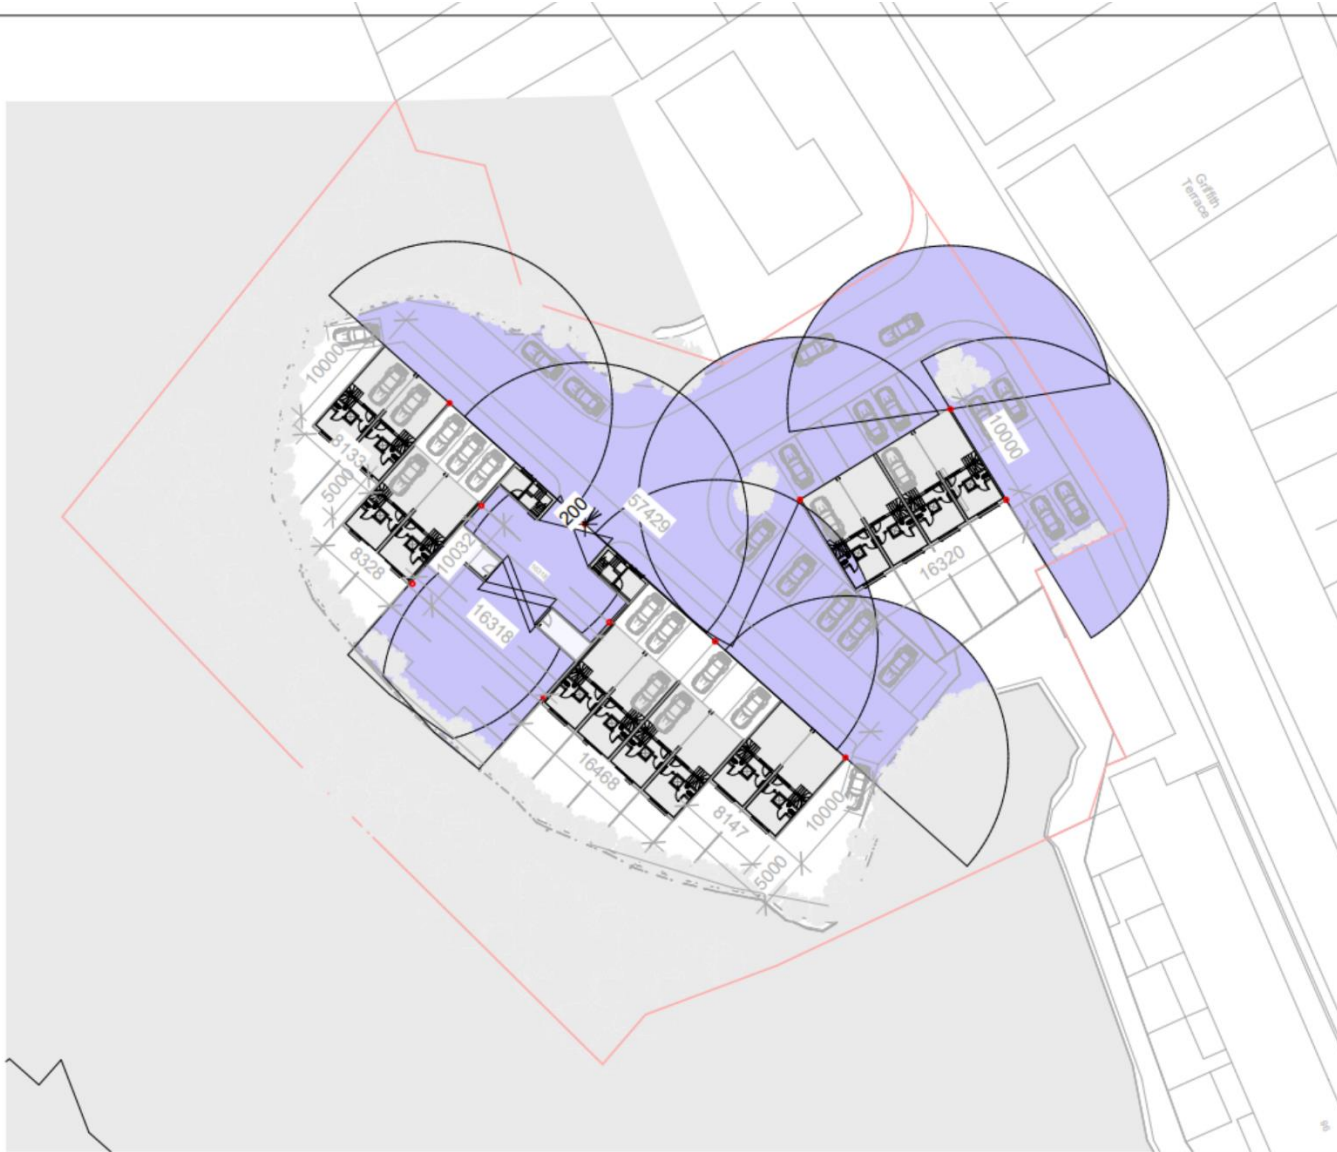
## LIGHTING SCHEMATIC

• Light fitting (wall mounted at 3m above ground)

• Light spread over ground

**TAURUS – Lighting for performance and security..**  
Bespoke optical design for dark sky performance in exterior wall applications with a reduction in light pollution.

- 2.27 The proposed light fittings are anticipated to be position at a height of 3m, will be downwards facing; and with baffles and hoods, this should ensure there is no light spill from the external lights upon the boundary habitat. As a result, the impact from the external lighting on the species detected during the site surveys is anticipated to be negligible.
