## Biodiversity Strategy - Pen Y Dre High School

**PROJECT TITLE:** Demolition of 2 Wings of Pen Y Dre Comprehensive School, Merthyr Tydfil, redevelopment to provide a modern facility and associated works

**PLANNING REF:** P/23/0225

**DATE:** 17th November 2023

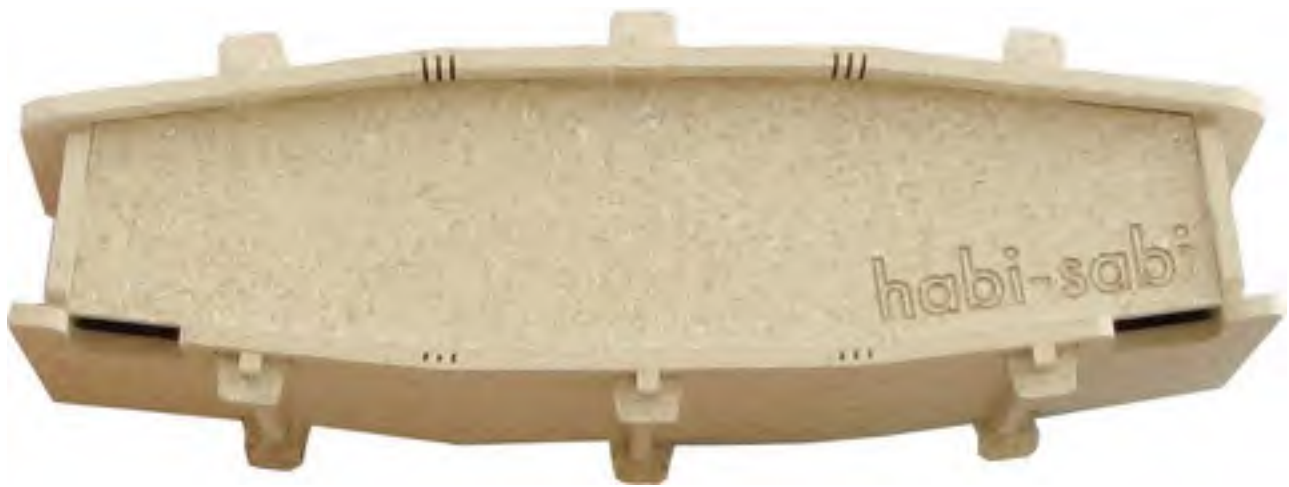
Habi Sabi Swift Box

- 3 x Habi Sabi Double Swift Boxes on the eastern elevation of the school buildings
- 2 x Habi Sabi Double Swift Boxes on the eastern elevation of the school buildings

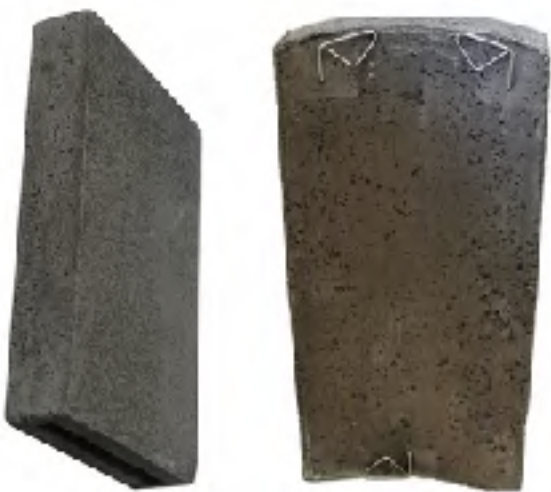
Greenwood's Ecohabitats Single Crevice Bat Box

- 2 x 1WQ Schwegler Summer & Winter Bat Box on the northern elevation of the school buildings,
- 1 x Greenwood's Ecohabitats Single Crevice Bat Box on the southern elevation of the school buildings,
- 1 x Greenwood's Ecohabitats Two Crevice Bat Box on the southern elevation of the school buildings,
- 1 x Greenwood's Ecohabitats Two Crevice Bat Box on the northern elevation of the school buildings,
- 2 x 1FQ Schwegler Bat Roost Boxes on the southern elevation of the school buildings,
- 2 x Vivara Beaumaris Woodstone Bat Box on the southern elevation of the school buildings,

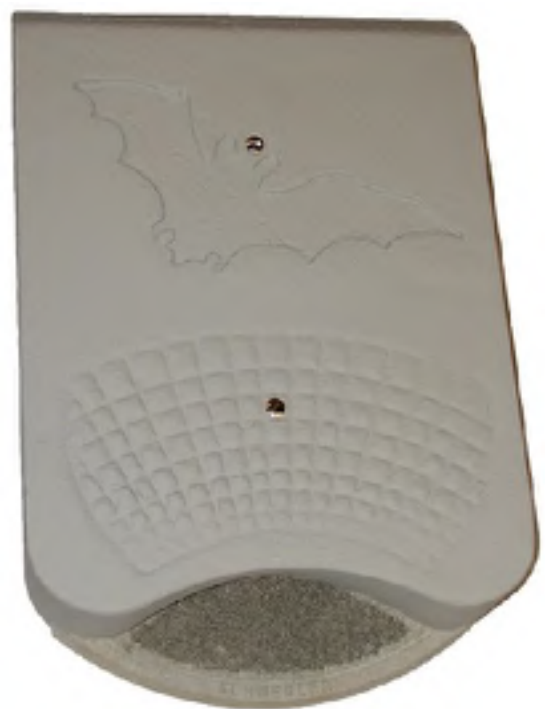
1WQ Schwegler Summer & Winter Bat Roost

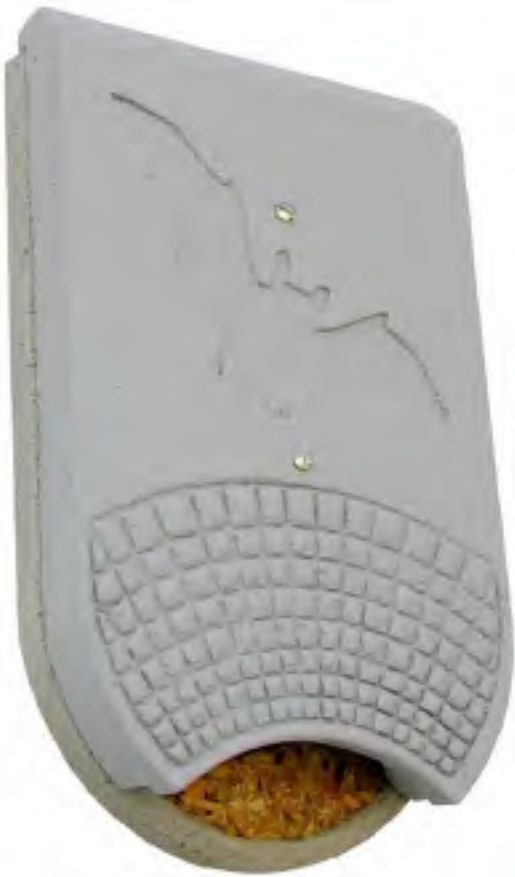
1FQ Schwegler Bat Roost

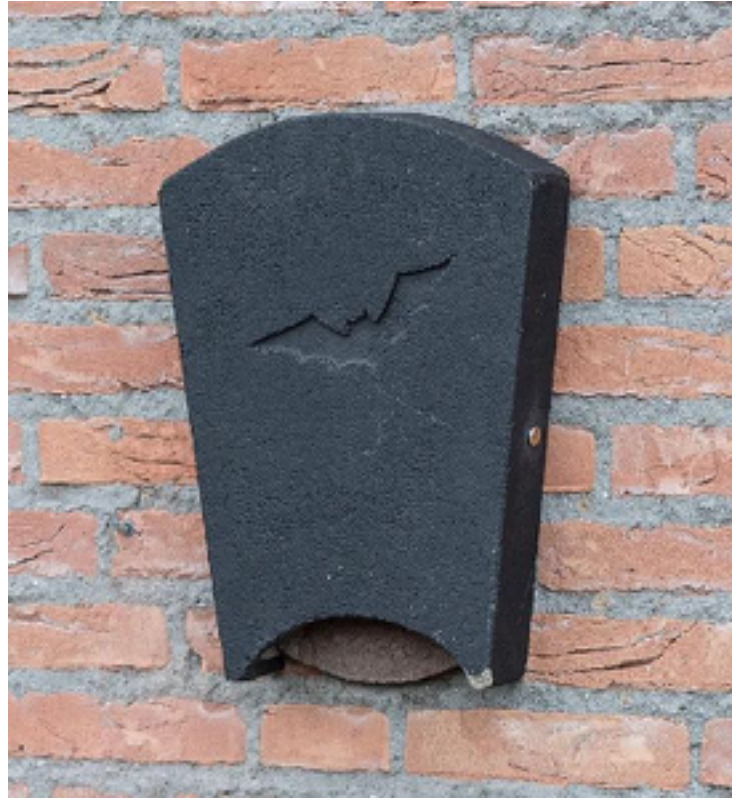
Beaumaris Woodstone Bat Box

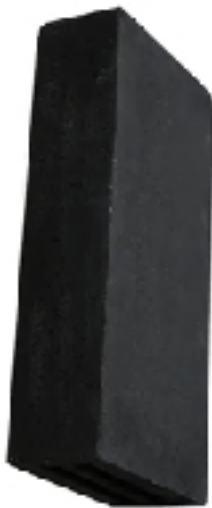
Greenwood's Ecohabitats Two Crevice Bat Box
