## Preliminary Ecological Appraisal

Premier Inn Merthyr Tydfil, Duffryn, Pentrebach, Merthyr Tydfil, CF48 4BB

Premier Inn Hotels

The construction of an extension to the hotel for the construction of 16 additional rooms.

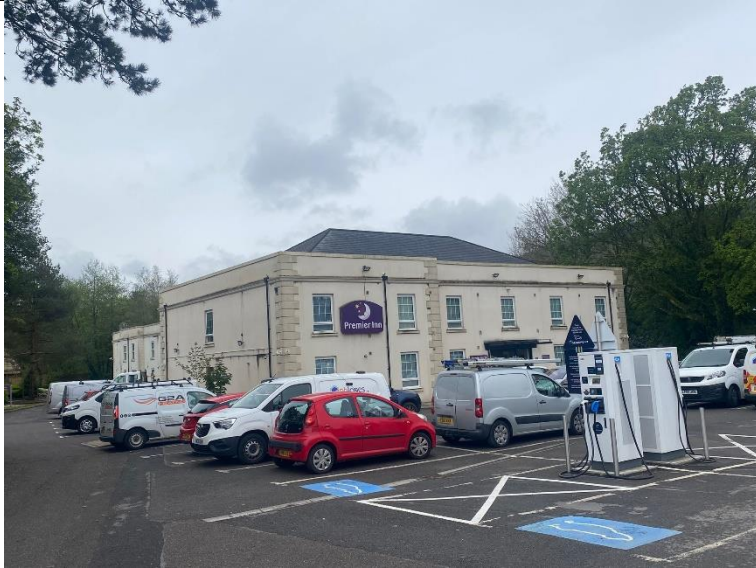
| | <p>&lt; Image 1: North elevation of B1 with rendered brickwork and secure slate roof tiles.</p> <p>&gt; Image 2: East elevation of B1, showing the scaffolding for a closer inspection above the buttress wall edge around the building edge.</p> | |

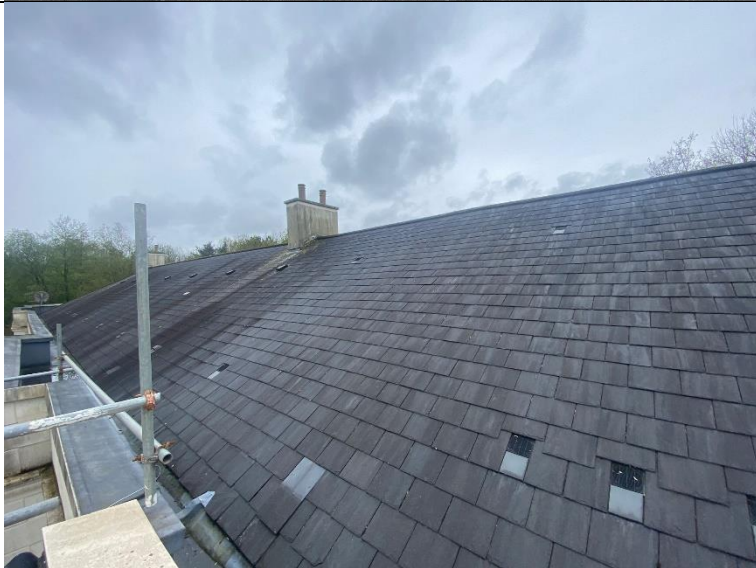
| | <p>&lt; Image 3: A close up of the field tiles on the east elevation of B1. They are in excellent condition.</p> <p>&gt; Image 4: The local landscape east of the site, ideal for foraging and commuting bats.</p> | |

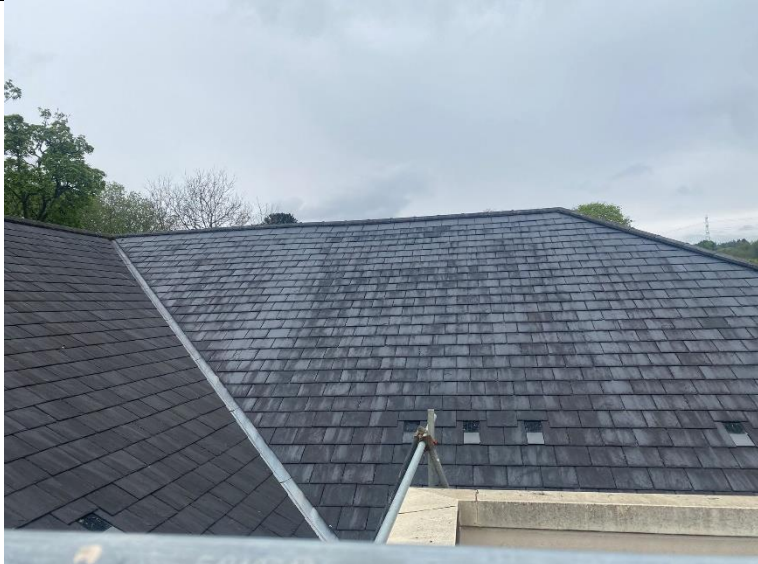
| | <p>&lt; Image 5: Looking northwest at the field tiles on the L of the building.</p> <p>&gt; Image 6: A close up of the minor, narrow, ridge gap on this northern elevation.</p> | |

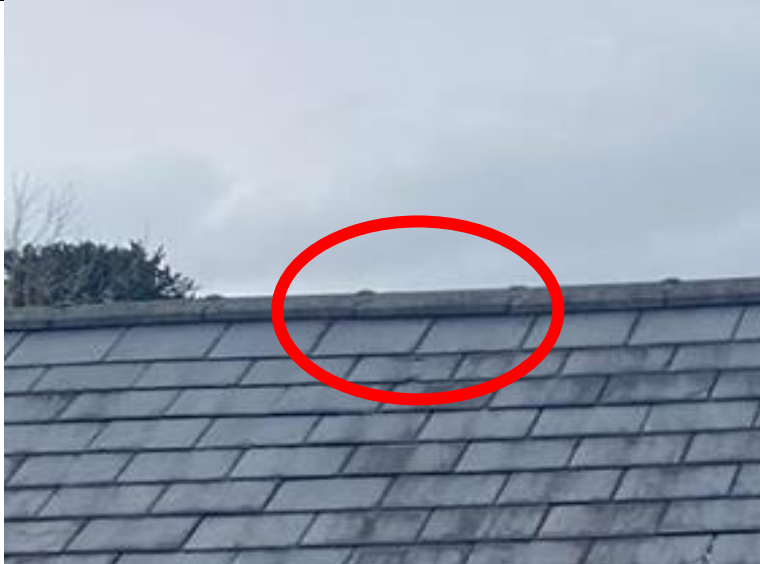
| | <p>along the centre of the loft, with a ladder to an elevated level which contained water tanks. The remaining spaces were covered in loose wool insulation.</p> <p>The loft was mostly secure. There were areas of gaps within the lining, particularly near the ridge of the loft (see Appendix 1b for approximate locations). The presence of undisturbed cobwebs along this area can indicate that bats are not using this area as an access or roosting point. With the exterior roof tiles being so well sealed, it is unlikely that bats could utilise these features to access the loft for roosting. No light entered either of the spaces and there were no droppings or feeding remains seen within. In addition, there is a bright green fire safety light permanently on within the loft space, the lux level lowers the suitability for roosting bats significantly.</p> <p>Based on this information, the building is concluded to have suitably low value for supporting roosting bats, but based on the proposals, the section of the building has negligible value for roosting bats.</p> <p><b>Roosting habitat – Building 2</b></p> <p>There is another building (B2) within the red line boundary, a two-storey multipitch restaurant bar. The brickwork is covered by render, which is in excellent condition, no cracks, or visible crevices. There are three chimneys present. The windows and doors are UPVC and in very good condition with no gaps around at all and no means of ingress. The roof is pitched and has slate tiles and lead flashing at the ends, which are mostly in excellent condition. The roof tiles are all present, although there are some raised tiles around the chimney areas which crevice dwelling species may utilise.</p> <p>The internal of this building could not be accessed during the survey. Based on this information, the building is considered to have “low” value to support roosting bats</p> |

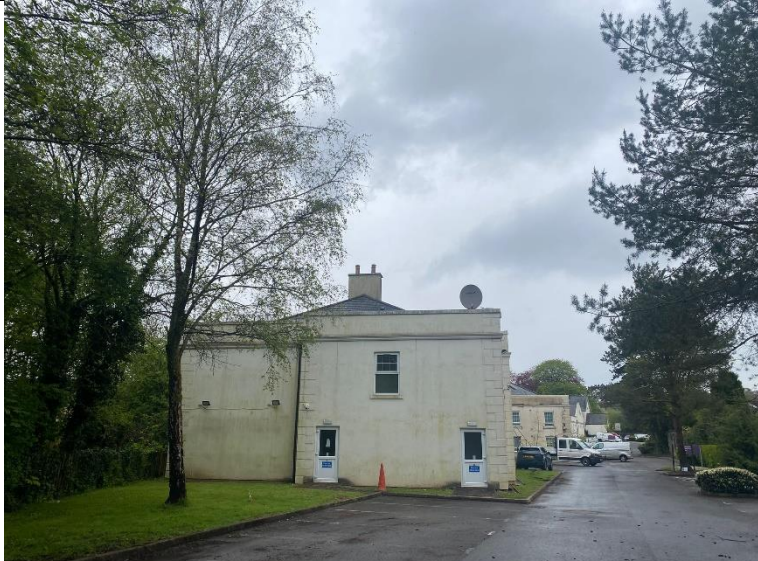
| | <p>&lt; Image 7: South elevation of B1 and T2 in front of it, which has no features present.</p> <p>&gt; Image 8: The exterior of B2. The west facing elevation.</p> | |

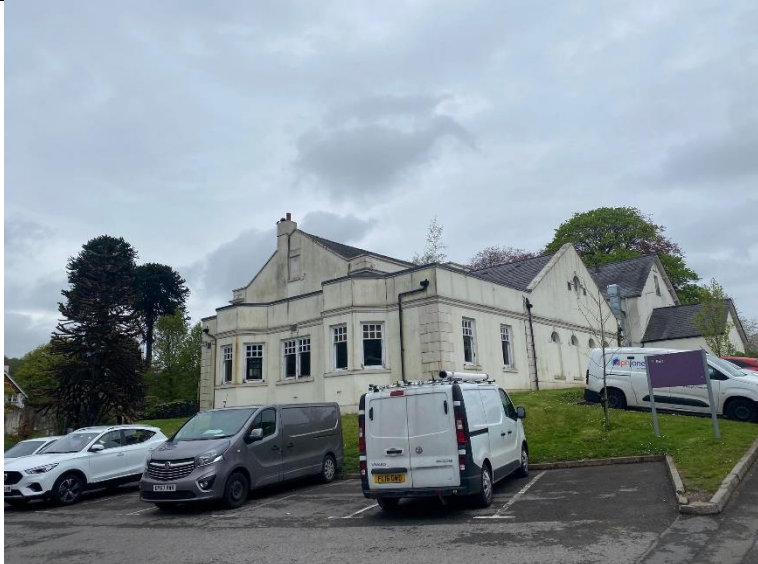
| | <p>&lt; Image 9: South and east elevations of B2.</p> <p>&gt; Image 10: The loft space of B1. There are undisturbed cobwebs along the ridge.</p> | |

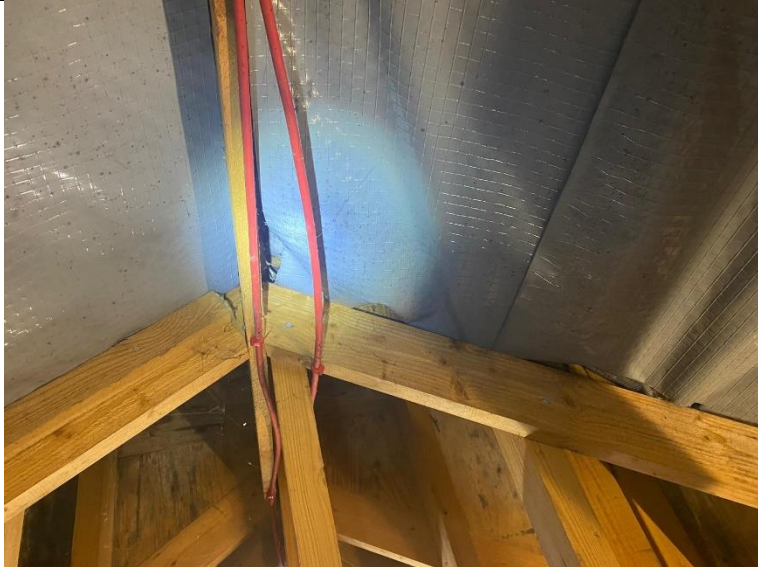
| | <p>&lt; Image 11: Close-up of some gaps along the ridge internally, but with no connection to the exterior of the building.</p> <p>&gt; Image 12: Green fire exit light on permanently within the loft space.</p> | |

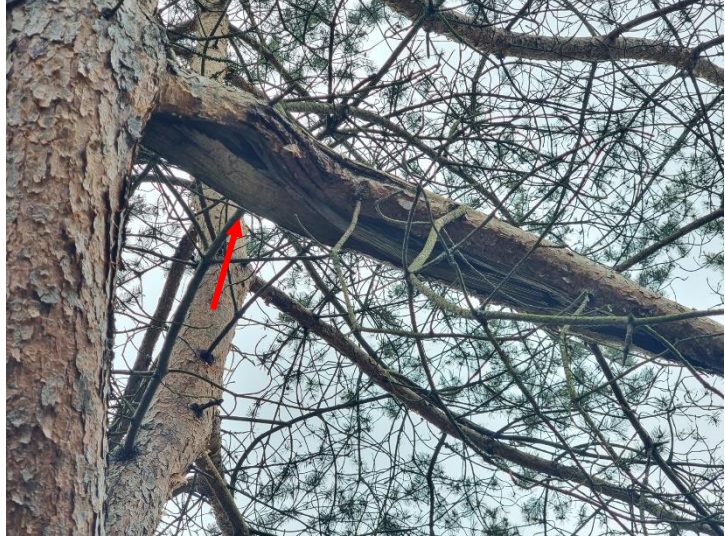
| | <p><b>Roosting habitat – T1 and T2</b></p> <p>There are multiple trees on site. Some which have roosting features for bats to utilise, but only two are due to be removed for the proposed works and therefore were assessed for their suitability.</p> <p>T1, a Scott's pine has a limb torsion split on its east facing stem approximately 3m up. This crevice is open to the elements making this feature suboptimal. In addition, the feature is easily inspected and therefore can be checked prior to felling. There are no other features present on the tree.</p> <p>T2, is a silver birch with no suitable features on this tree for supporting roosting bat species.</p> <p>Associated images of the buildings and trees can be found at the end of the report, Appendix 4</p> <p><b>Foraging and commuting habitat</b></p> <p>Bats could use the woodland and watercourse for foraging along the boundaries within the local landscape for foraging and commuting and could also be used by bats dispersing from nearby roosts outside of the site and commuting around the area.</p> |

| | <p>&lt; Image 13:<br/>internal walls were<br/>secure with no<br/>external light<br/>entering, no<br/>evidence of bats<br/>or droppings<br/>found inside.</p> <p>&gt; Image 14: The<br/>limb feature on T1<br/>which can be<br/>inspected prior to<br/>felling.</p> | |

| <i>Recommendations</i> | <p><b>Foraging and commuting habitat</b></p> <p>No further surveys are recommended for the buildings on site.</p> <p>Prior to the felling of T1, a close-up inspection of the roosting feature will be undertaken by a licensed ecologist to determine the presence or likely absence of roosting bats.</p> <p>In the unlikely event that a bat or evidence of bats is discovered during the development all work must stop and a bat licensed ecologist contacted for further advice.</p> <p><b>Artificial lighting</b></p> <p>A low impact lighting strategy will be adopted for the site during post-development which outlines the areas of the site that will be retained as dark corridors. Parameters can be found on the Bat Conservation Trust website: <a href="https://www.bats.org.uk/our-work/buildings-planning-and-development/lighting-2">https://www.bats.org.uk/our-work/buildings-planning-and-development/lighting-2</a></p> <p><b>Suggested biodiversity enhancements</b></p> <p>The installation of two bat boxes at the site will provide additional roosting habitat for bats. The bat boxes will be installed on the hotel or on mature trees within the woodland, or incorporated into the design. Bat boxes should be positioned 3-5m above ground level facing in a south or south-westerly direction with a clear flight path to and from the entrance, away from artificial light. The bat box will be a specification suitable for crevice dwelling species such as Woodstone bat box or a similar alternative brand, or Ibstock bat bricks.</p> |

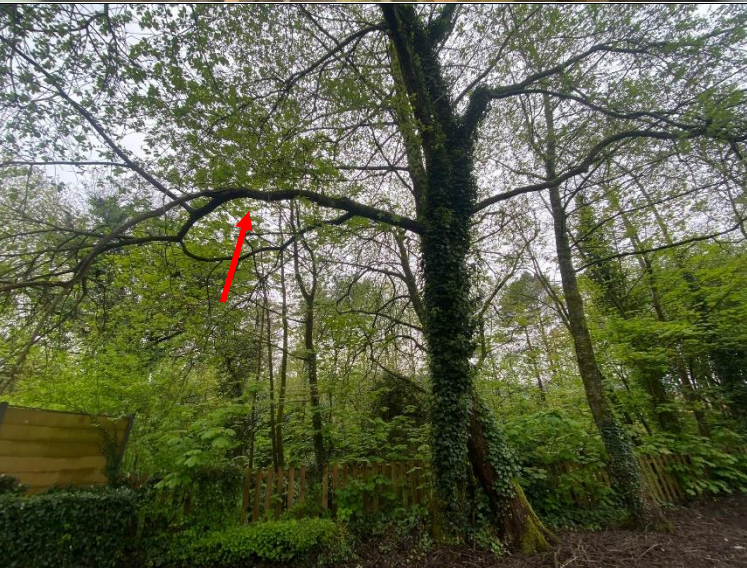
| | <p>&lt; Image 15: T3, an<br/>alder, is further<br/>south of T1 and T2<br/>and not due to be<br/>impacted by the<br/>works but has<br/>some features<br/>present.</p> <p>&gt; Image 16: The<br/>limb feature on T3<br/>close-up.</p> | |

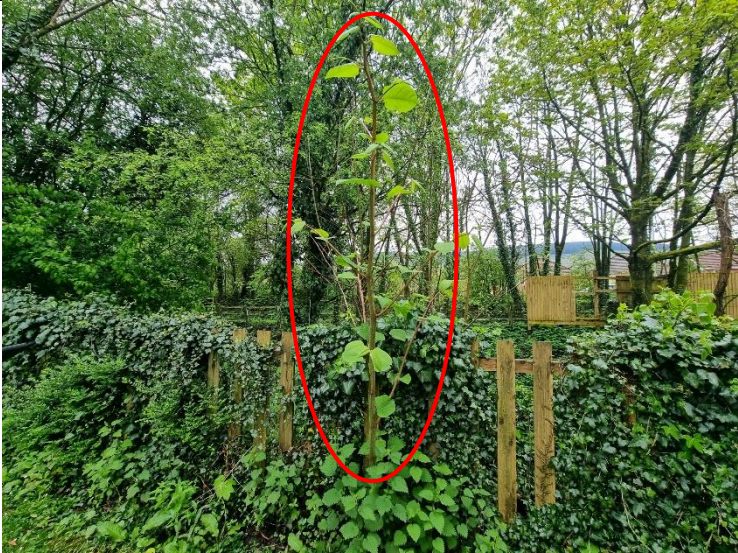
| <i>Summary of Survey Findings</i> | Immediately adjacent to the proposed extension of the building, Japanese knotweed is present on site. |
| <i>Foreseen Impacts</i> | Any disturbance or damage to the plant or the soil could result in the spread of the plant – which is an offence. The visible stands above ground can have rhizomes underground which spread as far as 7m. |

| | <p>&lt; Image 17:<br/>Mature beech trees, willow trees and short modified grass on site.</p> <p>&gt; Image 18: A large stand of JPK adjacent to the south-west corner of the building to be developed.</p> | |

| <i>Recommendations</i> | <p>Visible stands of JPK should have secure fencing installed with a buffer of 7m from the visible stands to prevent machinery, materials or persons entering the zones and to prevent accidental spread.</p> <p>An invasive species management plan will be required to control and/or eradicate Japanese knotweed which will likely include the injection of strong herbicides and will require a waste permit for removal of hazardous waste from site. Specialist contractors should be contacted for treatment and removal of JPK.</p> |
