# THE CROFT, QUEENS ROAD, MERTHYR TYDFIL

## Preliminary Bat Roost Assessment

February 2023

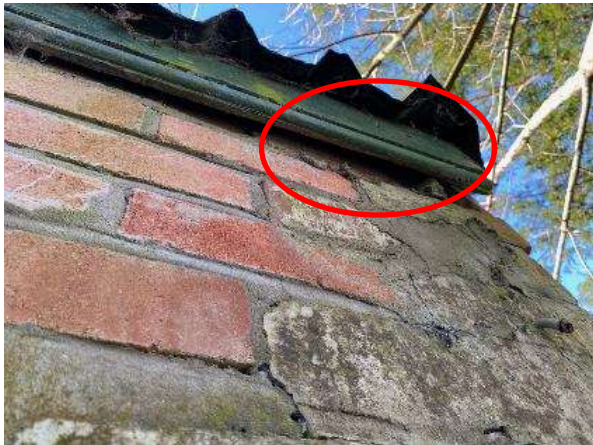
| <b>External Survey Results</b> | <p><b>Photo 1:</b> Northern elevation<br/>Showing gap along the fascia board allowing bats access internally (<b>red circle</b> refers).</p> |

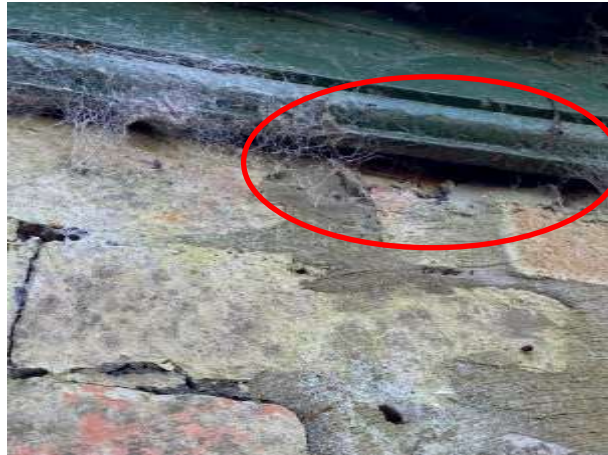
**Photo 2:** Northern elevation

Showing gap along the fascia board allowing bats access internally (**red circle** refers) with some cobwebs present indicating inactivity.

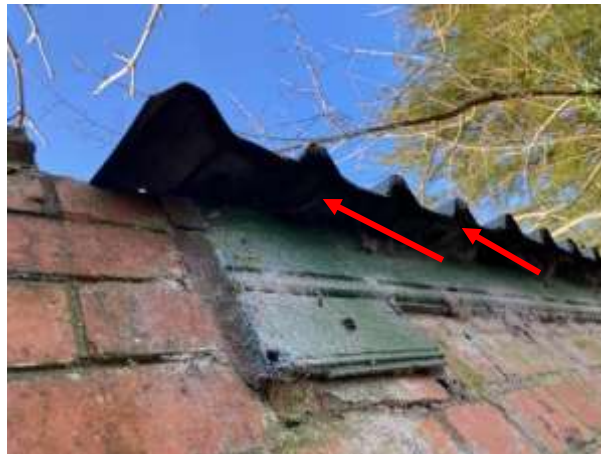
**Photo 3:** Northern elevation

Showing gaps between the corrugated metal roof and ceiling allowing (**red arrows** refer).

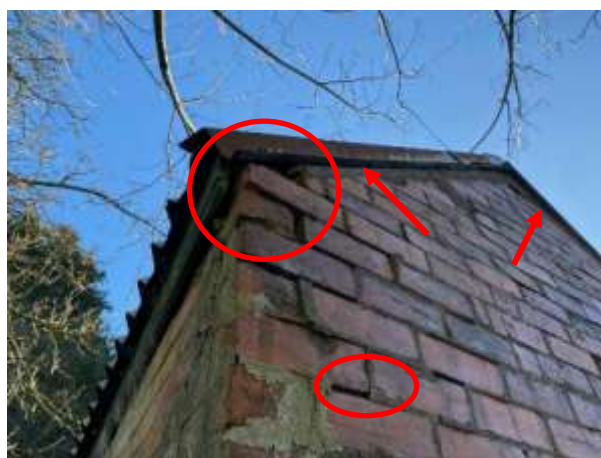
**Photo 4:** Western elevation

Showing gaps from missing mortar and bricks (**red circles** refer) and gaps along barge flashing and brick wall (**red arrows** refer)

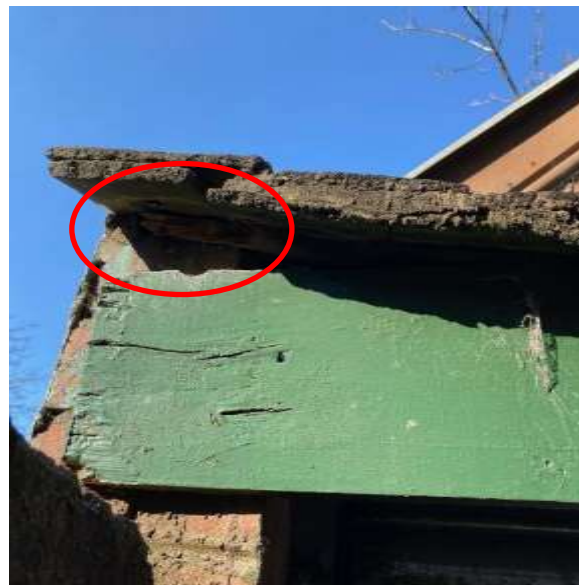
**Photo 6:** Eastern elevation

Showing gap between the fascia board and shingle tiles (**red circle** refers)

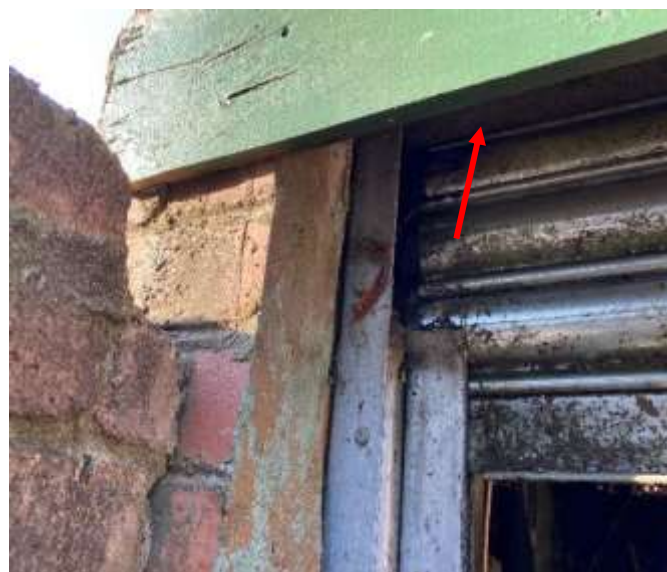
**Photo 7:** Eastern elevation

Showing gap above the roller door (**red arrow** refers).

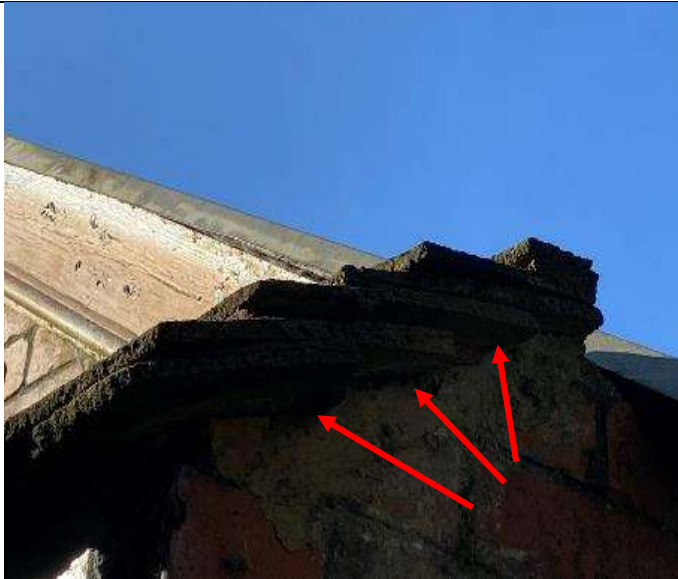
**Photo 8:** Eastern elevation

Showing gaps between wall and shingle tiles (**red arrows** refer)

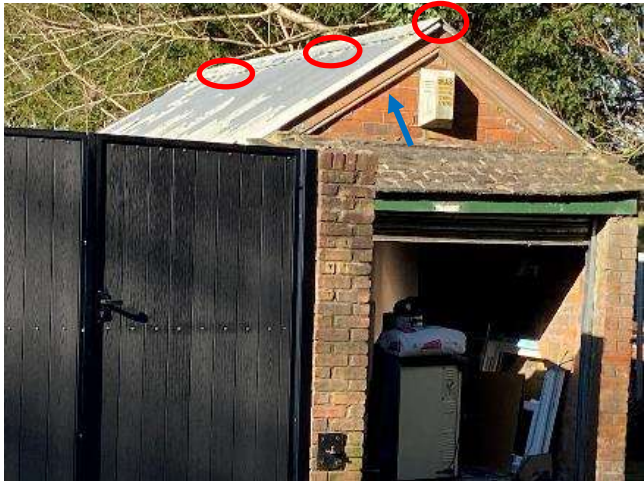
**Photo 9:** Southern and eastern elevation  
Showing gaps between ridge flashing and corrugated metal roof (**red circles** refer) and gaps at barge board at the gable end (**blue arrow** refers)

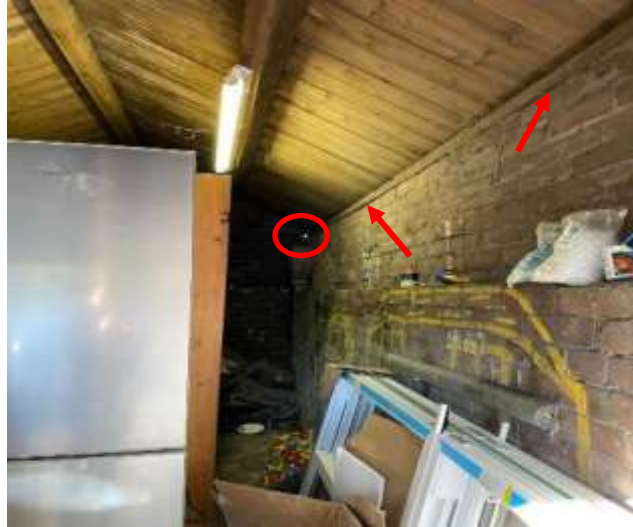
**Photo 10:**

Showing gap at the north-western corner of the garage allowing bats assess internally (**red circle** refers) and gap between eaves and wall providing roosting locations (**red arrows** refer).

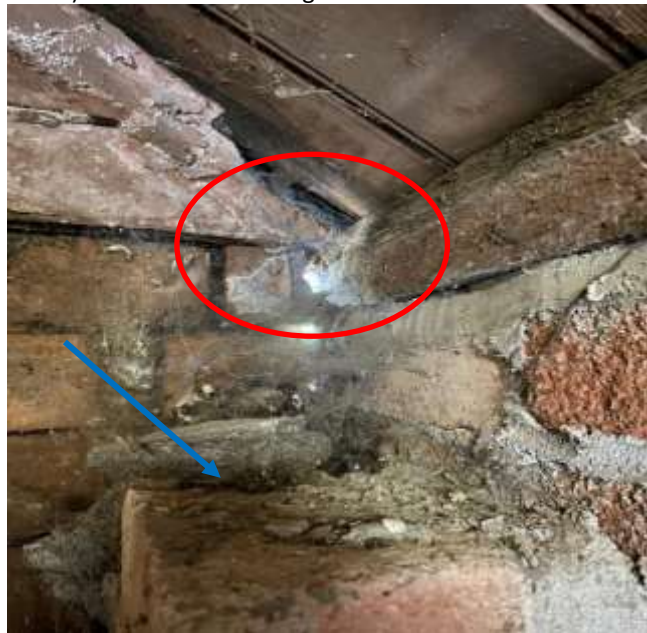
**Photo 11:**

Showing gap at the north-western corner of the garage up close which at the time of the survey was covered with intact cobwebs, which indicates inactivity (**red circle** refers). Suitable bird nesting location are indicated with blue arrow.

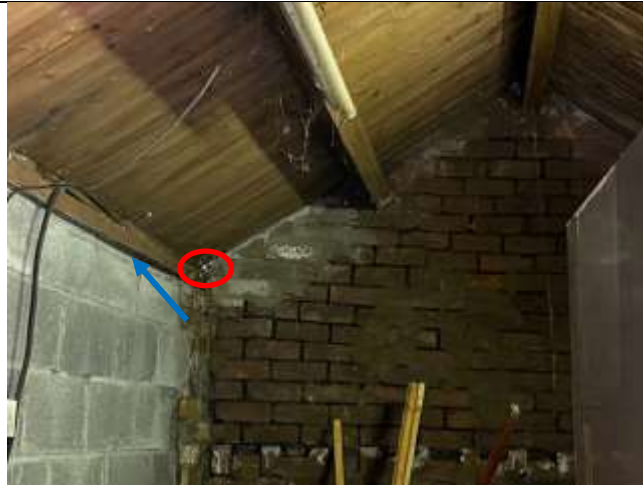
**Photo 12:**

Showing gap at the south-western corner of the garage allowing bats assess internally (**red circle** refers), gap between wall and purlin (**blue arrow** refers) and gaps from missing mortar all along the back brick wall (western elevation) providing roosting locations.

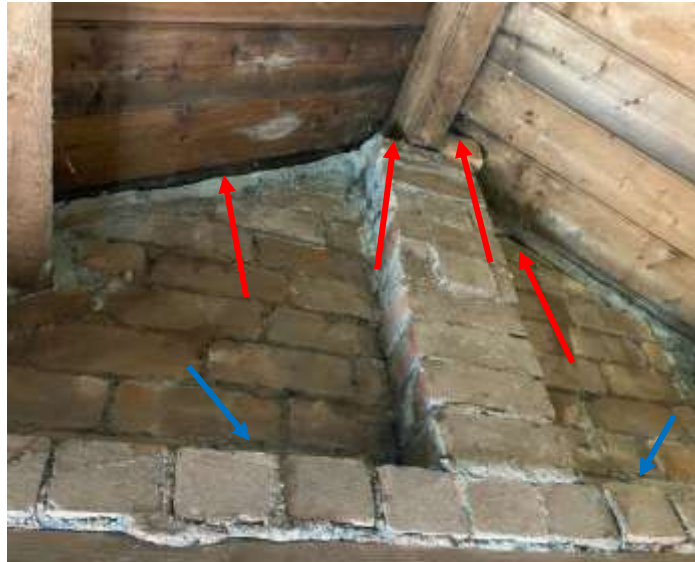
**Photo 13:**

Showing crevices between wall and ceiling (**red arrow** refers). Suitable bird nesting location are indicated with **blue arrows**.

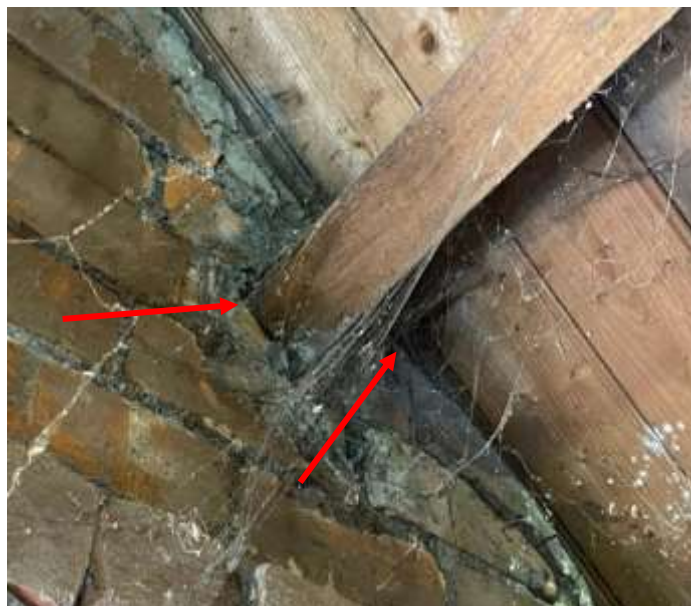
**Photo 14:**

Showing crevices between wall, ceiling and purlin of which some were covered with intact cobwebs at the time of the survey indicating inactivity.

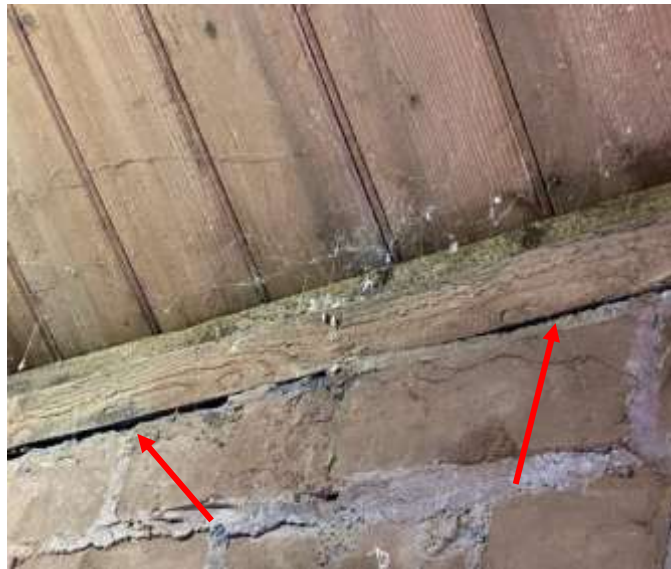
**Photo 15:**

Showing gaps from missing mortar (**red arrows** refer).

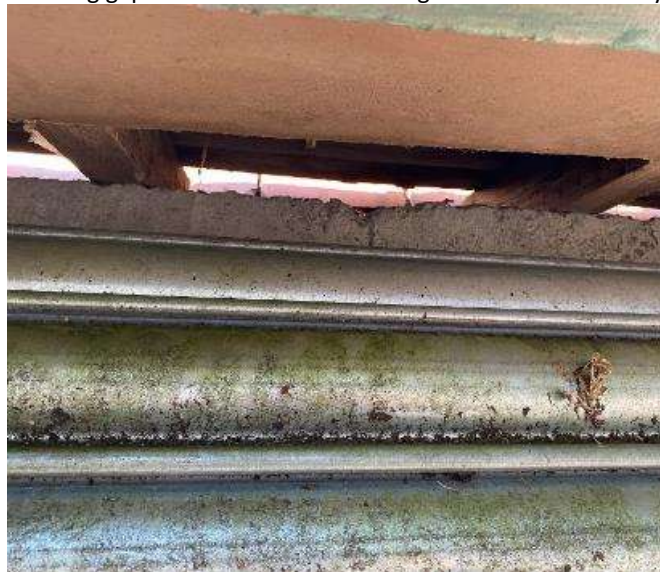
**Photo 16:**

Showing gap above roller door allowing bats access internally.
